Bulletin of the Department of Geology, Tribhuvan University, Kathmandu, Nepal, Vol. 10, 2007, pp. 79-88

# Bio-engineering measures for stabilising cut-slopes of Dipayal-Mellekh road, Far Western Nepal

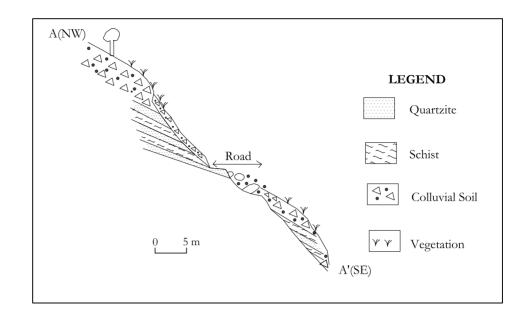
Problem: A debris slide of 20 m x 12 m exists. The half of the width of the road is badly affected by erosion due to improper surface drainage (Fig. 4). Tension cracks are developed on downslope of the road. Gullies are active and well developed.

Considering all the site conditions, the function required are armouring and reinforcing the slope. The effective measure is diagonal grass lines plantation and vegetated gabion. The failed road segment may be protected by construction of Retaining wall with tree plantation and proper side drain.Palisades are recommended for protection of rill and gullies. Suitable grasses for the site are *Eulaliopsis binata*, Neyraudia reynaudiana, Arunduell nepalensis and Cymbopogon microtheca. The trees are *Erythrina species* and *Pinus roxburghii*.

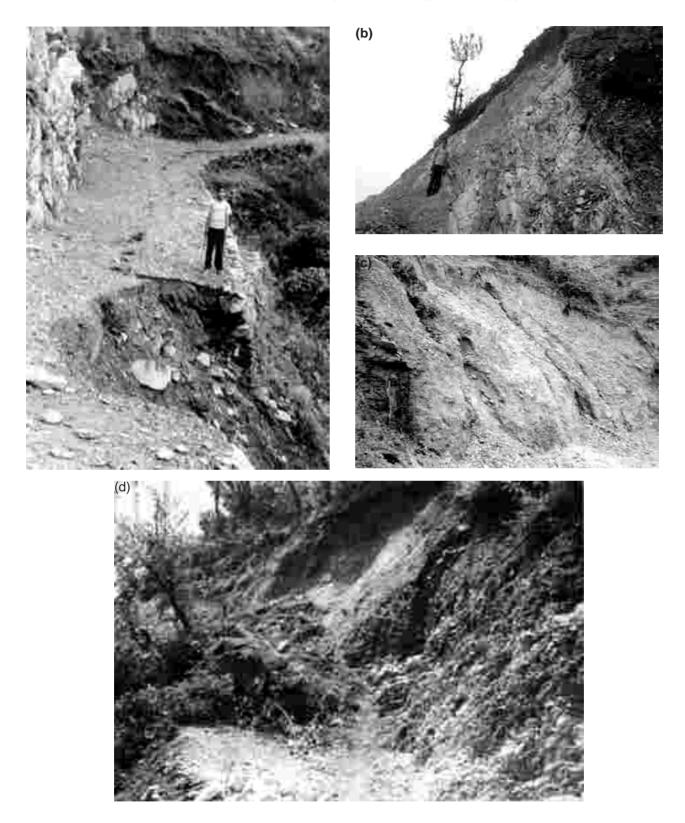
The proposed site B1 is located at chainage 16+400 km (Fig. 5a). The site condition is given as below:

Problem: A debris slide of 30 m x 10 m exists and a portion of the road has collapsed.
Bedrock: Weathered mica schist and quartzite
Soil cover: Colluvial silty sand, 1 m thick
Vegetation: Sparse on the upslope of the site
Natural slope: 40 to 60°

Fig. 5 Photographs showing proposed sites for bioengineering: (a) Site B1 showing damaged road segment; view towards southeast, (b) Site B5 showing steep rock slope containing mica-schist and quartzite bedrock; view towards east, (c) Site B7 showing soil slide with distinct gully erosion; view towards southeast and (d) Site B8 showing debris slide on weathered quartzite and phyllite; view towards east

Problem: A rock slide of 40 m x 10 m exists. Bedrock: Weathered mica-schist and weathered

This site contains a rock slide (Fig. 5b). The functions required are reinforcing and anchoring of the slope. Therefore, jute netting with site seedling of shrub or small trees is the best solution. This method allows steep, rocky and unstable slopes to be revegetated. The species as proposed in sites B3 and B4 are applicable in site B5.

Problem: A soil slide of 15 m x 10 m exists. Gully and rill erosion was observed (Fig. 5c).

- Problem: A debris slide of 20 m x 8 m exists. Development of rills and soil erosion is remarkable (Fig. 5d).
- Bedrock: Highly weathered phyllite and highly fractured quartzite
- Soil cover: Colluvial silty sand of 3 m thickness
- Vegetation: Upslope of the site is covered by a forest

Considering all the site conditions, the function required are armouring, reinforcing and support the slope. The effective measure is combination of diagonal grass lines plantation with revetment wall. The dry stone masonry wall in the road segment has failed due to improper construction. The proper construction of masonry wall with a line of large trees and large bamboo clump planting can stop road failure towards downslope. Palisades are recommended for protection of rill and gullies. It stabilzes the gully floor by forming a strong barrier and trapping materials moving downwards. Eulaliopsis binata (Babiyo), Neyraudia reynaudiana (Dhonde), Arunduell nepalensis (Phurke), Cymbopogon microtheca (Khar) and Thysanolaena maxiama (Amliso) are the most suitable grass species and Erythrina species (Phaledo), Pinus roxburghii (Rani salla) and Alnus nepalensis (Utis) are some of suitable tree species proposed for plantation. Colquhounia coccinea (Namdiphul) and Erythrina species (Phaledo) are suitable plant species for construction of palisades.

Construction of brush layers is the effective method. Brush layers armor and reinforce the upper soil layers up to 2 m depth (Lammeranner et al. 2005). These layers form a strong barrier, preventing the development of rills, and trap soil moving down the slope. The suggested species are *Lantana camara*, *Erythrina species* and *Vitex negundo*.

Diagonal grass lines plantation with revetment wall at the toe of the slope is recommended. Grass plantation in this way provides a surface cover with good armouring and reinforcement. Palisades are recommended for protection of gullies and rills. Suitable grasses for the site are *Cymbopogon microtheca* (Khar), *Saccharum pontaneum* (Kans), *Thysanolaena maxiama* (Amliso) and *Themeda species* (Katara khar).
