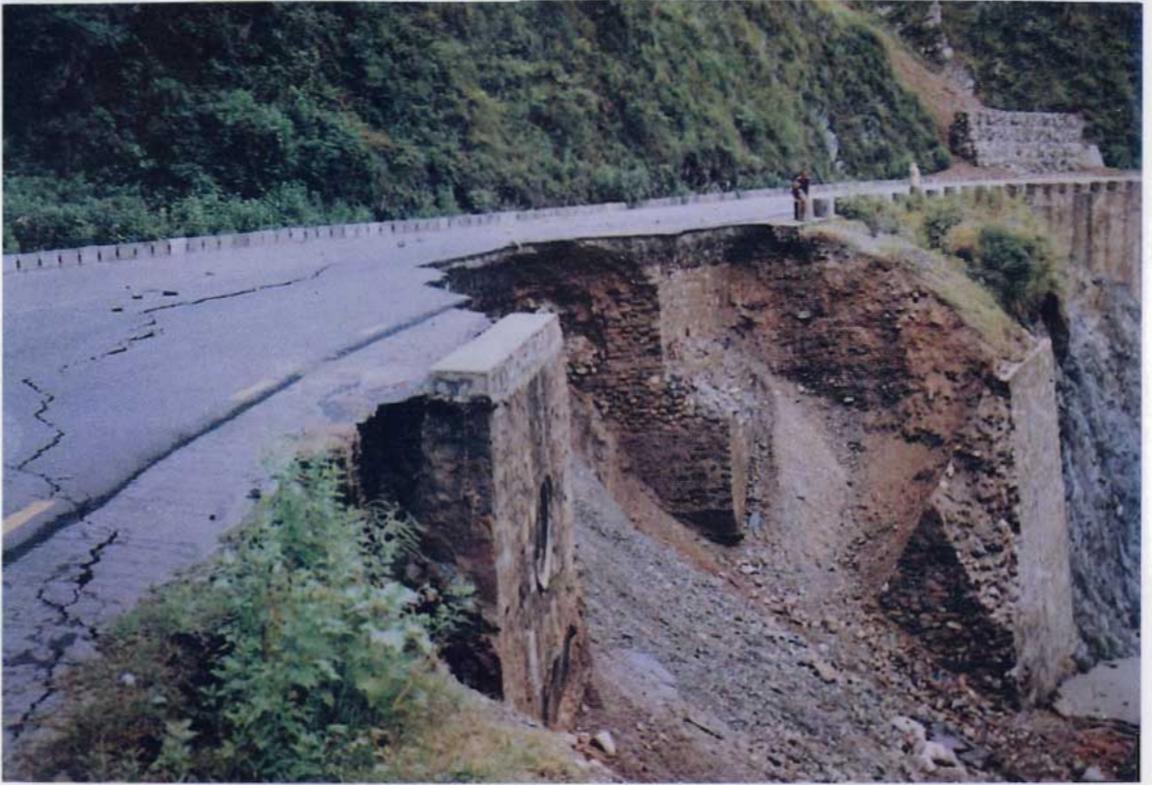
1. Lack of proper drainage behind the retaining wall has caused early failure of the retaining wall

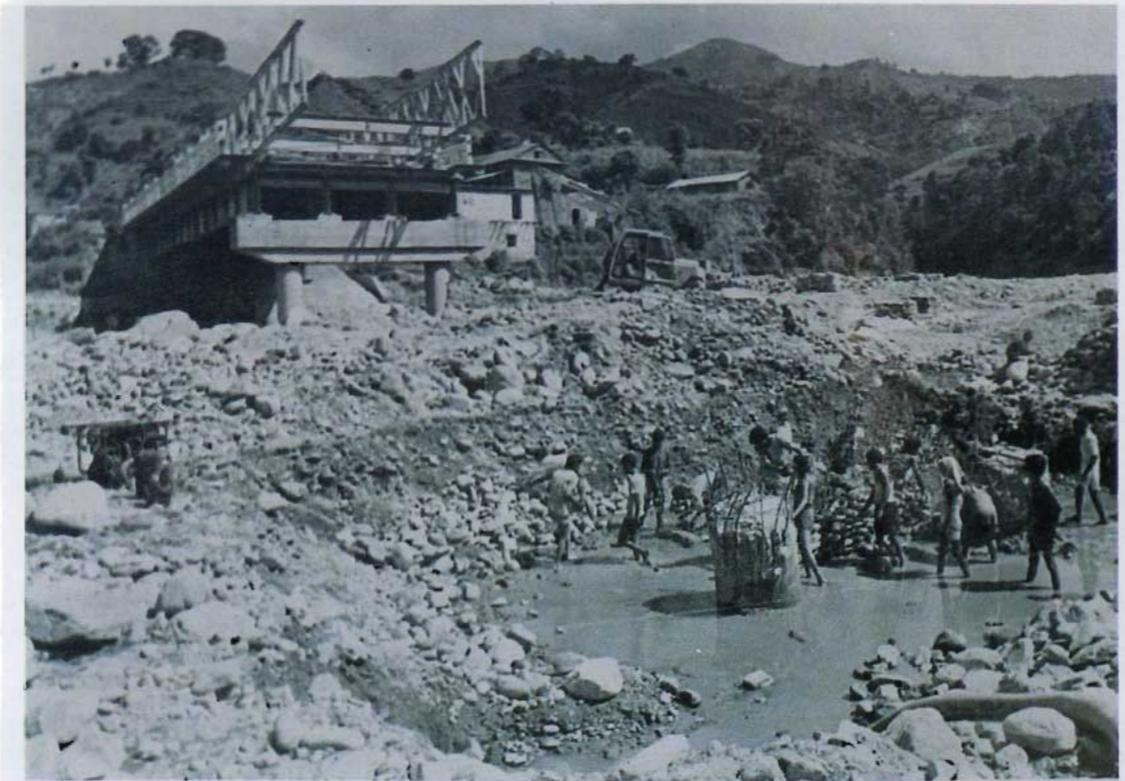
2. High flexural and shear stresses transmitted to the pier caused bridge failure

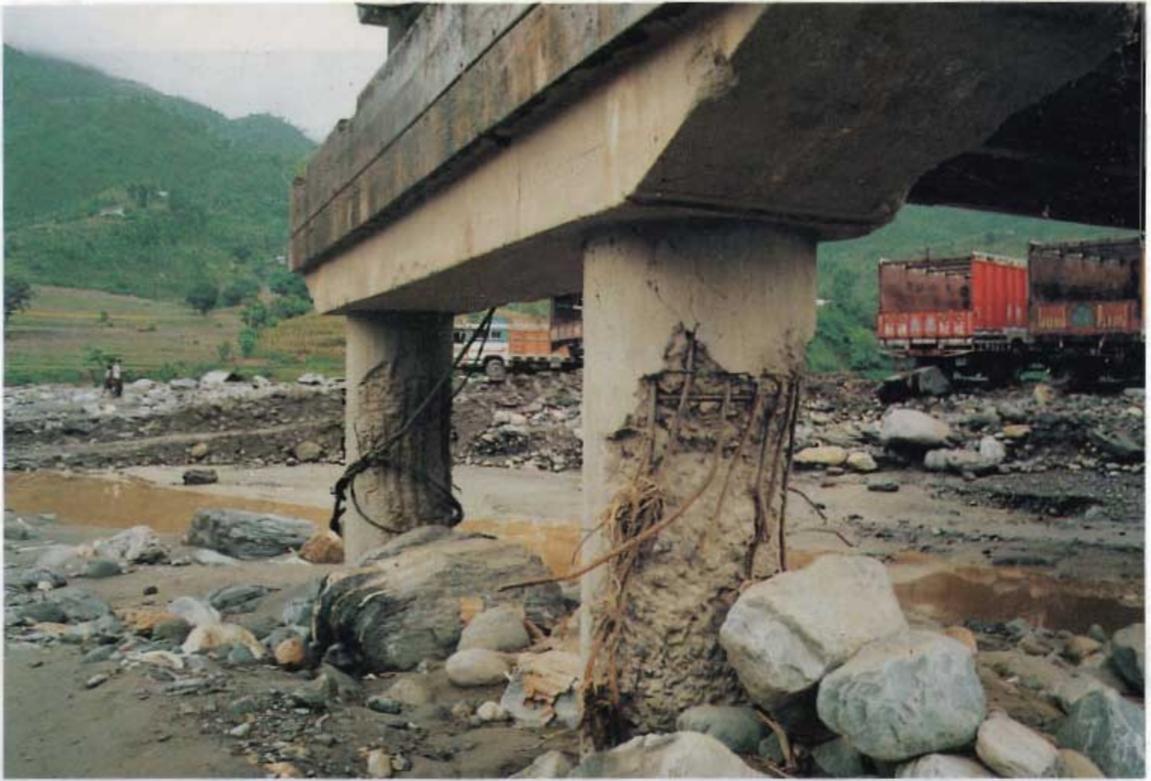
3. High flexural and shear stresses transmitted to the pier caused bridge failure

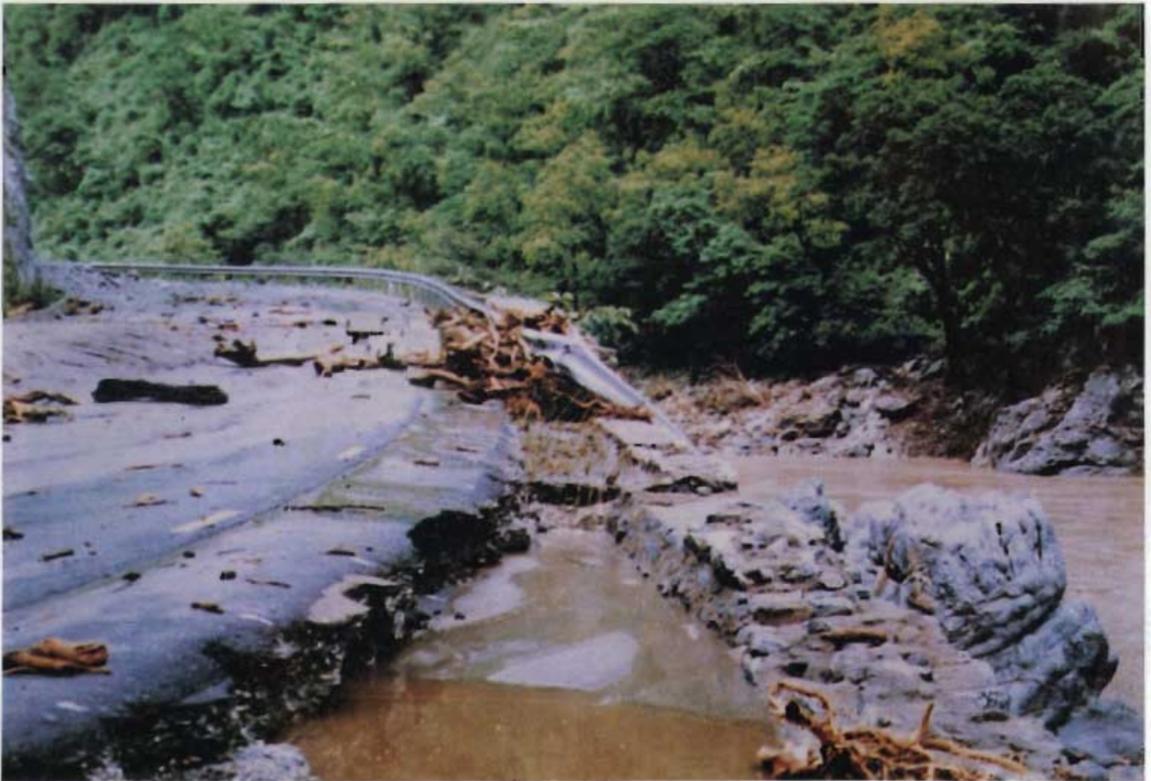
4. Submergence of road bed located close to the river

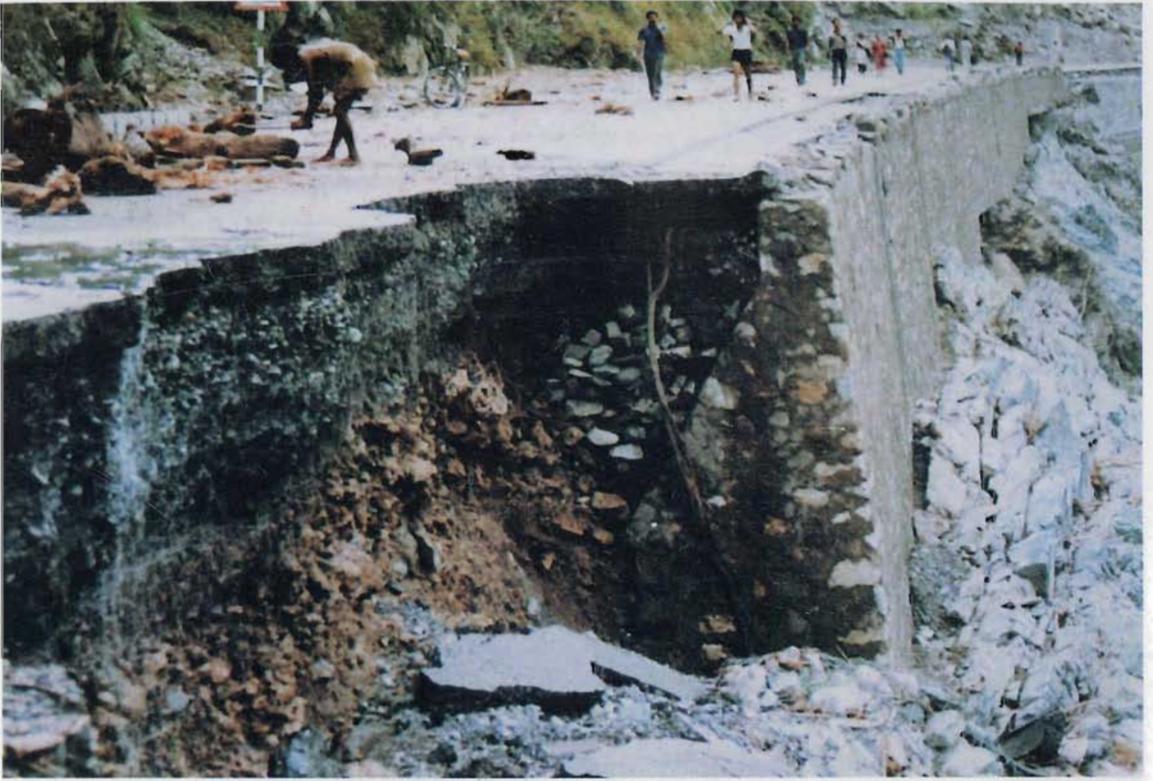
5. Failure of road elements due to subsequent rise in groundwater, toe-cutting, and undermining of the foundation of the retaining wall

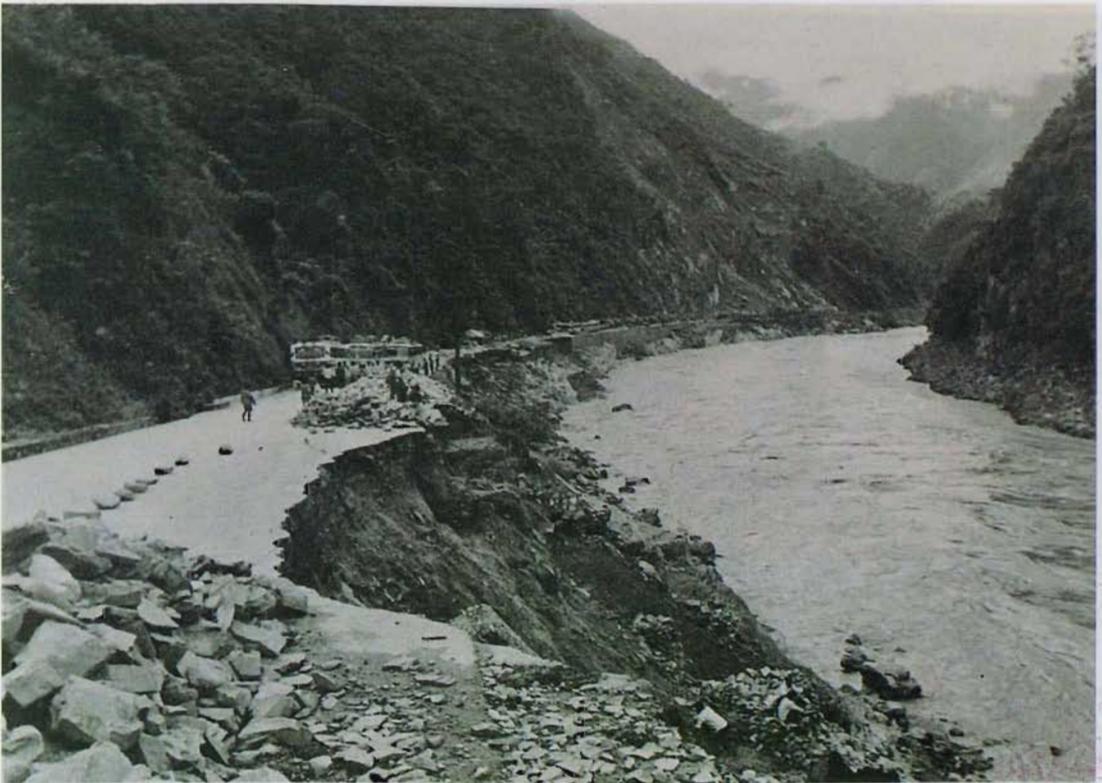
6. Effect of improperly designed river training work for mountain roads following the river

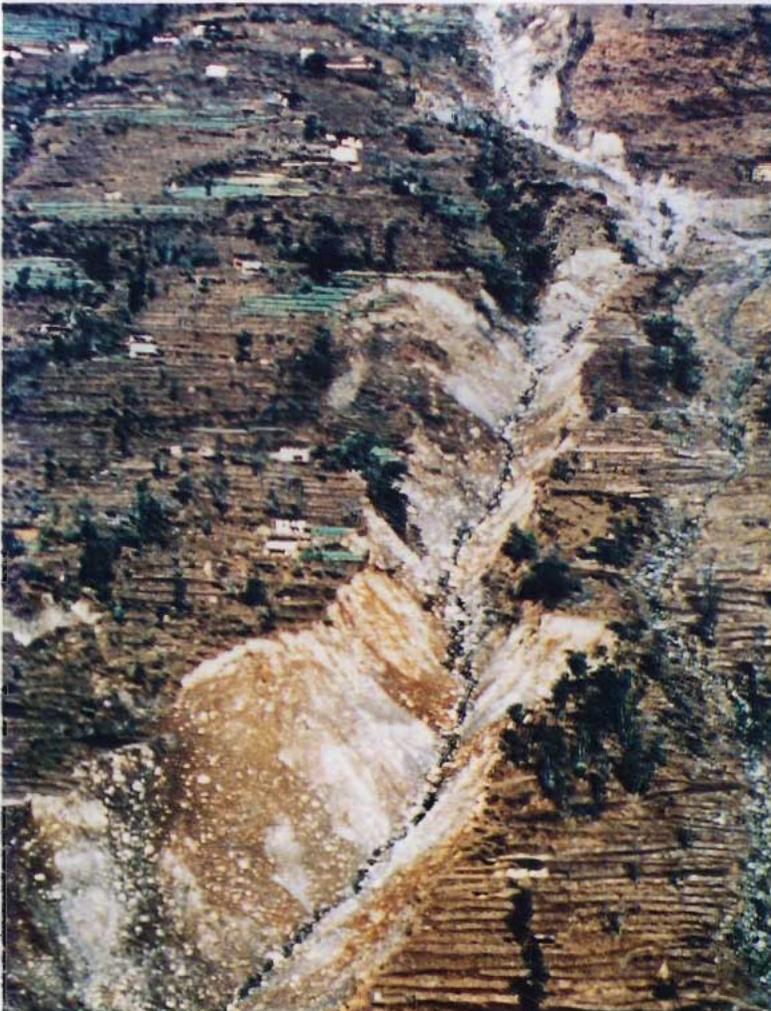
10. Erosion: Off the Lamosangu-Jiri Road, 1987

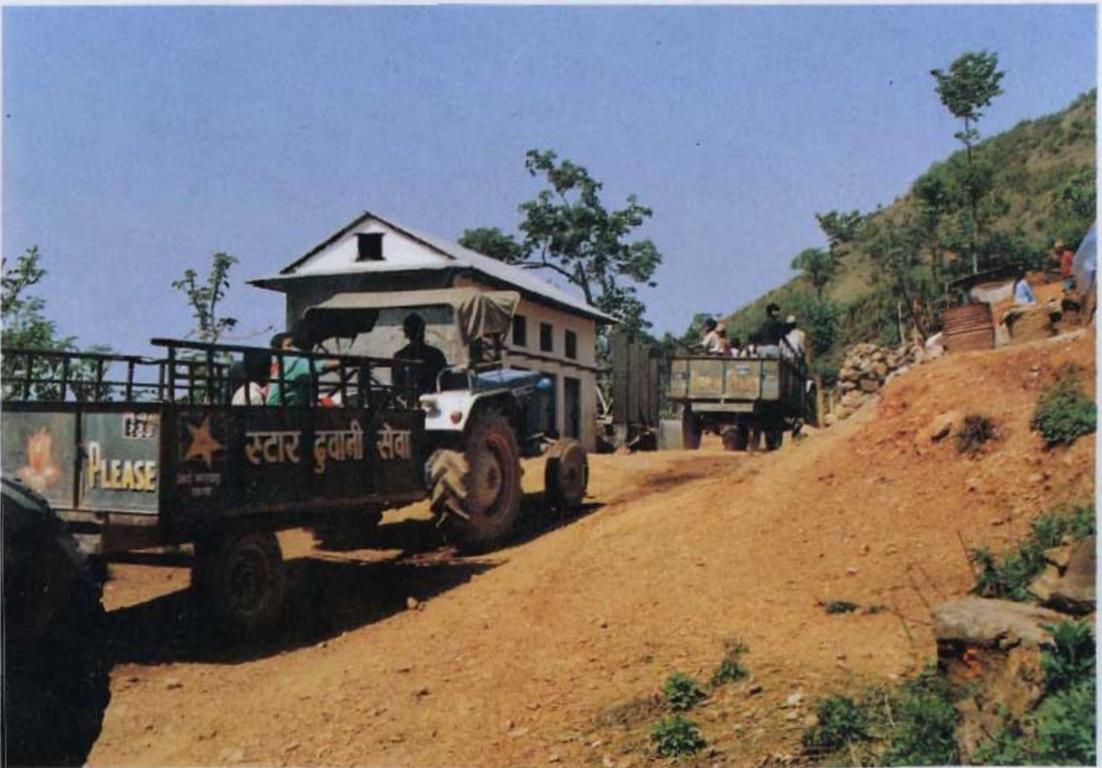
15. Scars from careless construction of village road at Lamatar, Lalitpur

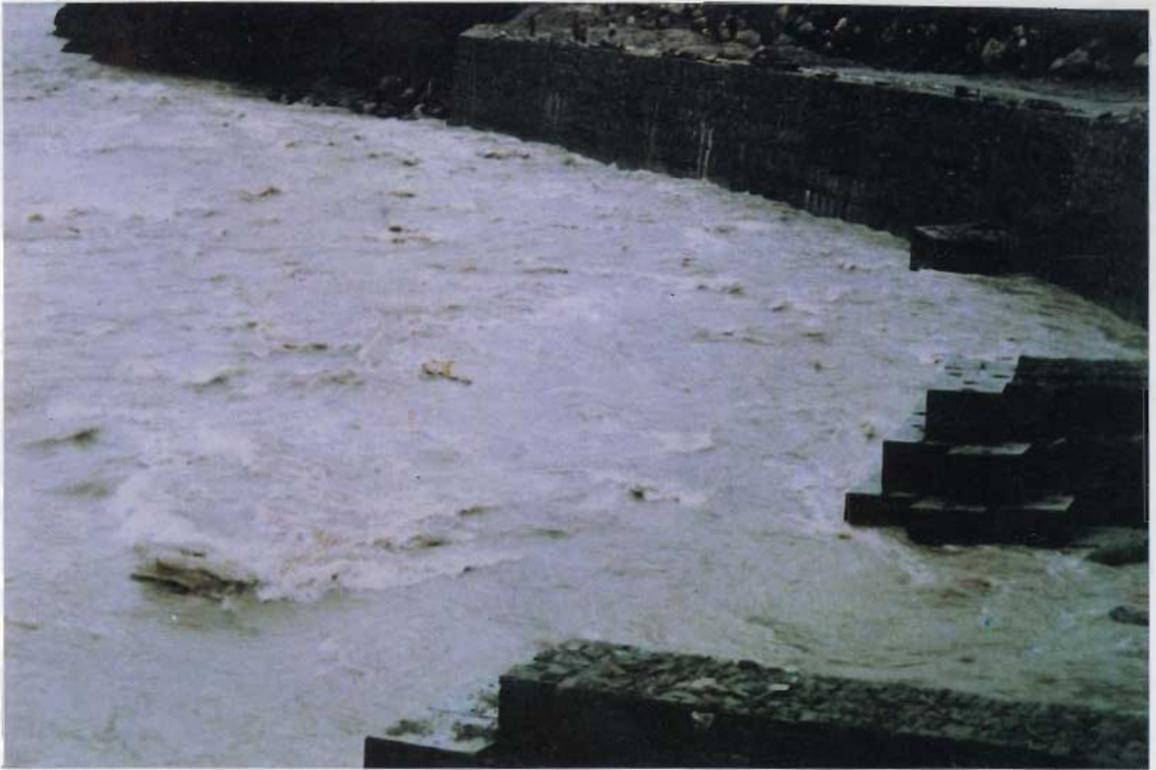
22. Improper river training work, road supporting structure without adequate foundation, Arniko Rajmarg

23. Construction of bridge in favourable conditions, to avoid massive river training work, improvements to Plate 22
