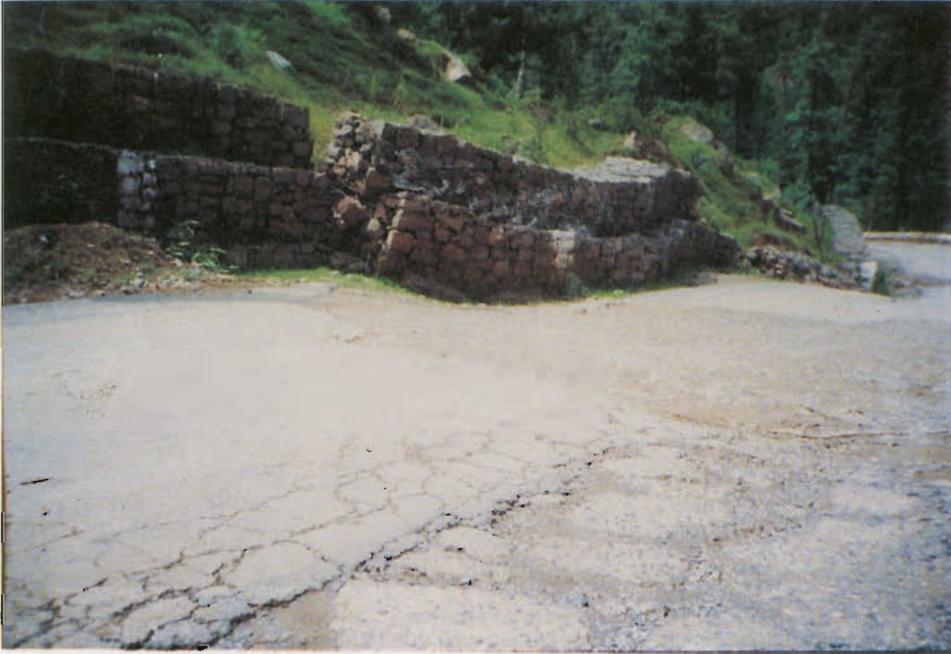
Plate 1: Medium-sized gabion structure showing deformation due to creep

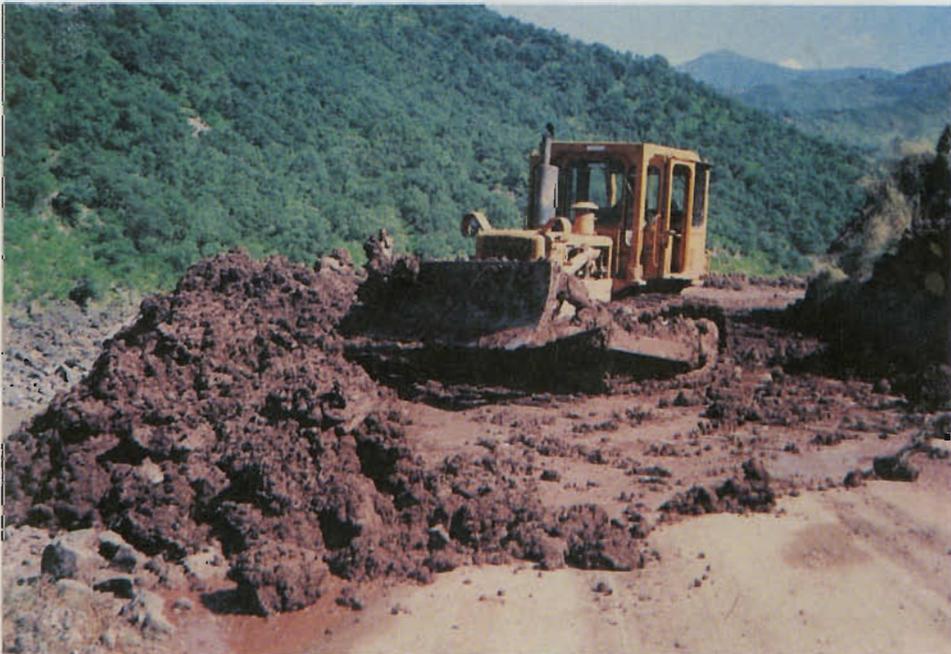
Plate 2: Landslide between Muzaffarabad and Garhi Dupatta (Failure is within the ancient landslide)

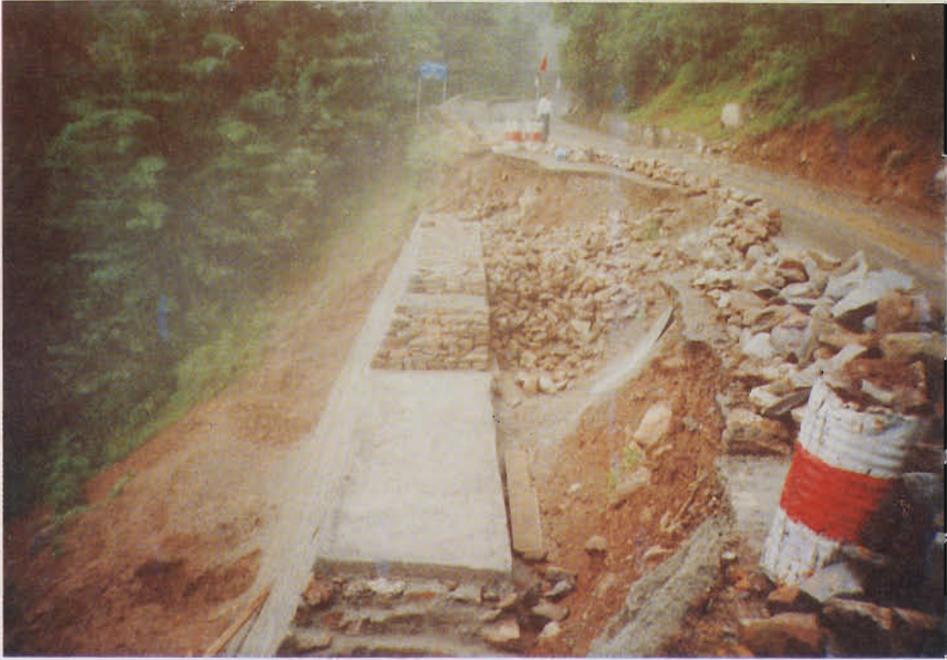
Plate 3: Downslope failure of the retaining wall due to landslide as a result of saturation

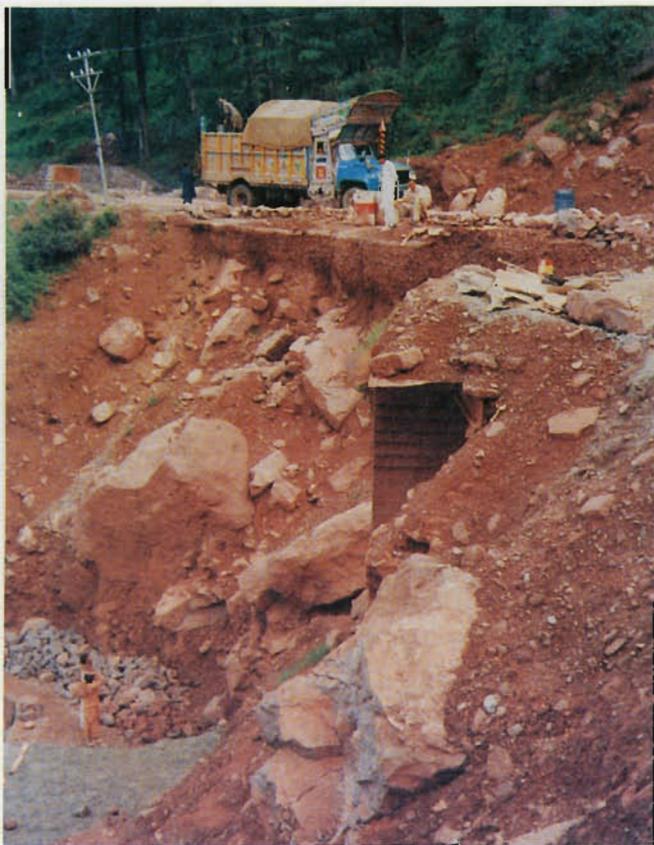
Plate 4: Failure of retaining wall due to slump failure

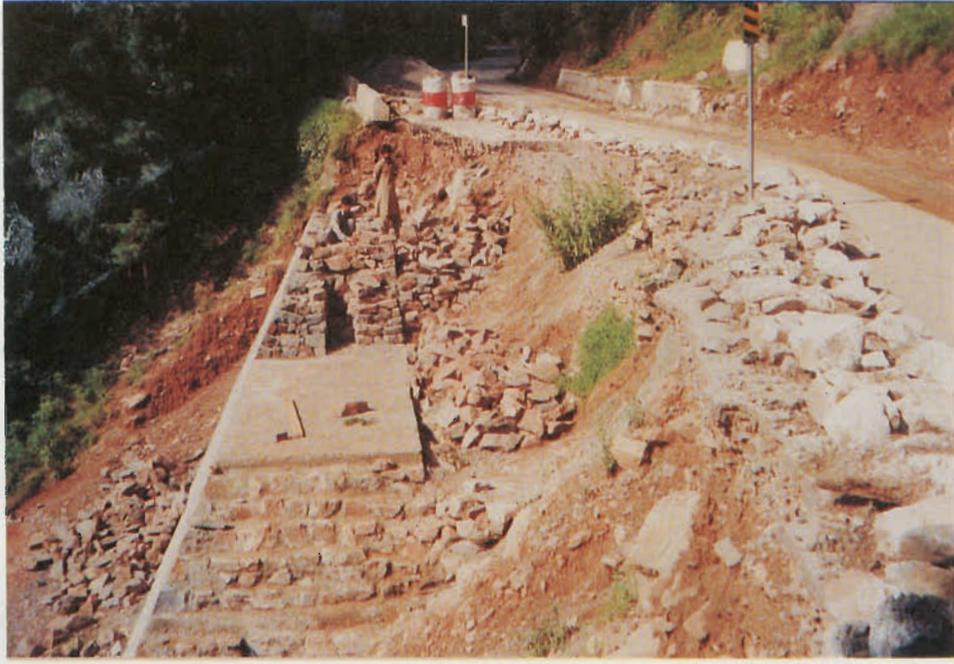
Plate 5: Reconstruction of retaining wall after landsliding along the Murree-Muzaffarabad Road

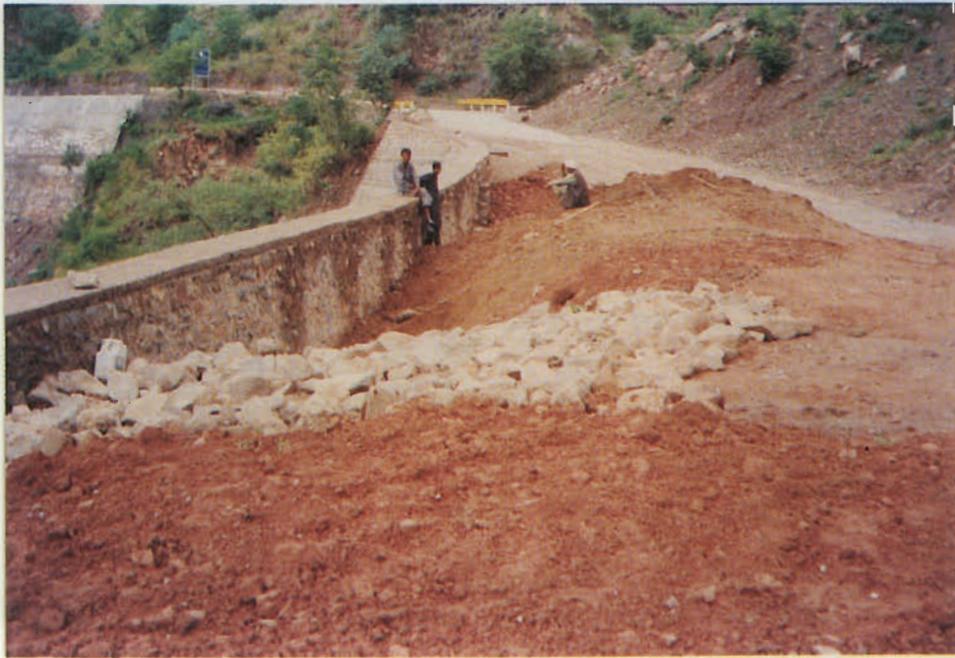
Plate 6: Backfilling behind the retaining wall along the Murree-Muzaffarabad Road

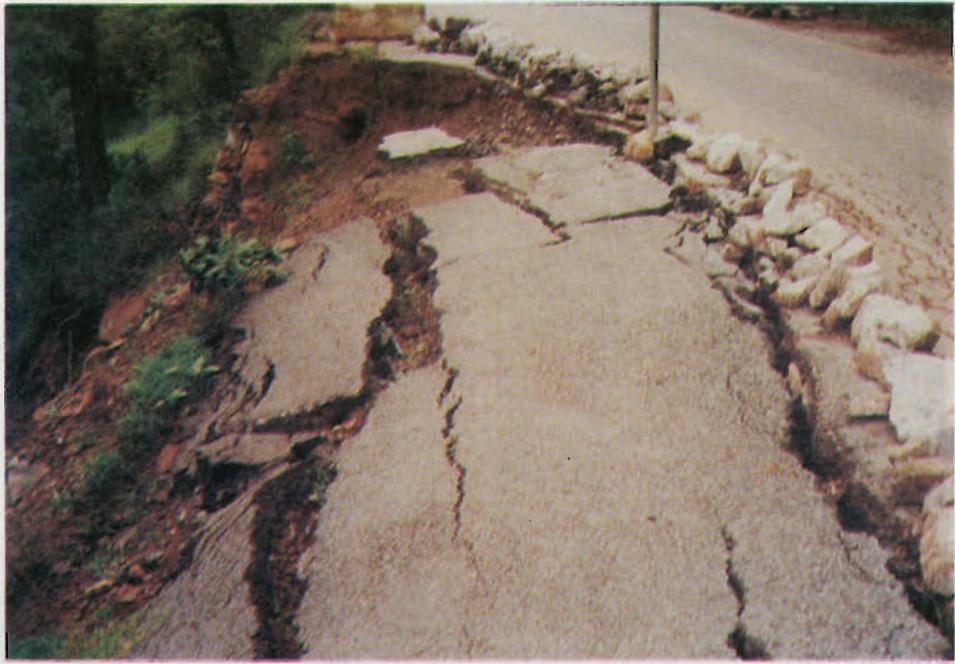
Plate 7: Subsidence of metalled road near Kohala

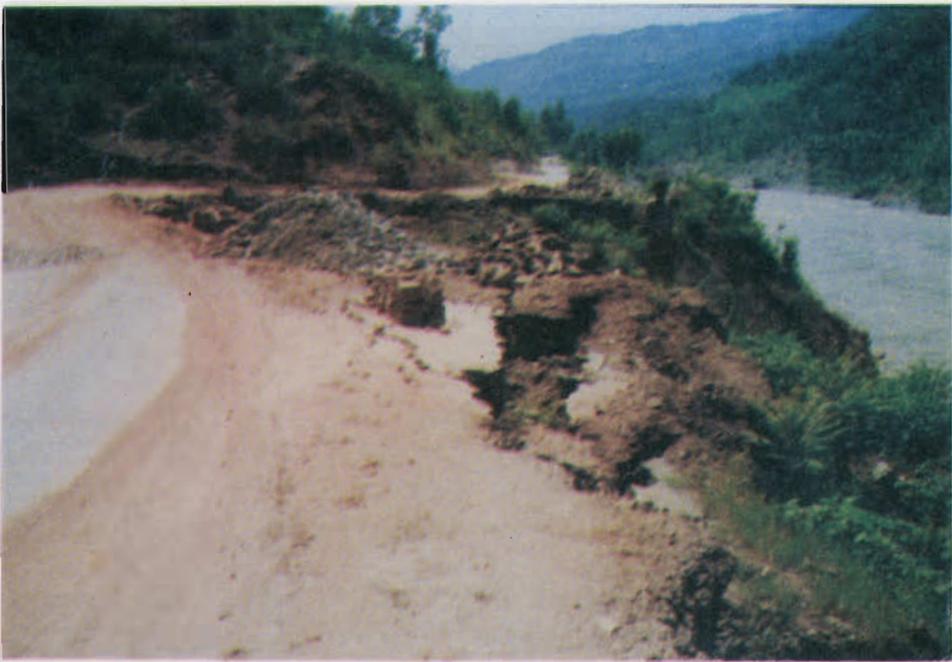
Plate 8: Initiation of failure of downslope due to absence of retaining wall

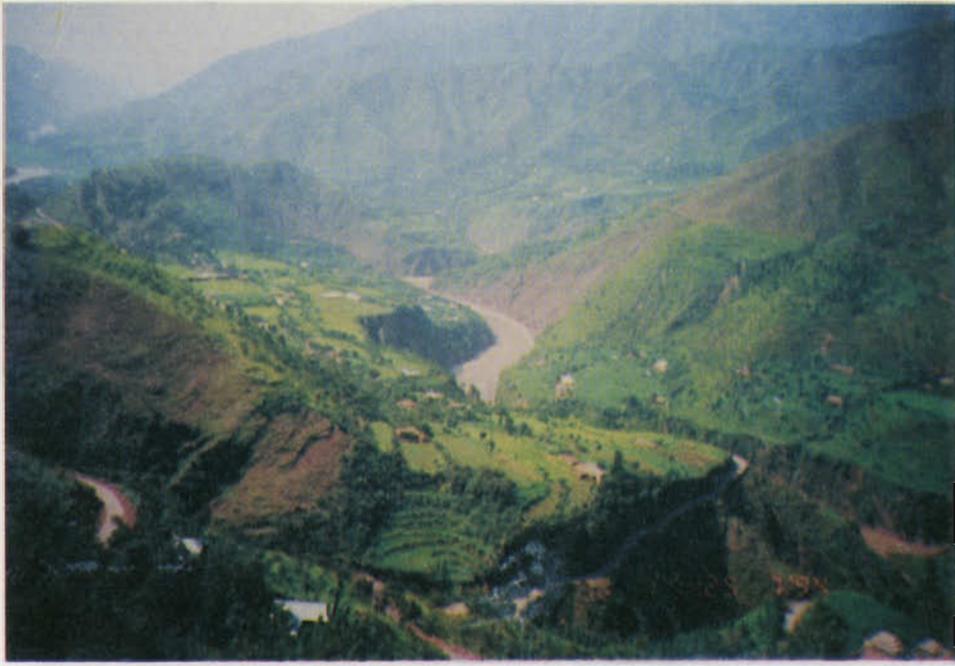
Plate 9: Landslide due to deforestation

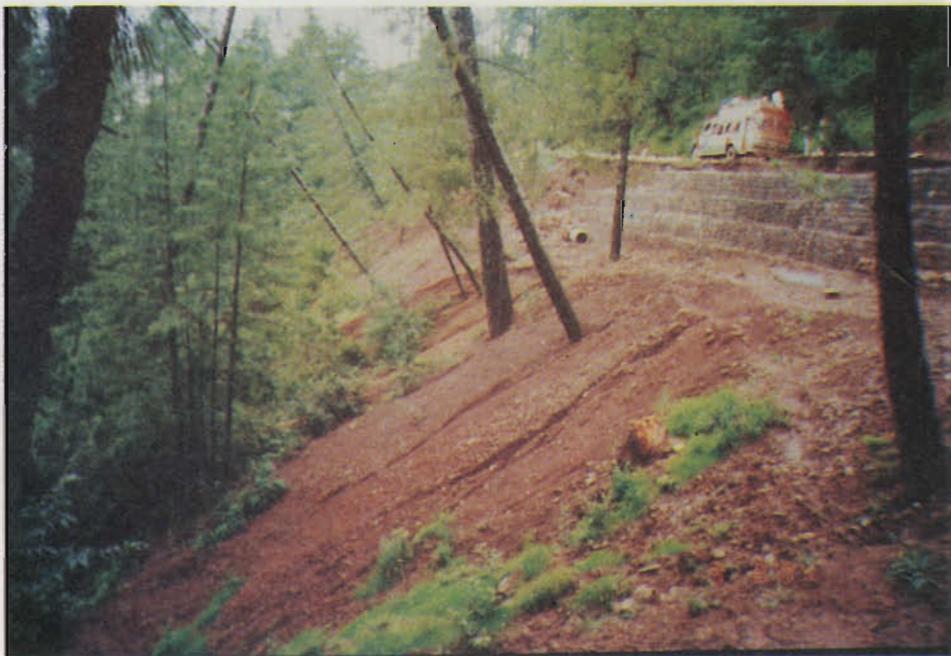
Plate 10: Tilting of trees due to landslide

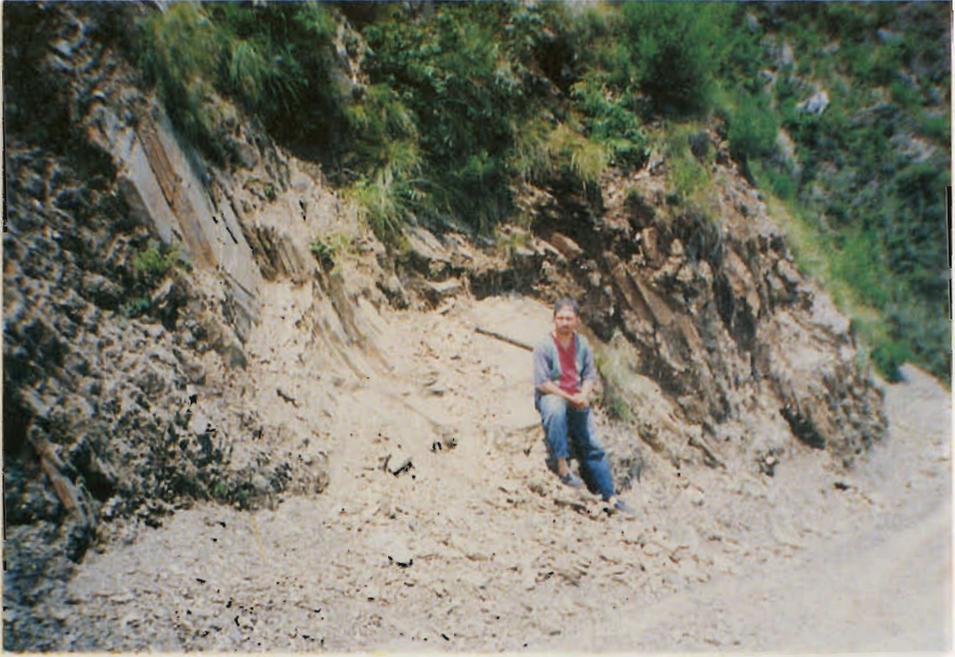
Plate 11: Plane failure in schists at Lower Gali near Muzaffarabad

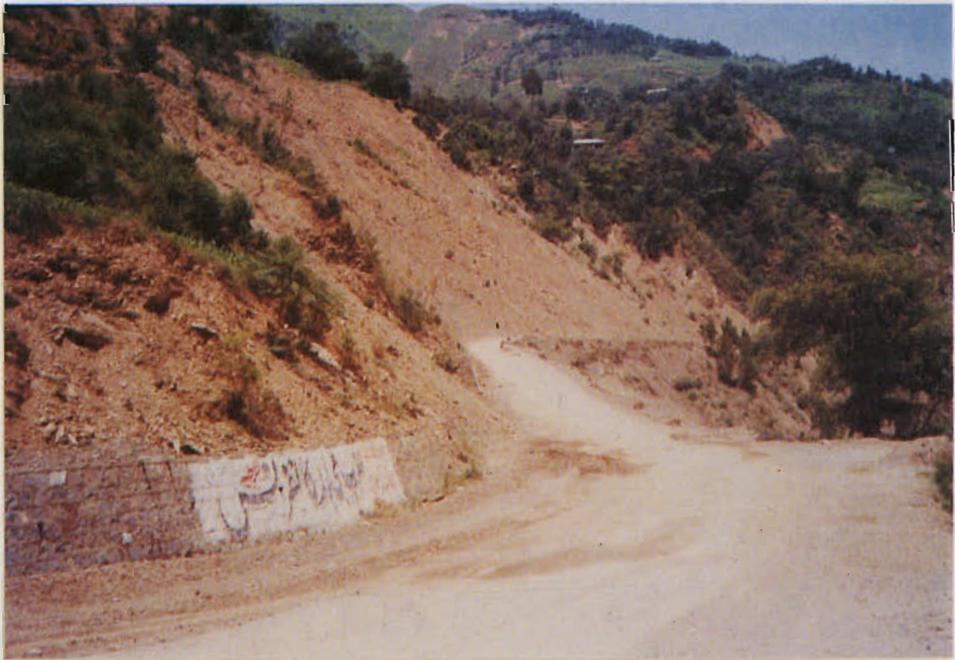
Plate 12: Movement of scree slope blocking the road between Muzaffarabad and Garhi Habib Ullah

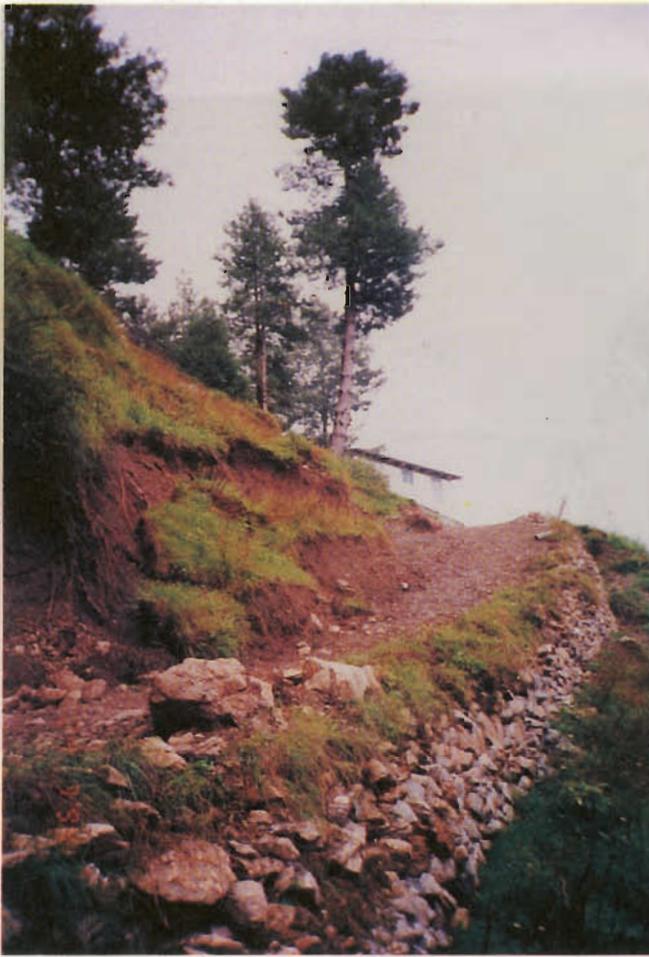
Plate 13:
Small-scale
landslide caused
by making a path
for a newly-built house

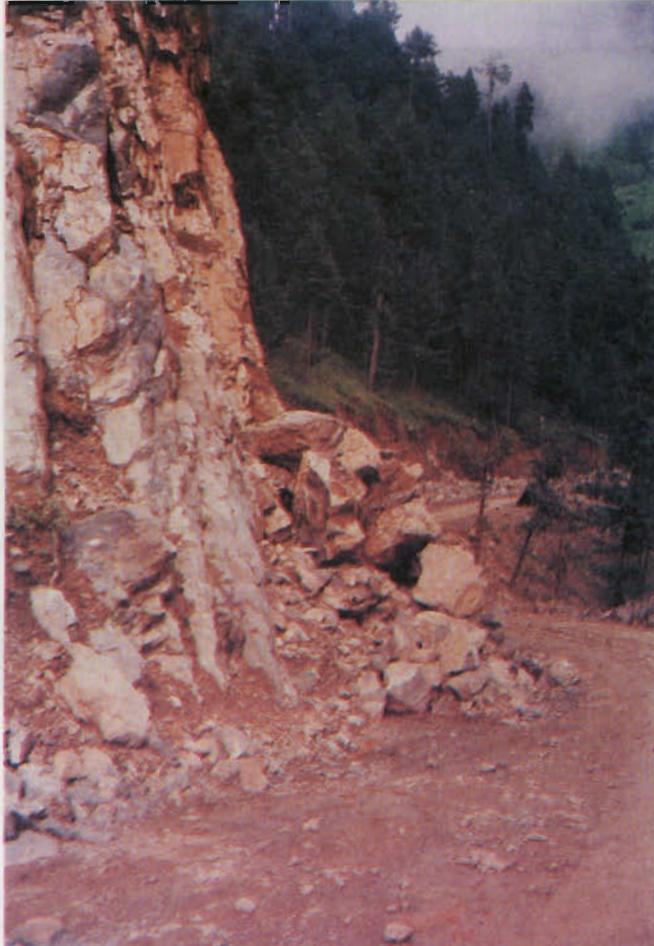
Plate 14:
Widening of
road by blasting
(may cause
threatening
slope ultimately)

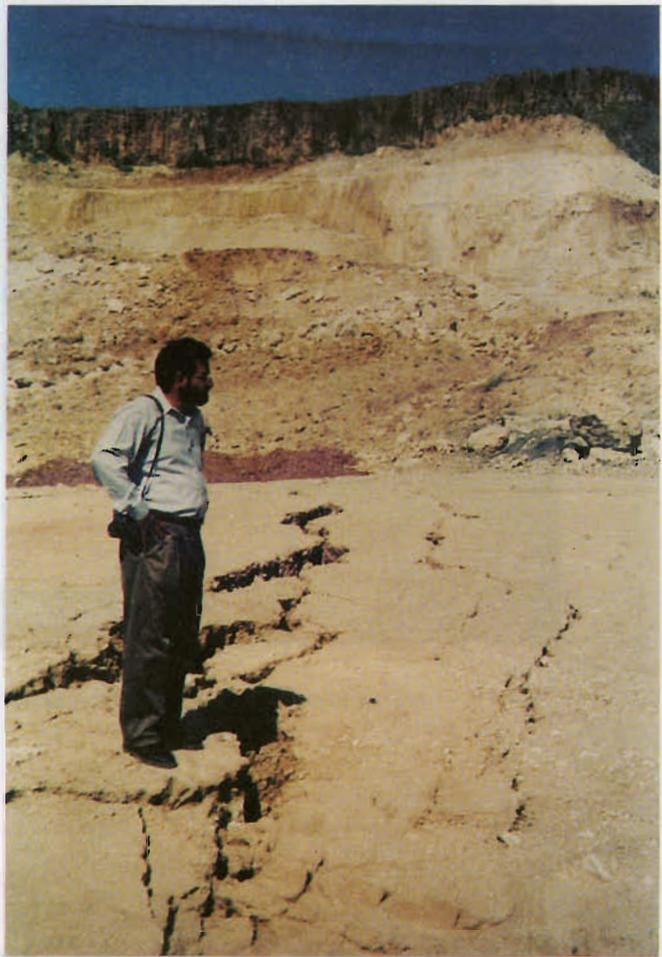
Plate 17: Landslide activity in Aug. 1994 shows slip surface in background and cracks in displaced material along the M1 Motorway Lahore-Islamabad

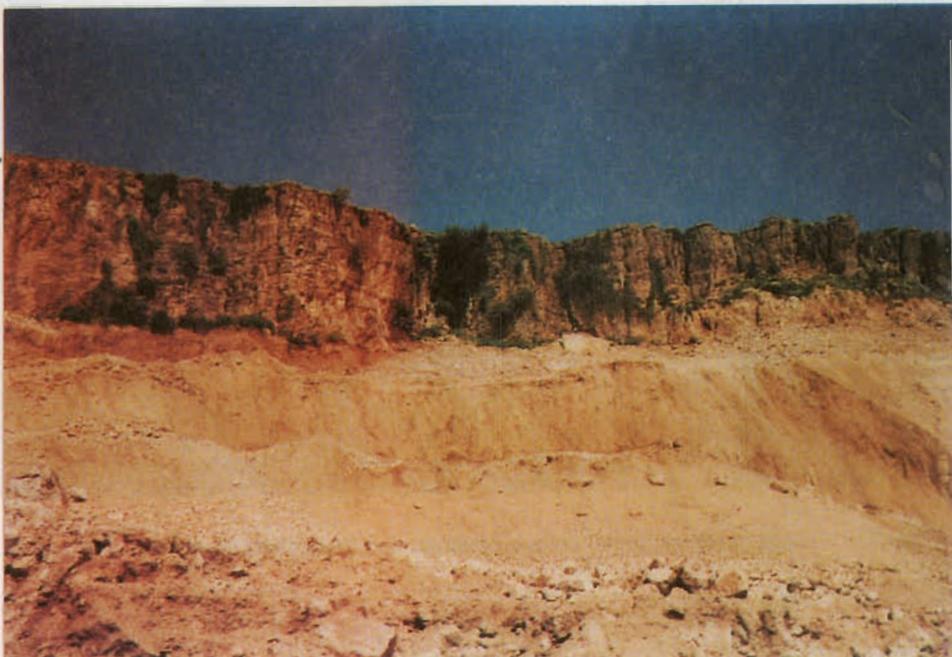
Plate 18: Fresh slip surface (Aug. 1994) along the M1 Motorway (Simbal landslide) between Lahore and Islamabad

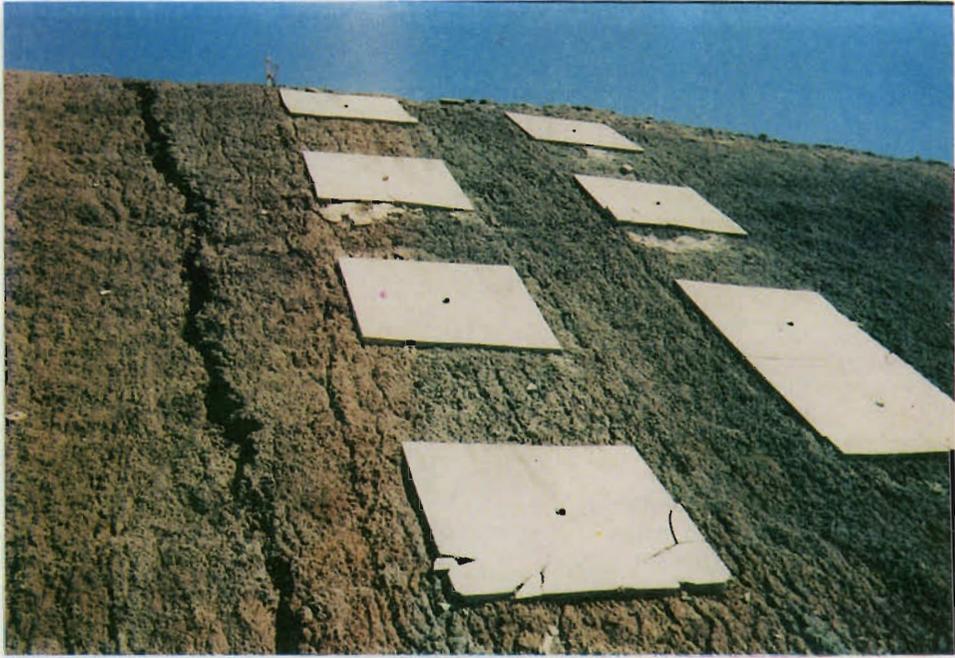
Plate 19: An experiment for protection of excavated slope by plaster covering plates

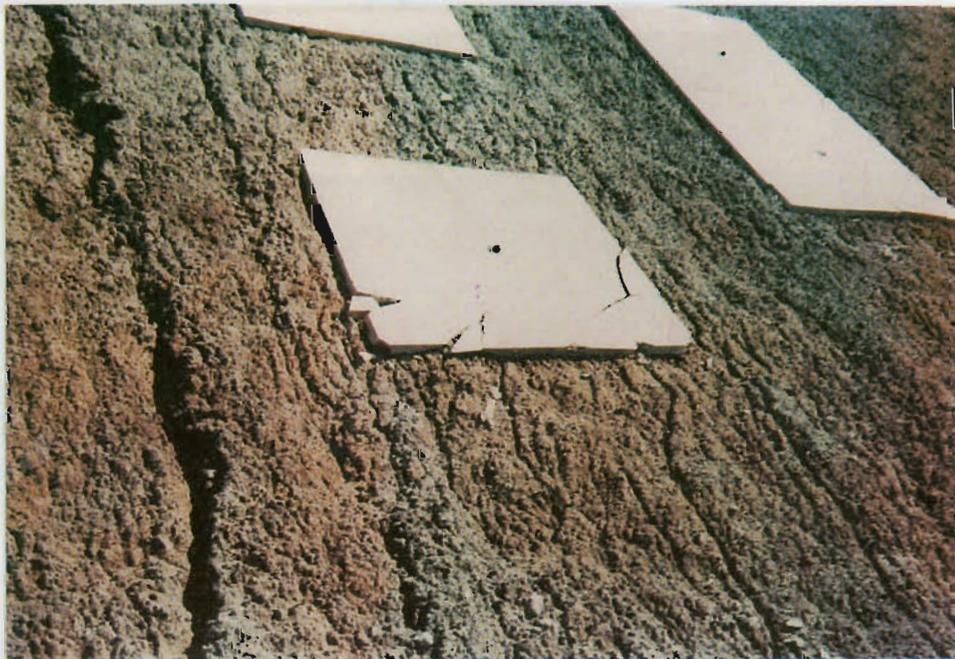
Plate 20: Failure of experimental plaster covering due to swelling of shales
