## Field Visit to the Site on the Kathmandu-Trishuli Road

### Box 2: Background Information to the Landslide Site 19 km along Kathmandu-Trisuli Road

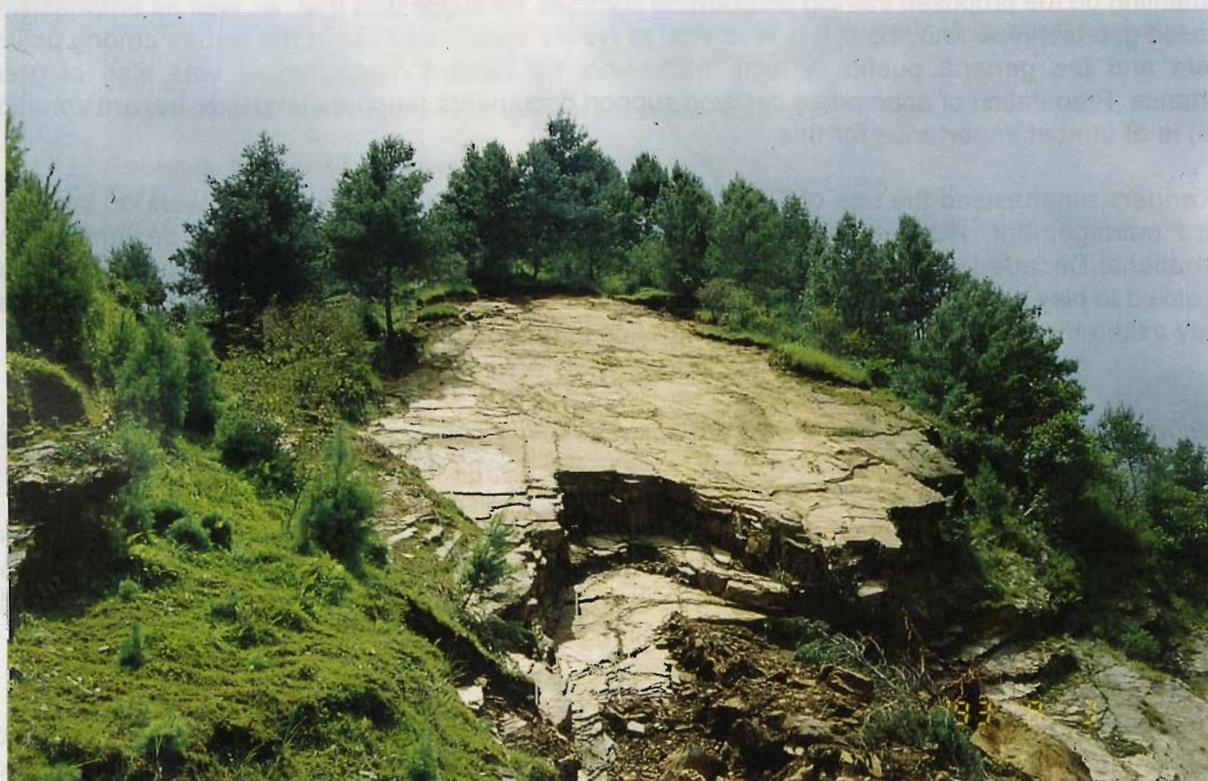
Landslide along the Tribhuvan Rajpath
