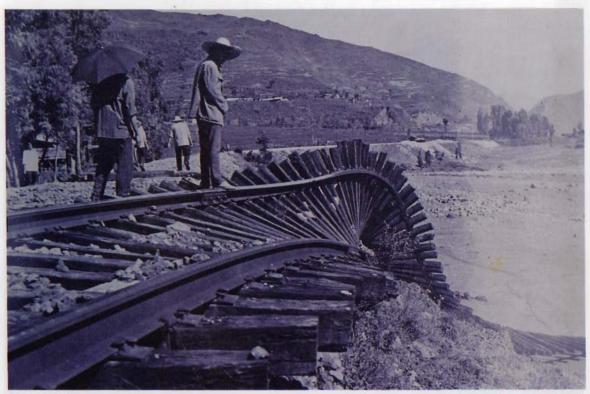
Plate 1: View Looking Southwards from the Embankment of Dongchuan-Kunming Railway
Downstream from Dade Ravine, Yunnan Province

The embankment was undermined by debris flow and flooding following breaching of a debris flow dam formed on 30 June, 1981.

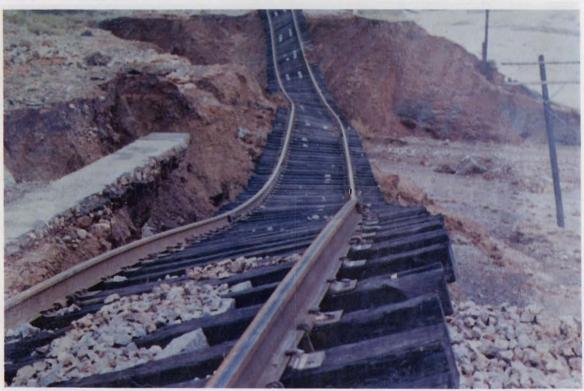
Plate 2: Embankment of Dongchuan-Kunming Railway Destroyed by a Landslide near Laogan on 1 July, 1985

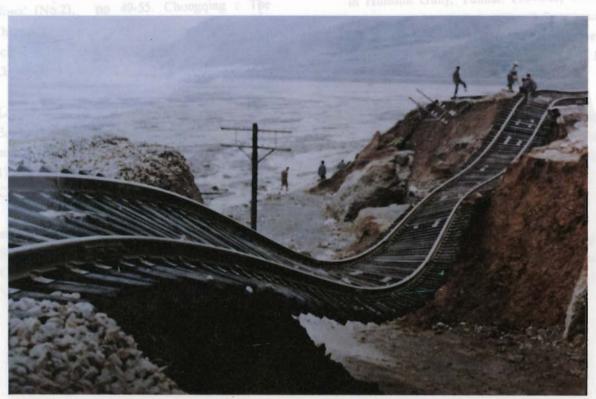
Plate 3: Debris Flow Undermining the Embankment of Dongchuan-Kunming Railway (1 July, 1985)

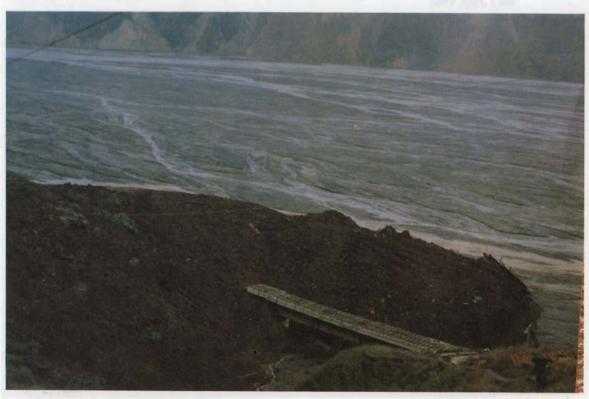
Plate 4: Forward Movement of the Railway Embankment by 100m and Destruction of Two Railway Bridges at Dalisu in Dongchuan District (Oct. 6, 1986)

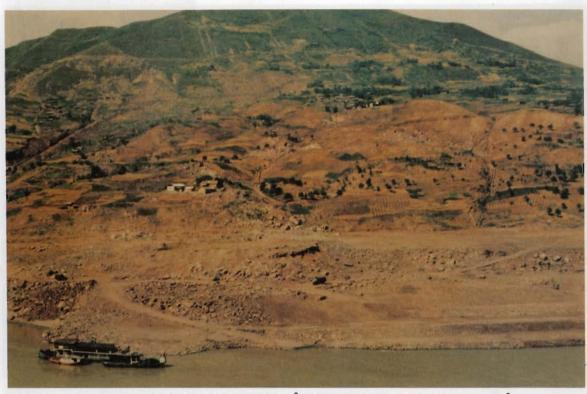
Plate 5: Looking North across the Changjiang River Towards the Jipazi Landslide

The total volume of the landslide is more than 15 million m³ (centre). The front section of 2.3 million m³ separated off from the slide channel and slid down below the flood level of the Changjiang River (foreground) to form low rapids that obstructed navigation for about 5 years. The photograph was taken in May, 1985, after stabilization of the landslide.

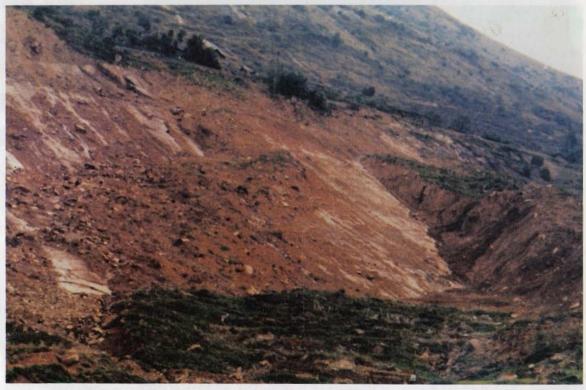
Plate 6: A Close View of the Upper Section of the Jipazi Landslide (Looking Northwards)

The sliding bed is composed of mudstone.

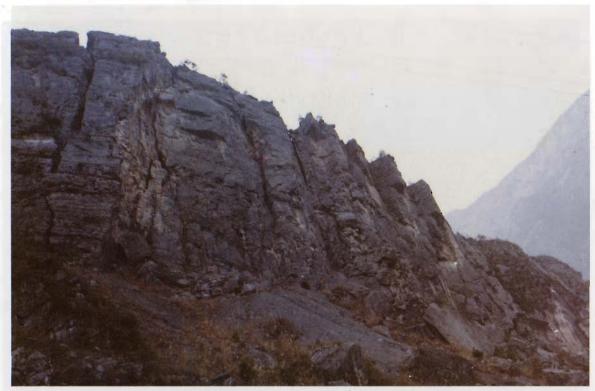
Plate 11: View from the East of the Lianziya Limestone Rockmass

The rockmass is located 27 km upstream from the Three Gorges Dam Site on the South Side of the Changjiang River directly across from the Xintan Landslide, (Hubei Province). The rockmass appears to be undergoing a slow geological process of toppling, sliding, or falling.

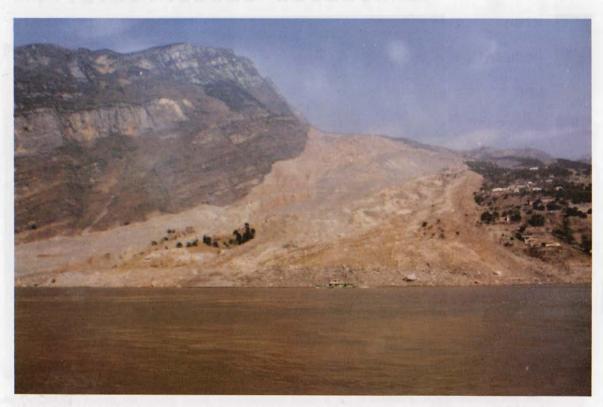
Plate 12a: Xintan Landslide on the North Bank of the Changjiang River

The landslide destroyed Xintan Town (middle background), Hubei Province

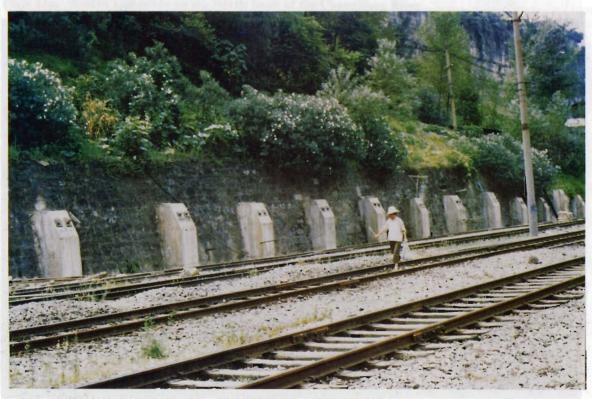
Plate 15: Control Works at the Jianjiyan Landslide, Songzao Coal Mining Area, Sichuan Province

The use of anchor-rope driven piles (centre, background) to stabilise landslides

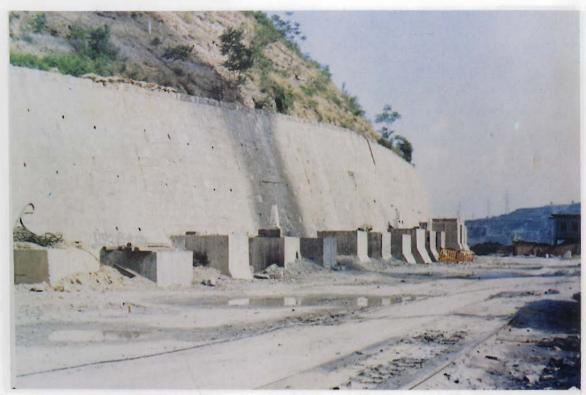
Plate 16: Control Works of the Xiangshan Lanslide, Hangcheng Power Plant, Shaanxi

The use of driven piles and a retaining wall (centre, background) to stabilize the landslide

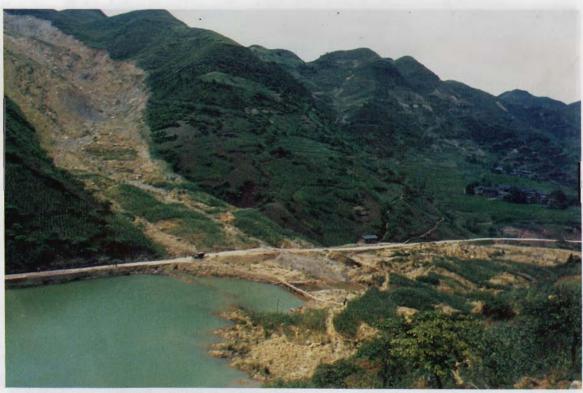
Plate 17: Looking Southwards from the Geling Landslide Dam (Sichuan Province)

The landslide dam formed in July 1982 during heavy rainstorms in Eastern Sichuan. This photograph shows the lake (foreground), remains of the Geling landslide dam (foreground), and the landslide (background).

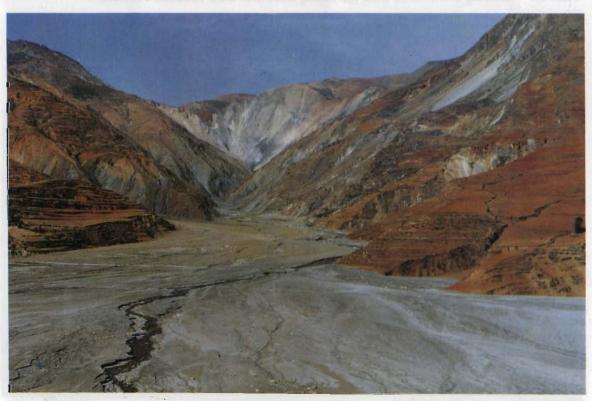
Plate 19: Landslide in Dabeini Ravine (Yunnan Province)

The landslide occurred at the head and on both sides of the valley, transporting large quantities of material into the ravines, and creating serious damage in the lower watersheds.

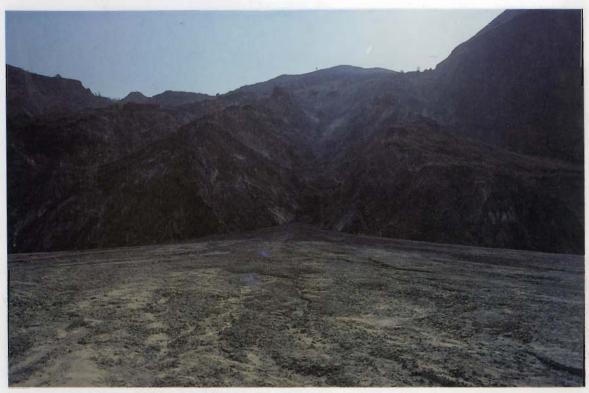
Plate 20: Landslides and Debris Flows in Xiaobeini Watershed (Yunnan Province)

Debris flow from the watershed temporarily blocked the Xiao River (immediate foreground). View looking westwards of large landslide above Xiabeini Ravine on hillside; alluvial fan of debris flow (centre).
