Landslide Dam Outburst Flood in Chin Hill, Myanmar

Field Report

International Centre for Integrated Mountain Development, Kathmandu
January 2017

Salient Features of the Tonzang Landslide Dammed Lake and Landslide Dam Outburst Flood in Chin Hill, Myanmar

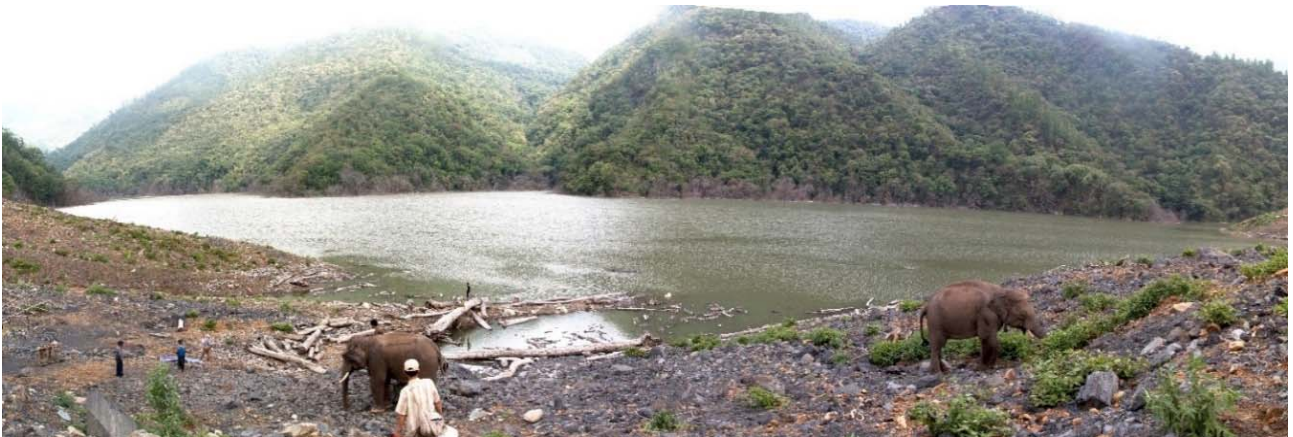
The landslide dam outburst flood (LDOF) of July 2016 released about 11.6 million cubic meters of water and lowered the lake level by 35 m (Figures 2 and 3). At present the outflow from the lake is 1.2 m³ per second. The terrace markings on the right bank of the lake outlet indicate that the LDOF might have occurred in more than seven phases (Figure 4). Discharge in the last phase of LDOF is estimated to be 7 to 8 m³ per second based on flood markings.

Figure 2: Lake and dam material (25 May 2016)

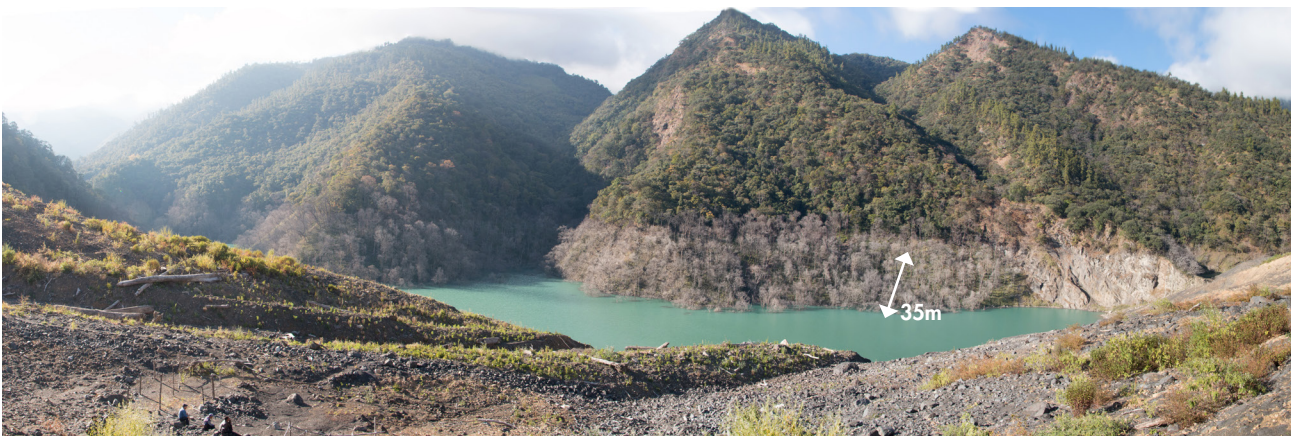
Figure 3: The lake water level has decreased by 35 m after LDOF. (photo: 16 December 2016)

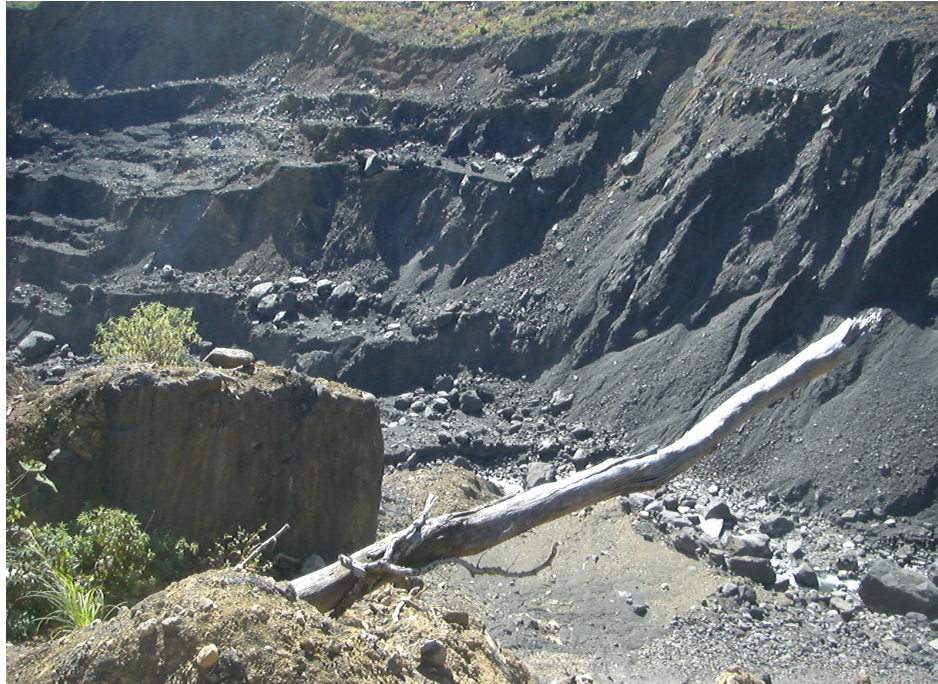
Figure 4: The terrace markings on the river bank show the LDOF has occurred in more than seven phases.
(16 Dec 2016)

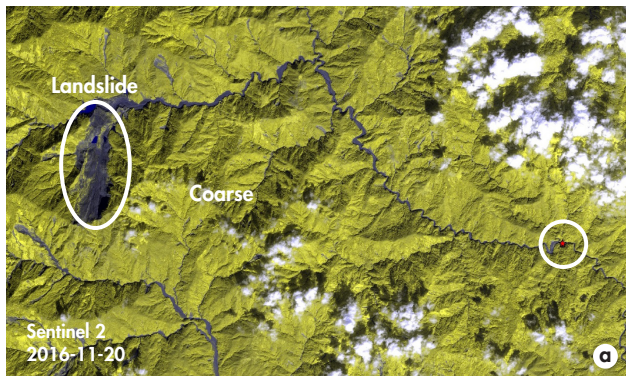
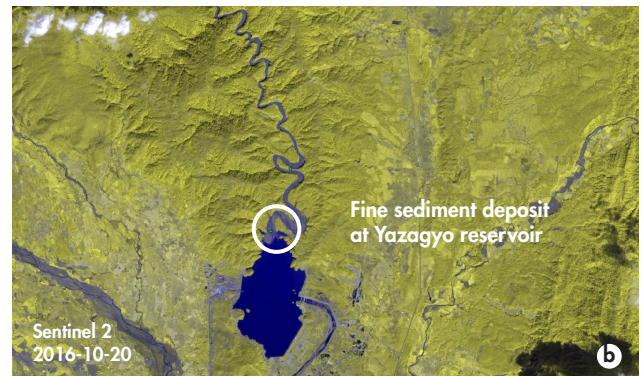
The outwash of the LDOF deposited the debris 8 m thick near the dam and 4 m thick near Hangken village. The coarse sediment deposits can be seen down to 29 km along the river from the dam toe (as seen on the satellite image). Much fine sediment was transported up to the Yazagyo reservoir (Figure 5).

Figure 5: Sediment deposited along (a) Tui Lam Lui river valley and (b) in the Yazagyo reservoir.

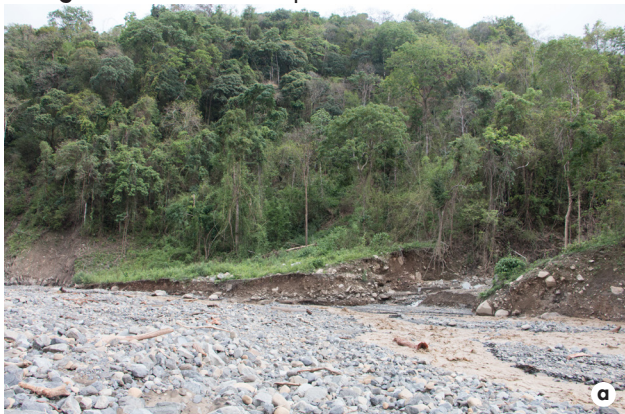
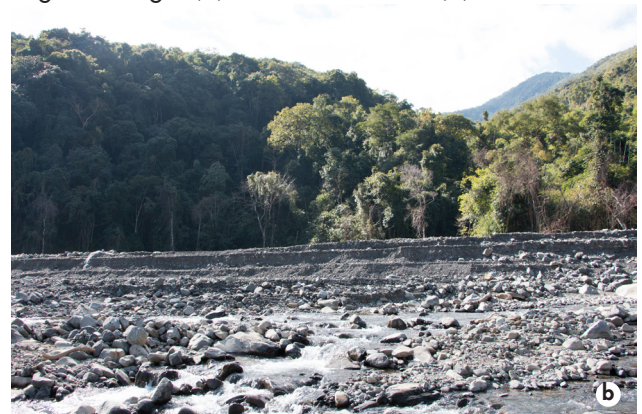
Figure 6: Sediment deposits on the river banks near Hangken village: (a) before LDOF and (b) after LDOF

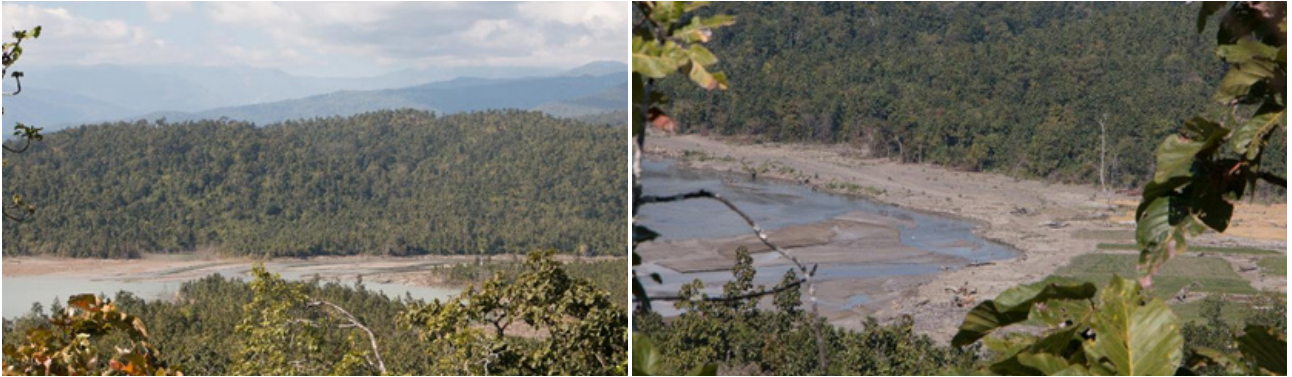
Figure 7: Sediment deposits near the Yazagyo reservoir

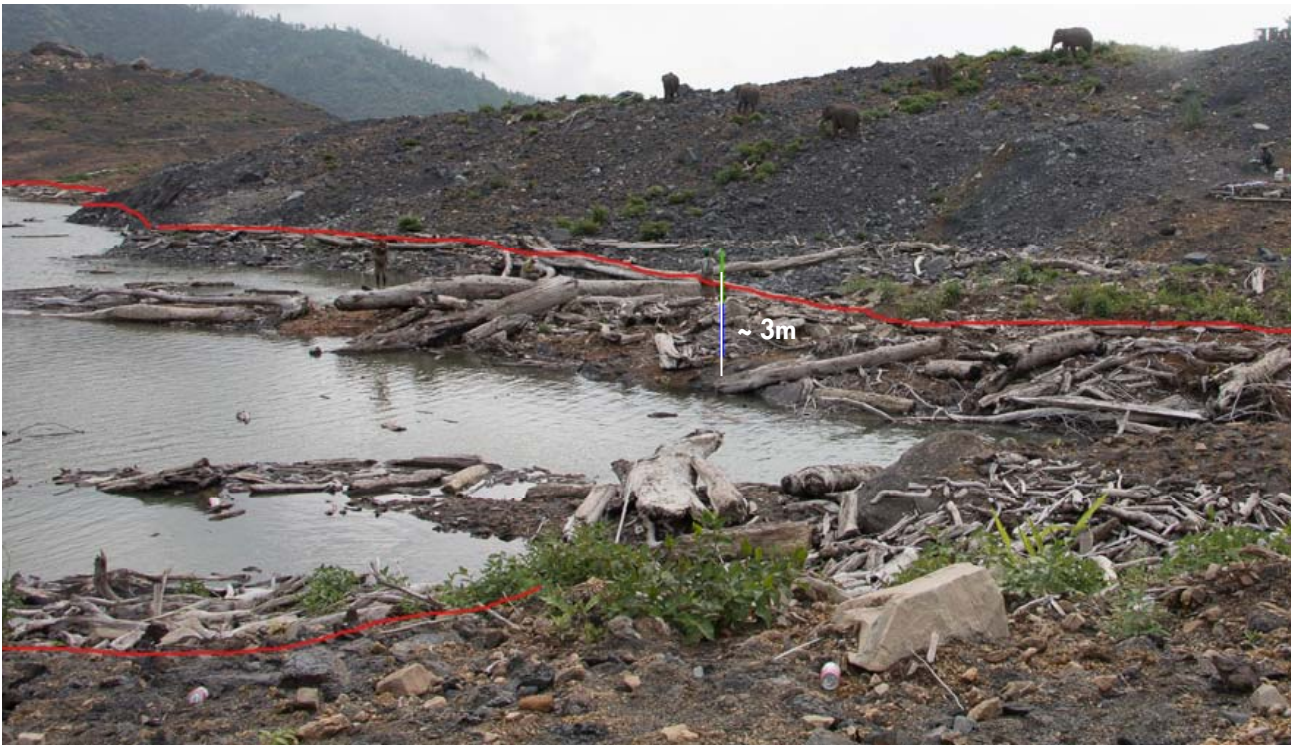
The July 2015 landslide dammed the Tui Lam Lui River and formed a large lake. The lake area grew to 34 ha by September 2015 and 40 ha a month later, as reported by *UNITAR-UNOSAT*. The lake area grew an additional 10 ha by March 2016. The fieldwork from May 2016 shows the lake area decreased by 3 m after attaining its maximum height during the last monsoon season. The water level during the May 2016 investigation stood at 1,364 masl.

Figure 8: The lake water level dropped by 3 m in the dry season (May 2016)

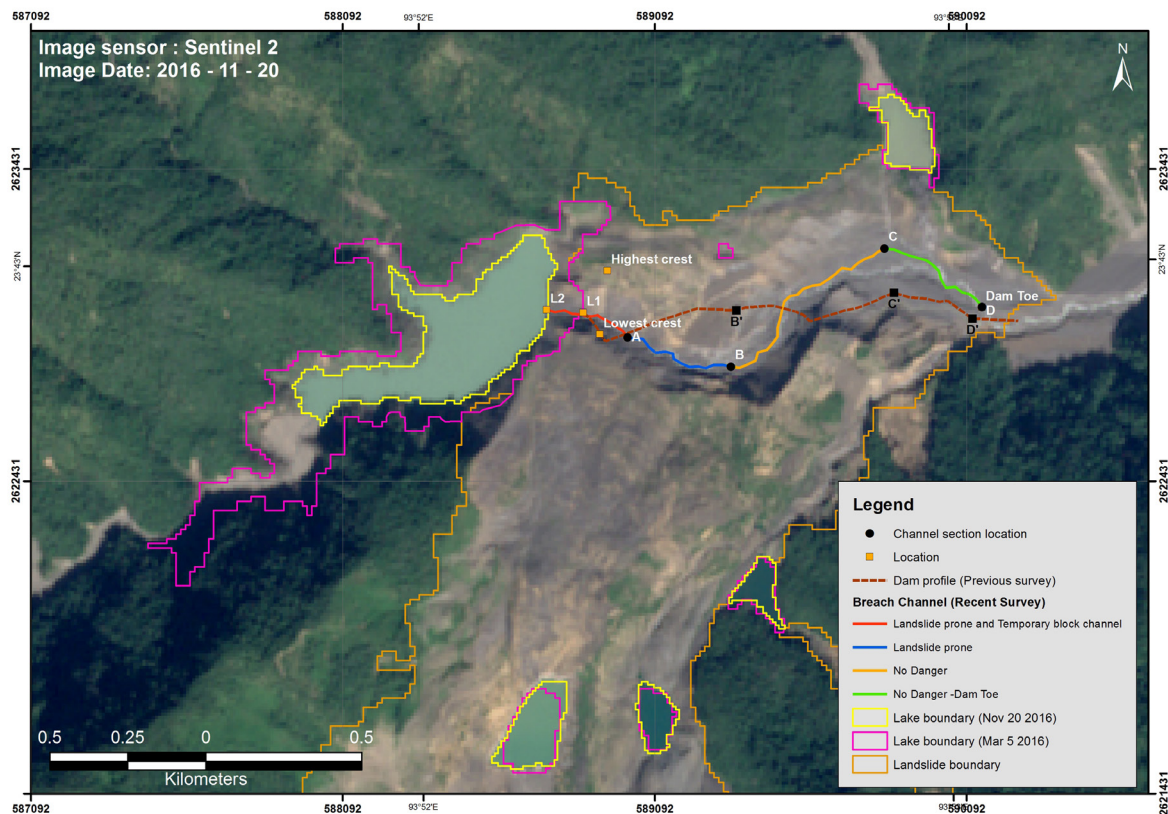
Figure 9: Chin hill landslide dammed lake area change scenario of pre and post LDOF

After the LDOF, the lake area had decreased from 50 Ha to 21 Ha. The red and yellow lines are the lake boundary before and after LDOF respectively (Figure 9). The lake water level had lowered by 35 m with the estimated water volume released was about 11.6 million cubic meter. The remaining lake area is 21 Ha in December 2016. The elevation of the lake had reduced from 1364 masl to 1330 masl. At present the average depth of the lake is 15 m with 4 million cubic meter of water estimated based on the previous exiting reports.

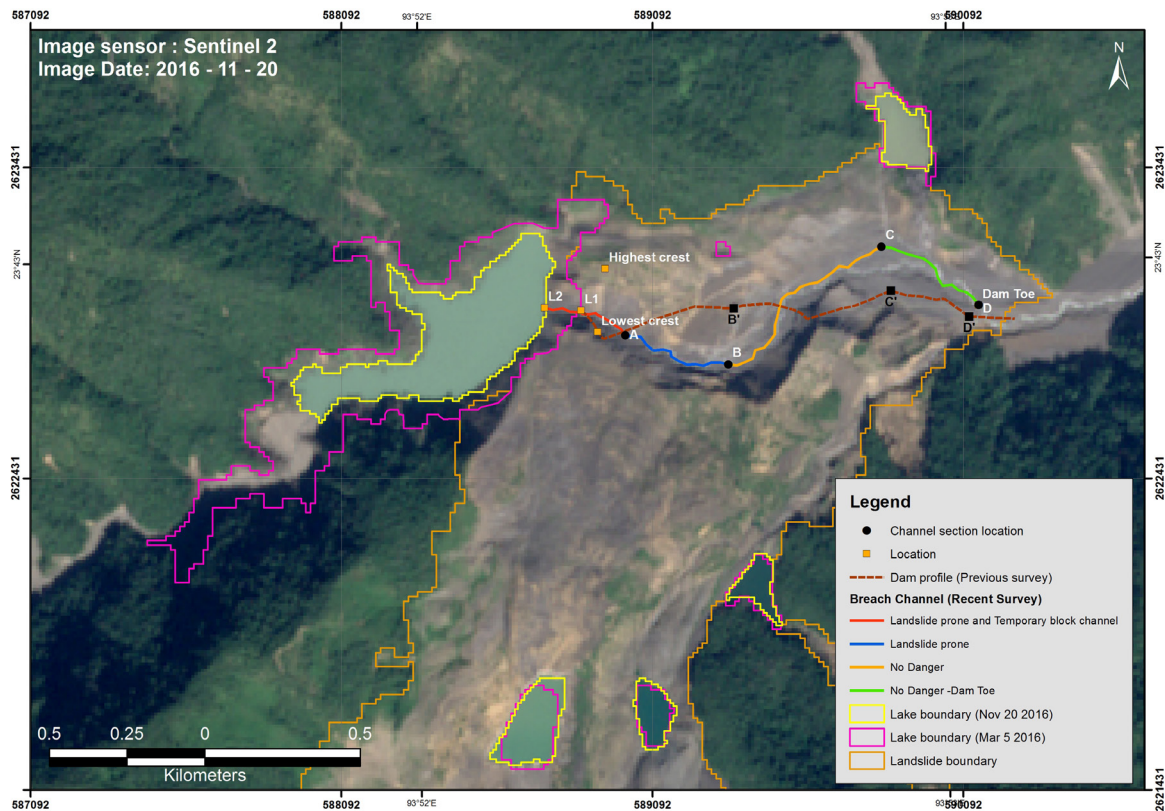
The Tonzang landslide dam ranges in elevation from 1,126 to 1,402 masl. The dam length from the lake to the toe of the dam is approximately 1,500 m and 1,860 m along the river channel. The dam and channel profile plan is shown in the figure 10. Its profile is divided into six zones based on the gradient and their characteristics as shown in the figure 11 and 12. The new lake level (L1) to Lowest Crest (A) is the breaching area. The present slope is about 7° towards the lake with a length of about 89 m. The lowest crest to point A also had a 7° slope for 132 m. The section A to B' and B' to C' are 8° and 9°, respectively, with distances of 336 m and 535 m. The lowest section C' to D' has an 18° slope and 274 m in dam length. The overall dam length has a slope ranging from 7° to 18°. This degree of slope is not prone for erosion.

Figure 10: Longitudinal profile along the dam as it was on 25 May 2016. The dark brown broken lines mark the dam. The other lines (red, blue, brown, and light green) mark the channel after LDOF (16 Dec 2016) and mark the changes in the lake area. These markings were established from Landsat 8 images taken on 5 March 2015. The yellow lines were marked from Sentinel-2 images taken on 20 November 2016.

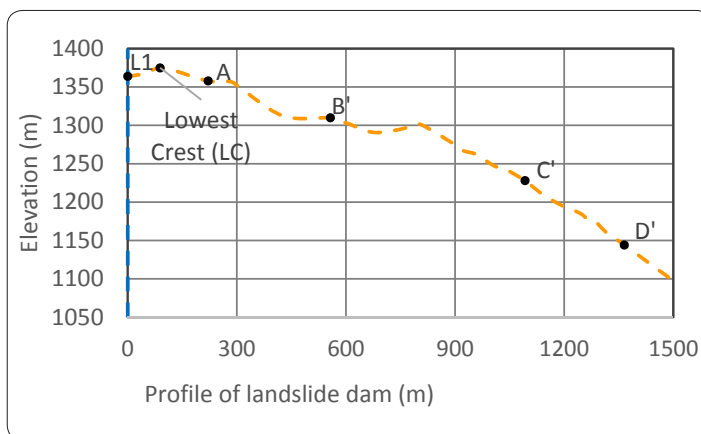
Figure 11: Longitudinal profile along the dam (25 May 2016)

Section	Highest (masl)	Lowest (masl)	Distance (m)	Slope (deg)
L1 to L.C	1375	1364	89	7
LC to A	1375	1358	132	7
A to B'	1358	1310	336	8
B' to C'	1310	1228	535	9
C' to D'	1228	1144	274	18
LC to D'	1375	1144	1365	10

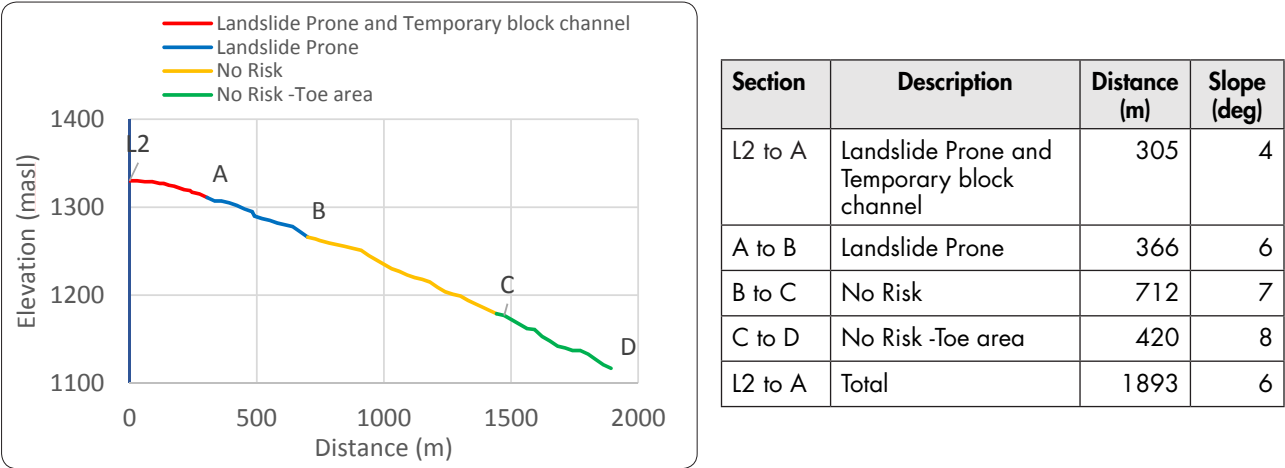
The current channel developed in the dam after the LDOF and has reached a length of 1,893 m long. This profile is also divided into four zones ranging from 4° to 8° with an average slope of 6°. The new lake level to point A of about 305 m length have 4° slope along the channel (Figure 13). Rest of the zones are having 6° to 8° slope for approximately 1,500 m. From L2 to point A has high potential for landslide and temporary blocking of this area is expected. The zone from point A to B also has the possibility of landslide but with less chance of blocking the river should a landslide occur. Further down from point B to C and C to D, these zone pose no risk, however, the gradients are slightly higher than the other zones. Overall the channel gradients are in stable condition.

Figure 12: Longitudinal profile along the river channel after LDOF (16 Dec 2016)

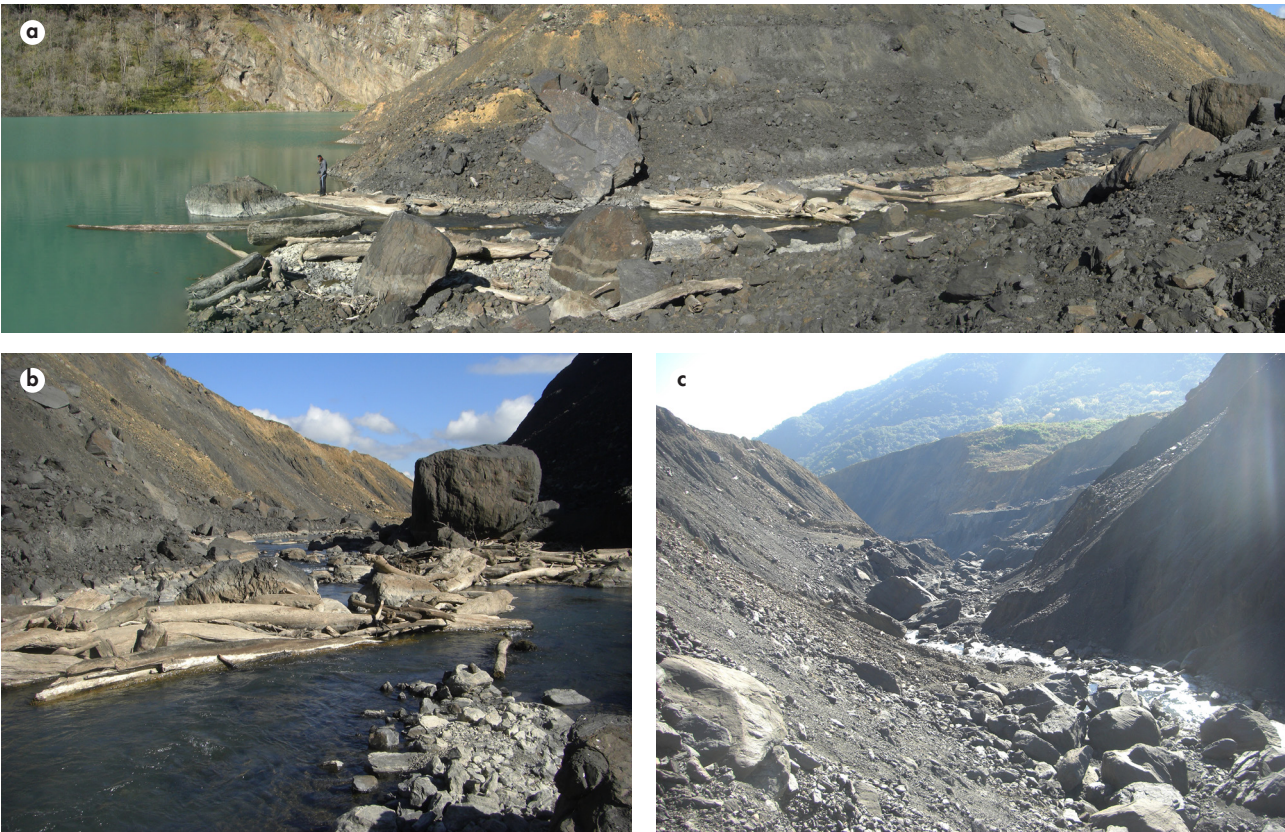
Figure 13: The lake outlet scenario: (a) The dammed lake outlet; (b) The gradient of the lake outlet channel near the snout; and (c) the gradient of the channel at 300 m downstream.

- Debris may derive from the dammed material on the banks and in landslides
- The channel gradient from the lake outlet was 4° for more than 300 m. This indicates that the lake will be stable in normal condition.

- Gauge rain to measure the rainfall
- Continue measuring flood discharge
- Monitor flood levels
- Do not need to install early warning systems
- Construct a supporting wall at the lake outlet
- Construct check dams along and across the river to control debris
- This area could be developed for micro-hydropower and/or tourism
