Investigation of the Landslide Dam in Chin Hill, Myanmar

Field Report

15 July 2016

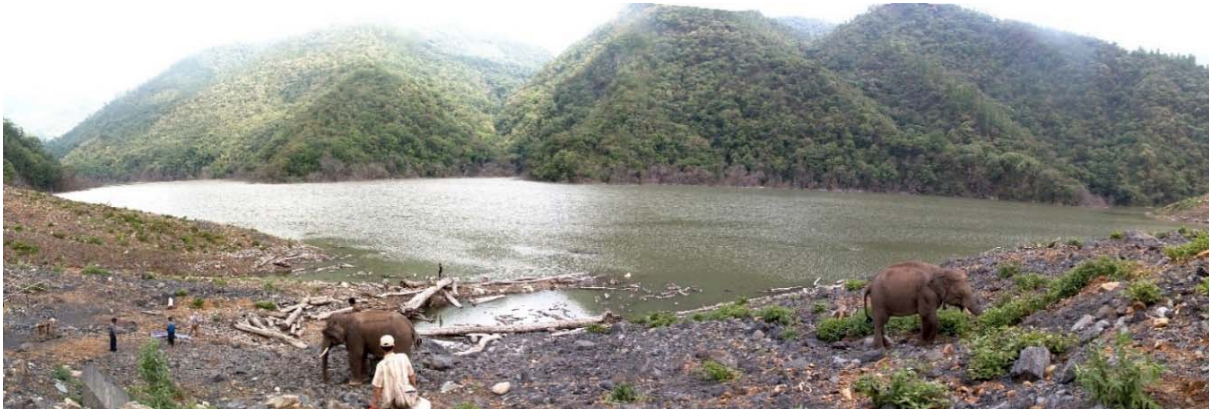
Figure 3: The Lake formed after the landslide damming the Tui Lam Lui River. The foreground and right side of the photograph are the landslide dam material on 25 May 2016

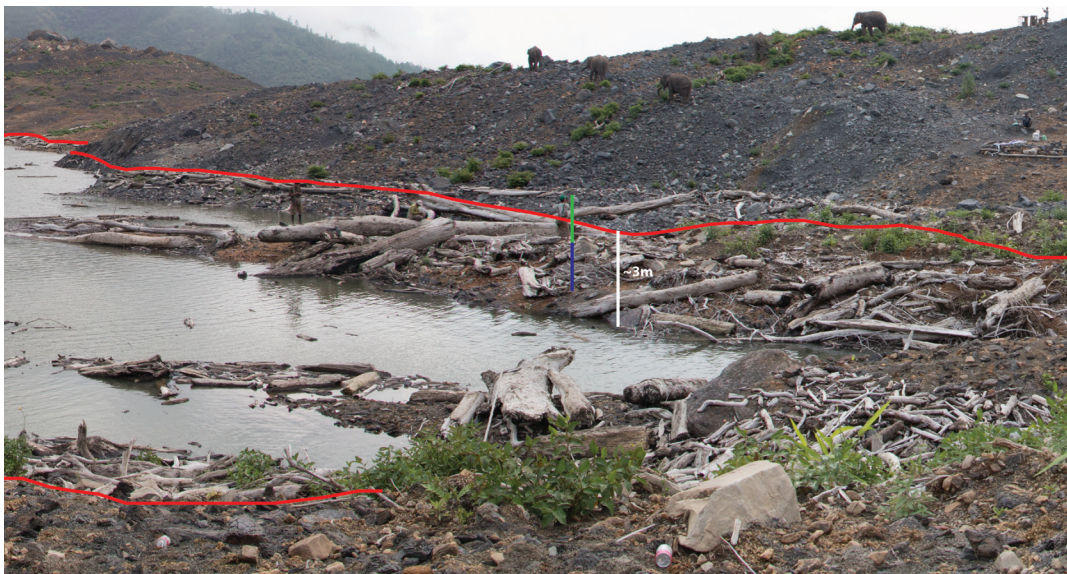
Figure 4 is a photograph taken during fieldwork on 25 May 2016. By this point, the lake area had decreased by 3 m from its maximum (Figure 4). The water level during the field work was 1,364 masl.

Figure 4: The lake water level reduced by 3m in dry season, 25 May 2016.

Observation: The lake area and water level had decreased in the dry season of 2015 and will increase in monsoon of 2016

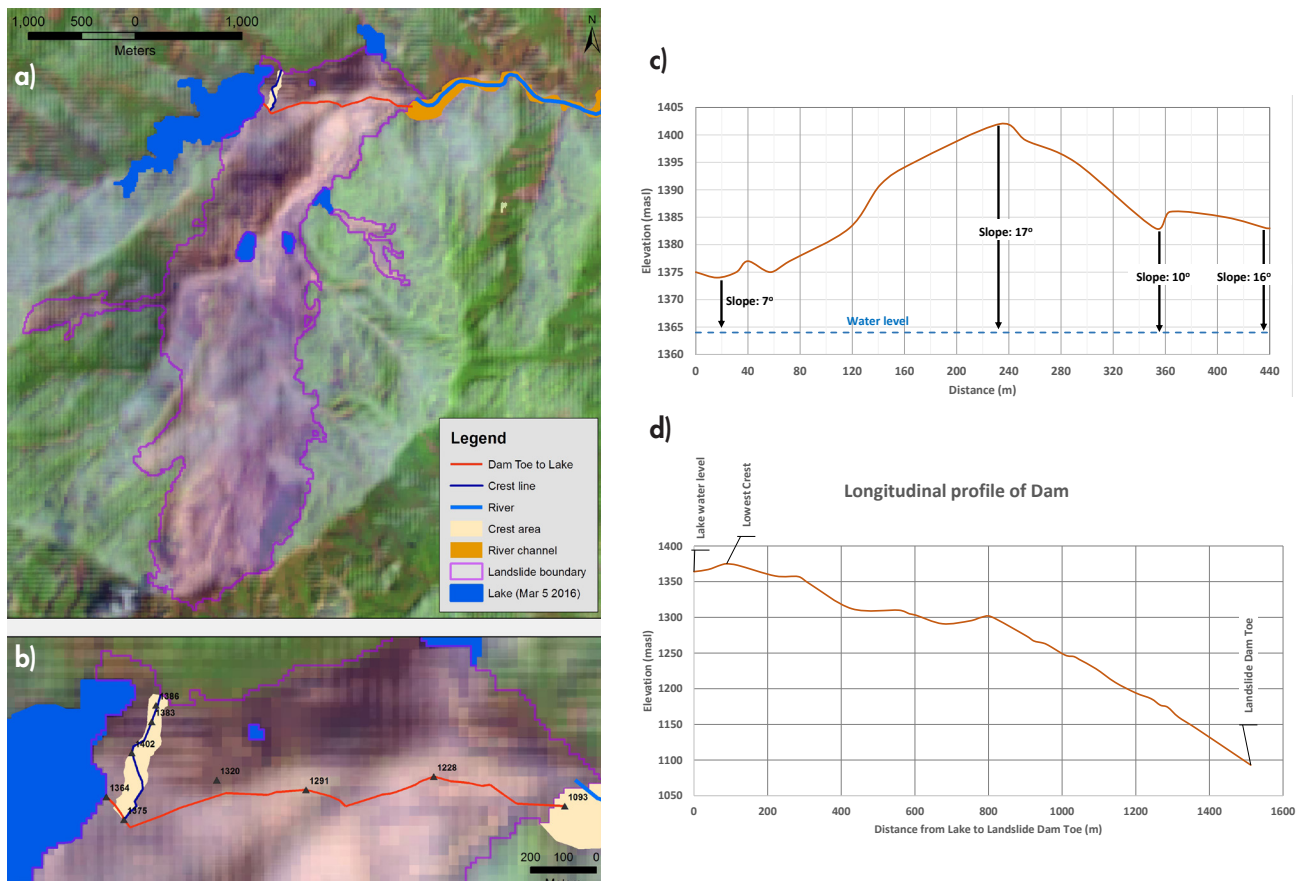
The Tonzang landslide dam measured 276 m high with the toe of the dam at 1,126 masl and the top of the dam at 1,402 masl. The total length of the dam was approximately 1,500 m (Figure 5). Though we did not measure dam thickness, the dam crest width ranged from 43 to 75 m and the freeboard ranged from 9 m to 38 m. The inner side-slopes ranged from 7 to 17 degrees. The smaller the crest width the higher probability of breaching. The lowest free board had 7 degree slope towards the lake and 46 m length from crest to lake.

1. Over-topping which may lead to progressive upstream erosion and lateral widening of the overtopped channel. This might happen if the freeboard of the lake decreases due to heavy rainfall and a large inflow to the lake. The lowest freeboard of the dam is just 9 m.

Figure 5: a) Lake and landslide dam mapped from Landsat 8 satellite image of March 5, 2016; b) A zoom view of landslide dam and crest; c) the crest profile and inward slope; and d) the longitudinal profile of dam.

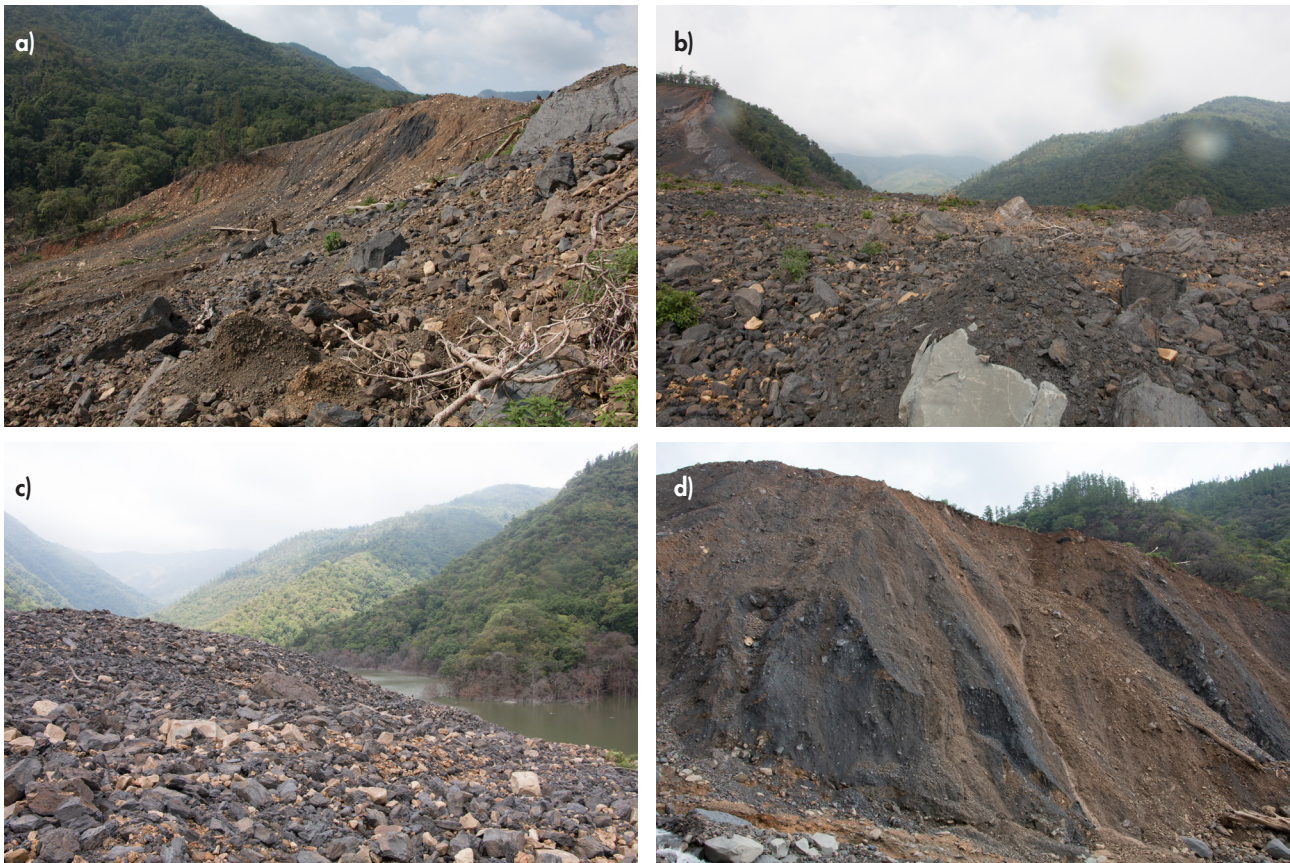
The landslide dam material was composed of highly fractured boulder-sized shale with subordinate cobble sized sandstones. The material size was generally smaller than 1 m, but some blocks are >3 m. Red and black clays were found at the middle and bottom parts of the dam (Figure 4). Owing to the fracture, the shale is easily shattered and sandstones were weathered, which made the dam material highly permeable.

Figure 6: Dam material analysis; **a)** view from lake to highest crest; **b)** view from lowest crest toward lake; **c)** on lower crest at right side of the dam; and **d)** toe of dam.

Observations: Shattered shale and weathered sandstone rocks. Highly permeable, crumbling rocks with no clays indicate a fragile dam.

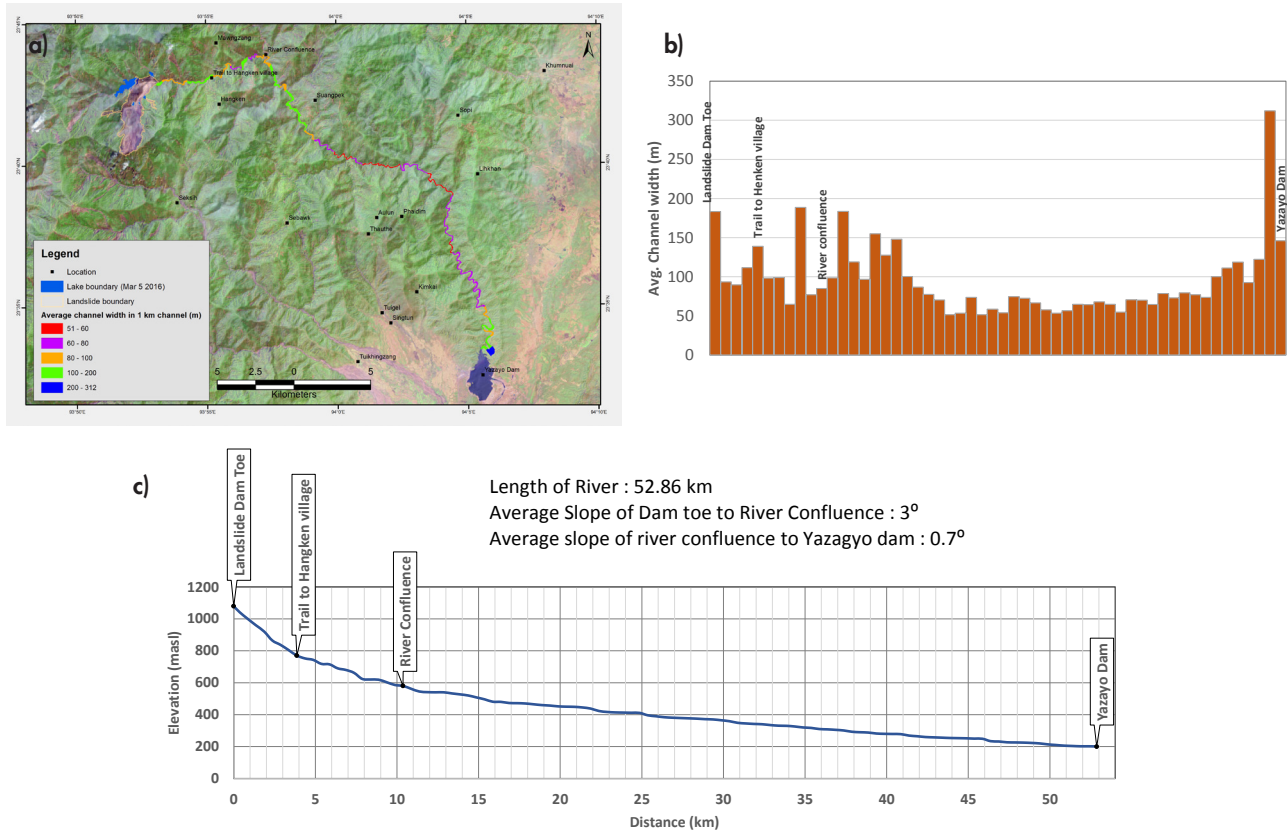
The length of the Tui Lam Lui River is 52.86 km from the toe of the Chin hill landslide (Tonzang landslide) dam to the Yazagyo Dam. Though the river is generally wide ranging from 50 to 300 m in a stretch of 1 km, some sections are narrow, reaching only 30 m in the middle reaches of the river. The widest section of river channel (504 m) was observed near the Yazagyo Dam (Figure 6). The average slope of the river is 3 degrees from the toe of the landslide to the nearest big bend of the river confluence and about 0.7 degrees from the river confluence to the Yazagyo Dam. The river bed is mainly composed of shale, sandstone and quartzite with some boulders and cobble, but the highest percentage is gravel with little fines (Figure 7).

Figure 7: a) Location of landslide dam, lake and Yazagyo Dam showing average channel width within 1 km; b) Average channel width in 1 km from the toe of the landslide to Yazagyo Dam; and c) A longitudinal profile of the river from the toe of the landslide to Yazagyo Dam.

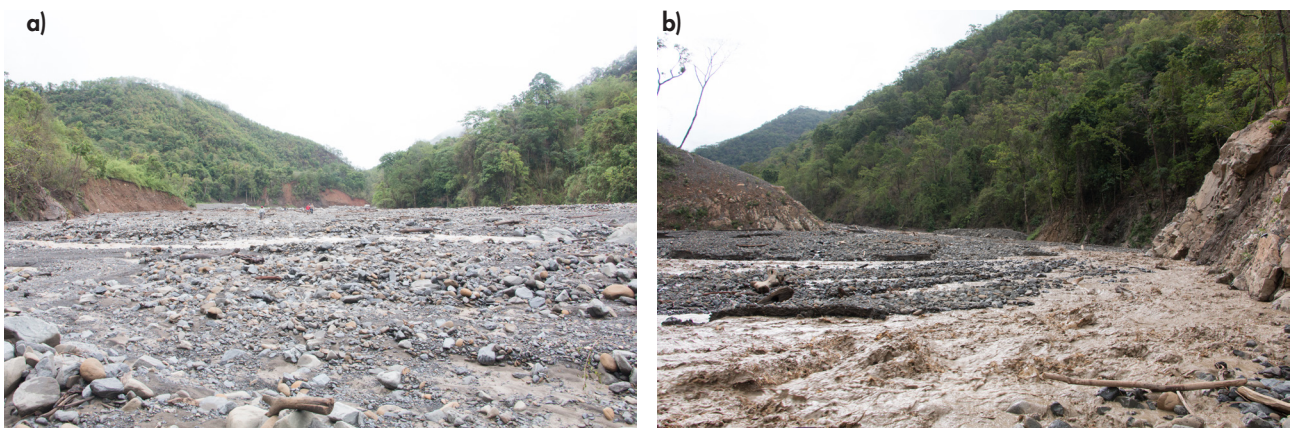
Figures 8 a and b: Field photographs of river bed materials showing a wide river channel.
