Geotechnical Study of Unstable Slopes: A Case Study at Sunkoshi Power-house Site, Central Nepal

G.S. Pokharel

Soil, Rock and Concrete Laboratory, Nepal Electricity Authority
Bhagwan Pau, Swayambhu, Kathmandu, Nepal

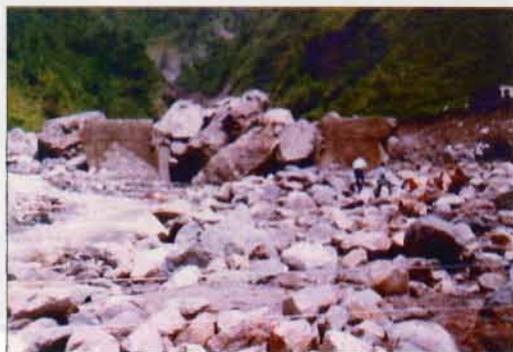
- 1995 – a debris flow occurred on Slope No. 2 of the Sunkoshi powerhouse, causing extensive damage.
- 1996 – an intensive debris flow in the Larcha Khola tributary of the Bhotekoshi near Tatopani killed 54 people, and swept away 18 houses and an RCC bridge on the main highway. A number of very large boulders, some estimated to weigh more than 1,000 tonnes, destroyed the bridge on the highway (Figure 15.2).

Figure 15.2: The debris deposit brought down by the Larcha Khola in 1996, a tributary of the Bhotekoshi near Tatopani village. Some of the larger boulders seen in the photograph weigh over 1000 tonnes

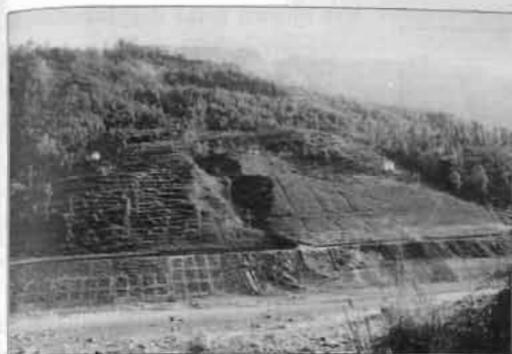
Figure 15.4: General view of Slope No. 2 towards the south

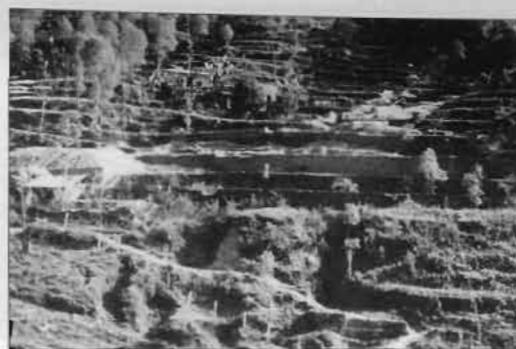
A large failure occurred in Slope No. 2 of the Sunkoshi Power Station area in July 1995, when the slope was already being investigated in detail (see below), which caused extensive damage to the power project and surrounding property. The mass wasting process started early in the afternoon of July 5, when a great amount of debris gushed down-slope together with a torrent of water, breaching the sides of check dam No. 1 which was located underneath the toe of the upper unstable area. This event was probably caused by a great amount of colluvial material being saturated and loosened during three days of intensive rainfall. This created a torrent of water that ran down from the upper mountain face and drained onto the unstable parts of Block C.

The debris torrent buried the ground floor of a two-storey house adjacent to check dam No. 3. Fortunately, the house was not inhabited at the time. Another 14 houses on the slope were affected. The standing crop was destroyed over a few hundred square metres. Check dams 6, 7, and 8 on the lower elevation of the slope were completely filled up; check dams 1 to 8 were breached from both ends; and check dam 6 was also breached in the middle.

Figure 15.5: Debris accumulation at the check dams brought down by the debris torrent of July 1995

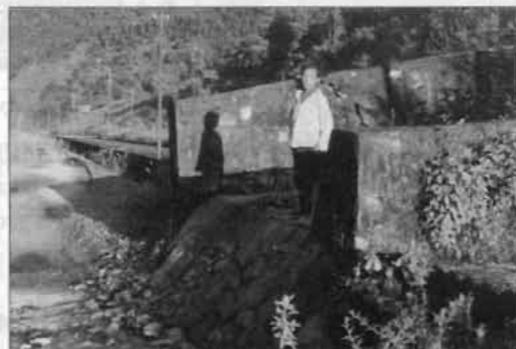
Slope No. 2 was rated as unstable before the project was completed. The first major impact was the 1976 debris torrent, which caused extensive damage to the power project by breaching the power canal around the toe of the slope. The debris flowed along a gully down the middle of Slope No. 2. To try and mitigate this problem, a series of check dams (numbered from the top part of the slope) were constructed across, and stone masonry walls along, this flow channel (Figure 15.5). These walls subsequently moved as much as 25 cm (Figure 15.6) as a result of movement of the slope.

Figure 15.6: Displacement of the drainage masonry wall at the toe of the slope

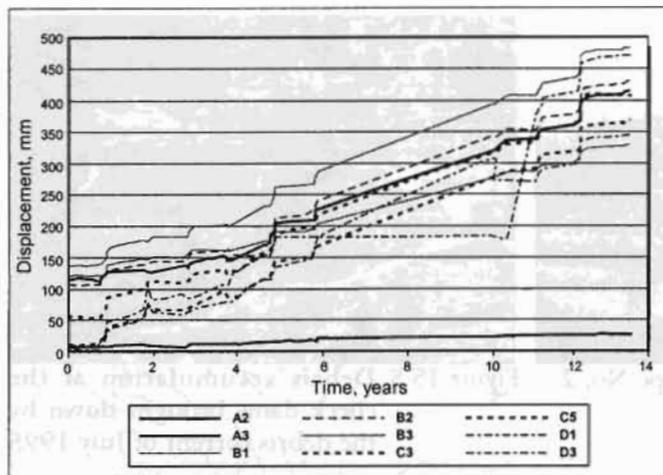
Figure 15.7: Horizontal displacement of the reference monuments against time. No axis labels, still to come

has shown total displacements varying from 0.09 m at A1 to 1.32 m at B1. The relation between horizontal displacement and time is illustrated in Figure 15.7.

The water level in the piezometers rose in the wet season; horizontal displacement of the slopes took place at the same time. This suggests a close relationship between the rise in the groundwater table and the horizontal displacement of the reference monuments.

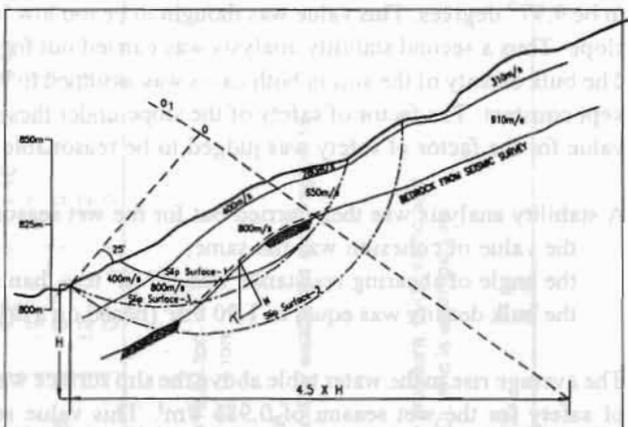
Figure 15.12: Stability analysis based on the seismic depth profile

The graphical method (Fellenius method) was used to draw the theoretical slip surface. The centre of the slip surface is drawn as follows. The steps are illustrated in Figure 15.12.

A stability analysis was carried out for the dry season. The first stability analysis was based on the assumption that the slope has a factor of safety of one during the dry season. The value of cohesion was assumed to be 0.25 t/m^2 for the lower six slices and zero for the remaining three slices (effect of loosening and loss of fines by piping from the upper part of the slope). From this analysis, the angle of shearing resistance (ϕ) of the material composing the slope was determined to be 9.97° degrees. This value was thought to be too low for the type of colluvium composing the slope. Thus a second stability analysis was carried out for an angle of shearing resistance of 20° . The bulk density of the soil in both cases was assumed to be 1.75 t/m^3 . The value of cohesion was kept constant. The factor of safety of the slope under these conditions was found to be 1.48. This value for the factor of safety was judged to be reasonable during the dry season.

The average rise in the water table above the slip surface was equal to 11m giving an average factor of safety for the wet season of 0.985 t/m^3 . This value seems reasonable as the slope is fairly unstable having shown a maximum displacement of 1.32m (pillar C1) and an average horizontal displacement of 1.056m over 14 years. The rate of horizontal displacement of the slope appears to be constant at about 7-10 cm per year.

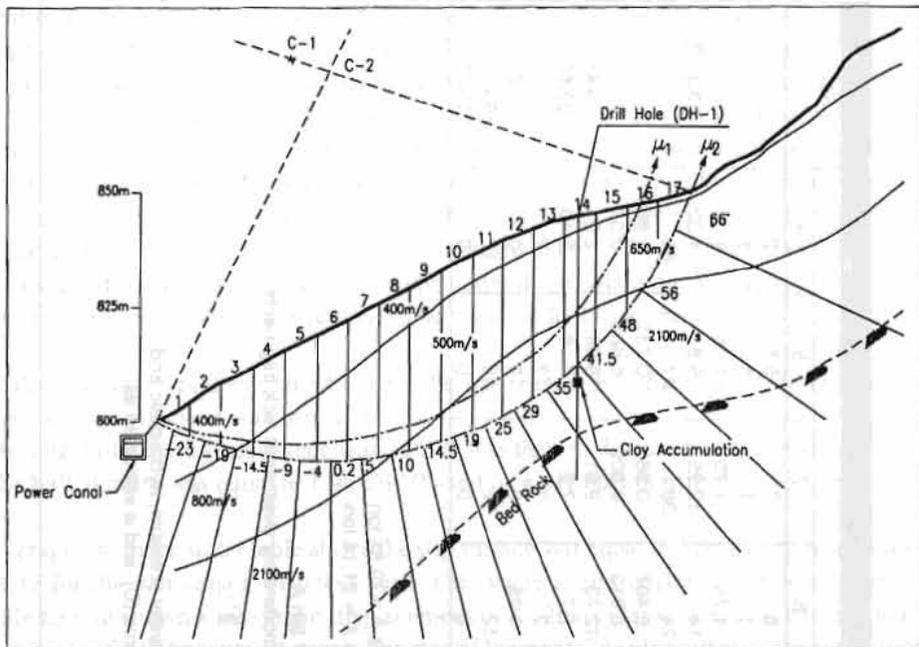
Figure 15.13: Stability analysis of Slope No. 2

Separate stability analyses were performed for blocks A1 and (A-A1). The analysis for A1 was carried out using both the graphical method with a circular slip surface (Figure 15.13) and the Hoek and Bray method. The stability analysis for A-A1 was carried out using the Hoek and Bray method only.

The stability analysis for Block A1 using the graphical method is presented in detail in Table 3; the graphical plot is shown in Figure 15.13. As with the preliminary stability analysis, the soil properties were taken to be : (Φ) = 20 degrees for the lower part of the slope decreasing step by step in the upper sections (Table 15.3) ; cohesion (c) = 0.25 t/m^2 ; dry density (D_d) = 1.75 t/m^3 ; wet density (D_w) = 1.9 t/m^3 ; rise in water table during the wet season = 19.5 m ; decrease in the Φ - value of the soil upon wetting = 10%.

The factor of safety was found to be approximately equal to 1.1 in dry conditions, close to a state of equilibrium, and to decrease to 0.89 as the groundwater table rises in the wet season.
