Landslide Control and Stabilisation Measures for Mountain Roads: A Case Study of the Arniko Highway, Central Nepal

T. L. Adhikari

ITECO Nepal (P) Ltd., New Baneswor, Kathmandu Nepal

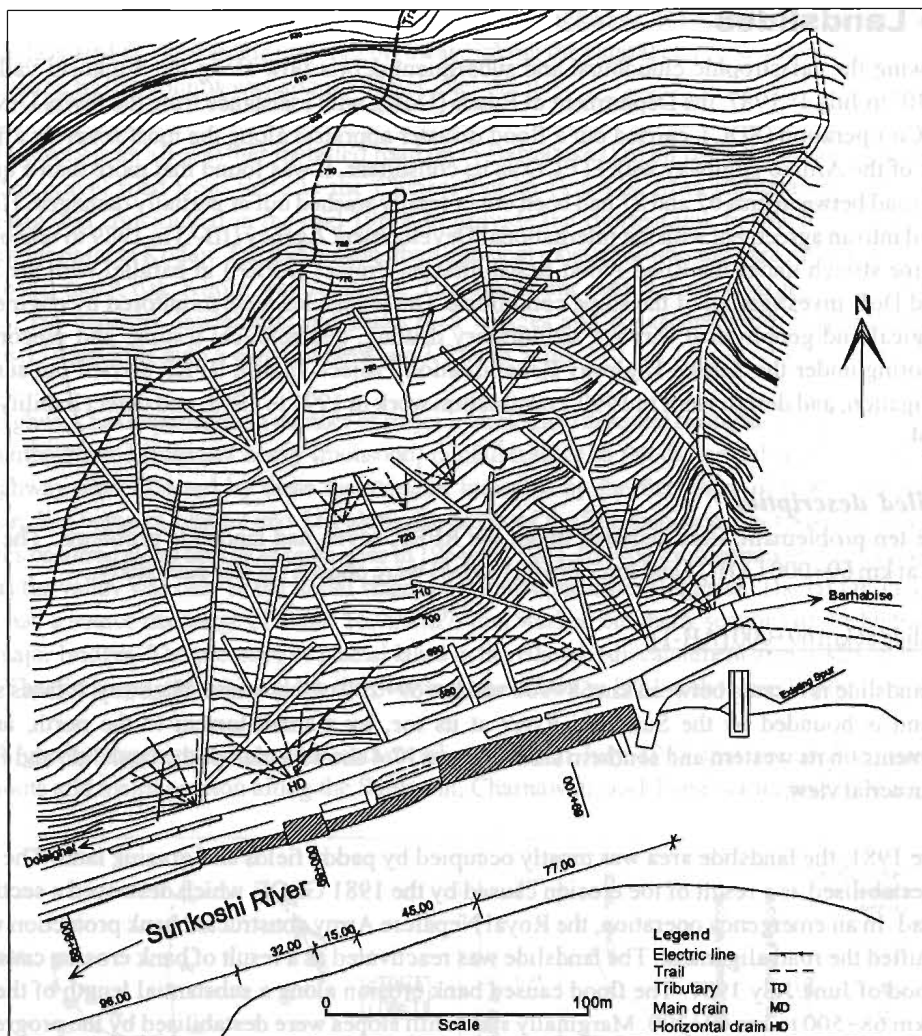
Figure 17.4: Plan of landslide AH-1 (RFRP 1990)

Before 1981, the landslide area was mostly occupied by paddy fields and grazing land. The slope was destabilised as a result of toe erosion caused by the 1981 GLOF, which destroyed a section of the road. In an emergency operation, the Royal Nepalese Army constructed bank protection works and shifted the road alignment. The landslide was reactivated as a result of bank erosion caused by the flood of June/July 1987. The flood caused bank erosion along a substantial length of the road from km 68+500 to km 69+200. Marginally stable hill slopes were destabilised by the progressive development of this landslide.

After the 1987 flood, the landslide was monitored and stabilised through extensive drainage works, bioengineering, and a few structural measures. The initial development of the landslide had been rotational, which was followed by a series of slumps, tension cracks, and translational slips. Though the reactivated depth of the slide was shallow, there was a potential for a deep-seated failure.

The landslide area was made up of colluvial material with a sandy-silty matrix with isolated boulders of up to 4m across. The colluvial slope extended from the Sunkoshi River bank to 600m above it. The landslide involved more than 100,000 m³ of colluvial material. It covered an area of 300m along and 400m above the road and was destabilising paddy fields, dry crops, and settlements. Minor symptoms of instability and tension cracks extended a further 200m.

The main triggering factor responsible for the sliding was the bank erosion of the Sunkoshi River. The propagation of the landslide from the riverbank to 400m above the road is attributed to the saturation and high ground water table, which was re-charged by the irrigated paddy fields above and within the unstable area. Photographs taken from a helicopter illustrate the extent of the landslide (Figure 17.5).

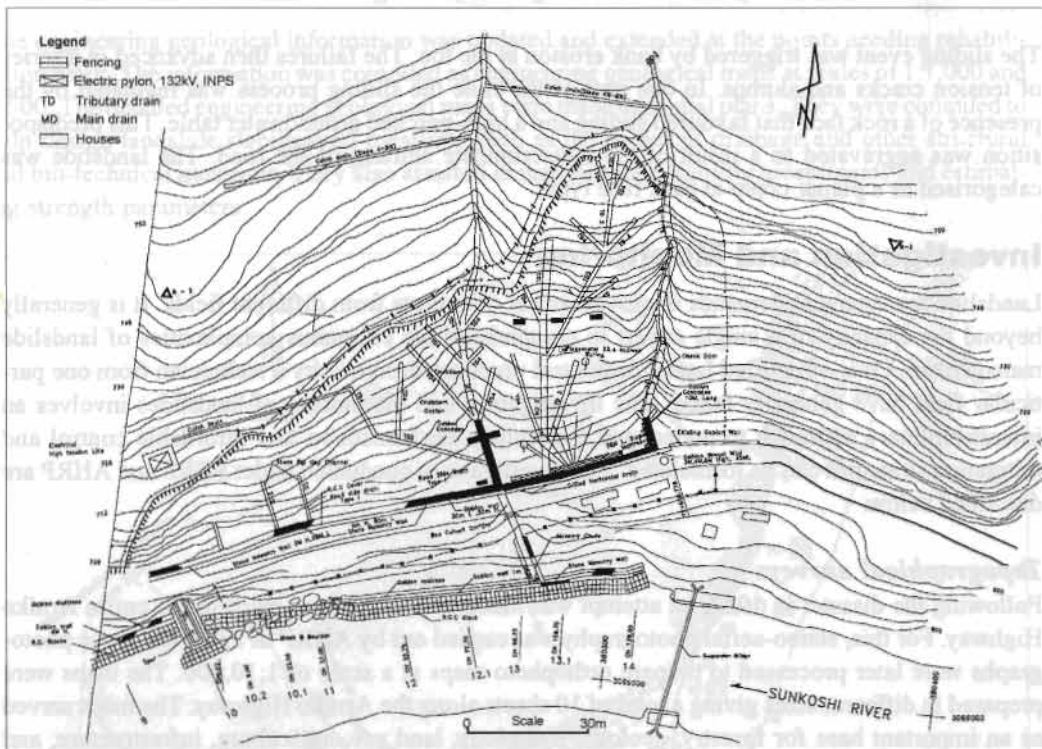
Figure 17.6: Plan of landslide AH-4 (RFRP 1990)

The landslide consisted of colluvial debris and gravels with a silty to clayey matrix. About 30,000 m³ of material was involved. The landslide affected an area 150m along and 100m above the road and had destroyed a number of cultivated terraces. Some tension cracks were noted above the crest of the active part of the landslide. The growth of the landslide and bank erosion along the Sunkoshi River had led to the loss of at least two hectares of cultivated land and a few houses at Balephi. An electric pylon was also endangered. The landslide remained active from 1987 to 1989 and was still in a moderately active state during the initial stages of RFRP.

The sliding event was triggered by bank erosion at the toe. The failures then advanced in a series of tension cracks and slumps. In one part of the slide the sliding process was regulated by the presence of a rock face that favoured sliding and a high-perched groundwater table. This predisposition was aggravated as a result of the indiscriminate shifting of the road. The landslide was categorised as a planar creep at rock face type.

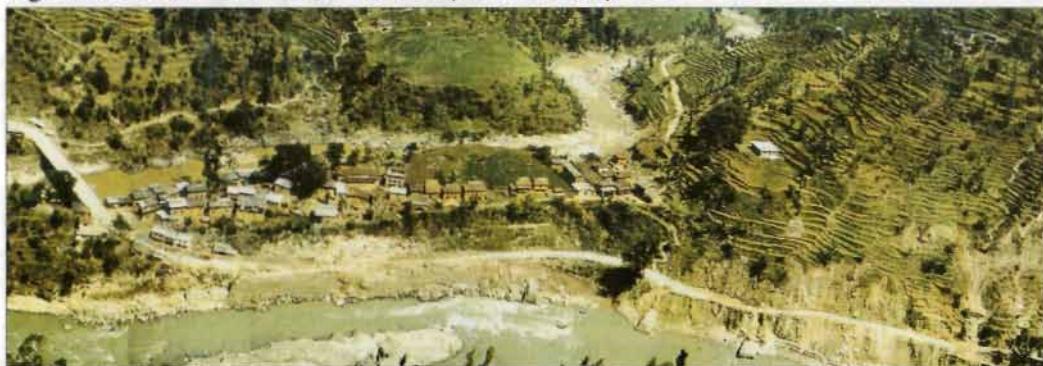
Figure 17.7: Aerial photograph of landslide AH-4 (AHRP 1989)

towards the hillside. However, this destabilised the fragile colluvial slope. The flood event of July 1987 further jeopardised the stability of the slope. Emergency measures such as gabion walls and spurs were constructed in 1988. The landslide was studied by AHRP (1989) and during the RFRP design phase (1990). These studies provided the basis for designing and building mitigation measures, which were completed in 1994.

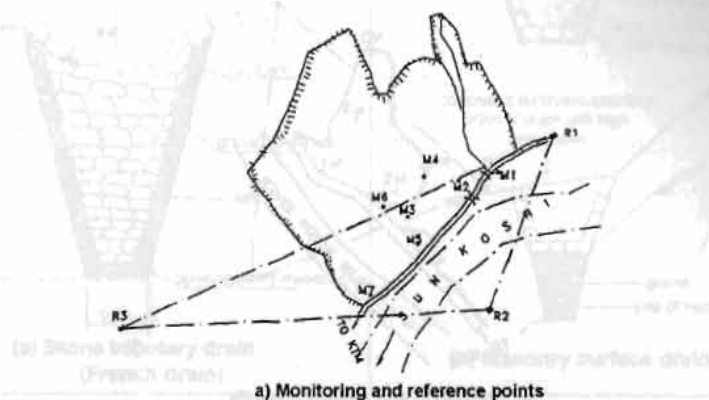
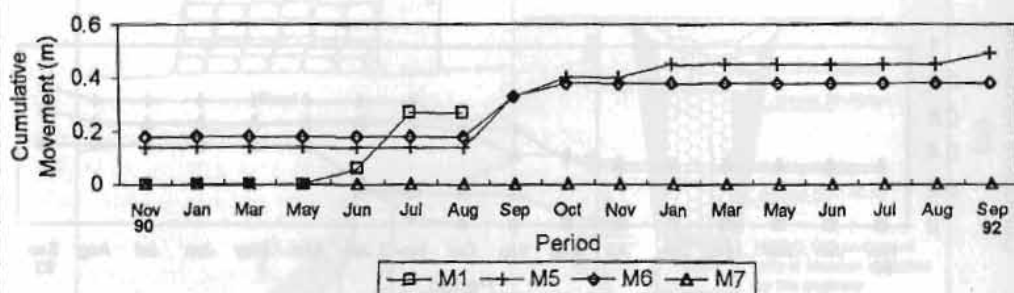
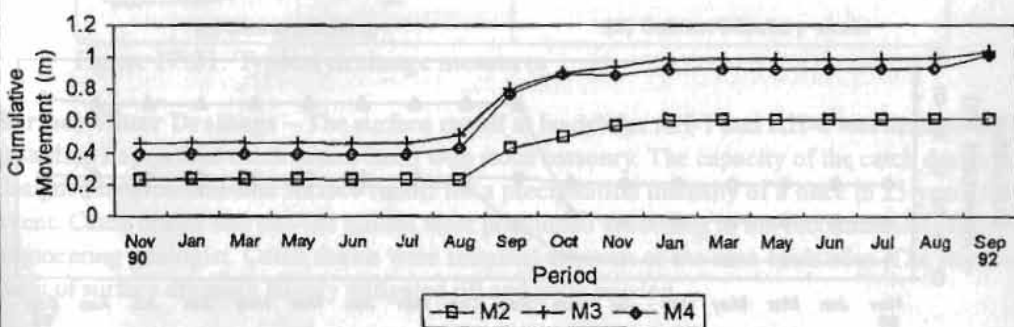
Figure 17.19: Landslide movement monitoring at landslide AH-1 (AHRP 1990)

b) Movement of selected monitoring points from Nov 1990 - Sept 1992

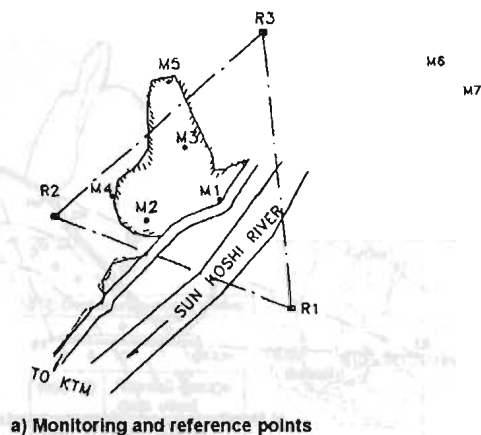
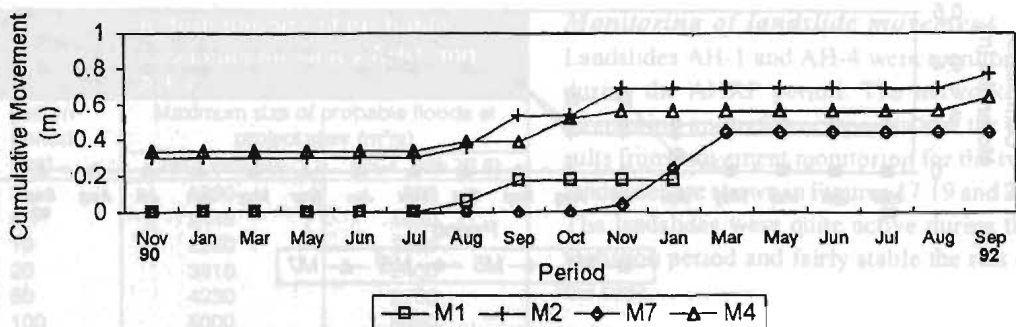
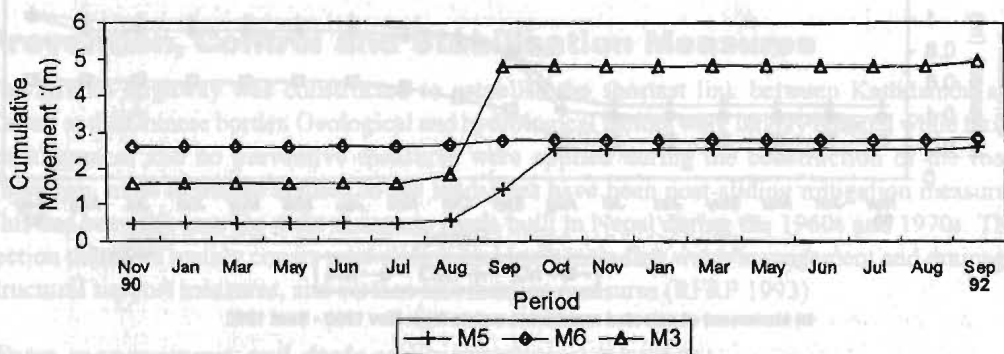
Figure 17.20: Landslide movement monitoring at landslide AH-4 (AHRP 1990)

b) Movement of selected monitoring points from Nov 1990 - Sept 1992

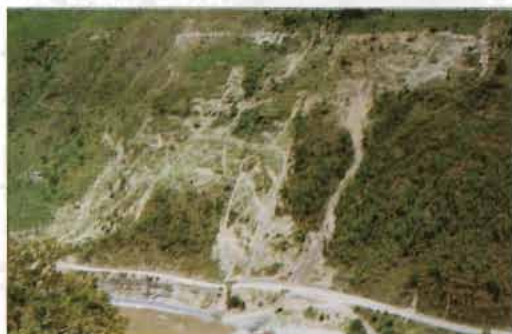
Figure 17.25: Landslide AH-1: a complex network of landslide drainage

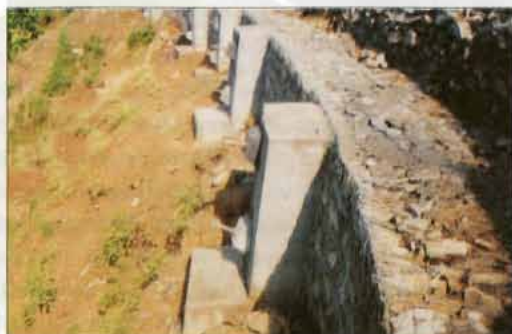
Figure 17.26: Landslide AH-1: an anchored gabion-retaining structure

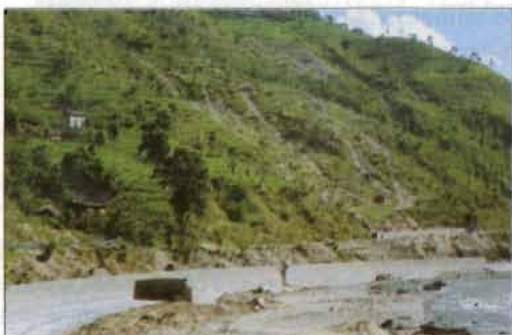
Figure 17.27: Landslide AH-1: a revetment wall is being constructed with a concrete framed apron

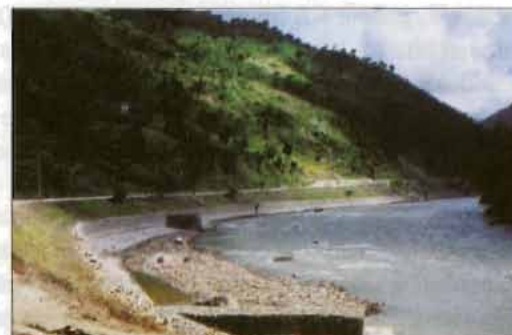
Figure 17.28: Landslide AH-1: completed bank protection works

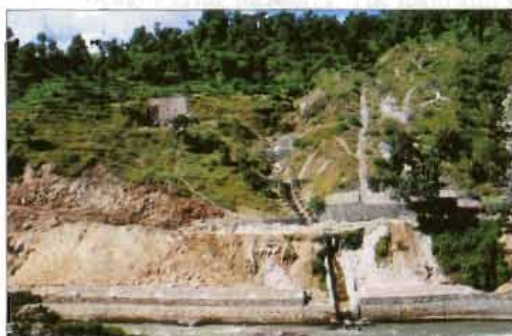
Figure 17.29: Landslide AH-4: landslide drainage and bank protection upstream from the landslide

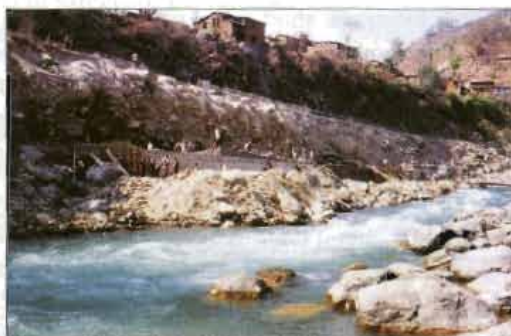
Figure 17.30: Landslide AH-4: construction of revetment wall

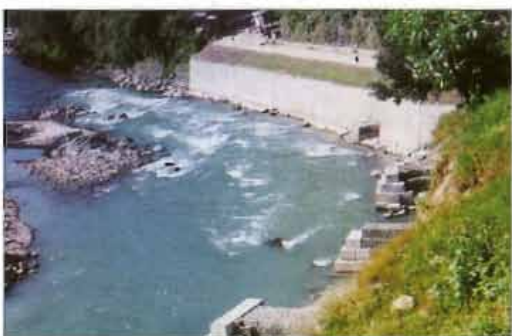
Figure 17.31: Landslide AH-4: completed revetment wall
