Landslides Induced by June 2017 Rainfall in Chittagong Hill Tracts, Bangladesh Causes and Prevention

Field Report

Landslides induced by June 2017 rainfall in Chittagong Hill Tracts, Bangladesh

Causes and Prevention

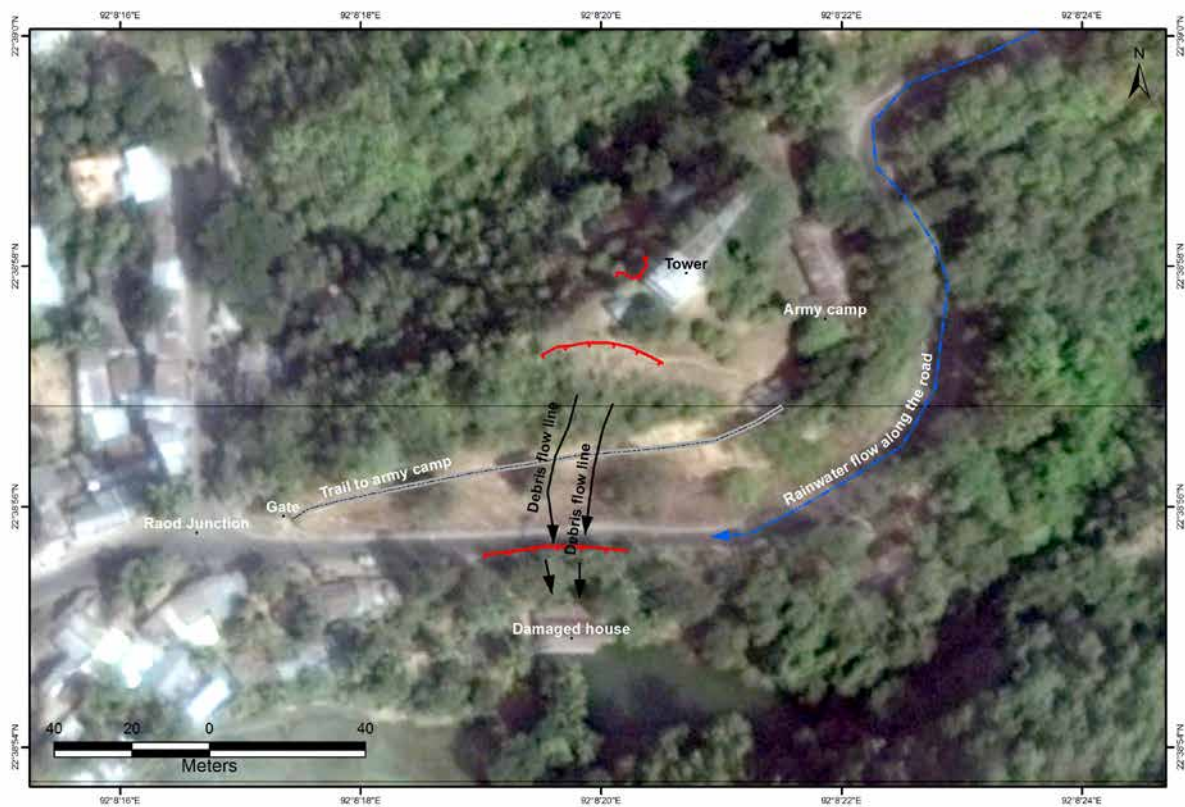
1	Hill Slope Failure
A	<p>Hill slope failure at Manikchari — Figure 5 and Figure 6</p> <p>Location: 22° 38' 56" N, 92° 8' 19" E (30 m toward Rangamati from the Khagrachari-Rangamati Road junction)</p> <p>Debris slide at the southern slope near to the telecommunication tower. Trail to the army camp and main road blocked by the debris. Almost 45 m of the road section washed out and disconnected Rangamati city from Chittagoan for 15 days.</p> <p>Geology: The area is covered by 3 to 5 m thick yellowish-brown silty clay over the yellowish-brown less compacted fine-grained sandstone on top and underlain by intercalation of the shale and sandstone layers. The bottom layers are mostly shale towards the junction of the road to Chhitagoan and Khagrachari. Less than half a meter thick fine sandstone bed consisting of mud balls is also observed in between. The rock is exposed only at the base of the slope at road cut section. The attitude of shale bed is N16W/28E.</p> <p>Cause of failure</p> <p>Due to saturation and surface erosion of sediment on the slope, the sediments near the tower slid down and deposited on the trail to the army camp and further on the main road (Figure 6). The debris deposit on the road blocked the rainwater surface flow, which was flowing along the road. The flow was diverted at the side slope of the road due to the blockage. The debris-loaded surface runoff eroded and washed out the side slope of the road and damaged the houses on the down slope.</p>

Figure 5: **Plan view of hill slope failure at Manikchari Army Camp area**

Prevention

- Tower is safe but needs minor protection work to protect erosion on both side slopes of tower.
- Road needs to be supported by concrete structure for heavy vehicles.

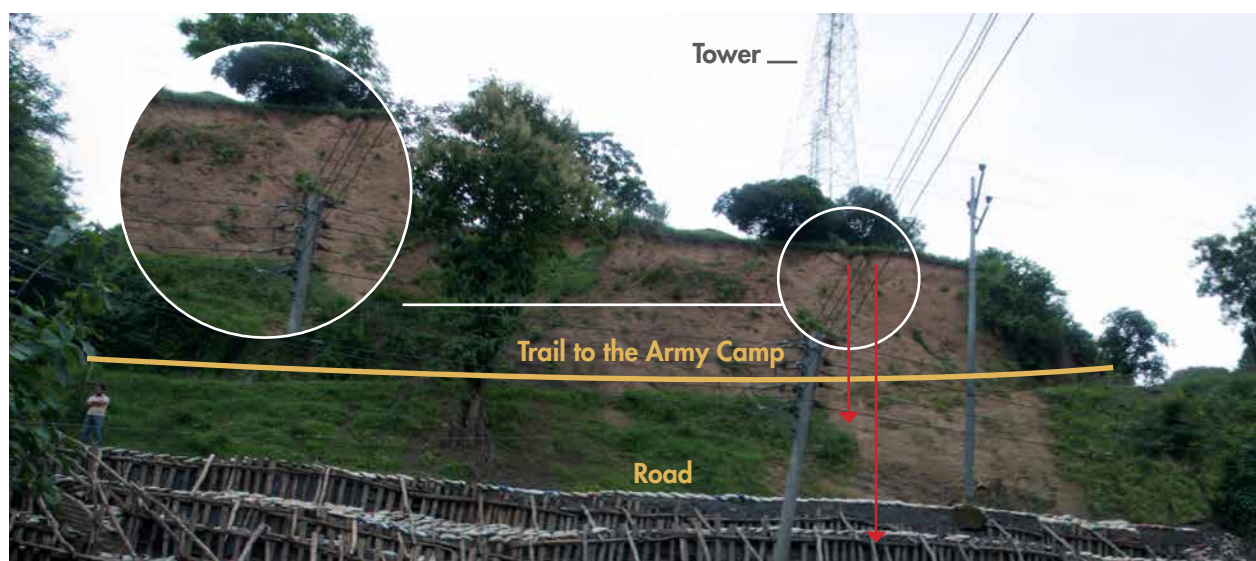
Figure 6: Hill slope failure at Manikchari Army Camp

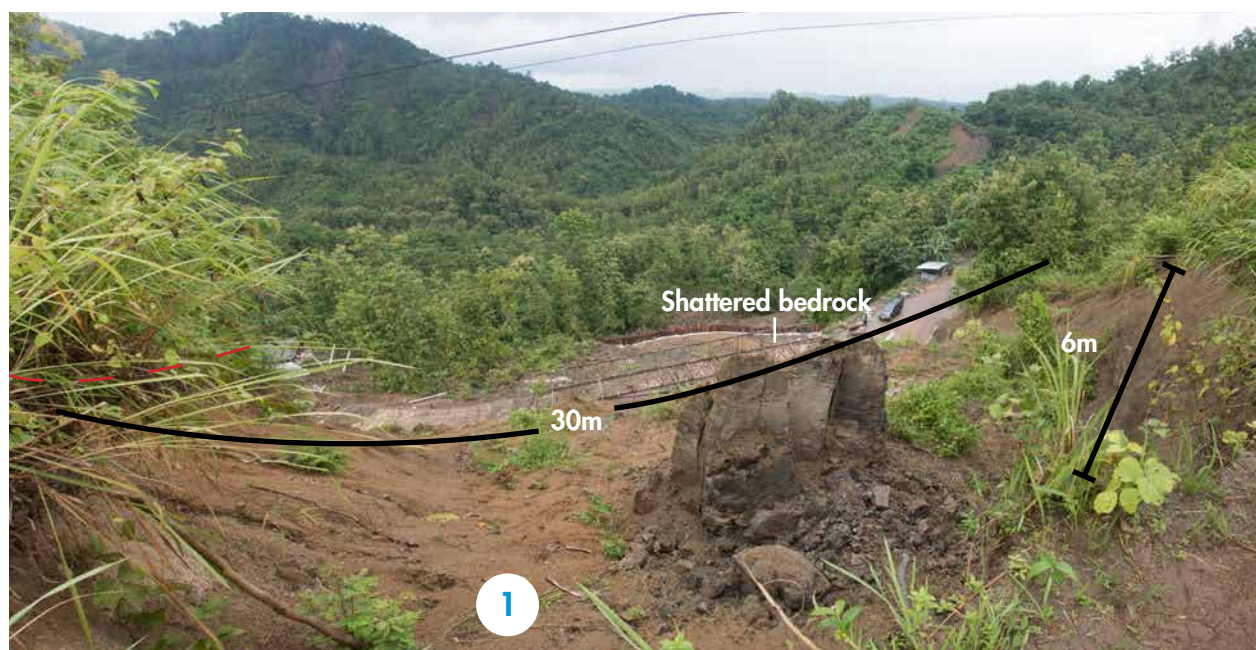
Deep erosion, debris slide, and debris flow resulting in almost 30 m wide and 6 m deep scarp at the crown. The exposed shale rock was shattered. The sediment has been transported through the road and finally road section washed out forming a deep gully. A Bailey bridge is under construction over the deep gully.

Concave type of landform from the ridge to the down gully indicates that the area is the gully head of a watershed. The area is easily eroded and transported as the sediments were saturated due to the continuous rain. The over-hanged sediments are also slipped down.

Figure 7: Hill slope failure at Sapchari-Salbagan Bailey bridge site

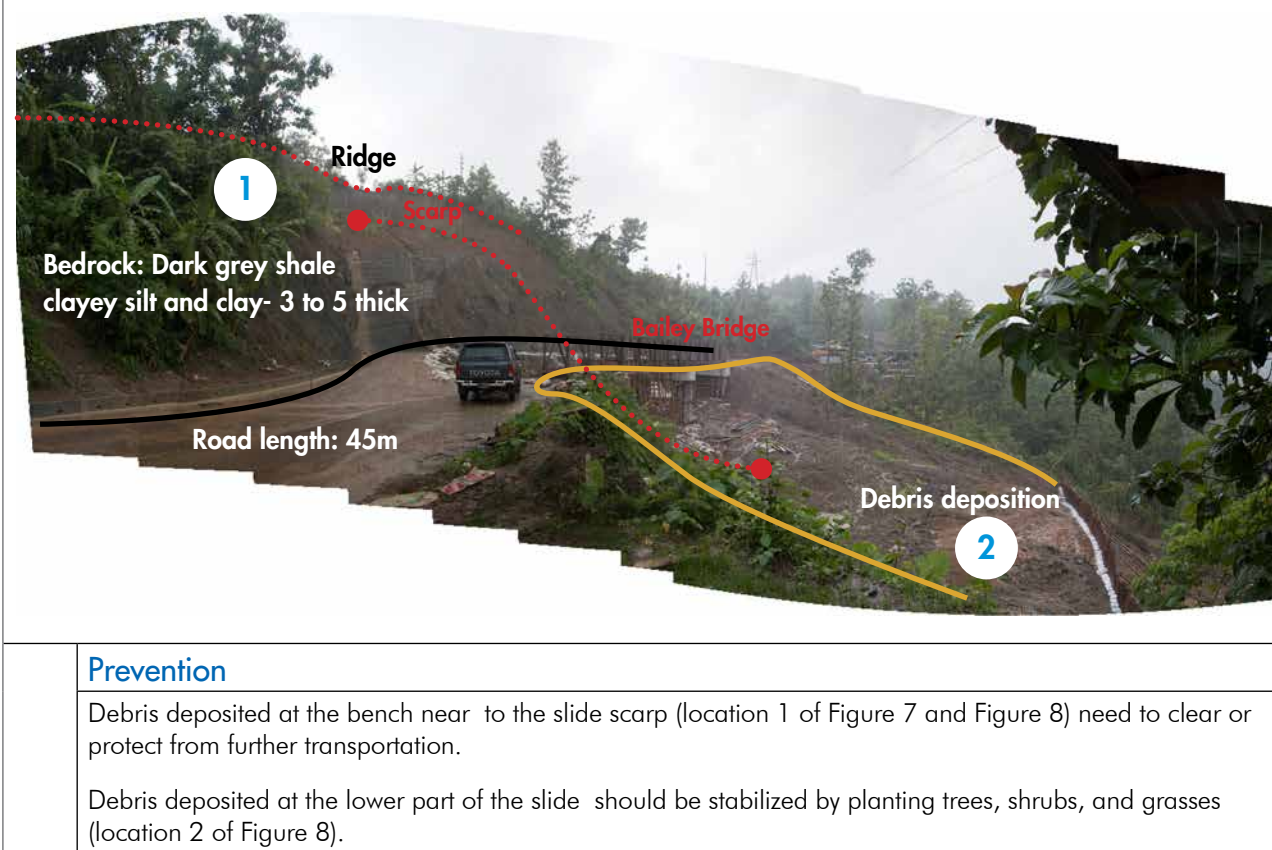
Figure 8: Hill slope failure and debris deposition at Sapchari-Salbagan Bailey bridge site

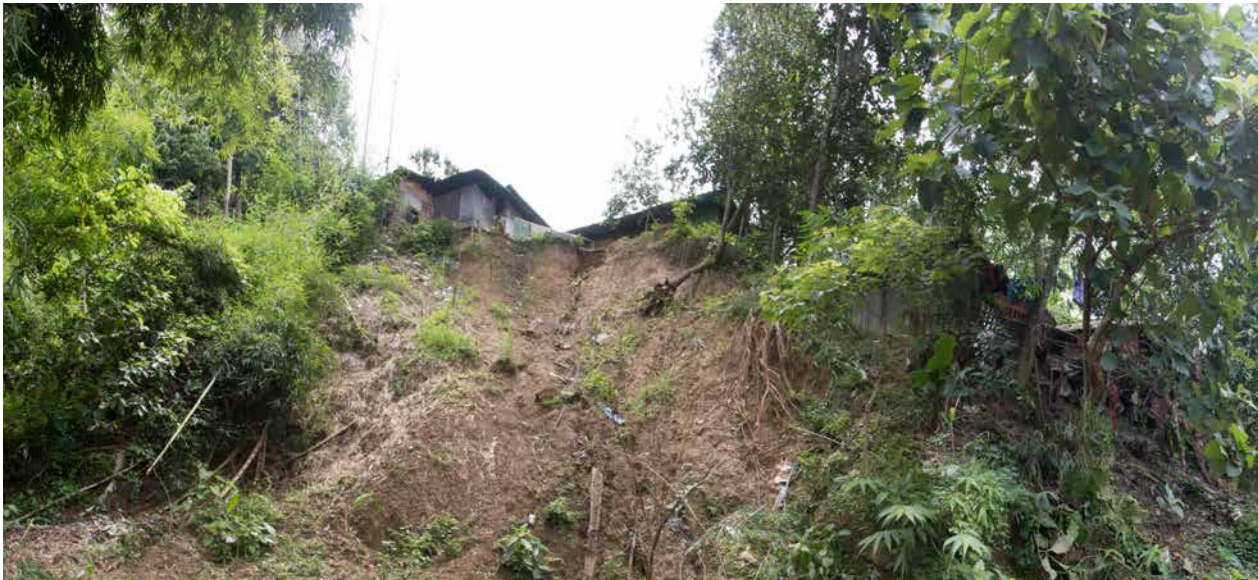
Location: 22° 36' 32" N, 92° 5' 55" E at Ghagra Bazar (50 m south of Rangamati-Kaptai Road junction)
Gully head or catchment head failure. Some houses buried and damaged by the debris at the base of the slope.

Geology: The area is underlain by the intercalation of shale and brownish sandstone with sediments of about 3 to 5 m thick on the surface. The length of the gully slope is about 20 to 25 m. At the head is some flat land with some houses (Figure 9). The accumulated surface water drained through that gully.

Figure 9: Catchment gully head failure at Ghagra Bazar (50 m south of road junction of Rangamati-Kaptai Road)

<p>Cause of failure</p> <p>The area is a concave type of landform with open and unpaved drainage at the slope. The surface water accumulated at the house area flowing down to the slope. Additional rainwater surface runoff eroded and transported the sediments down gully in the form of debris slide and flow.</p> <p>Prevention</p> <ul style="list-style-type: none"> • Drain surface water properly from confined channel • Need to construct paved gully • Protection work at gully head • Erosion control from vegetation measure • Tree plantation at the bottom of the slope to protect the slide
--	--

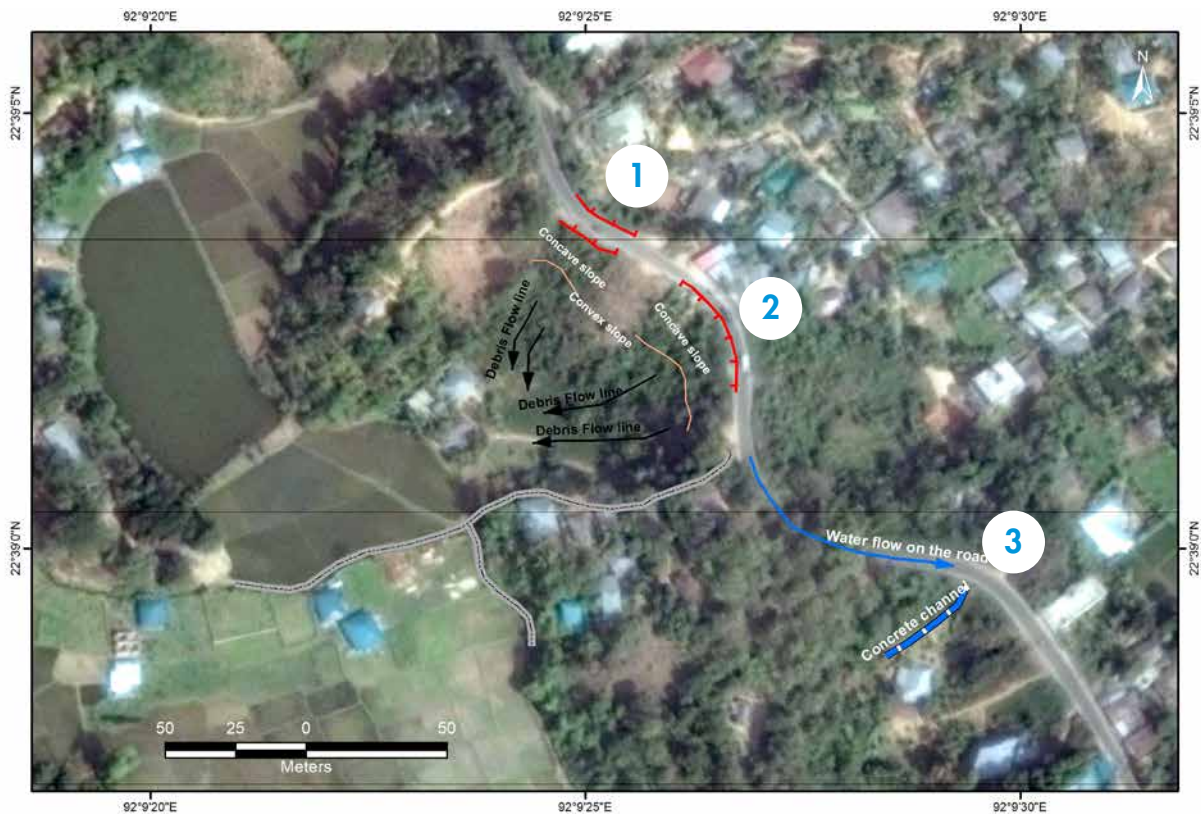
3	<p>Saddle (Ridge) Side Failure</p> <p>Location: 22° 39' 4" N, 92° 9' 26" E at Monoghor-Rangapani Road (Figure 10)</p> <p>Side slope of the ridge road failure forming 15 and 20 ft scarps at locations 1 and 2, respectively, in Figure 10. Erosion and debris slide extending to the catchment or gully head narrowing the ridge road.</p>
----------	--

Figure 10: Plan view of saddle side slope failure at Monoghor-Rangapani at Ghagra bazar

<p>Cause of failure</p> <p>The Monoghor-Rangapani Road at Ghagra bazar is a ridge road functioning as a water divide of the catchments. Furthermore this section is a saddle type. The rainwater surface runoff flows along the road and drains somewhere at the side of the saddle down to the gully. The landforms are forming alternatively concave and convex at both sides of the road. The concave landforms indicate the existing gully, and convex landforms form the water divide. The surface runoff drained from the concave slope (locations 1, 2, and 3 in Figure 10). The concave surface already weakened due to saturation and overload of debris. The runoff of unprecedented heavy rainwater and accumulated surface rainwater at the ridge easily eroded and transported the sediment as debris flow and slide, which damaged both sides of the road at location 1 and the front side of the road at location 2 of Figure 10 and Figure 11. The rainwater completely drained to only one side of the road eroded even the base of the road (location 2 in Figure 10 and Figure 11). Side and protection walls of the road collapsed. The existence of many gullies at the headwater indicated that there was continuous runoff even after the collapse.</p>

<p>Prevention</p> <ul style="list-style-type: none"> • Need to manage road side drainage down to the gully. • Protection structure should be on the basement rock and fill.
B	<p>Weird road side drainage</p> <p>Location: 22° 38' 44" N, 92° 11' 51" E at Risermok (Desbangla 1 km chainage) (Figure 13)</p> <p>Edge of the road section including protection wall and road side drainage collapsed due to debris slide.</p> <p>Cause of failure</p> <p>Road side drainage is used to drain the accumulated water at the road safely. The road at Risermok is laid over the sediments. The sediments are soft and easy to erode by the surface runoff water. To protect the erosion side drainage is used to control the surface runoff erosion. However the constructed road side drainage was not properly maintained in this section. Malfunction of road side drainage washed out the sediment damaging the side slope of the road. The side drainage is drained to a gully but the gully was also not paved which resulted in gully erosion and debris slide.</p>

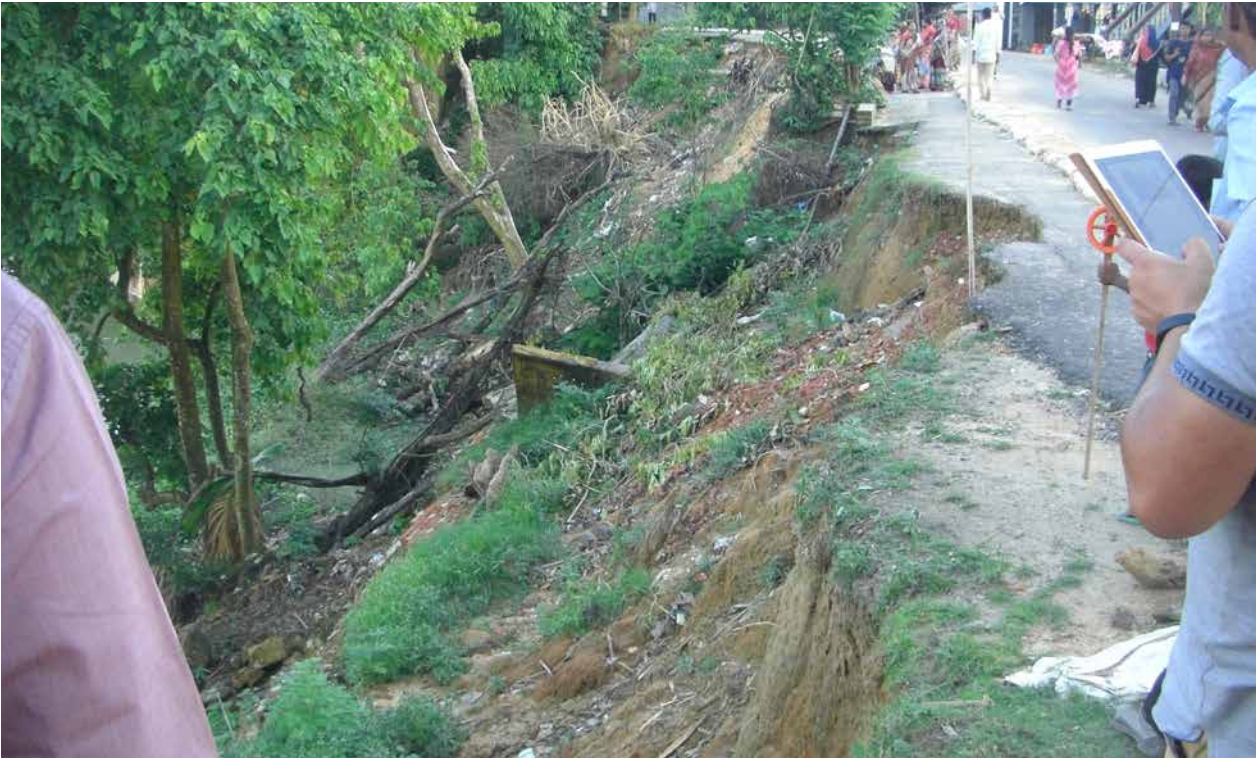
<p>Figure 13: Road side slope failure due to leakage of road side drainage at Risermok (Desbangla 1 km chainage)</p>

<p>Prevention</p> <ul style="list-style-type: none"> • Road side drainage management • Erosion control and protection work in the gully
C	<p>Water supply leakage</p> <p>Location: 22° 38' 26" N, 92° 11' 22" E at Tabalchhori (at road junction to Risermok and Rangamati, near Ananda Vihar) (Figure 14)</p> <p>Edge of the road section including drinking water supply pipes collapsed which narrowed the road width.</p> <p>Cause of failure</p> <p>Most of the road sections in Rangamati are paved on the sediments of silty clay or sandy clay, which are soft in nature. Continuous leakage of subsurface pipe water supply drains internally forms an internal gully. The void sometimes forms as a pothole on the road surface or subsidence of road section. The area will be easy to erode by additional surface runoff during the heavy rain.</p>

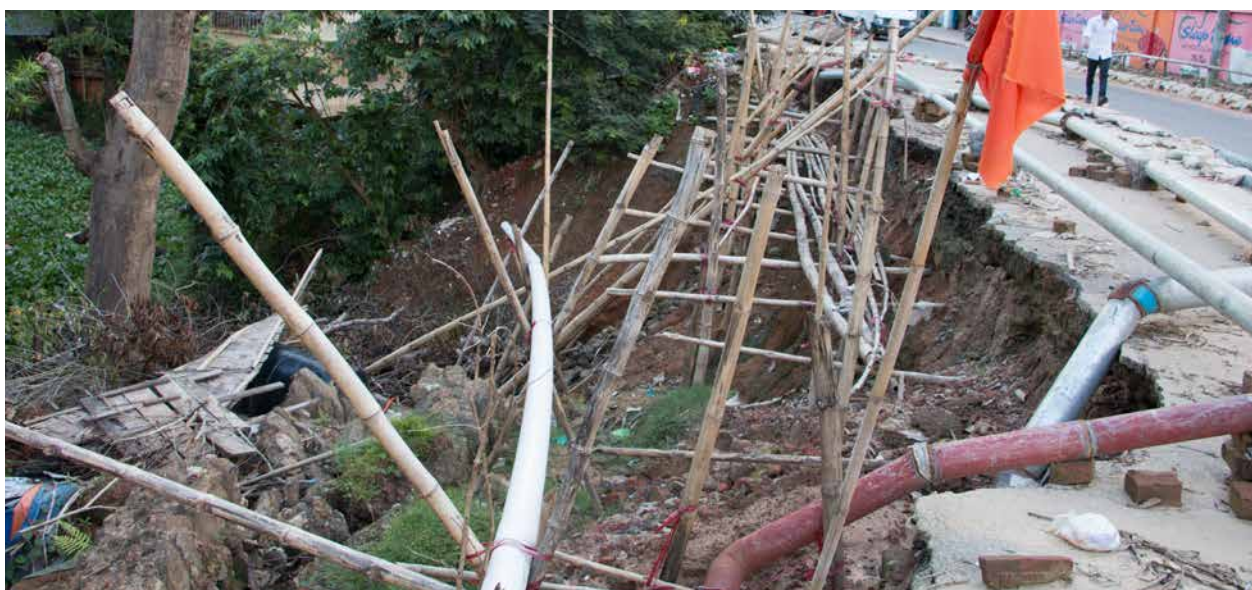
Figure 14: **Road side slope failure due to water supply leakage**

Prevention

- Water supply leakage management
- Road side drainage
- Gully protection work

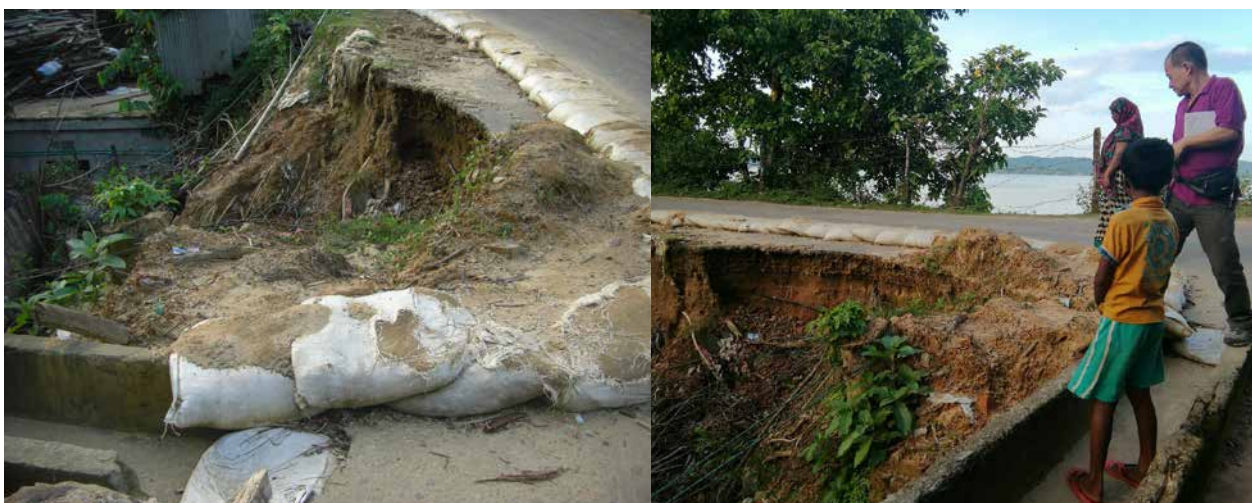
Edge of the road collapsed narrowing the road width and forming bottleneck road.

Side drainage at the road is to drain the water of the road to protect from the erosion. However the side drainage constructed at the road side was under capacity for the unprecedented heavy rain of 2017. The surface water drained through the drainage as well as from the side slope of the road, which is eroded and damaged the slope. But the damage was not so great compared to other areas.

Figure 15: **Road side slope failure due to under-capacity road side drainage at Risermok**

Prevention

- Need full capacity of road side drainage
- Need to construct road side drainage

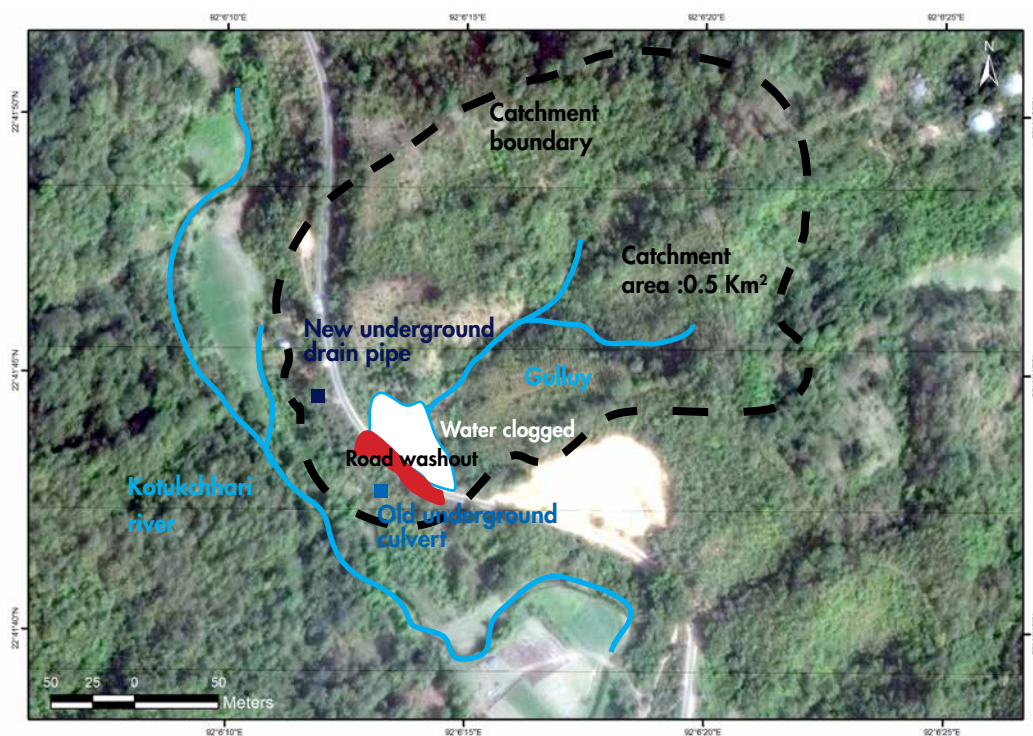
About 30 m length with 11 m high Rangamati-Khagrachhari Road at Montola Kijing washed out completely. The road section had under reconstruction.

Figure 16: **Plan view of drainage blockage outburst at Montola Kijing** (Rangamati-Khagrachhari Road)

A culvert of 1 m x 1 m under the road was maintained to drain the water of 0.5 km² catchment area. Debris slides with tree trunks at three places in the catchment accumulated at the culvert and choked the drain, forming a pond at the culvert. After three days the pond outburst at 8 a.m. on 15 June 2017 and 30 m length with 11 m high road washed out completely.

- Need full-capacity culvert
- Clear the blockage regularly particularly before monsoon

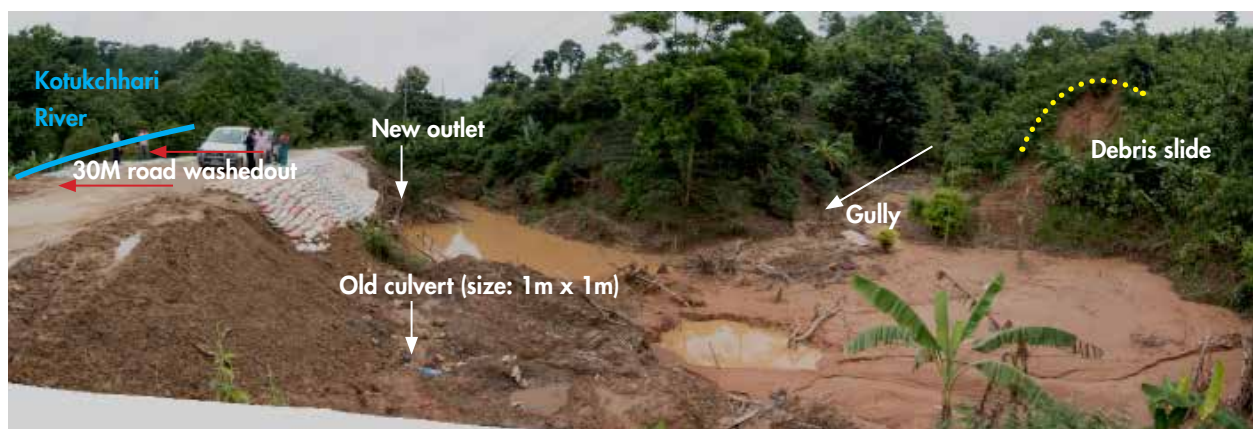
Figure 17: **Drainage blockage outburst at Montola Kijing (Rangamati-Khagrachhari Road)** (Note: New outlet made of about 60 cm diameter is not large enough in case trees and debris block the culvert.)

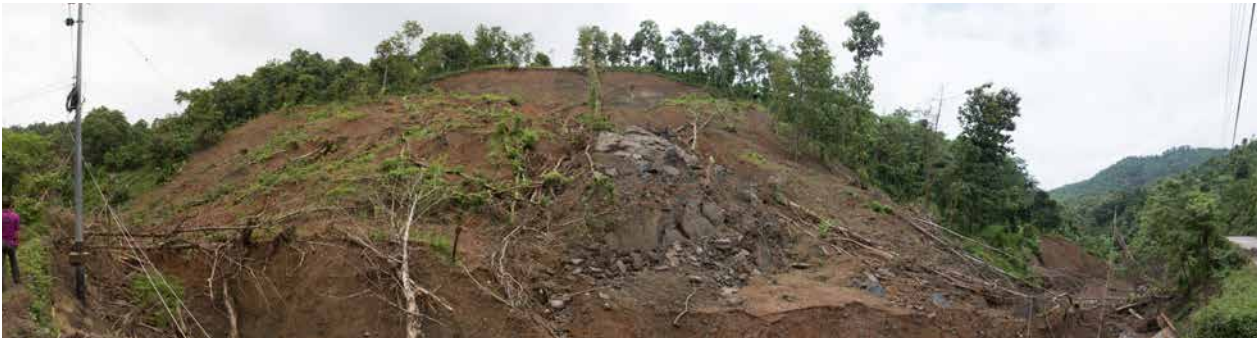
6	Toe Cutting
	Location: 22° 37' 56" N, 92° 06' 54" E at tributary of Ghagra River, Rangmati Road section (Figure 18)
	Debris slide at the left bank of the tributary of Ghagra River. No damage to settlement and infrastructure.
	Cause of failure
	Streams that flow at the base of mountain slopes continuously erode the base, resulting in lateral erosion (toe cutting). In this instance, heavy rainfall increased the discharge and erosional capacity of the stream and in addition the sediment on the slope is saturated and overloaded due to continuous heavy rain. Debris slide and flow has occurred at the mountain slope due to the combined result.
Figure 18: Debris slide due to toe cutting of the mountain slope

Prevention
	<ul style="list-style-type: none"> The slide does not affect the road and settlement at this area, so there is no need to protect the landslide.

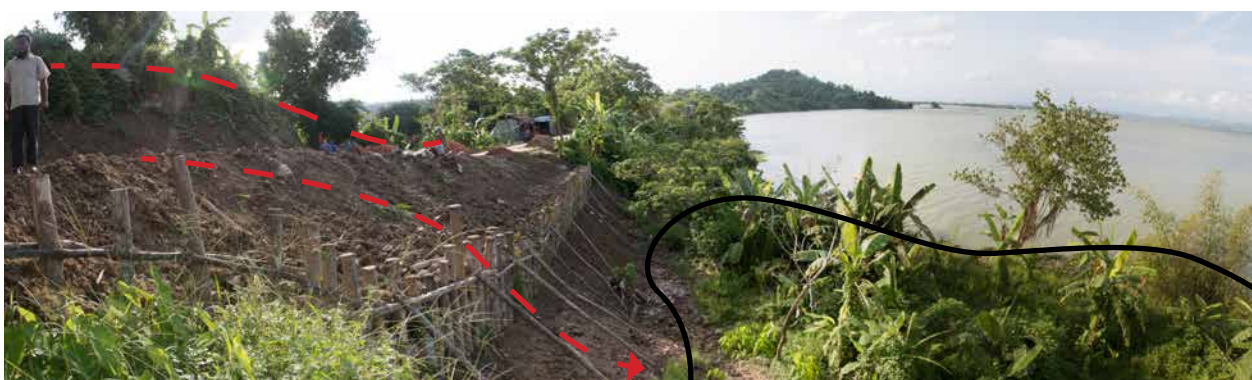
7	Reactivated Landslide and Subsidence
A	Banabhante (Rangamati-Kaptai Dam Road)
	Location: 22° 34' 41" N, 92° 10' 29" E at Banabhante (Rangamati-Kaptai Dam Road) (Figure 19)
	Subsidence of road section at Banabhante. The surface has dropped down by almost 5 m.
	Cause of failure
	The area is covered mostly by clay material with dense vegetation. The base of the hill slope is saturated due to continuous contact with the lake water. The continuous rain saturated the surface and subsurface layer, which became overburdened and overloaded. Finally the sediment had subsidence, debris slide and flow with some rotational movement. The existing road level had dropped down almost by 5 m.
	Prevention
	<ul style="list-style-type: none"> Management of subsurface drainage Add protection structure to the road Road needs to be supported by concrete structure for heavy vehicles

Figure 19: **Subsidence and debris flow at Banabhante** (Rangamati-Kaptai Dam Road)
