Managing Debris Flow Risks

Markus Zimmermann

Security Measures for a Hazard-Prone Resort in Switzerland

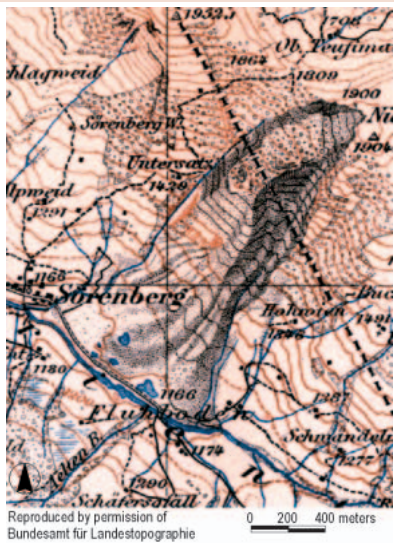
FIGURE 2 1918 topographic map, showing the open scars on either side of the mass and the typical accumulation features developed in 1910 and 1912. The few houses with the church (at the center of the village) are located in a safe place. (Map reproduced by permission of Bundesamt für Landestopographie, BA024084)

Analysis of past events makes an important contribution to the understanding of present and future hazards in a particular location. A number of historic documents such as maps (Figure 2), postcards or photographs, as well as a detailed description of the 1910 events by the famous geologist Albert Heim, provided the necessary information to reconstruct the sequence of landslide events in the 20th century. Between 1860 and 1910 the entire complex shifted downhill by more than 30 m in a large vertical movement. In 1910 another large vertical movement occurred, lasting several days and causing 2 major lateral collapses and massive debris flows of over 3 million m³. Throughout the rest of the 20th century development was irregular. Several lateral and frontal collapses occurred in 1912, 1922, and 1986, with 6 decades of geomorphic inactivity in between.

At the beginning of the 20th century the area now occupied by the village was used as grazing land. The map (Figure 2) indicates that the existing few houses in Sörenberg were arranged around the church in a safe place. Within the accumulation area of the 1910, 1912 and 1922 debris flows, only a very few isolated houses were destroyed.

Sörenberg's development into the tourist resort that it is today took place only over the past 30 to 40 years. The 1918 map (Figure 2) clearly shows that at that time only very few buildings were located in what was once a highly active accumulation area. Today this area is completely covered by houses (Figure 3). The long period of geomorphic inactivity following the events of 1922 was interpreted as a sign of future security. An analysis by experts in 1974 proved that there was no immediate threat, but did not altogether exclude the possibility of damaging events. An indication of the uncertainty of the situation was provided by displacement measurements begun in 1978. These clearly show that the whole mass is continuously moving about 3 to 10 cm per year. The speed of this movement increased dramatically in 1999 but has slowed down again since.
