Assessment of small-scale landslide treatment in Nepal

P. Mathema¹ and J. Joshi²

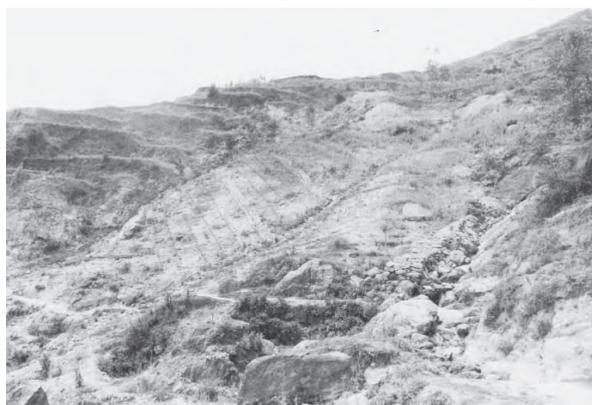
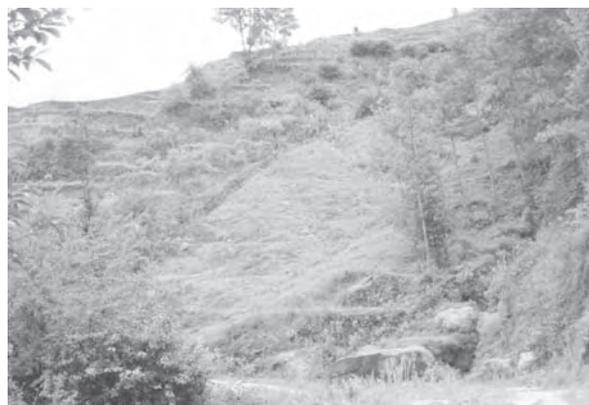
Photo 1 and 2 : Treated landslide in Sisneghari, Gagalphedi-3, Kathmandu in 1998 and 2008

This landslide damaged Mr. Mohan Lama's paddy field and about 40 m road section. The local people and Bagmati Watershed Management Project/DSCO Kathmandu agreed to stabilize the landslide. Toe wall and surface drainage in herringbone pattern within the landslide were constructed, and broom grass (*Thysanolaena maxima*) and bamboo were planted (Photo 1). After the treatment, the major portion of the landslide has been stabilized due to the growth of broom grass, bamboo and local plant species (Photo 2). Unfortunately, a new landslide had set off

about 70 m above the head scarp of the treated landslide. Mr. Lama is still continuing paddy cultivation in his field just above the head scarp. There is an irrigation channel just 30 m above the head scarp of the treated landslide, water flows from west to east towards a natural drain. Also, excess water from the paddy field has been flowing through the treated landslide. As a result, a parcel of sloping land, 20 m long and 17 m wide, has been destabilized at the western flank of the treated landslide due to unmanaged drainage. Besides, numerous rat holes have sprung up at the western scarp where broom grass had grown well. Rats had damaged the paddy field of the farmer, so he had burnt all the clumps of broom grass in March, 2008. But the grass had grown back after the rainfall in June 2008. No maintenance work seems to have been done in the treated landslide site. The main issue here is: how to change the landuse in the catchment of the landslide, and how to ensure regular maintenance?

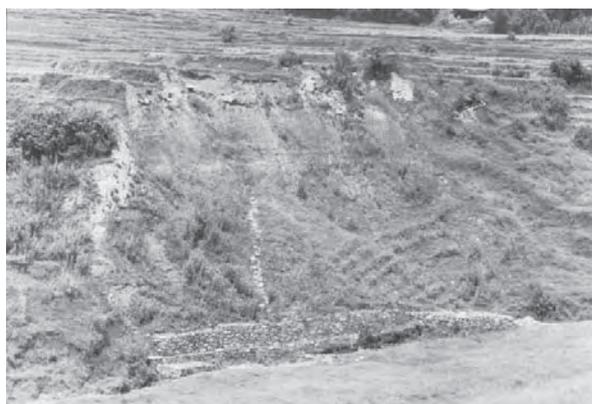
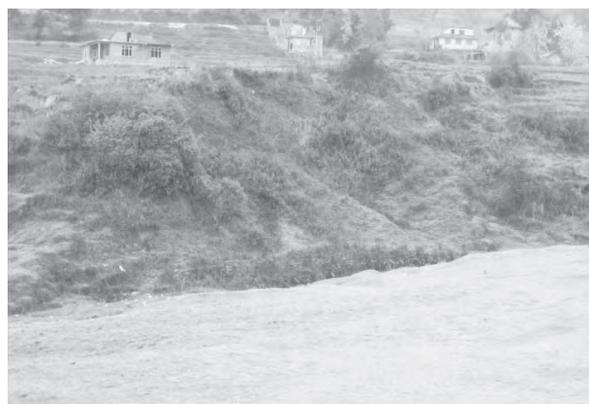
Photo 3 and 4 : Treated landslide in Naikap Puranobhanjyang-9, Kathmandu in 2001 and 2008

This landslide damaged valuable paddy fields above the head scarp area. The affected farmers approached Bagmati Watershed Management Project/DSCO Kathmandu for assistance. The Project agreed to treat the landslide. Toe wall and surface drain within the landslide were constructed. Broom grass and utis (*Alnus nepalensis*) were planted (Photo 3). After the treatment, the major portion of the landslide had been stabilized. Broom grass and local plant species had grown up. Some utis trees were growing on the upper side of the landslide (Photo 4). However, excess water from the paddy fields above had entered the treated landslide. As a result, erosion had started at the lower side of the treated landslide. No maintenance work seems to have been done in the treated landslide area. The main issue here is: how to change the present landuse in the catchment of the landslide, and how to ensure regular maintenance?

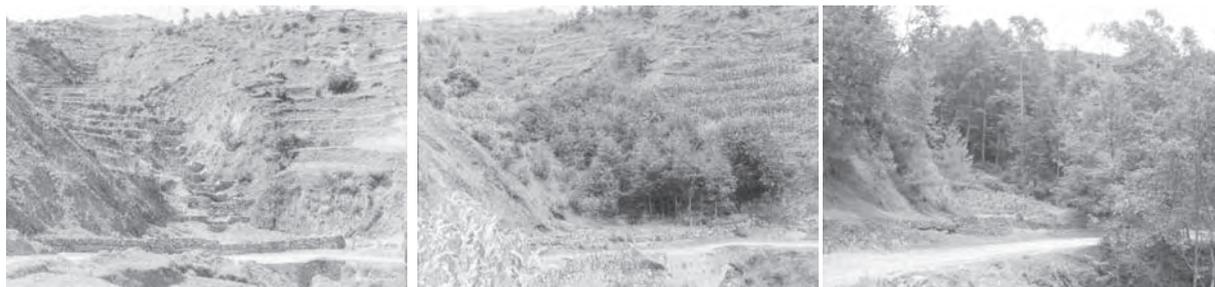
Photo 5, 6 and 7 : Treated landslide in Kunchhal, Bajrabarahi-3, Makawanpur in 1989, 1995 and 2008

This landslide damaged agricultural land and a section of the road to Kulekhani Hydroelectric reservoir (Photo 5). Kulekhani Watershed Management Project treated the landslide by constructing a toe wall and a series of checkdams, and by planting utis seedlings (Photo 6 and 7). After the treatment, the landslide was completely stabilized, and the utis trees and other

indigenous plants grew quite well (Photo 7). The agricultural land in the deposition zone just behind the toe wall had been reclaimed and the farmer had even started cultivation. The main issue here is related to the ownership, management and utilization of trees and grasses growing in the treated area.
