# Plates - PART ONE

## Plates - PART TWO

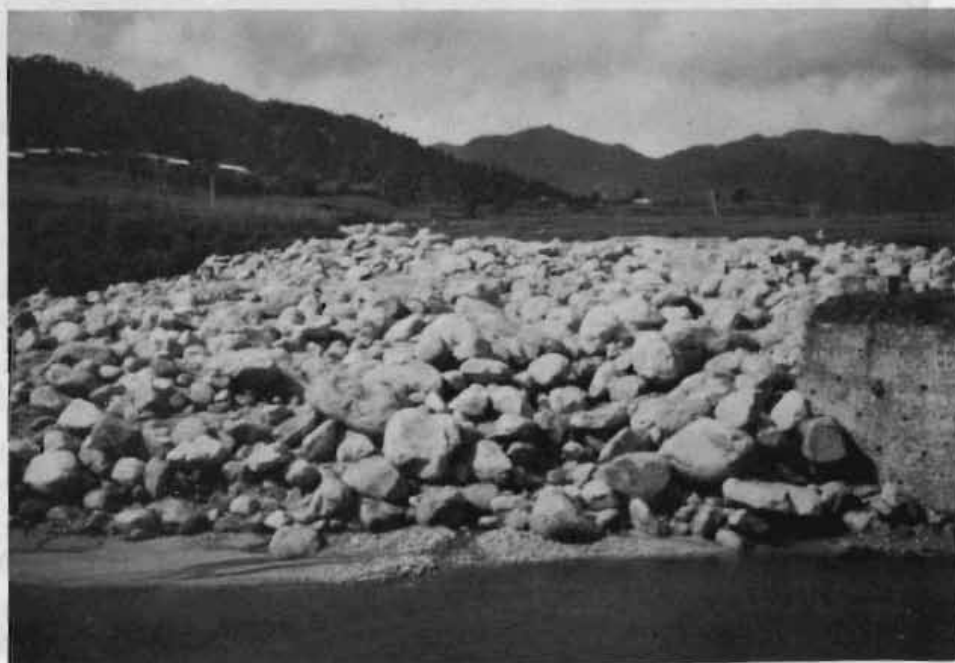
Typical fan formed by the cascading rivers. The Kitini catchment received over 300 mm of rain.

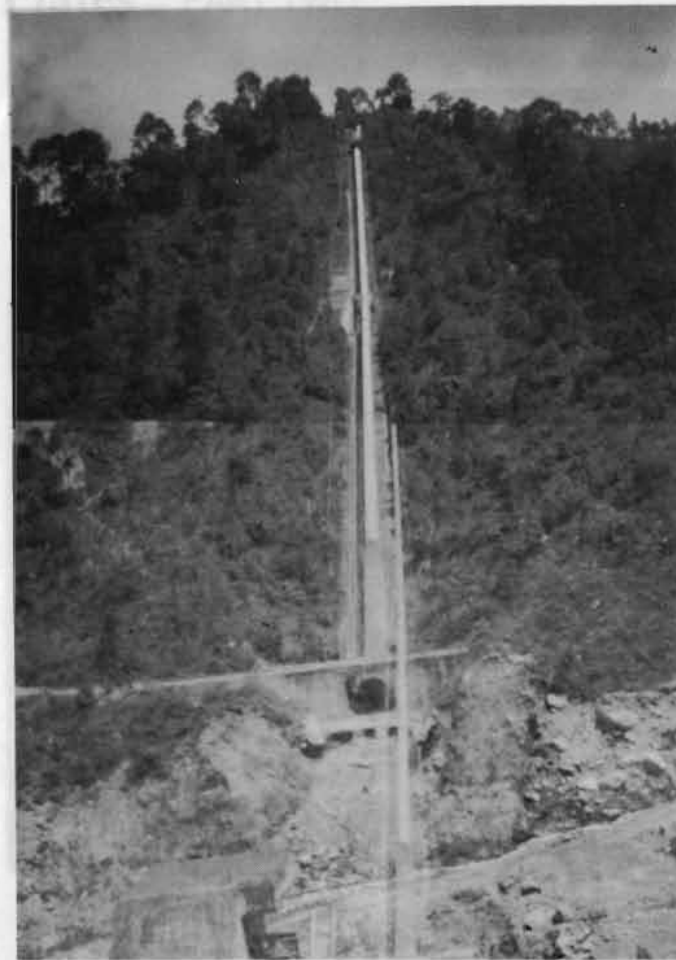
The smashed penstock  
by the debris flow  
at Jurikot

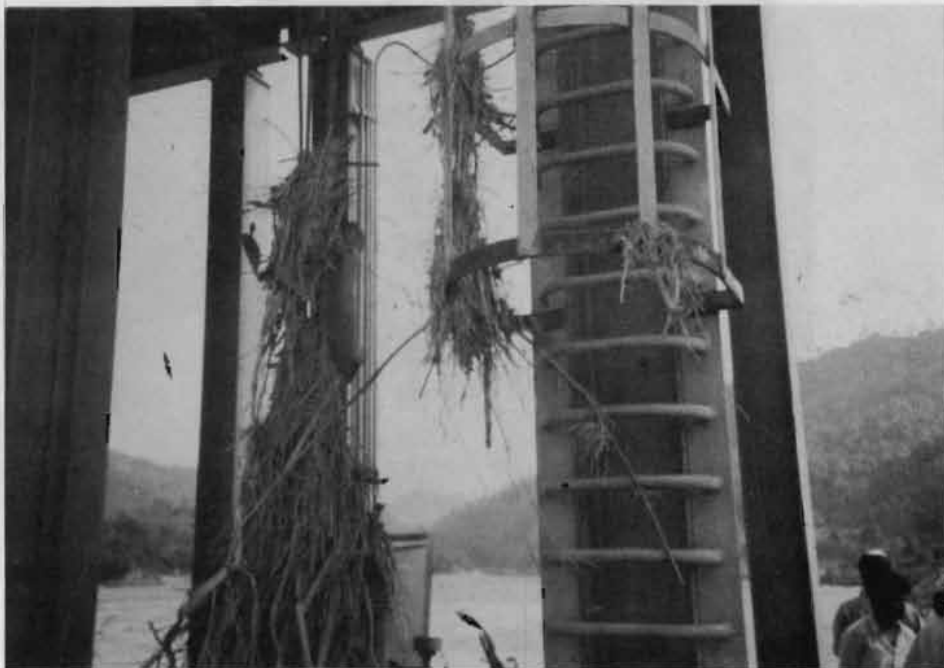
Debris entangled above the gates

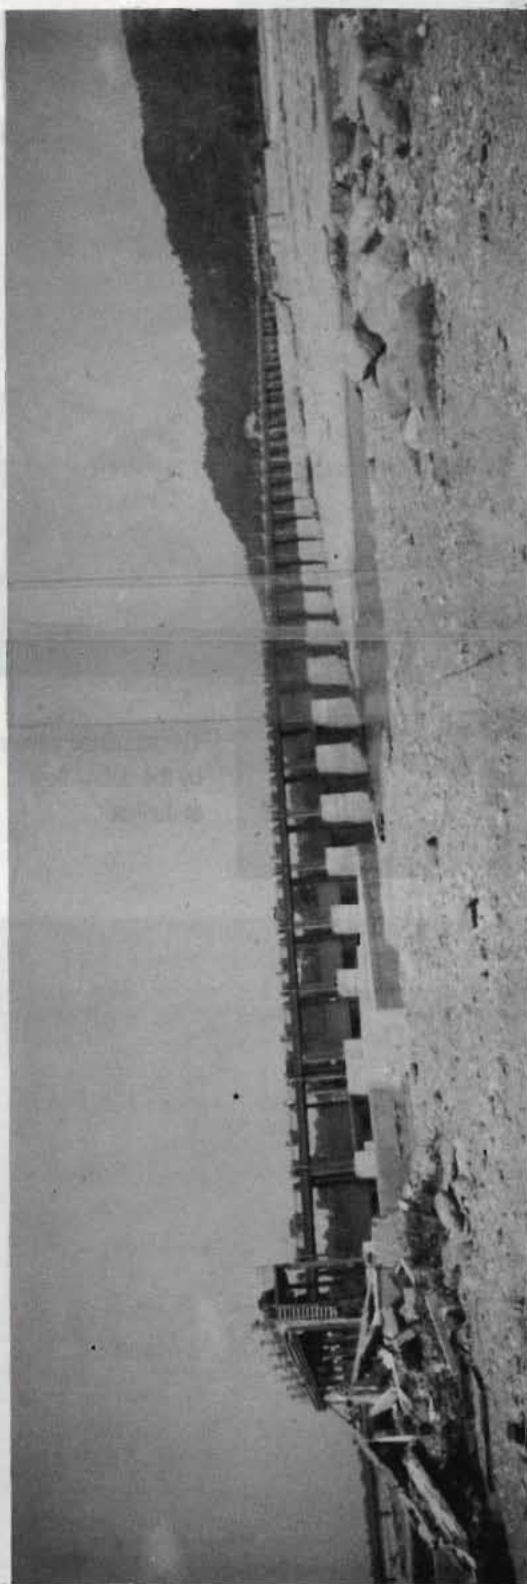
Downstream view of the crippled Karmaya Barrage - notice the channel bar

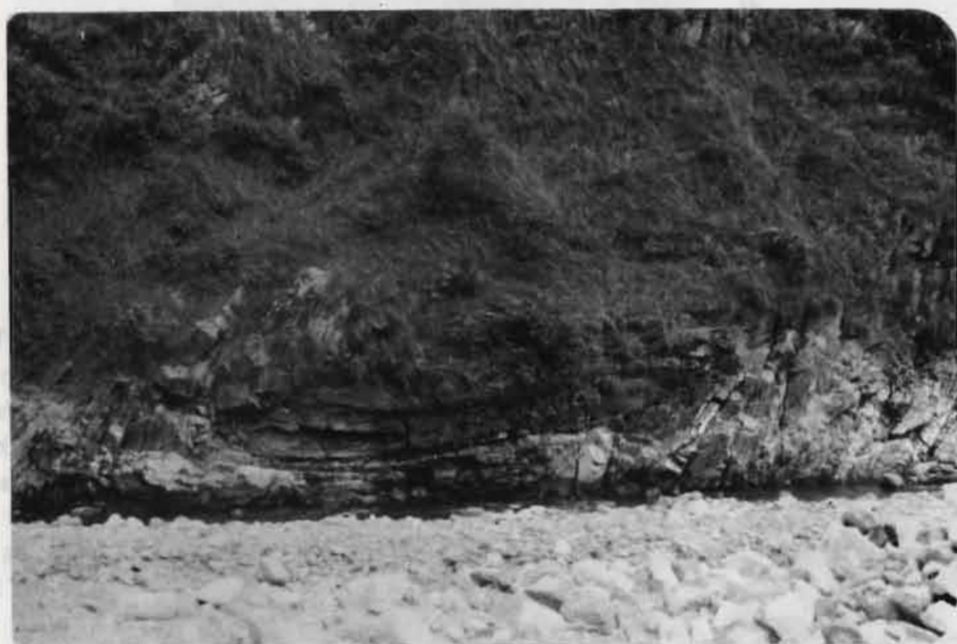
Plate 4: The folded schist and marble of the Markhu Formation on the right bank of the Kulekhani Khola south of Khani Khet. View towards the south

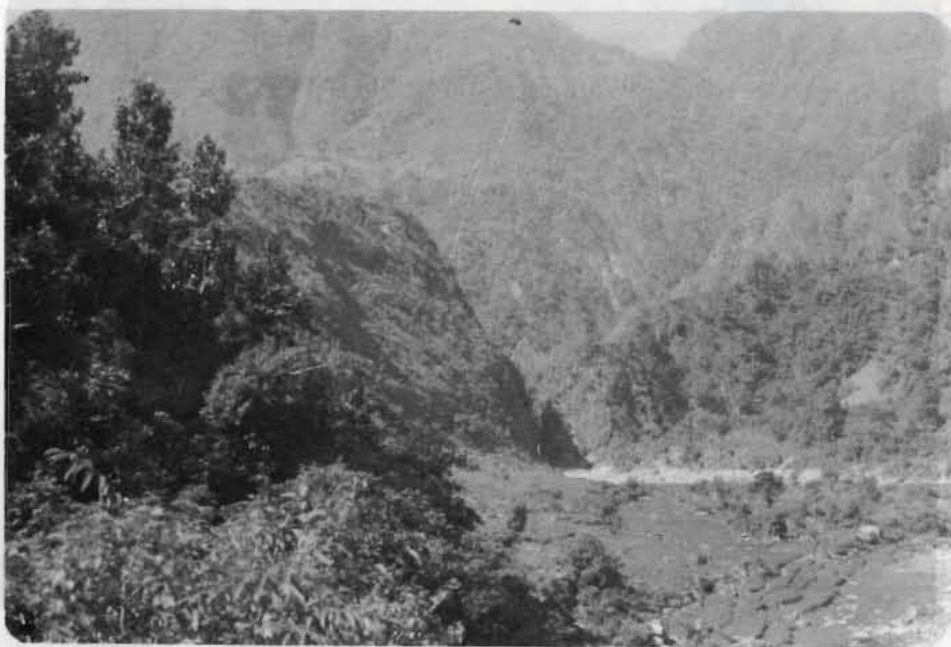
Plate 5: The Bagmati River gorge west of Malta, in the granite. View towards the south

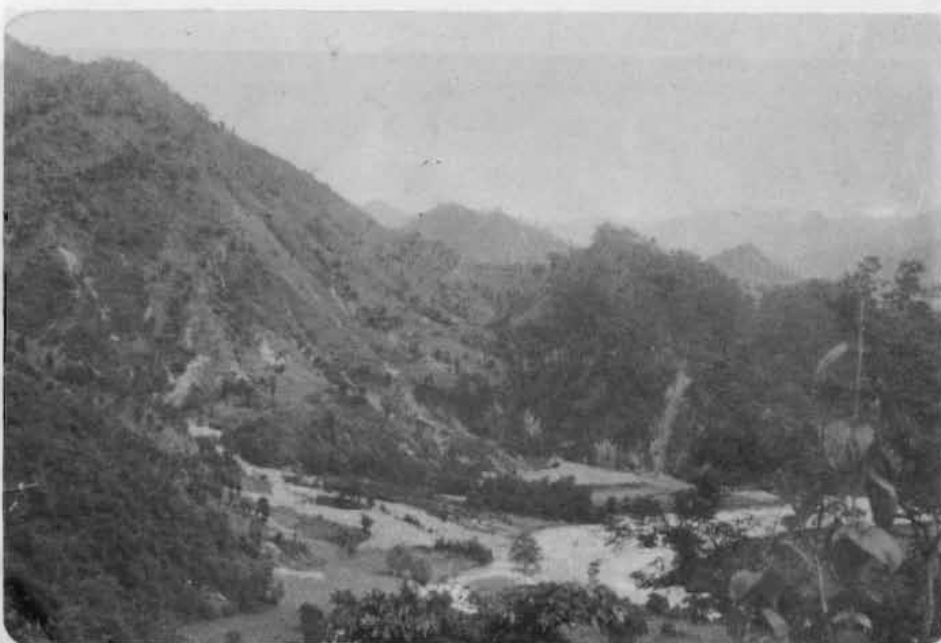
Plate 6: The Main Boundary Thrust as observed at Luinche. The fault is passing through the saddle along the gully. Notice also several soil slides and debris fans. View towards the east

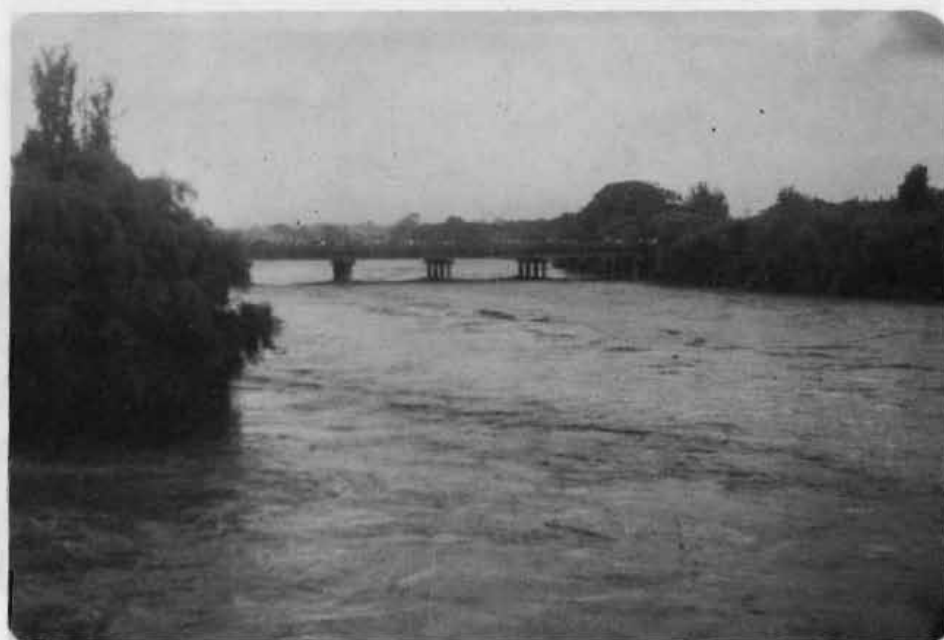
Plate 8: The Flooded Bagmati River at Balkhu on July 19, 1993. The Balkhu Khola is to the left. View towards the north

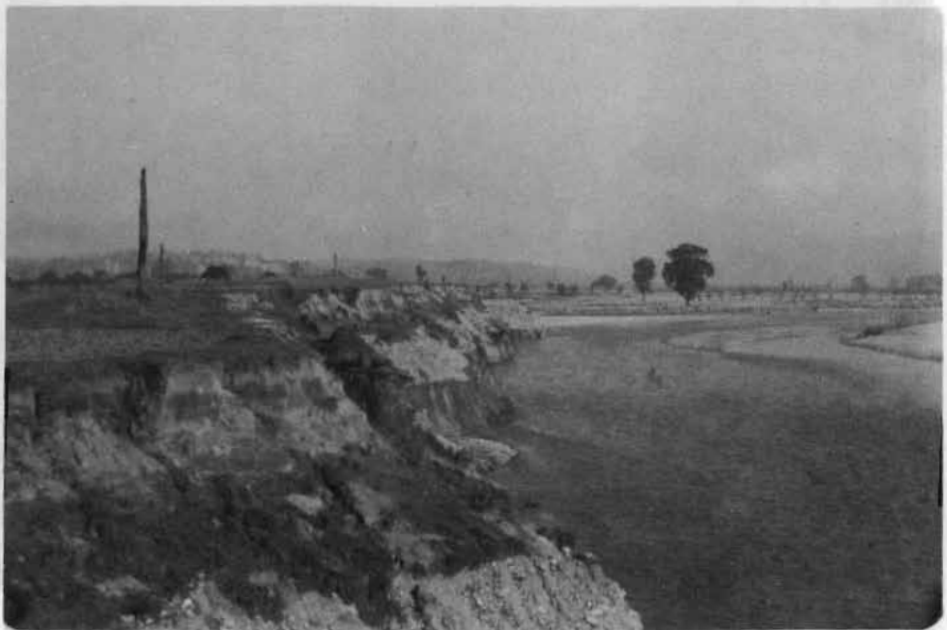
Plate 12: The Bagmati River and its floodplain at Rai *Gaun*. At present, the river channel is about 20m below the high flood level of July 21, 1993 (cliff to the left). View towards the north

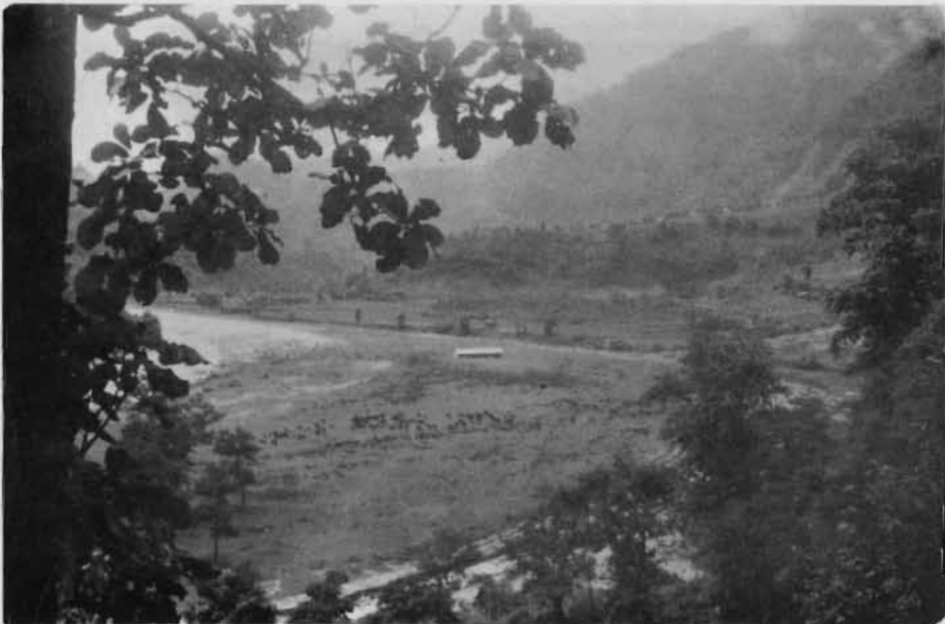
Plate 14: The channel bar on the Bagmati River at Kholme danda. Notice a school in the middle of the bar and an inactive channel to the north. View towards the west

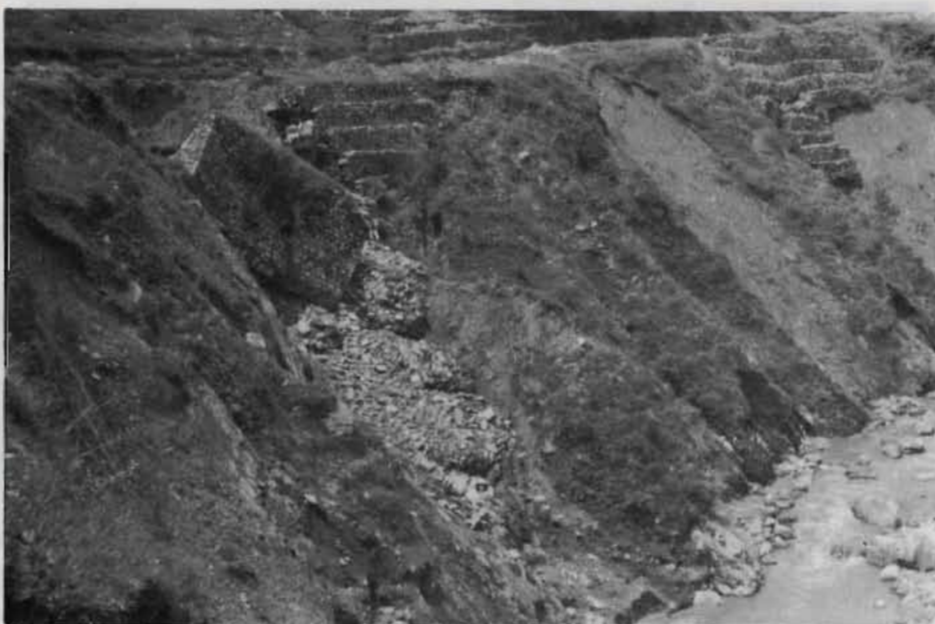
Plate 26: The damaged road and retaining wall on the right bank of the Bisinkhel *Khola*. View towards the north

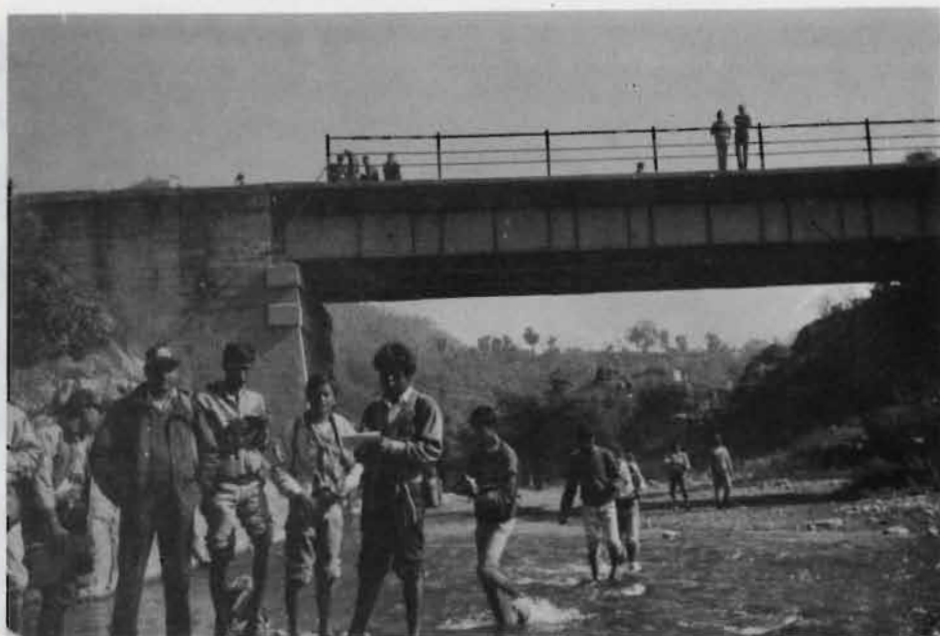
Plate 28: The previous (washed out) bridge over the Malekhu *Khola*, as observed on January, 1990. View towards the east. Courtesy T.R. Paudel.

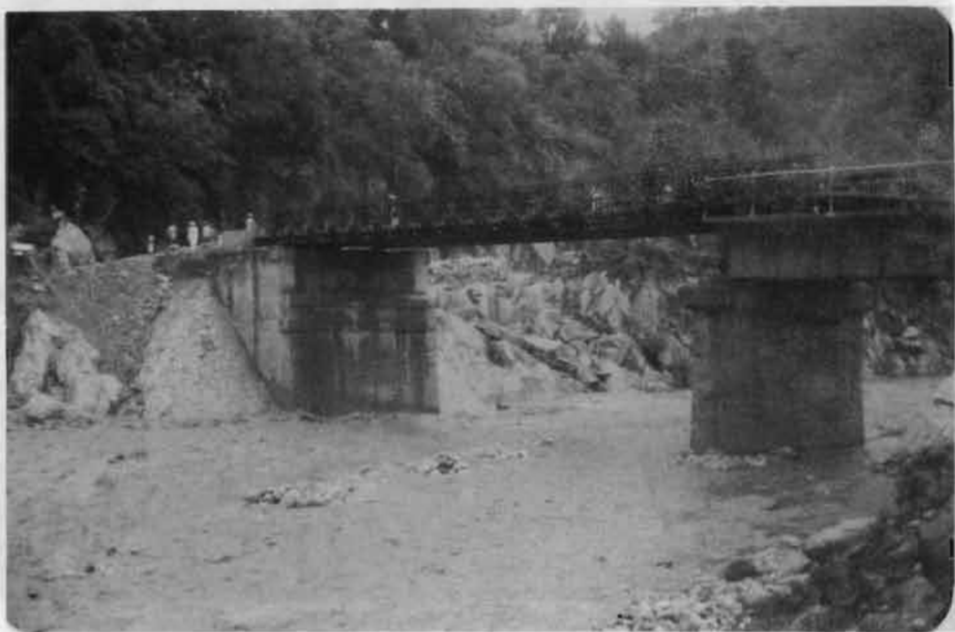
Plate 29: The partially damaged bridge over the Malekhu *Khola* replaced by a Bailey bridge. View towards the east

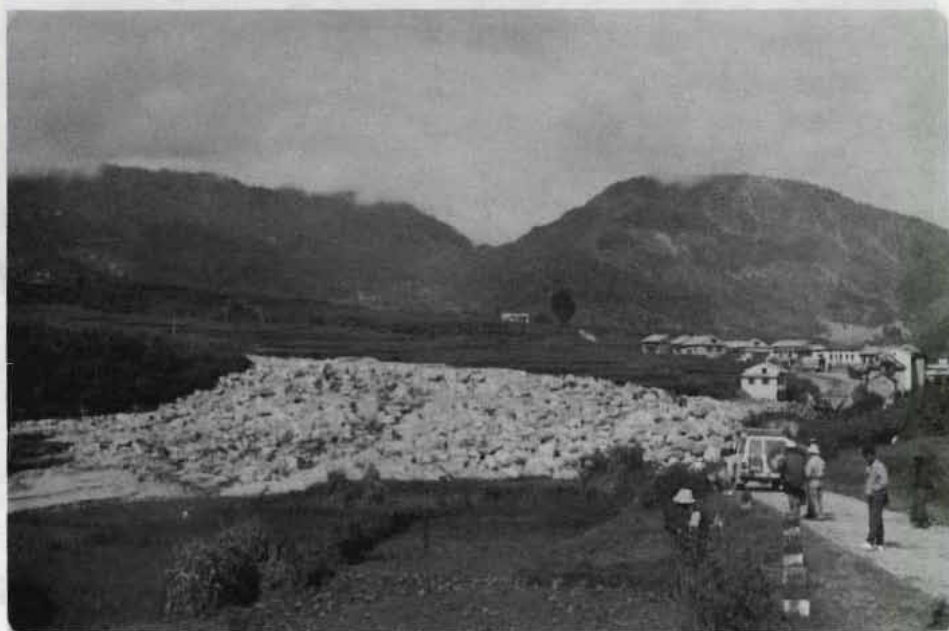
Plate 38: The Kitni *Khola* alluvial fan at Thana Bazaar, the confluence with the Sankhamul *Khola*. All the white boulders are of granite. View towards the north-west

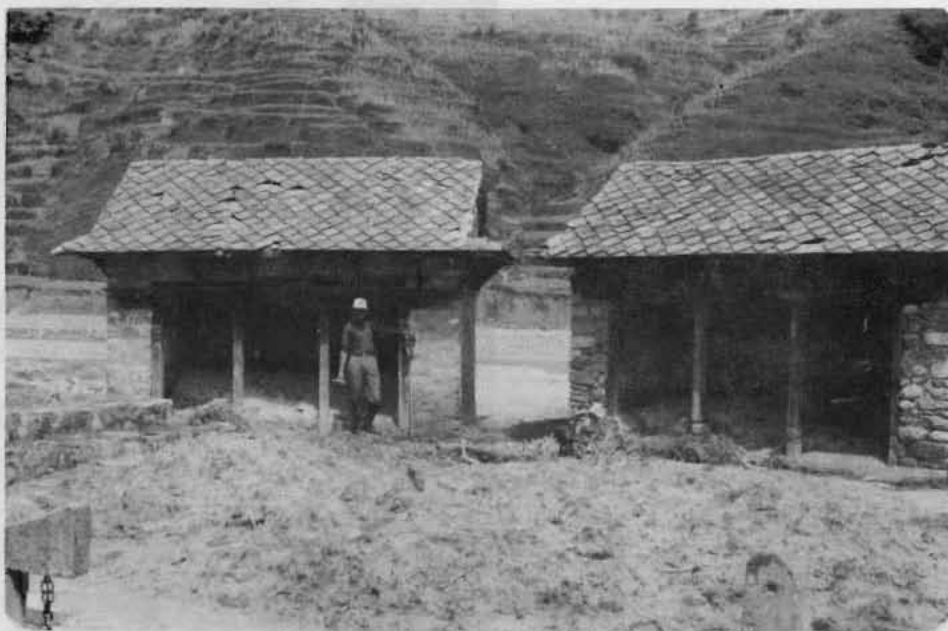
Plate 46: The sand and silt deposits in the temples at Indrenithan, about 70 cm above ground level. View towards the west

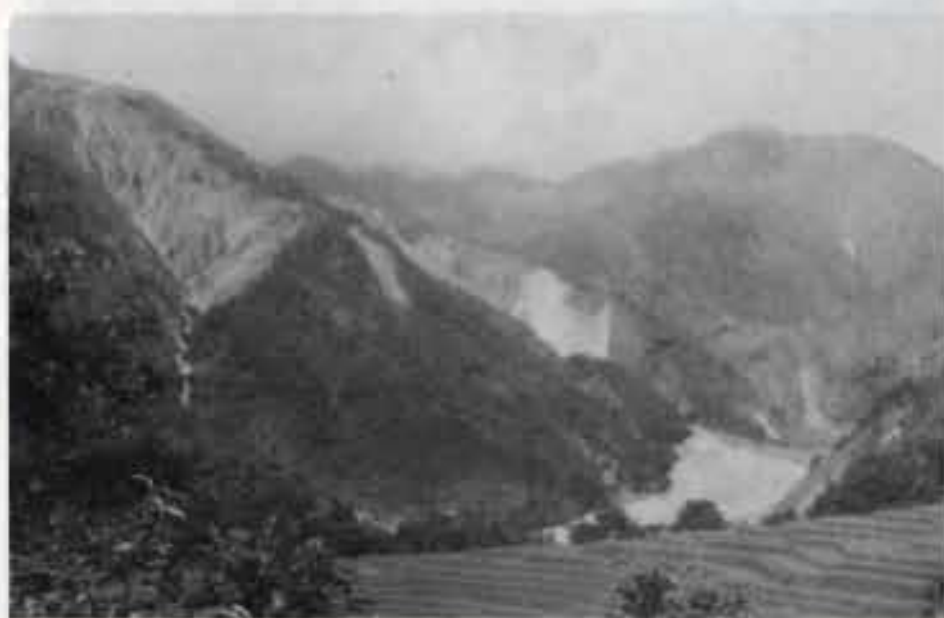
Plate 49: Large rockslide at the contact between granite (white) and slate (grey) on the right bank of the Ipa Khola. There is a wide debris fan below the slide. View towards the west

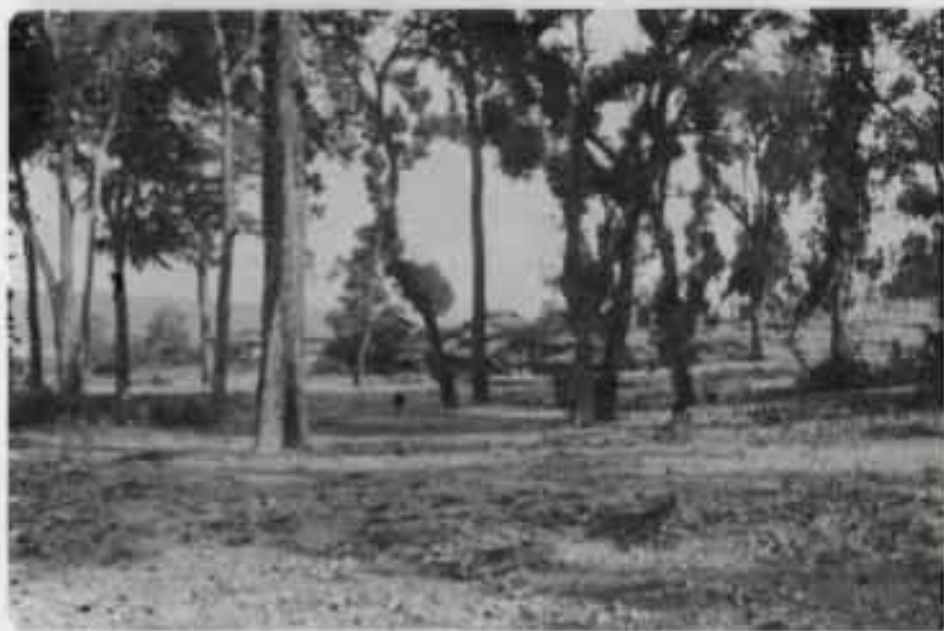
Plate 50: Sheet flooding and debris flow in Karsonje. Most of the pebbles are derived from the Upper Siwaliks. Notice buried and destroyed houses. View towards the south

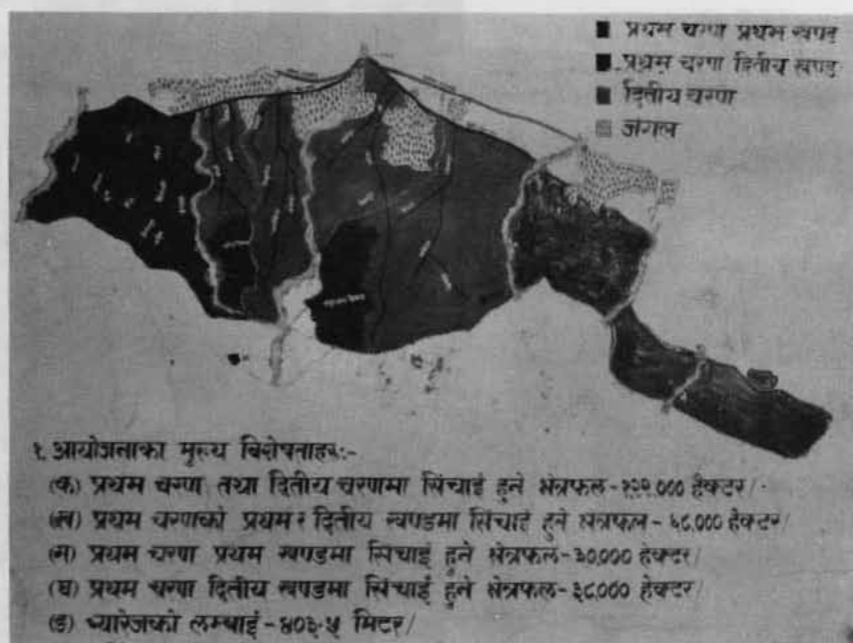
Plate 54: Sketch of the Bagmati Barrage command area. The total command area is 122,000 hectares

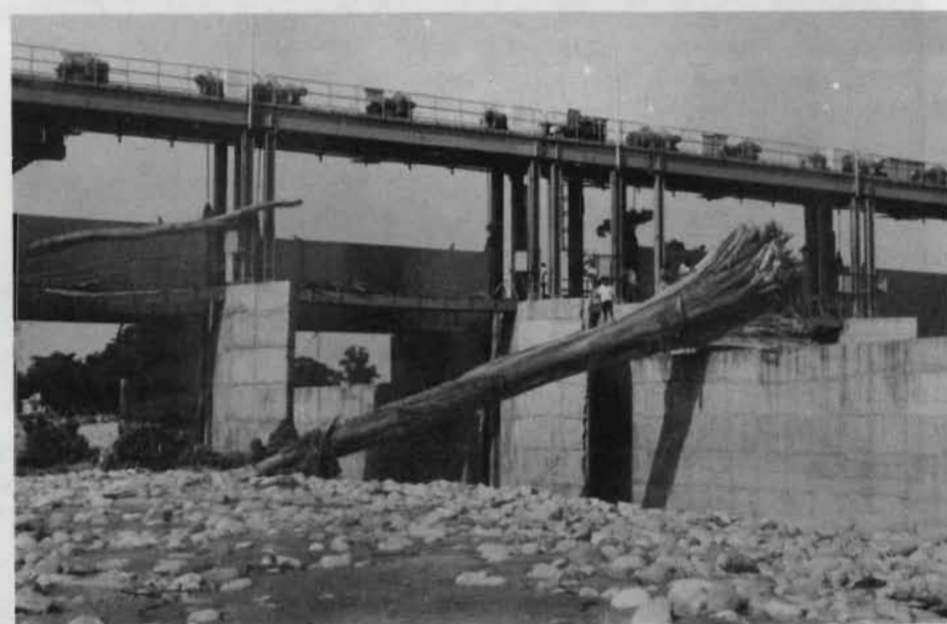
Plate 55: Downstream view of the Bagmati Barrage and the mid-channel bar. Notice a damaged gate (in the centre) and a 33 m long tree trunk. The Bagmati Bridge is seen in the background. View towards the south

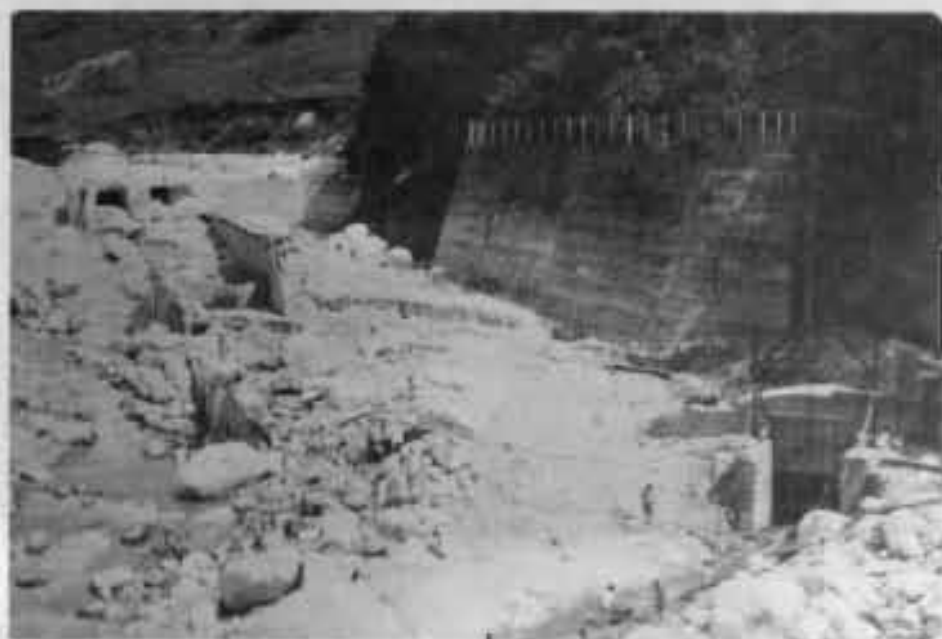
Plate 62: The outlet portal of the Kulekhari I tailrace tunnel damaged by the debris flow from the Mandu Khola. Notice also the damaged intake canal of Kulekhari II. View towards the north

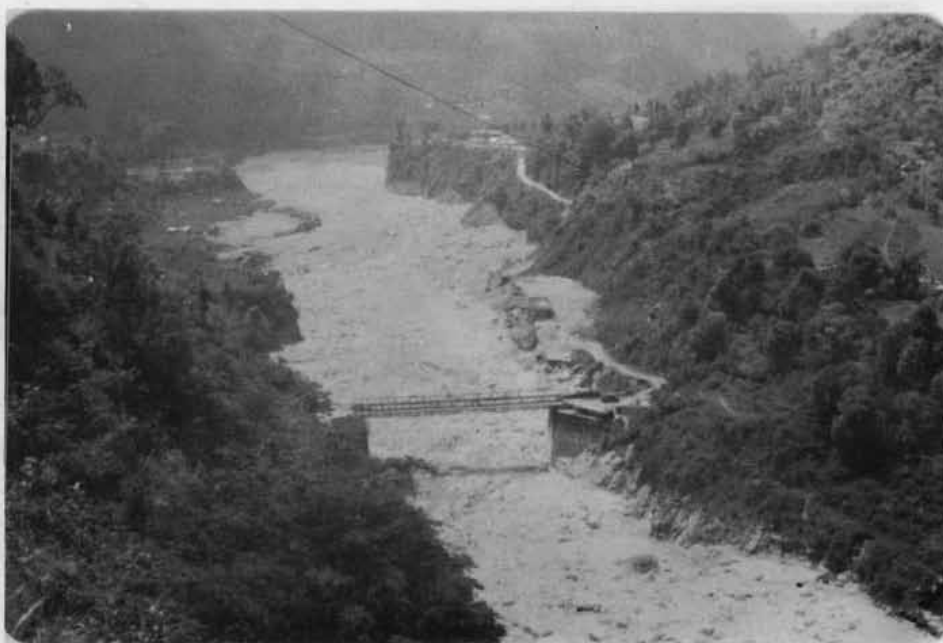
Plate 63:

The huge 'Indreni' boulder in the Mandu *Khola*, about 25m upstream from the intake canal of the Kulekhani II. It is about 15m long and 10m high. View towards the north-west

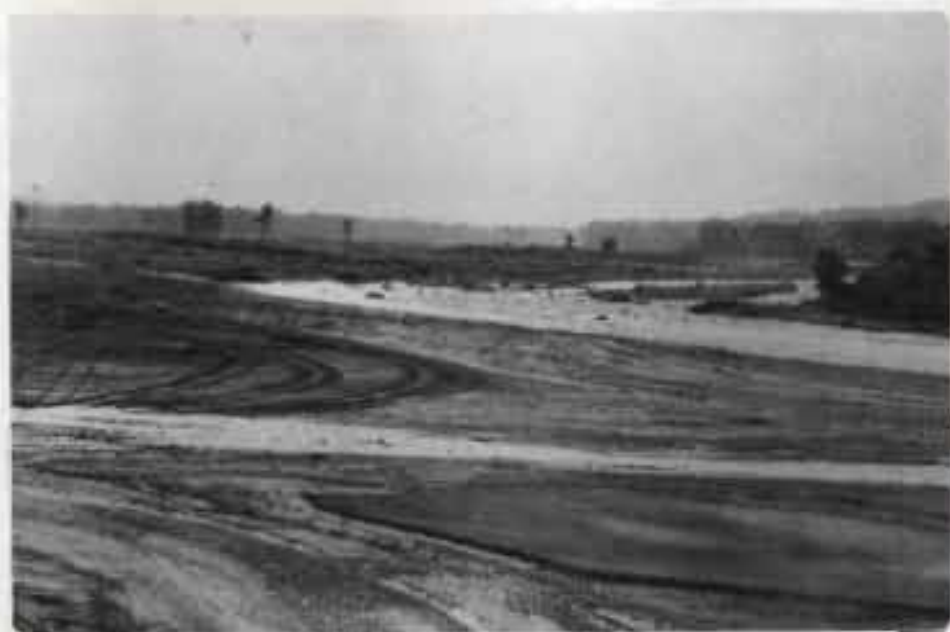
Plate 64:

Downstream view of the Mandu *Khola* from Dhorsing. Notice the damaged road on the right bank. The white boulders are of granite. View towards the south
