# The Geological and Geomorphological Background to the Hazards

## Background of the Area

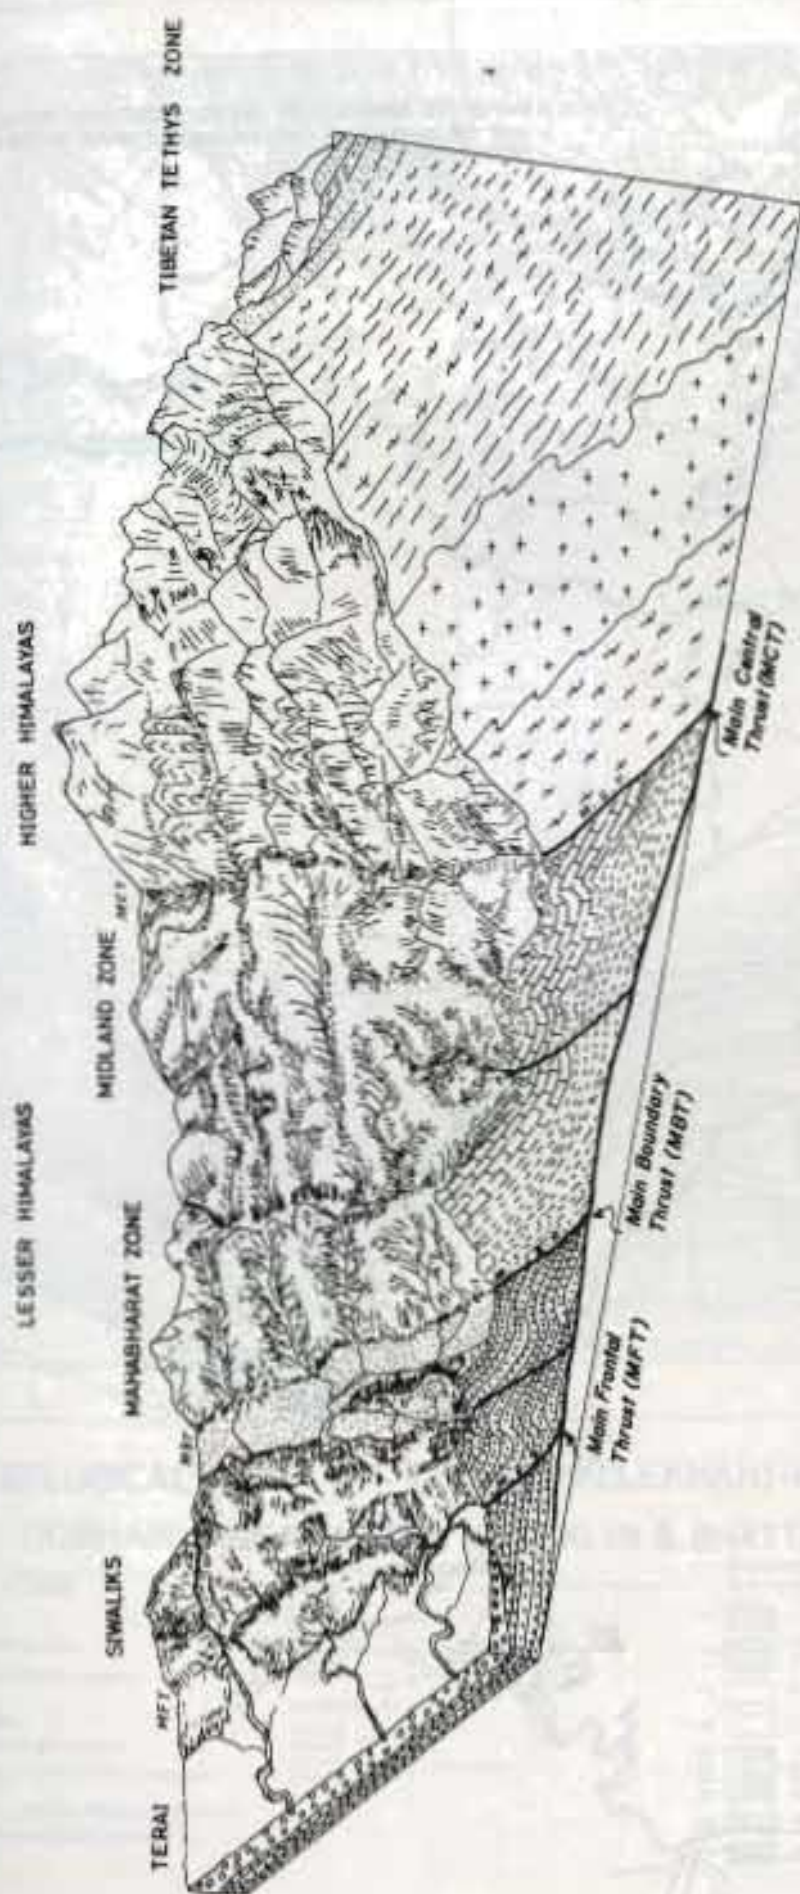
FIG.2.1: TECTONIC SUBDIVISIONS OF THE HIMALAYAS.

The Himalayan Belt can be subdivided into the following four tectonic zones from north to south respectively (Fig. 2.1).

The Tibetan-Tethys Zone is made up of sedimentary rocks and lies in the north of the high mountains. It is followed in the south by the Higher Himalayas. The Higher Himalayas are represented by high-grade metamorphic rocks with a few granite intrusions. The Lesser Himalayas lie to the south of the Higher Himalayas. They are bordered in the north by the Main Central Thrust (MCT) and in the south by the Main Boundary Thrust (MBT). The Lesser Himalayas are made up of medium to low-grade metamorphic rocks, some igneous rocks, and sedimentary rocks. The Lesser Himalayas can further be subdivided into the Midlands and the Mahabharat Range (Fig. 2.1). The Lesser Himalayas overlie the Siwalik Belt along the MBT situated to the south. The Siwaliks (also called the Churia Hills) are composed of fragile and soft mudstone, sandstone, and conglomerates.

The geological structure of the Himalayas is such that there are several roughly east-west trending fractures (faults) with several weak and crushed zones (Figures 2.1 and 2.2). Hence, in such areas, numerous small and large landslides aligned along, or parallel to, the fault zones are seen. On the other hand, orientation of fold axis, bedding, foliation, and joints in the rock also play a vital role in landsliding.

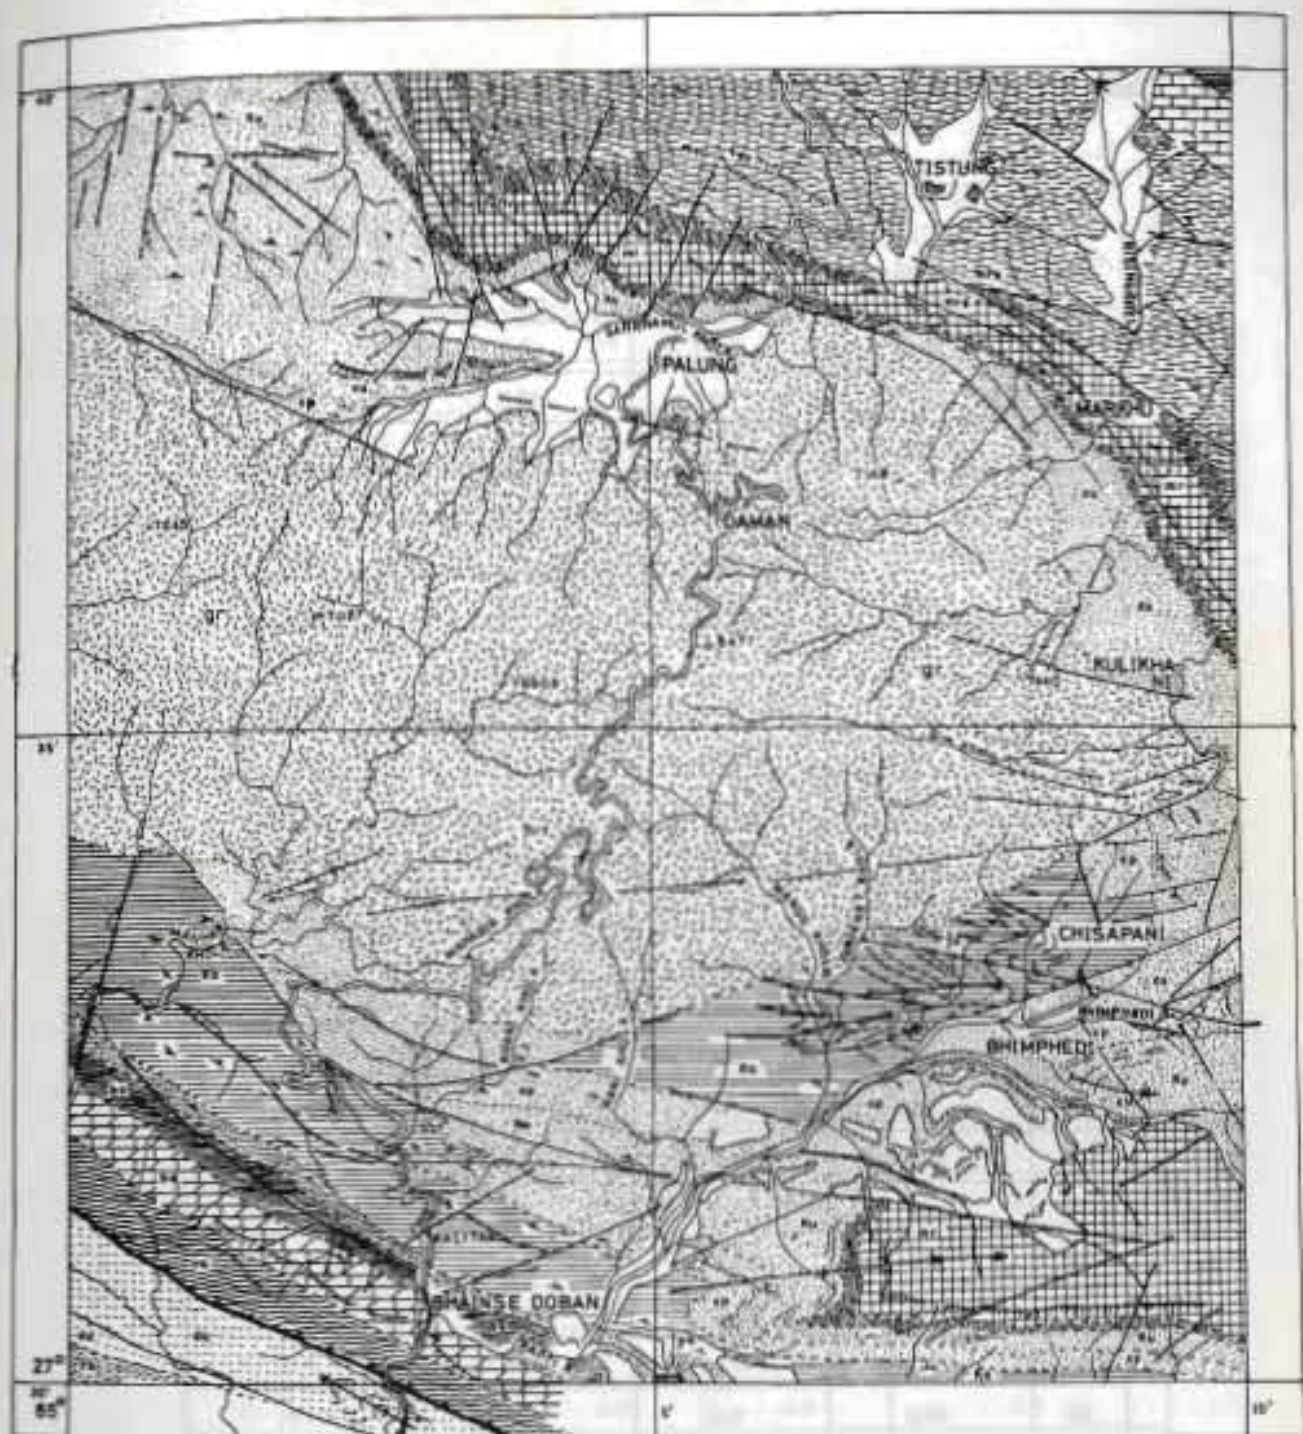
FIG 2.3: GEOLOGICAL MAP OF TISTUNG-KULEKHANI-BHAINSE DOBHAN AREA (AFTER STOCKLIN & BHATTARAI, 1978)

A few granite intrusions (Fig. 2.3) are observed in the central part of the Lesser Himalayas. The river finally crosses the fragile Siwalik rocks and reaches the *terai*.

The Kulekhani Valley is another important valley in the Bagmati watershed. The Kulekhani Dam is situated here (Fig. 2.2, Plate 10). The valley is controlled by the joints and faults present in that region, and its general trend is parallel to the foliation of the rocks. Slates, phyllites, marbles, and quartzites are found in the surrounding areas. The submerged surface area of the Kulekhani Reservoir (*Indrasarobar*) is about 2.2 sq. km. Water is collected from the Palung *Khola*, the Bisingkhel *Khola*, Chitlang *Khola*, and Chakhel *Khola* (Fig. 2.2). The Kulekhani Dam is situated on a faulted contact between granite (south) and schist and quartzite (north) of the Kulekhani Formation (Fig. 2.3).

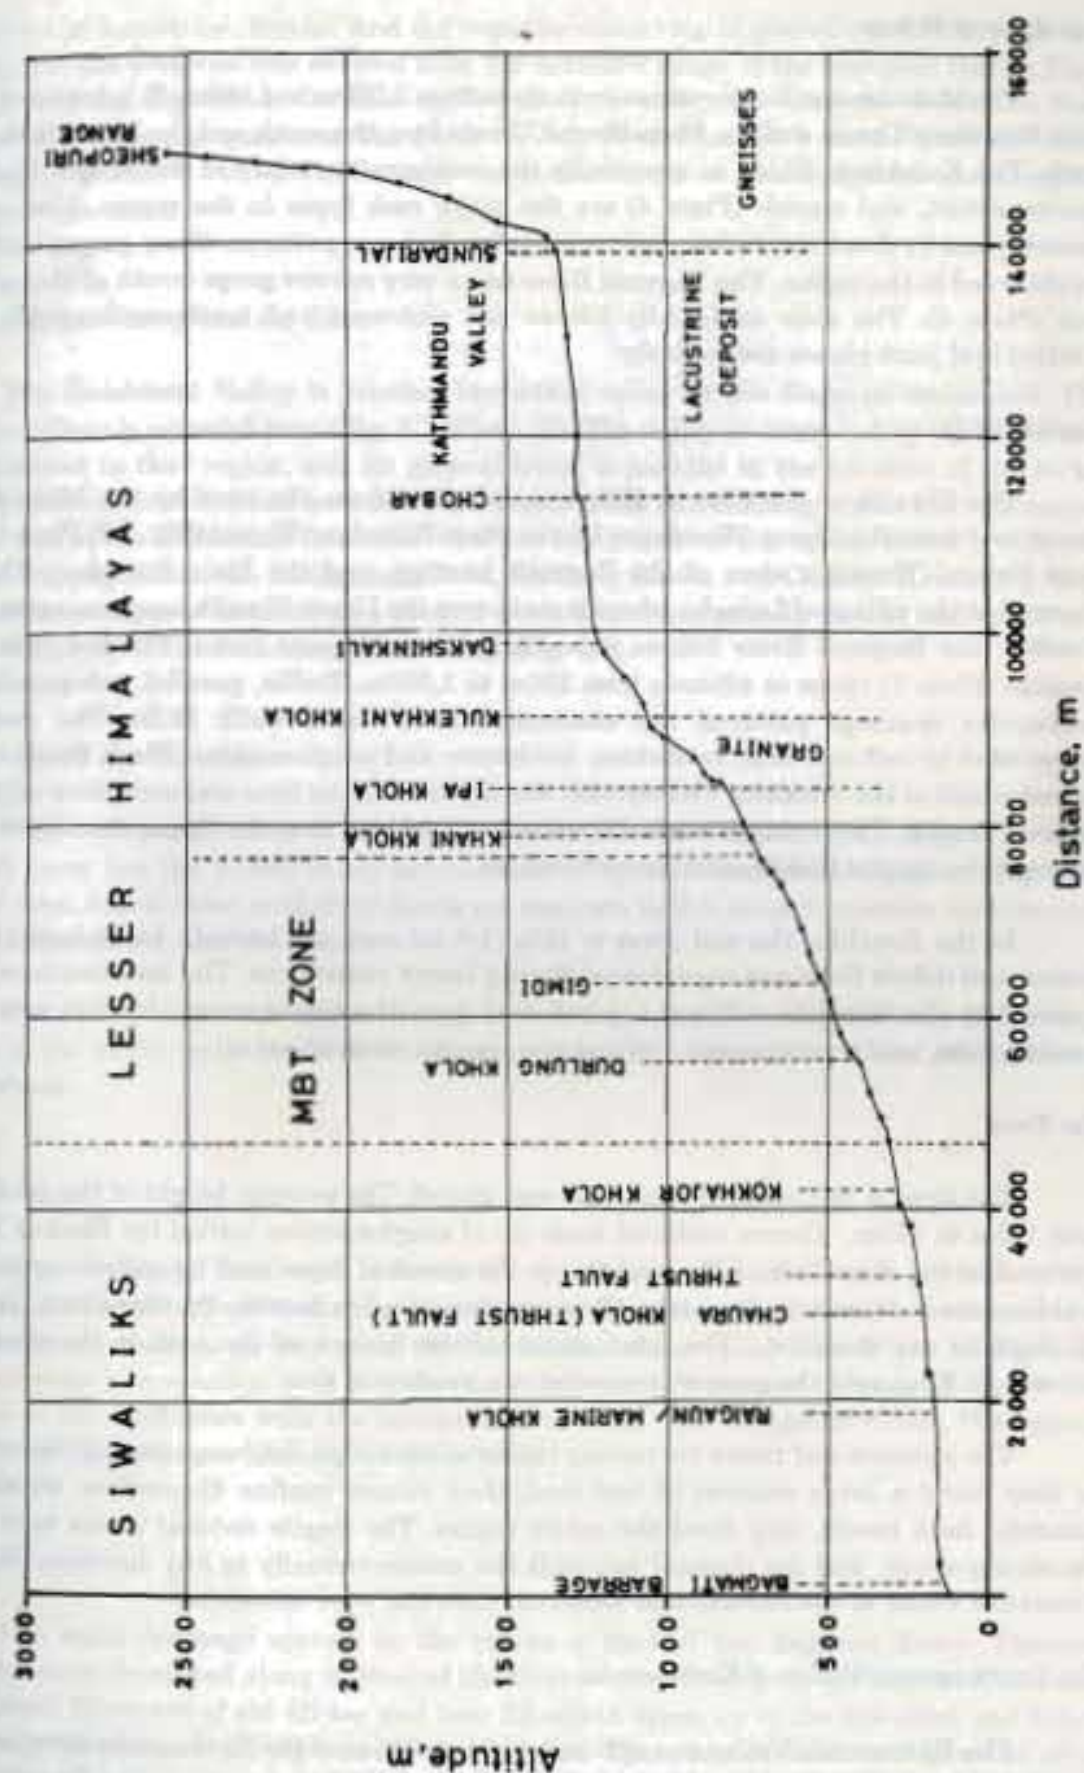
FIG.2.4: LONGITUDINAL PROFILE OF THE BAGMATI RIVER

The longitudinal profile of the Bagmati River (Fig. 2.4) exhibits several breaks in slope. Owing to the presence of gneisses, the river gradient is rather steep between the Sheopuri Range and the Kathmandu Valley. The gentler slope around the valley is due basically to the lacustrine and fluvial deposits in the basin. Steeper slopes south of the valley (between Dakshinkali and the Khani *Khola*) are related to the resistant rocks of the Lesser Himalayas. The gradient of the river becomes remarkably steep, especially while crossing the granite intrusion (Fig. 2.4). The Bagmati River flows onwards along the MBT and the MT with an almost uniform slope. Finally, it crosses the Siwaliks along a gentler gradient and reaches the *terai* with very gentle slopes.

The Midlands are made up of metamorphic and igneous rocks (Fig. 2.4, Plate 2). Granite is extensively distributed around Palung, Daman, Mandu, and between the Kulekhani Dam and Ipa. The territory covered by granite is deeply weathered to yield sand, pebbles, cobbles, and boulders. Generally, randomly-oriented joints are observed in the granite and the joint spacing varies from 20 cm to three metres. In most places, four sets of joints prevail. The groundwater percolates through the joints down to depths of from five to 10 metres and considerably increases the pore-water pressure leading to debris and rockslides.

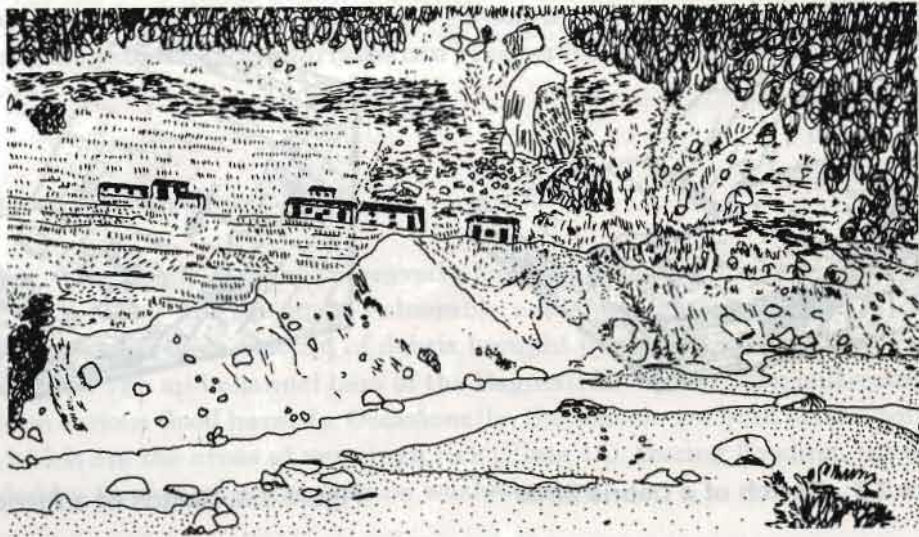
Figure 2.8: Sketch of bank scouring by a river

Large slides were especially common on the north-facing dip-slopes, whereas shallow slides were observed on the counter dip-slopes and on the slopes of granite. Mass movements were mainly of four types: debris slides (Fig. 2.5, Plate 16), rockslides (Fig. 2.6, Plate 17), debris flows (Plate 18), and deep-seated rotational slides (Fig. 2.7). Plane rockslides occurred on steep slopes where bedrock was close to the surface (Fig. 2.6, Plate 17). Debris and soil slides occurred on slopes that were either deeply weathered or covered by colluvium and/or residual soils of thicknesses ranging from one to six metres (Plate 16). River bank scouring (Fig. 2.8) was the main cause of road washouts.

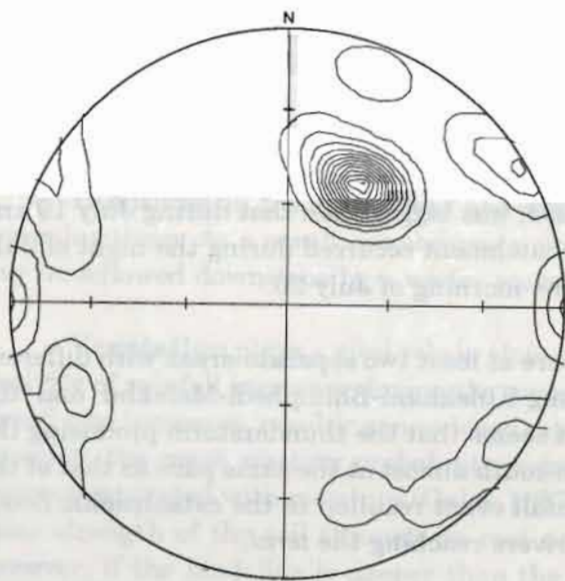
**Figure 2.9:** Stereographic projection of joints, Km 64 on the Tribhuvan Highway. Upper hemispherical projection. (See also Plate 9)

A large plane rockslide can be seen at Km 64 on the Tribhuvan Highway (Plate 21). The slide is on the Tistung Formation where the rock consists of highly fractured slate and quartzite. There are four distinct sets of joints developed in it (Fig. 2.9). The stereographic projection of joints (Fig. 2.9) clearly reveals that the basic mechanism of failure was caused by sliding along the bedding/foliation plane. The same type of plane rockslides and wedge rockslides can be observed around Jhapre (Km 51-52). Some of them also seem to be rotational slides in the rock.

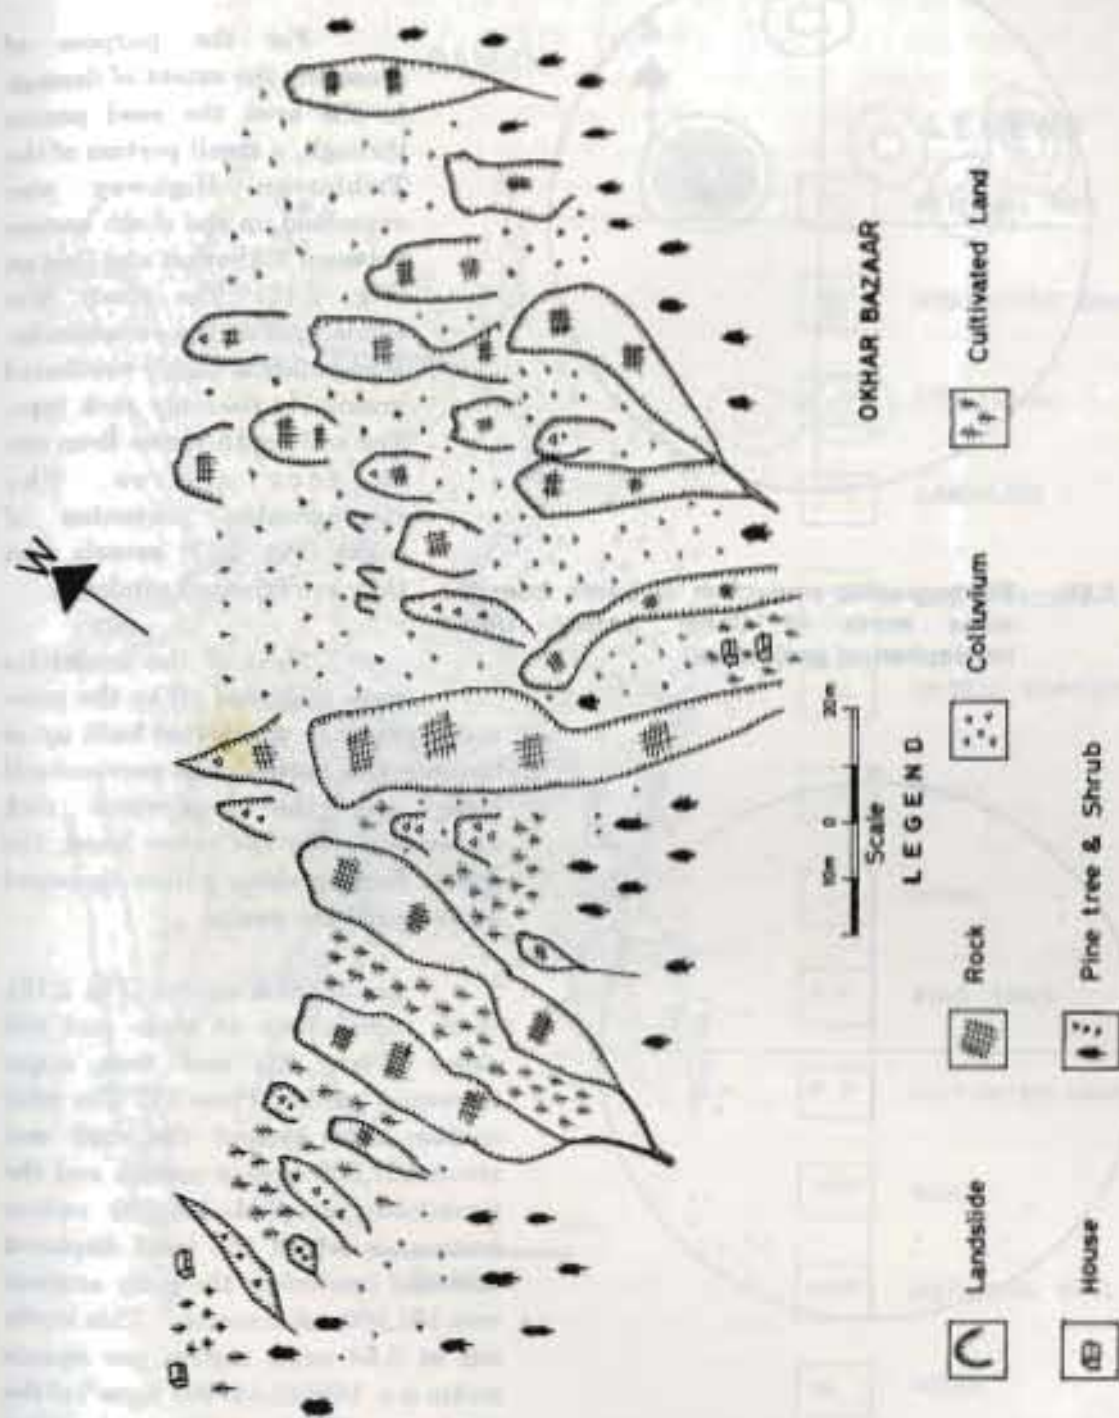
FIG.2.10: ENGINEERING-GEOLOGICAL MAP OF A WESTERN PART OF OKHAR BAZAAR

The study of landslides on the counter dip slopes near the village of Okhar Bazaar (Fig. 2.10) revealed that the total soil displaced by slides and gully erosion was about 6,700 cubic metres within an area of 21,400 square metres; which works out at 0.31 cubic metres per square metre (i.e.,  $1680 \times 0.31 = 520 \text{ kg/m}^2$ ) of the total area. The total landslide area was about 8,500 square metres; which works out at 40 per cent of the total surface area. The average natural slope was about 35 degrees, whereas the central part of the failed slope was about 41 degrees. The contoured stereographic projection (Fig. 2.11) shows the distribution pattern of the joints.

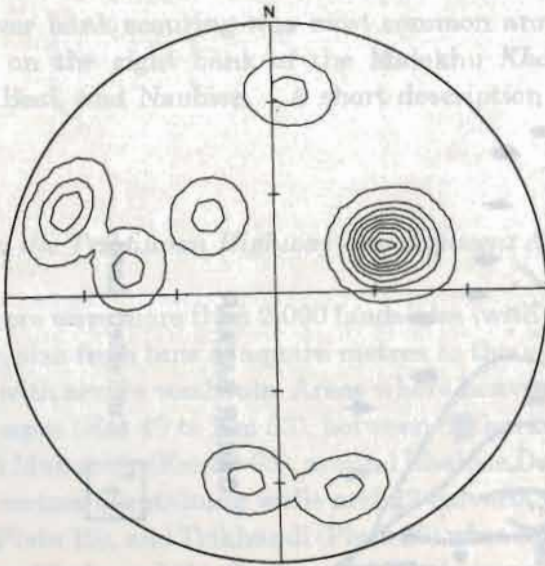
**Figure 2.11:** Stereographic projection of joints from the slope north of Okhar bazaar. Upper hemispherical projection.

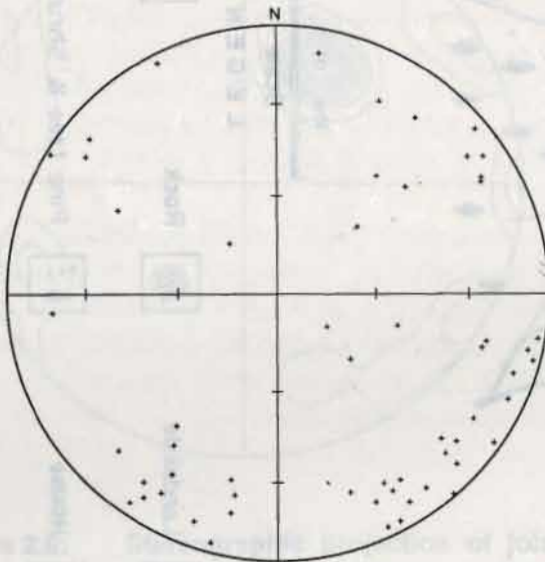
For the purpose of assessing the extent of damage in the area the road passes through, a small portion of the Tribhuvan Highway was examined on the climb section between Sikharkot and Daman (Fig. 2.12). The study was carried out on the switchbacks. Moderately to highly weathered granite is the only rock type. The soil depth varies from one to four metres. The stereographic projection of joints (Fig. 2.13) reveals that they are oriented randomly.

**Figure 2.13:** Stereographic projection of joints from the road section between Sikharkot and Daman. Upper hemispherical projection.

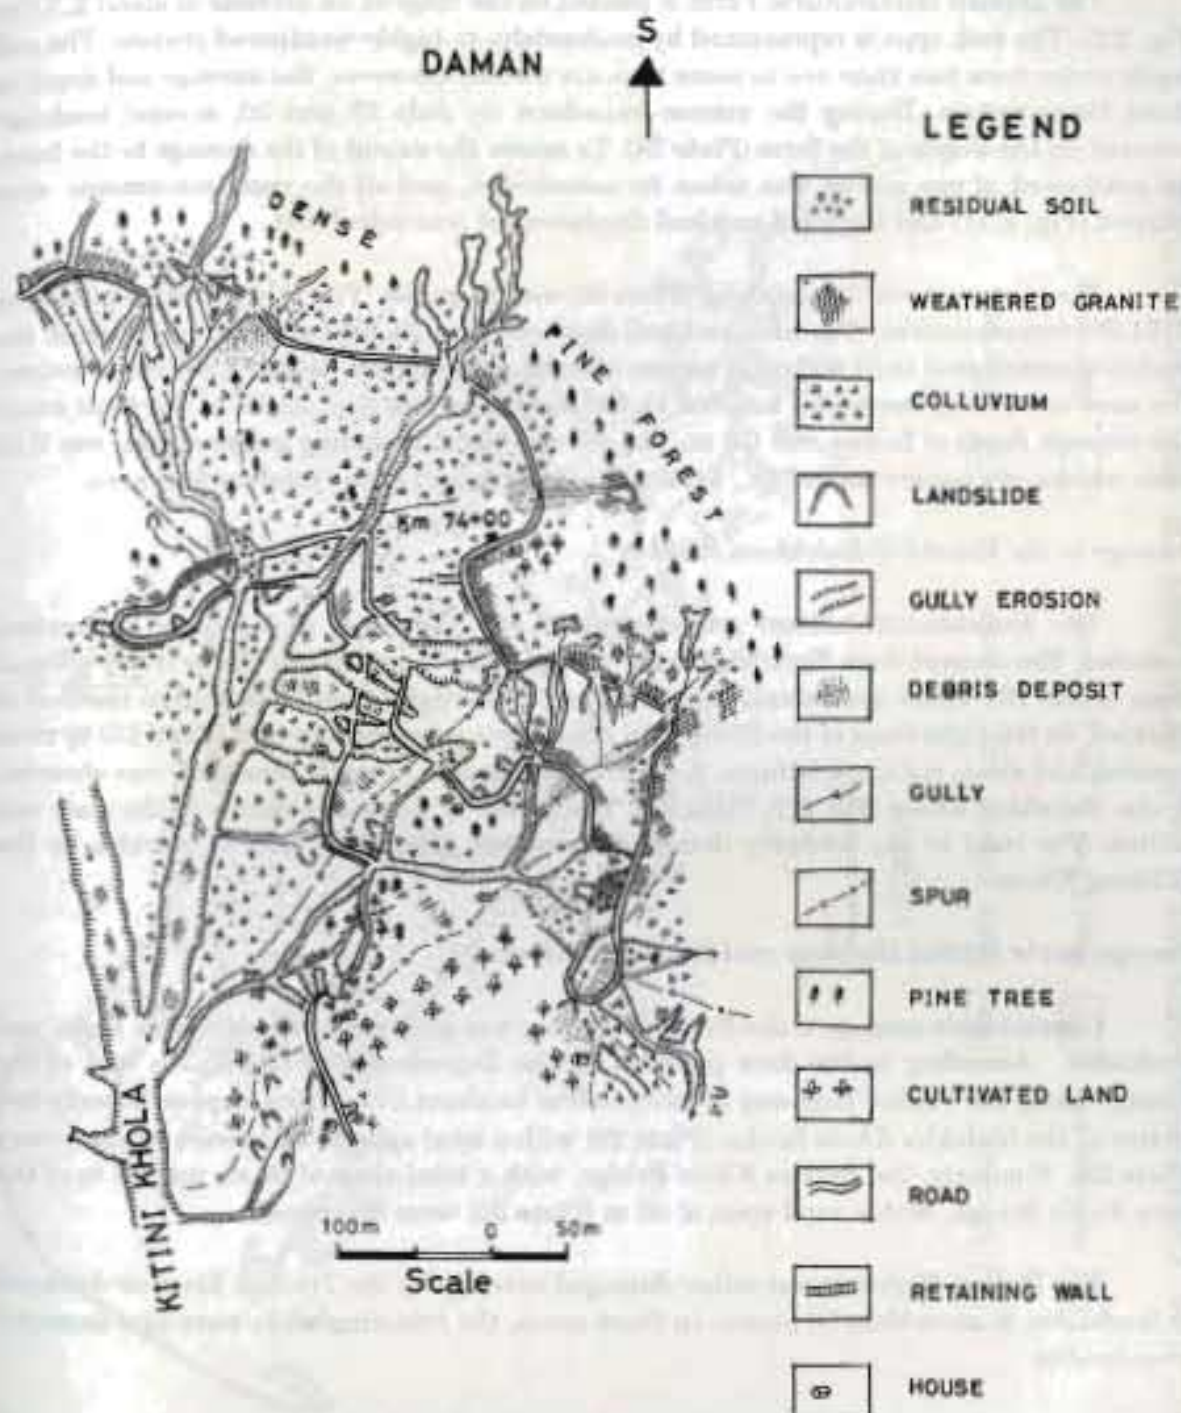
**FIG.2.12: ENGINEERING-GEOLOGICAL MAP OF A PART OF THE TRIBHUVAN HIGHWAY BETWEEN SHIKHARKOT AND DAMAN**

In a 2,185m stretch (Fig. 2.12), there were about 44 rock- and soil slides (Plate 22) and four major torrential gullies (Plate 23). The total surface area around the road was about 297,500 square metres and the landslides occupied 109,200 square metres, in which the total displaced material (excluding the gully erosion) was 161,000 cubic metres. This works out at 0.54 cubic metres per square metre (i.e.  $1680 \times 0.54 = 907 \text{ kg/m}^2$ ) of the total area. The landslides and gullies occupied about 36 per cent of the total surface area. The average depth of failure was 1.5 m, whereas the average natural slope was 31 degrees and the failed slope in the central part was 41

degrees. The total length of damaged road section (including the damages on the adjacent slopes) was 828 m (i.e., 38% of the total road length).

Most of the landslides were triggered off by the pore-water pressure which had built up at the interface between the pervious soil layer and the impervious rock underneath. On the other hand, the debris flowing along gullies damaged and scoured the banks.

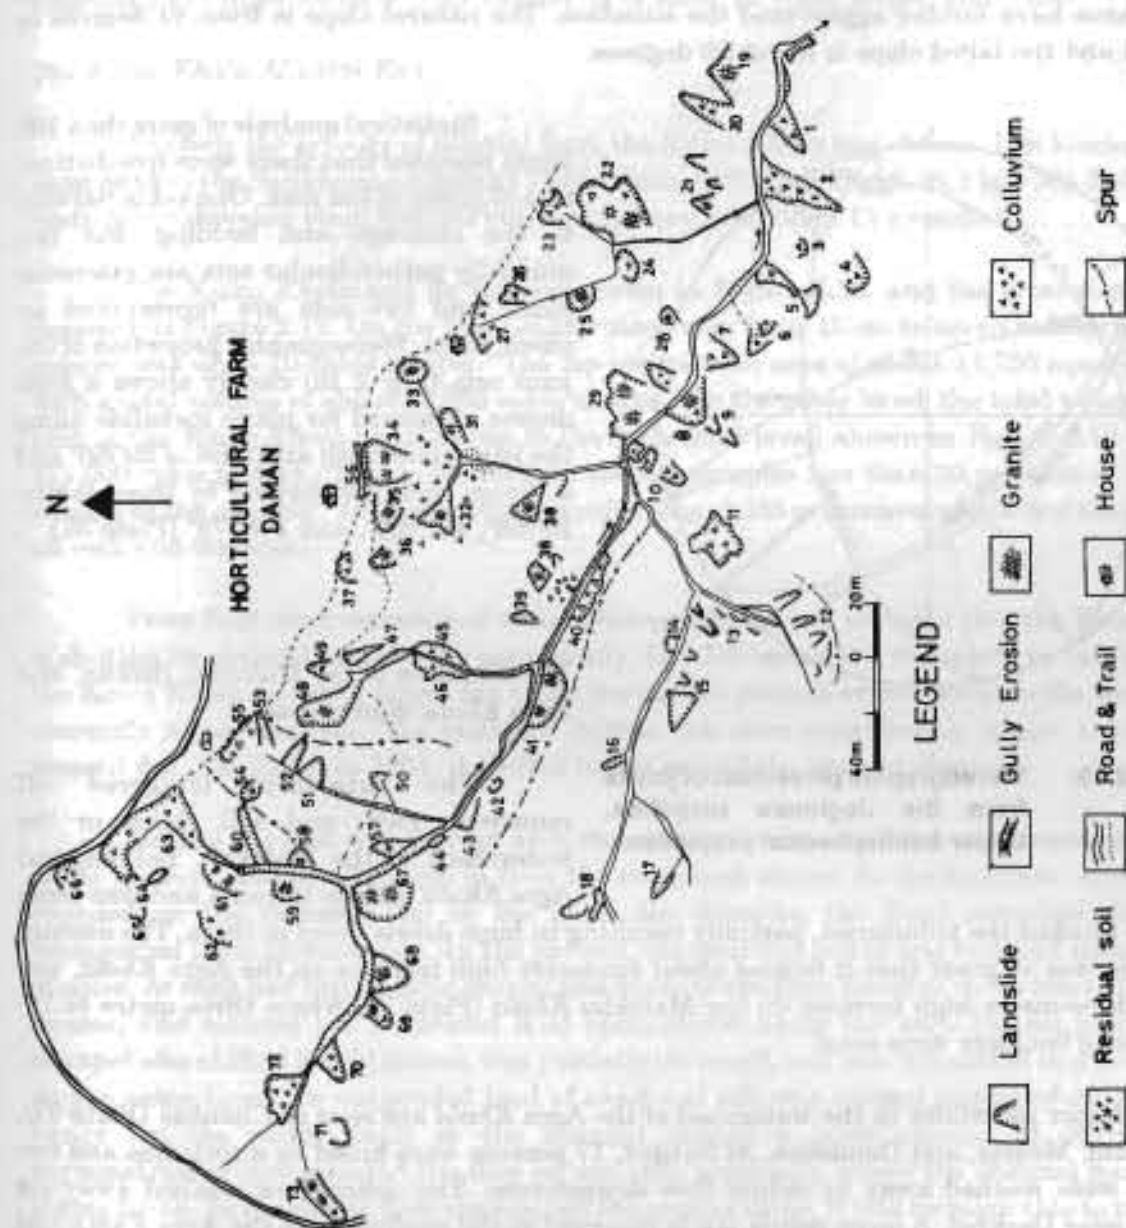
FIG. 2.14: ENGINEERING-GEOLOGICAL MAP OF A PART OF THE HORTICULTURAL FARM, DAMMAN

The Daman Horticultural Farm is located on the ridge at an altitude of about 2,300m (Fig. 2.2). The rock type is represented by moderately- to highly-weathered granite. The soil depth varies from less than one to more than six metres. However, the average soil depth is about three metres. During the intense rainstorm on July 19 and 20, several landslips occurred on the slopes of the farm (Plate 24). To assess the extent of the damage to the farm, the catchment of two gullies was taken for assessment, and all the mass movements were mapped (Fig. 2.14) and the total rock/soil displacement was calculated.

There were about 73 landslides (Plate 25) and 12 gullies (Fig. 2.14) within a total area of 51,600 square metres. The total rock/soil displaced was 34,100 cubic metres, of which the landslide contributed to 31,800 cubic metres and the gully erosion yielded 2,300 cubic metres. The area covered by landslides totalled 11,650 square metres (i.e., 22.6% of the total area). The average depth of failure was 0.8 m. The soil displaced (including gully erosion) was 0.61 cubic metres per square metre (i.e.,  $1,680 \times 0.61 = 1014 \text{ kg/m}^2$ ) of the total surface area.

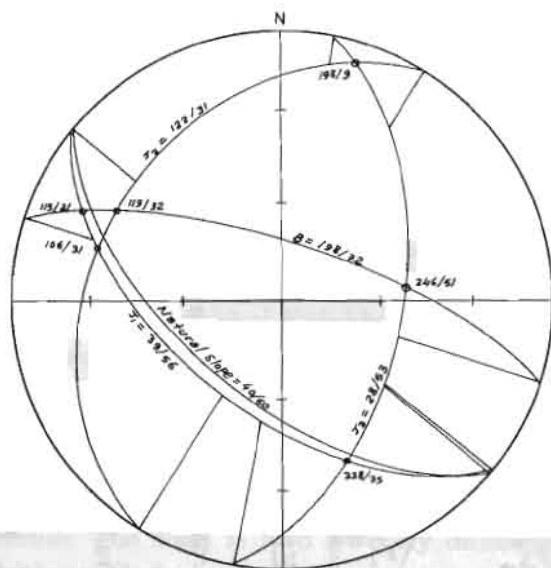
**Figure 2.15:** Stereographic projection of joints from the Jogimara rockslide. Upper hemispherical projection.

Statistical analysis of more than 100 joints revealed that there were five distinct sets of joints in the rock. One set is parallel to the cleavage and bedding, the two mutually perpendicular sets are extension joints and two sets are represented by shear joints. Stereographic projection of the joint sets (Fig. 2.15) clearly shows a high degree of hazard for plane rockslide along the joint plane with attitudes of  $39^{\circ}/56^{\circ}$  and a wedge rockslide formed by three joints:  $39^{\circ}/56^{\circ}$ ,  $122^{\circ}/31^{\circ}$ , and  $198^{\circ}/72^{\circ}$  (Plate 35).

The Jogimara landslide (Plate 34) is probably the most hazardous landslide on the Prithvi Highway. It has carried several buses into the Trishuli River and hundreds of people have lost their lives. The slide is located on the left bank of the Trishuli River on the Benighat Slates and Jhiku Limestone bands. The rocks are extremely jointed and the joint spacings vary from a few centimetres to tens of centimetres in the slate and from tens of centimetres to a few metres in the limestone. The approach road to the limestone quarry and the blasting in the area have further aggravated the situation. The natural slope is from 40 degrees to vertical and the failed slope is about 30 degrees.

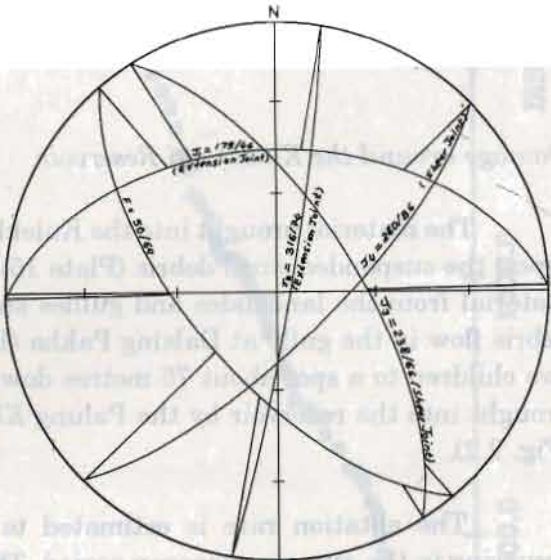
Many landslides and debris flow deposits are observed along the Kulekhani Khola below the dam. Plane rockslides are observed on the right bank of the Kulekhani Khola about 500m west of the confluence with the Chakhel Khola (Fig. 2.2). These slides have been active for quite a long time. One of the largest landslides and the resulting fan was observed between the villages of Thulo Tar and Sulikot (Fig. 2.2, Plate 11). The joint pattern is presented in Figure 2.19 and it shows that the failure was a wedge slide.

**Figure 2.19:** Stereographic projection of joints from the area between Sulikot and Thulotar. Upper hemispherical projection.
