EROSION AND SEDIMENTATION PROCESSES IN THE NEPALESE HIMALAYA

by Brian Carson

ICIMOD OCCASIONAL PAPER No. 1

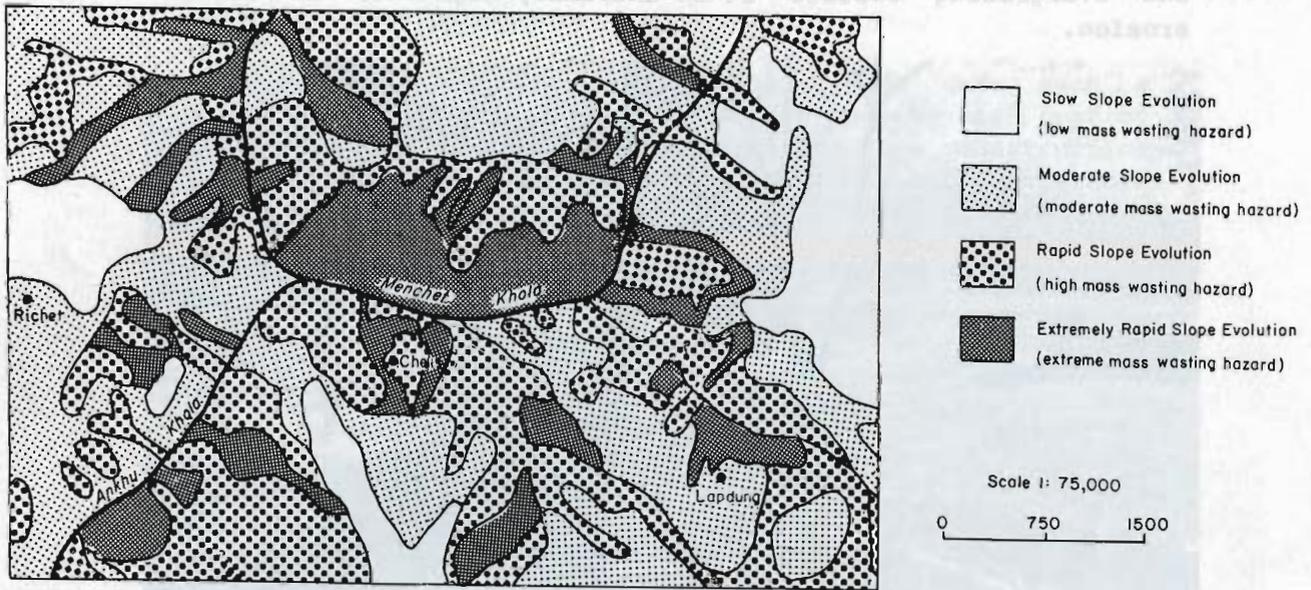
Figure 1

Geomorphic Nature of Upper Ankhú Khola (after Thouret 1981)

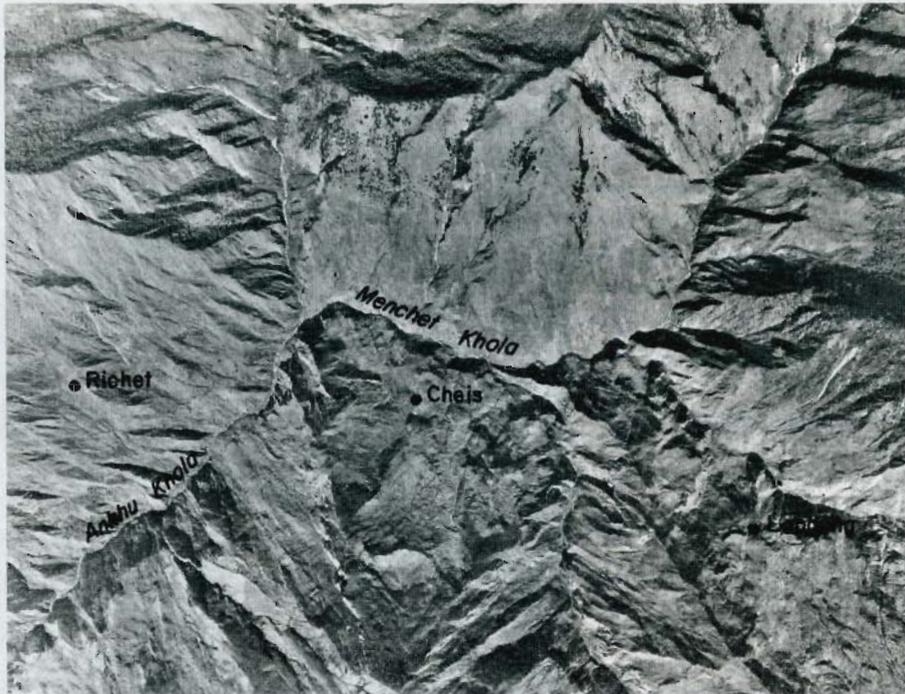
AERIAL PHOTOGRAPH OF UPPER ANKHU KHOLA

The interpretation of the above features requires a trained eye.

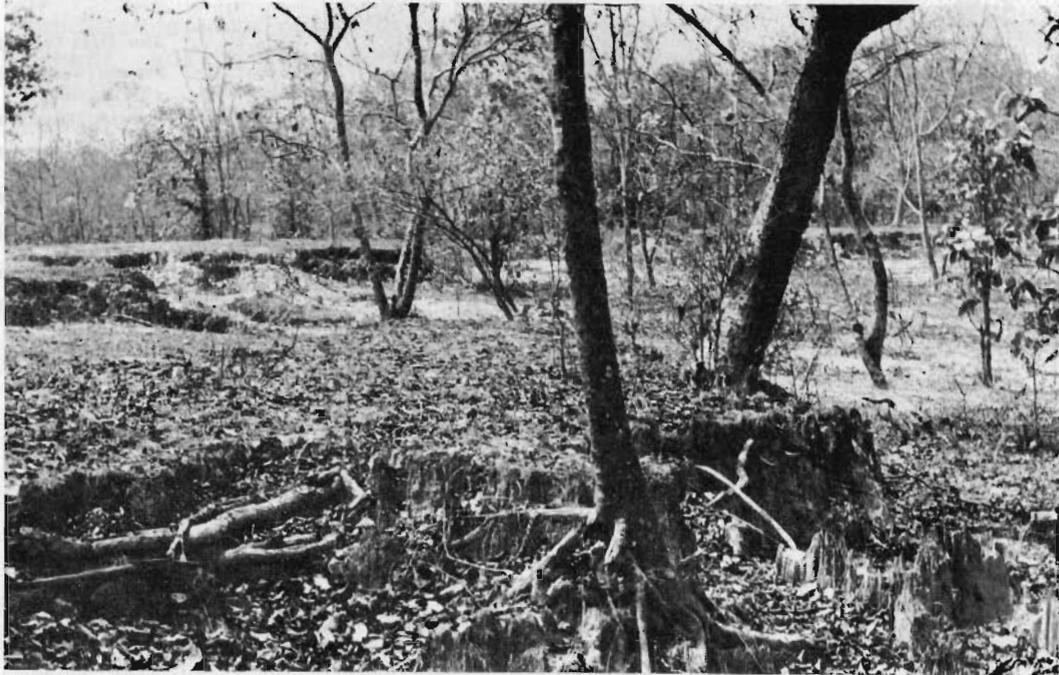
Roll 7940 No. 24

Photo I. - North of Nepalgunj, Banke District, dissected alluvial upland. High intensity rainfall combined with repeated burning and overgrazing results in an extremely high rate of surface erosion.

Surface erosion is less visually apparent than mass wasting but it is much more damaging to the livelihood of the people of Nepal. Loss of topsoil by surface erosion is the direct result of heavy rains pounding unprotected soils. Many of man's activities cause the soil to become less protected than it would be in a natural state. (See Photo I.)

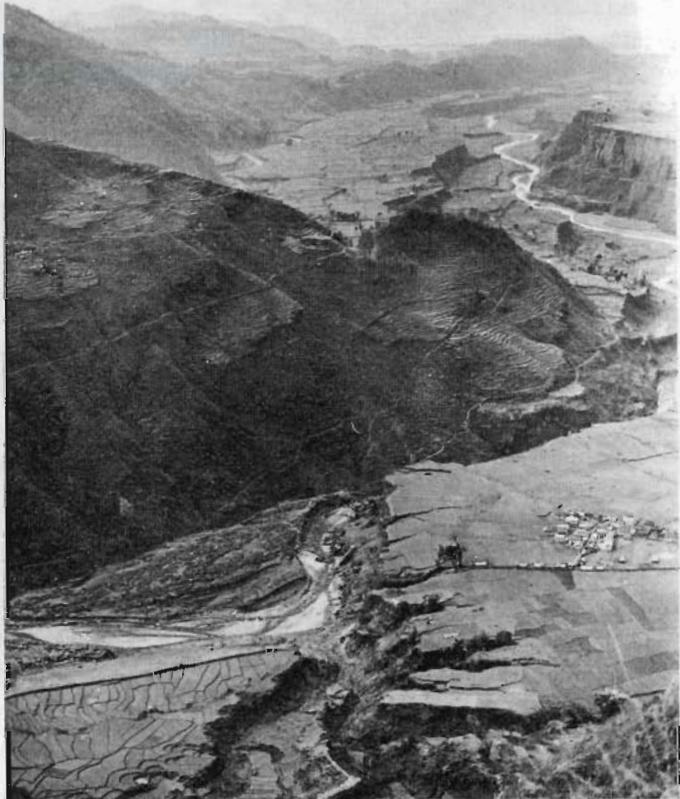
Photo II - The Pokhara Terraces, looking Southwest towards Gachok, Kaski District. These terraces are the result of a glacial dam outburst flood that occurred just 600 years ago.

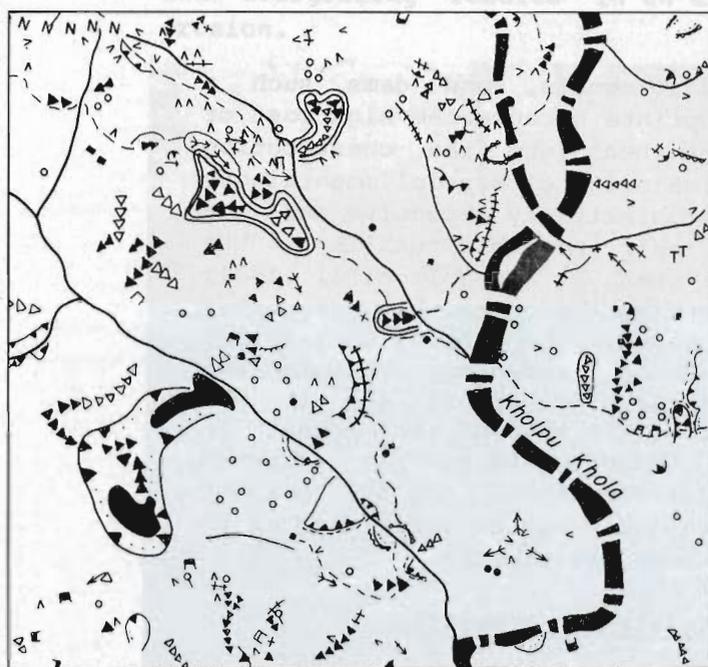
Figure 2

Geomorphic Damage, Kakani Area
(after Kienholz et al 1981)

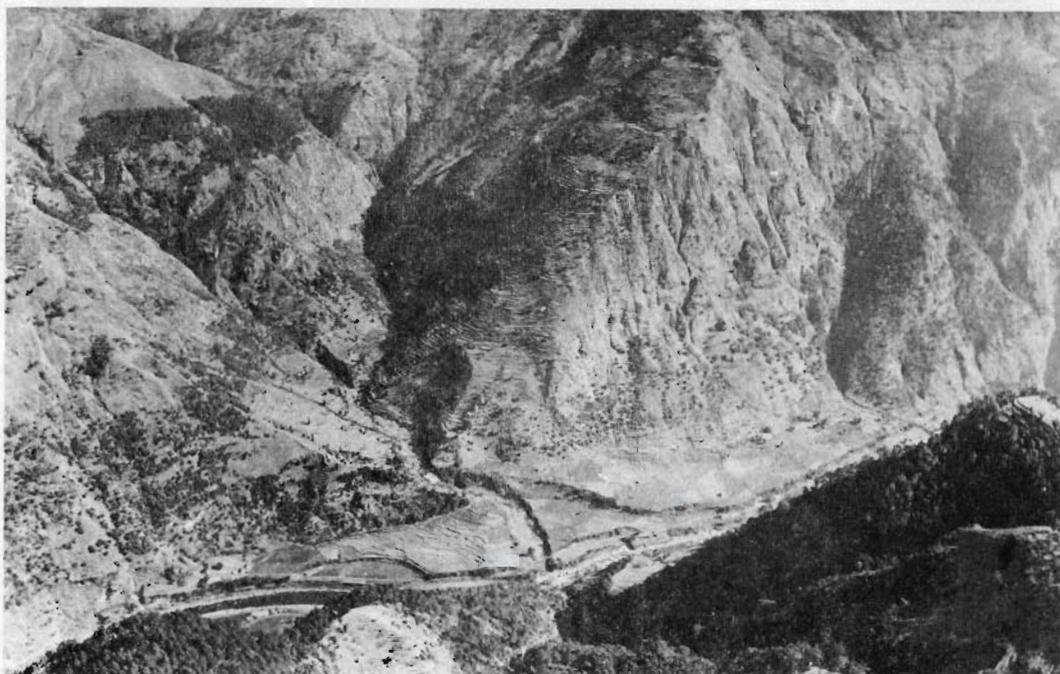
Phyllitic landscape similar to the Kakani area. Note the wide variety of erosion processes and their significance to landscape formation. Gullies, slumps, slides and debris torrents are common.

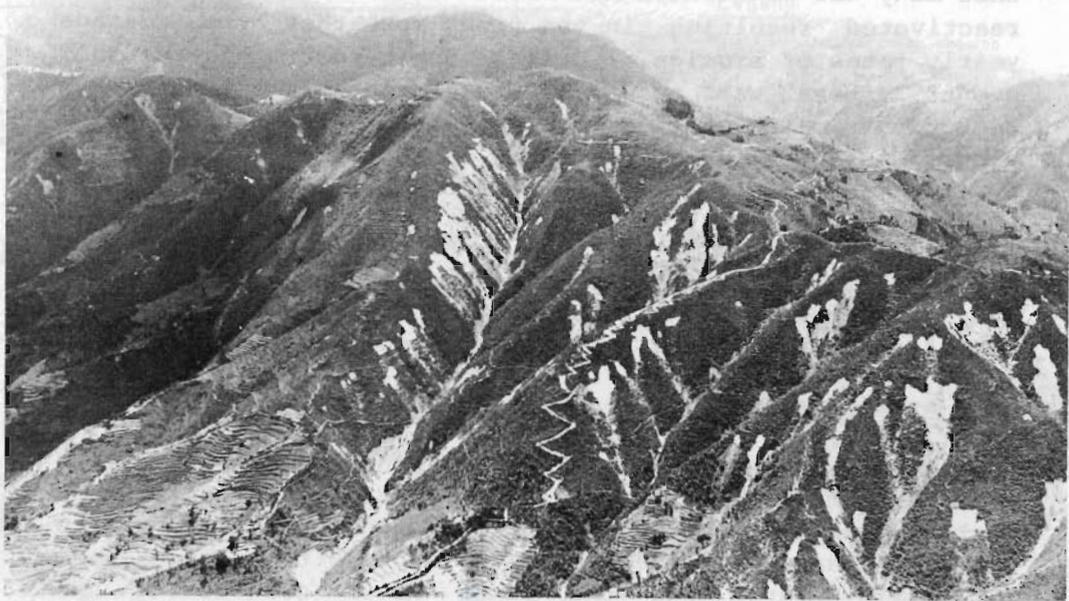
Photo III Near Lele, Lalitpur District. After a prolonged rainfall in Sept. 1981, this slope failed en masse in spite of thick shrub cover. Such catastrophic events are common on certain landforms within the Nepal Himalayas but are difficult to predict.

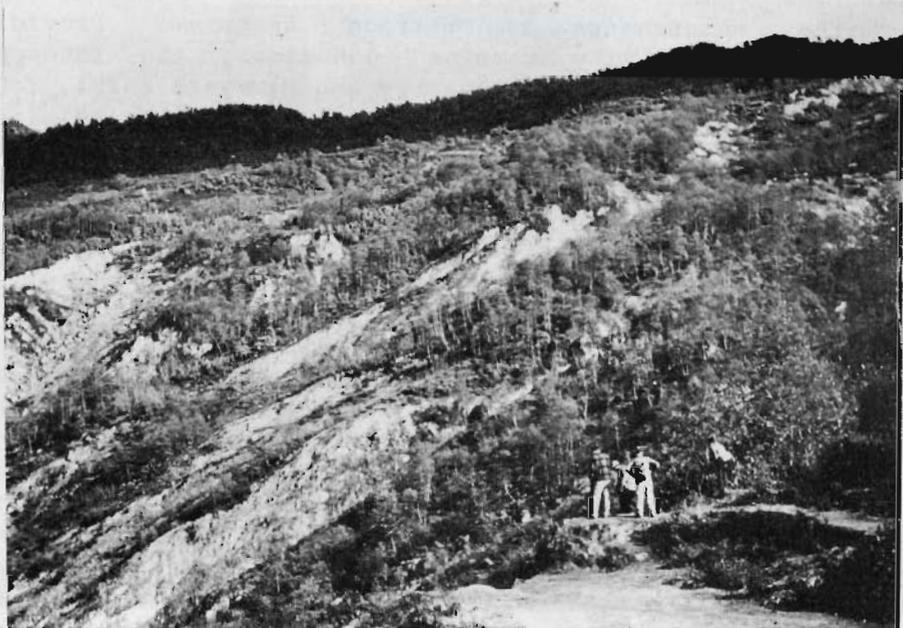
PHOTO IV. - Large landslide north of Taplejung, measuring over one km wide, three km long and over 20 meters deep. In the past fifty years over one hundred million tons of soil material has washed into the Tamur River from this slide. The progressive destruction of the hillside is difficult to blame on man's activities, as the land is generally well managed.

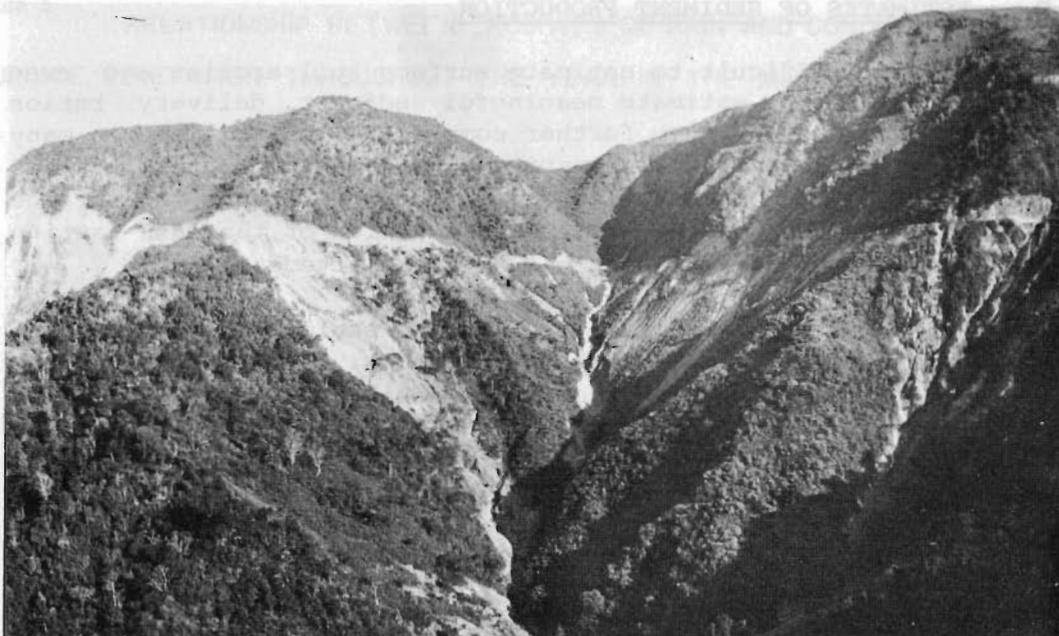
PHOTO V. - Feeder road construction northeast of Dharan. Severe erosion has been initiated by the poor layout, design and construction technique of this road. This alignment has since been abandoned as too costly to construct and maintain.

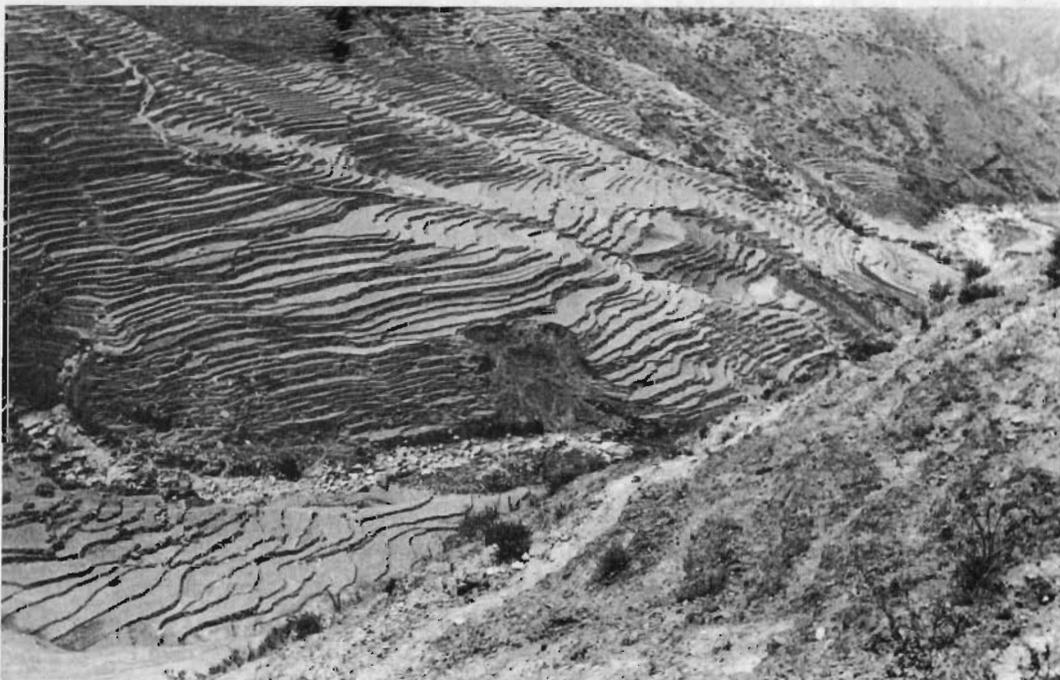
PHOTO VI. - Irrigated rice terraces in Accham. Irrigated lands are generally worth at least twice the value of nonirrigated lands. Small slope failures such as seen in this photo are quickly reclaimed as long as soils remain productive.

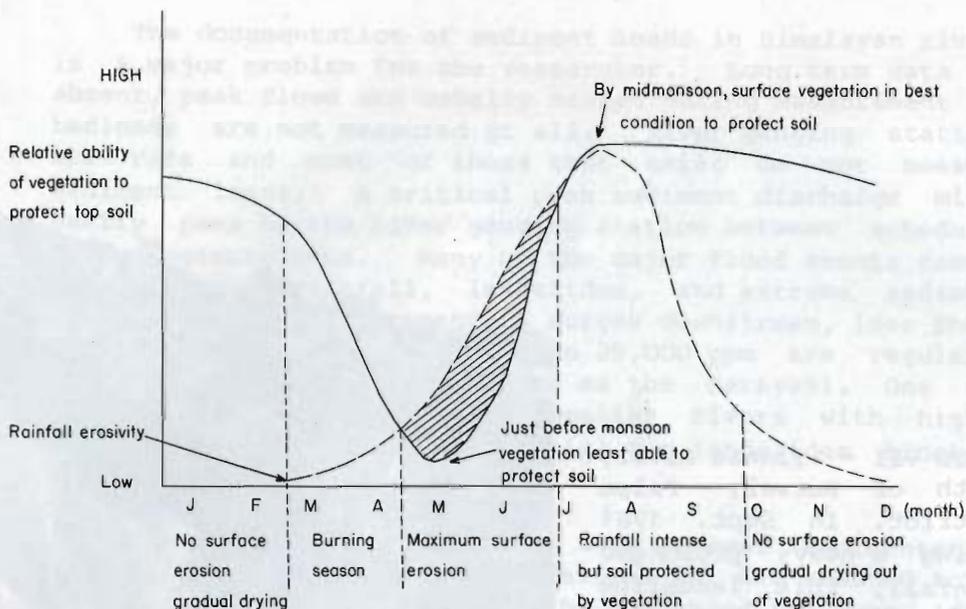
Figure 3

RELATIONSHIP BETWEEN EROSIVITY OF RAIN AND CONDITION OF SURFACE VEGETATION THROUGHOUT THE YEAR IN THE MIDDLE MOUNTAIN OF NEPAL

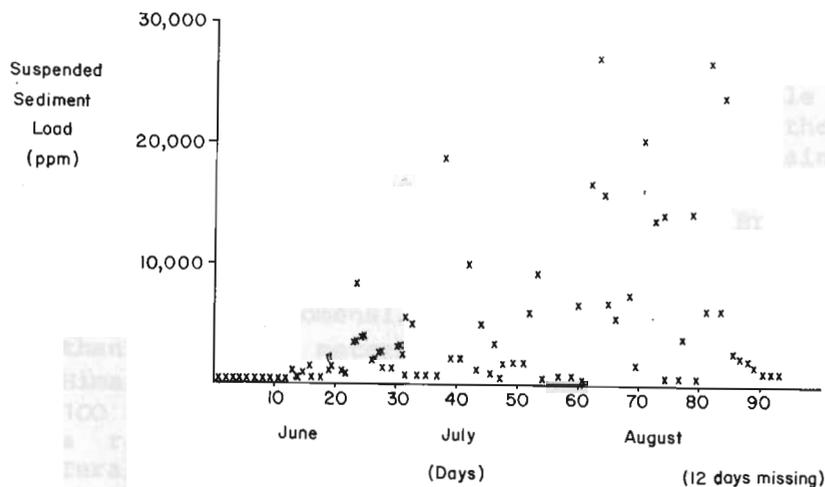
Figure 4

DAILY INSTANTANEOUS SEDIMENT LOAD FOR NARAYANI RIVER, NARAYANGHAT (JUNE, JULY AND AUGUST 1979)

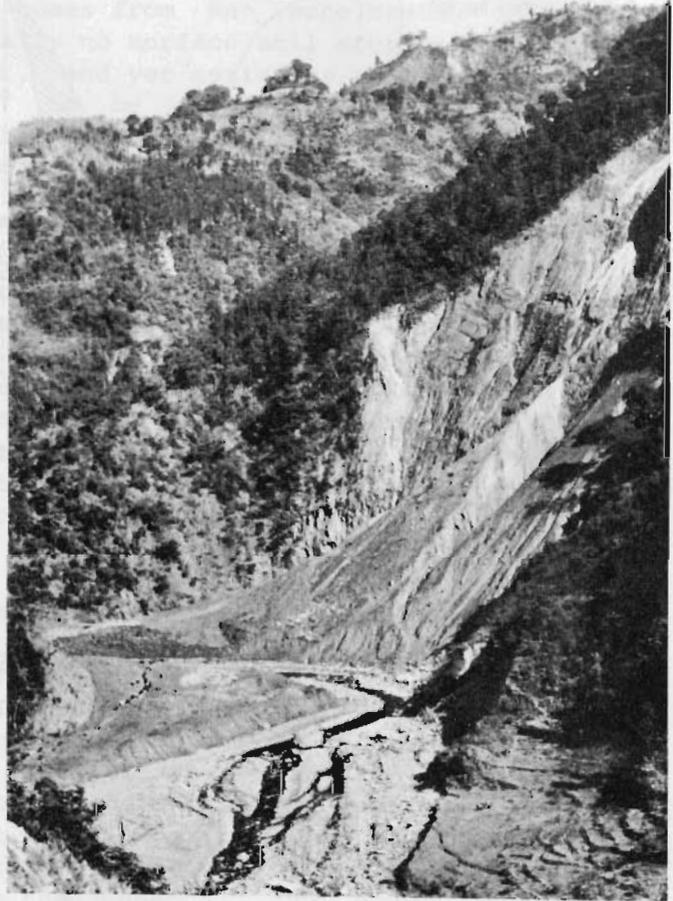
PHOTO VII - Tinnau River,
North of Butwal. Palpa
District. In Sept. 1981
during a heavy prolonged
rainfall, this landslide
temporarily blocked the
Tinnau River. The break
through of this dam
resulted in a downstream
surge that killed at least
two hundred people on the
Terai below Butwal.

The front cover shows the Tinna River, north of Butwal Palpa District (see p. 20)

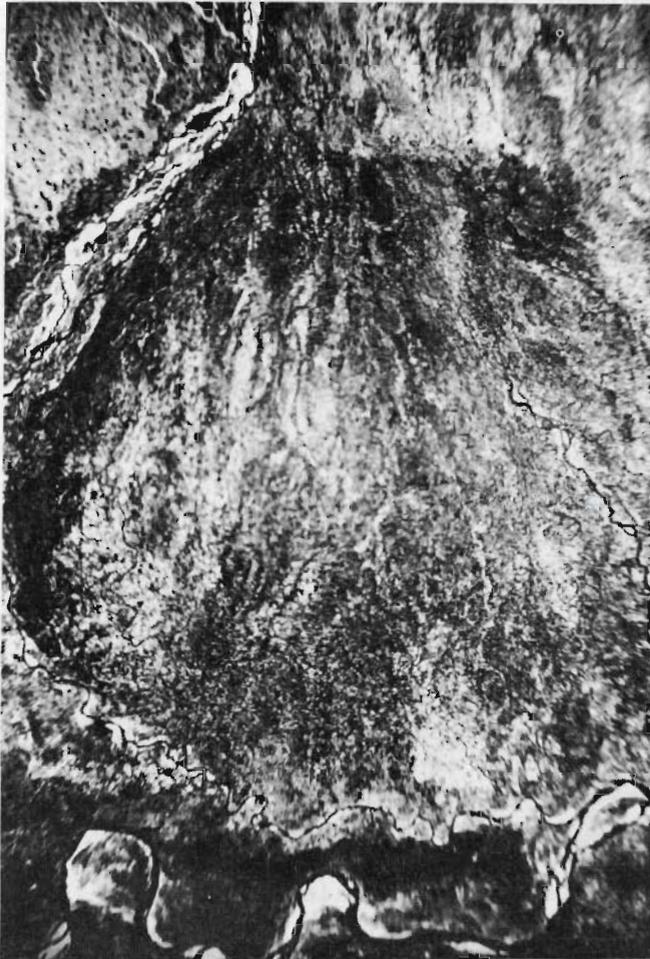
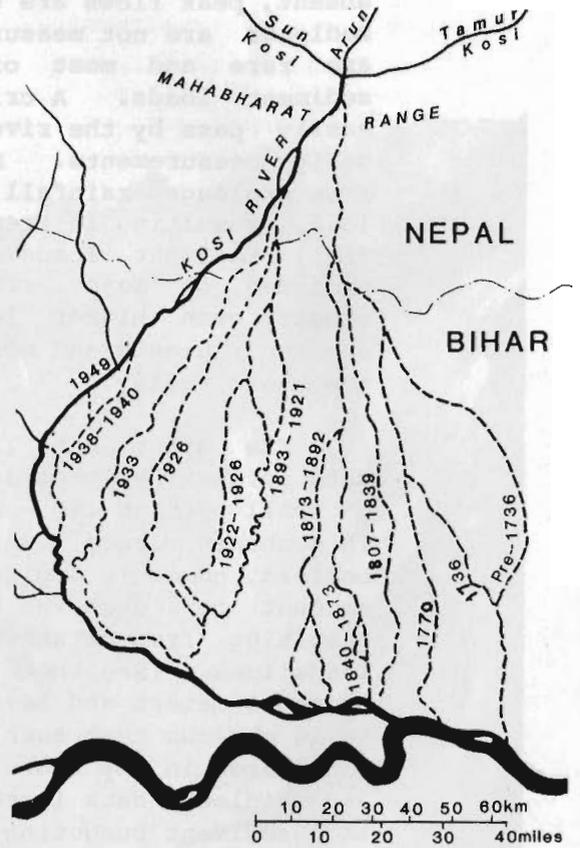
Figure 5 - Shifting of the Kosi River Since 1736
 Over the past 250 years, the Kosi has shifted progressively 120 km to the west in more than 12 distinct channels.

Landsat Imagery March 1975
 The Kosi River from the Himalayan Foothills to the Ganges.

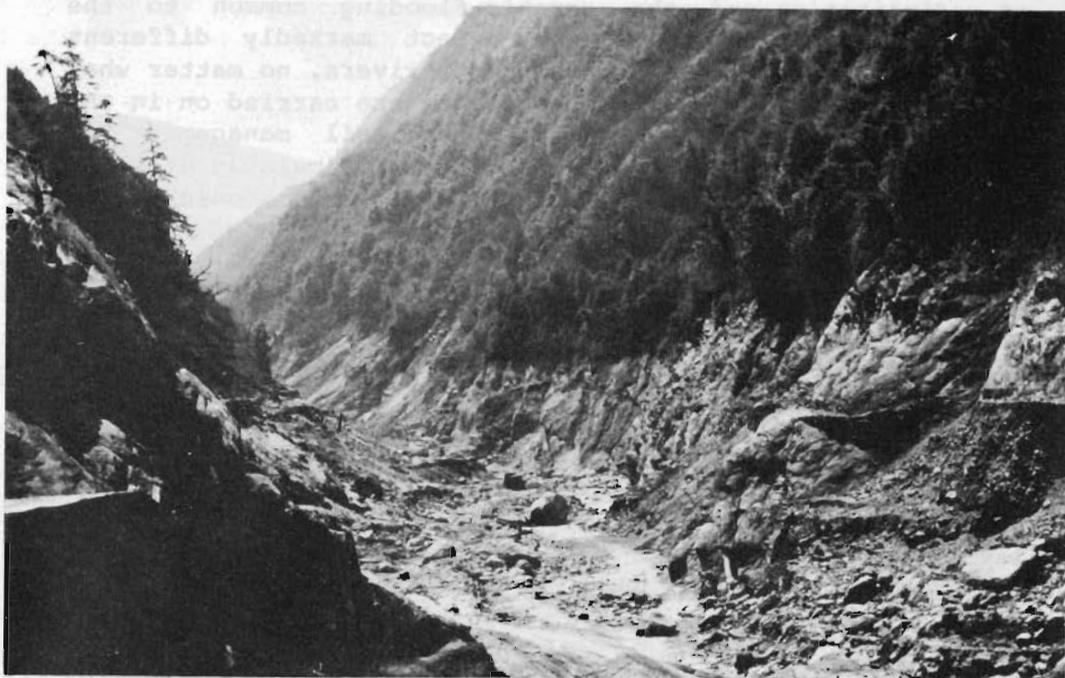
PHOTO VIII- Tamur River below Wallunchung Gola. Taplejung District. A massive surge, resulting from a glacial dam outburst flood above Yangma caused tremendous damage. At this point, over thirty kilometers downstream, all trees were stripped 20 meter above the river bank. Such events move a tremendous amount of sediment and are often not considered by existing hydrological models.

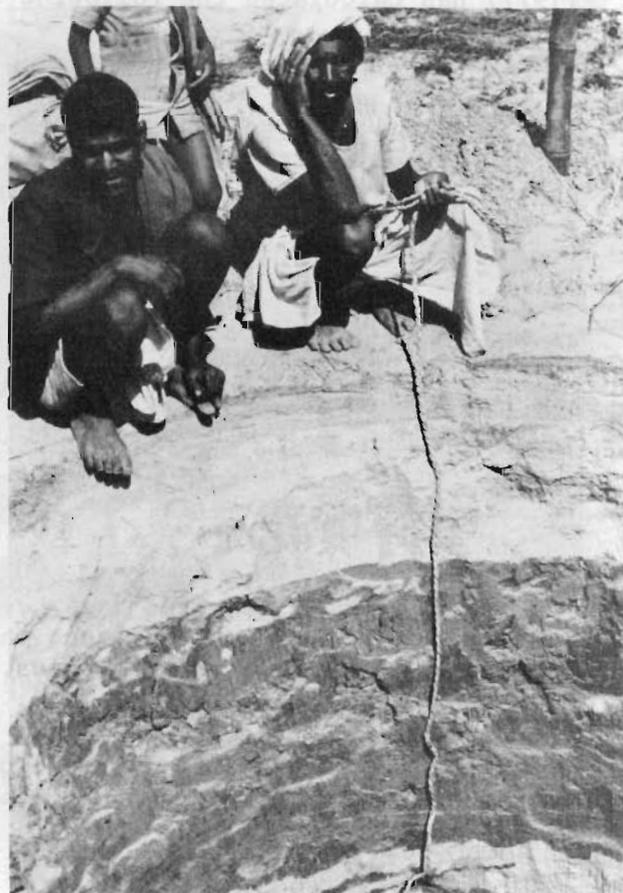
PHOTO IX - Sedimentation on the Terai, Ratu Khola, Mahottarai District. This farmer, in the past 45 years has witnessed the deposition of over two meters of sediment on his farmland. With the rope he indicates the soil he ploughed as a boy. Such rates of sediment deposition result in great hardship for the farmer, but rarely irreversibly destroy the land.

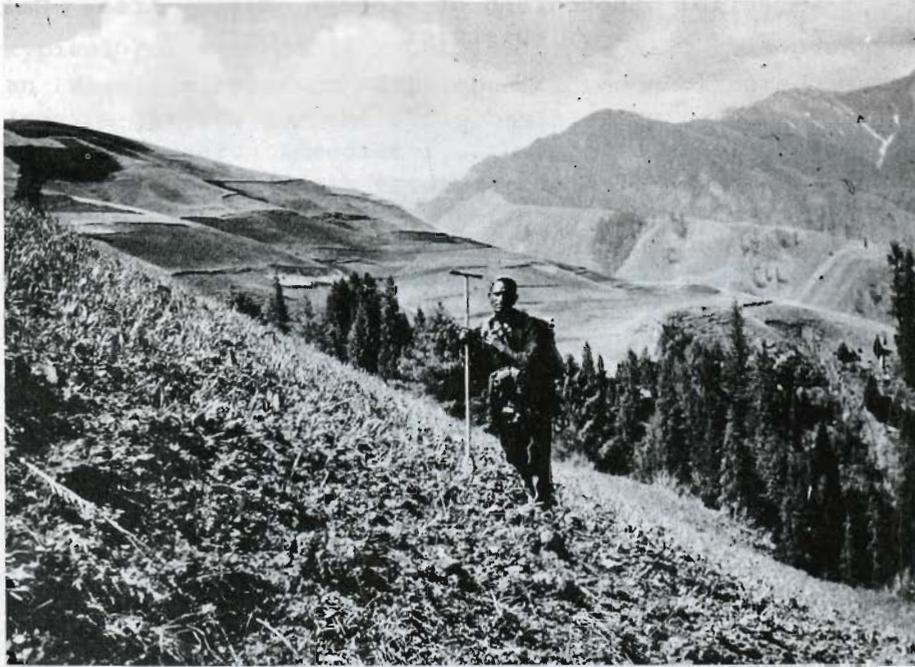
Photo X - South of Jumla, Jumla District (2400 m). Low intensity precipitation and relatively stable convex slopes result in low surface erosion and only minor mass wasting on this High Mountain landscape. Sediment yields from such areas are also relatively low.

Another common simplification is that all areas are producing sediment in equal amounts. This is not true for such varied landscapes as found in Nepal with equally varied climates, geology and geomorphology. (See Photos X and XI.) Data such as presented in Table I can be used to get a first approximation of accelerated erosion within a watershed by assigning soil loss values for various land use types*. Taking the example of a typical Middle Mountain slope in Dailekh District, one can develop an erosion profile. In Figure 6 a 1:10,000 aerial photograph and accompanying interpretation is provided. The interpretation and areas of Table IV are taken from these figures.

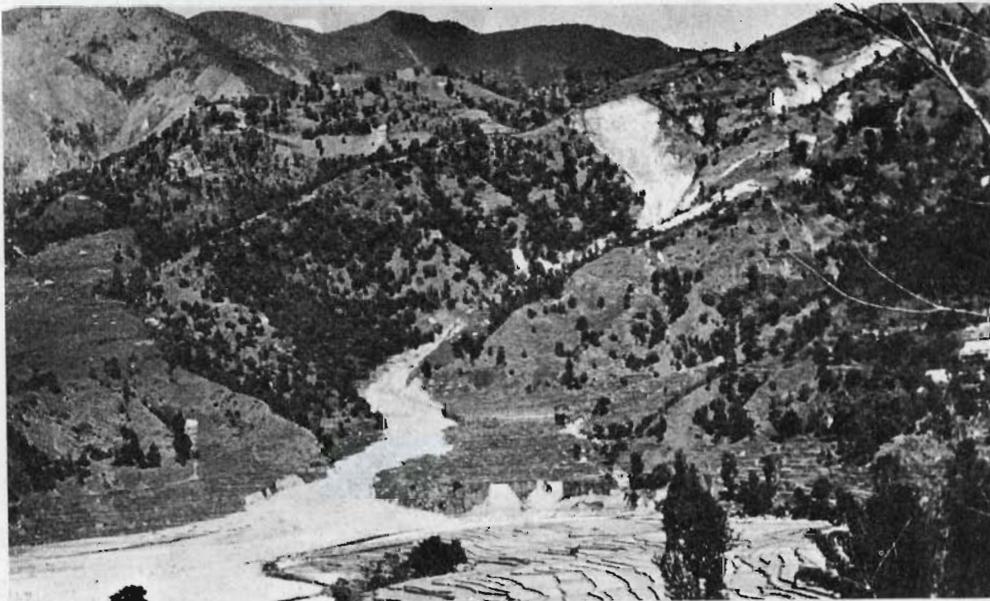
PHOTO XI - Andhi Khola - Syangja District (600m) Rugged local relief, unstable slopes and relatively high intensity precipitation result in high surface erosion and mass wasting on this particular Middle Mountain landscape. Consequently sediment yields are very high.

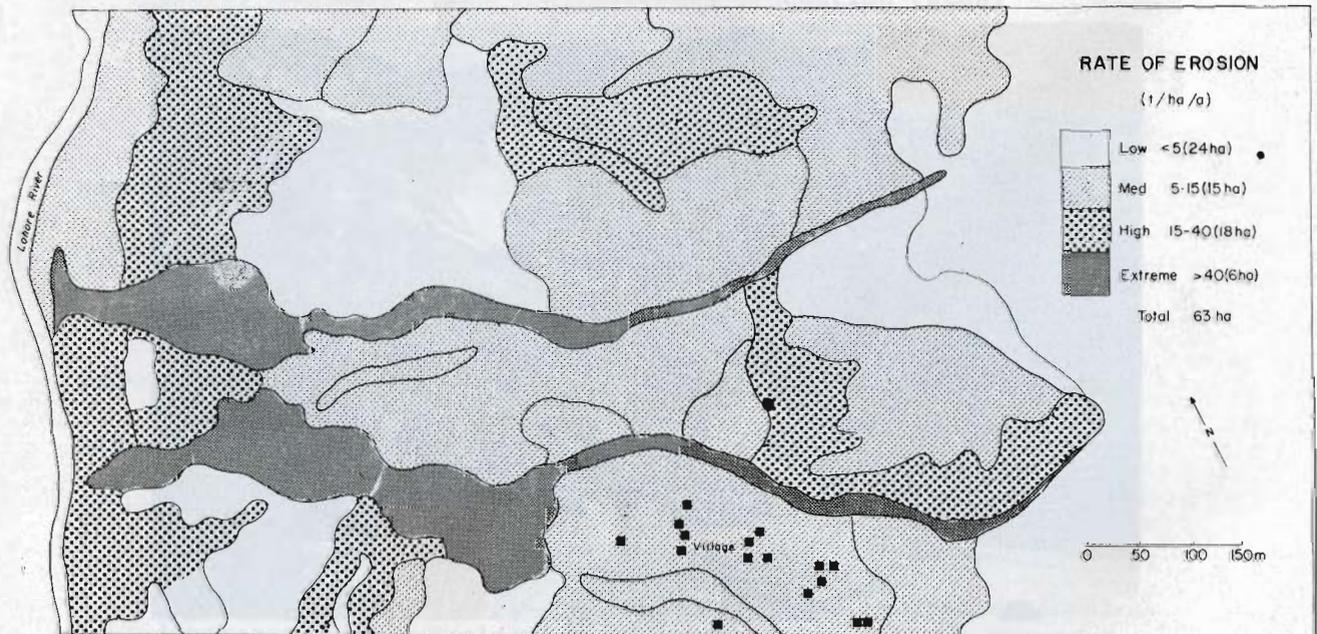
Figure 6 - Aerial photograph of Lohore River Area, Dailekh District

Area interpreted below

Rate of Erosion for 63 ha of watershed based on Aerial Photograph Interpretation. Extreme erosion, largely natural, is experienced adjacent to major drainage ways flowing into Lohore River. Areas of forest and rice cultivation have very low rates of erosion; rainfed land, moderate levels; and grazing, high levels.

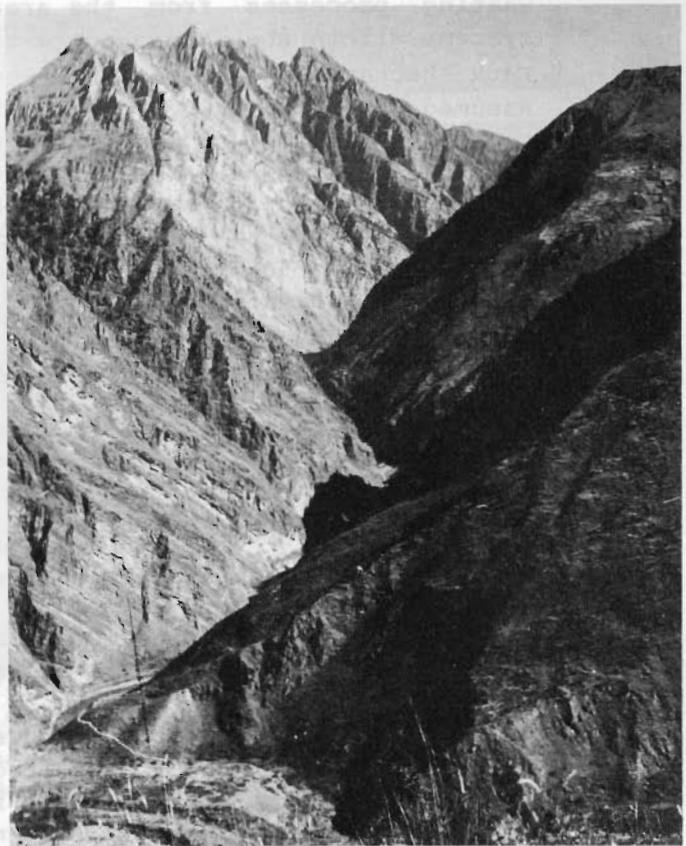
PHOTO XII - North of Tarakot, Dolpa - Arid alpine climate and deep regional river cutting results in a very rugged landscape with average slopes in excess of 45 degrees.

It is interesting to compare landscapes on the south side of the Himalaya, where precipitation averages 2000 mm per year, with those on the north side of the Himalaya, such as in Dolpa, where precipitation averages 200 mm per year. The dry climate of inner Dolpa, combined with the aggressively cutting streams, results in a very steep canyon landscape with average slopes of 45 degrees compared with around 20 degrees for the more humid Middle Mountains. The Dolpa canyons are near their angle of repose for free standing fractured rock, and so rockfalls are the dominant erosion process. In many of those valleys, slopes are so steep that man has not attempted to penetrate them. The lack of slope moisture greatly reduces the weathering of rock and thus the slopes' tendency to fail as slumps or landslides. Similar rock types on the southern side of the Himalayas are subject to aggressively weathering monsoon rains and the deep weathering of rocks is instrumental in reducing the gradient of slopes. (See Photos XII and XIII.)

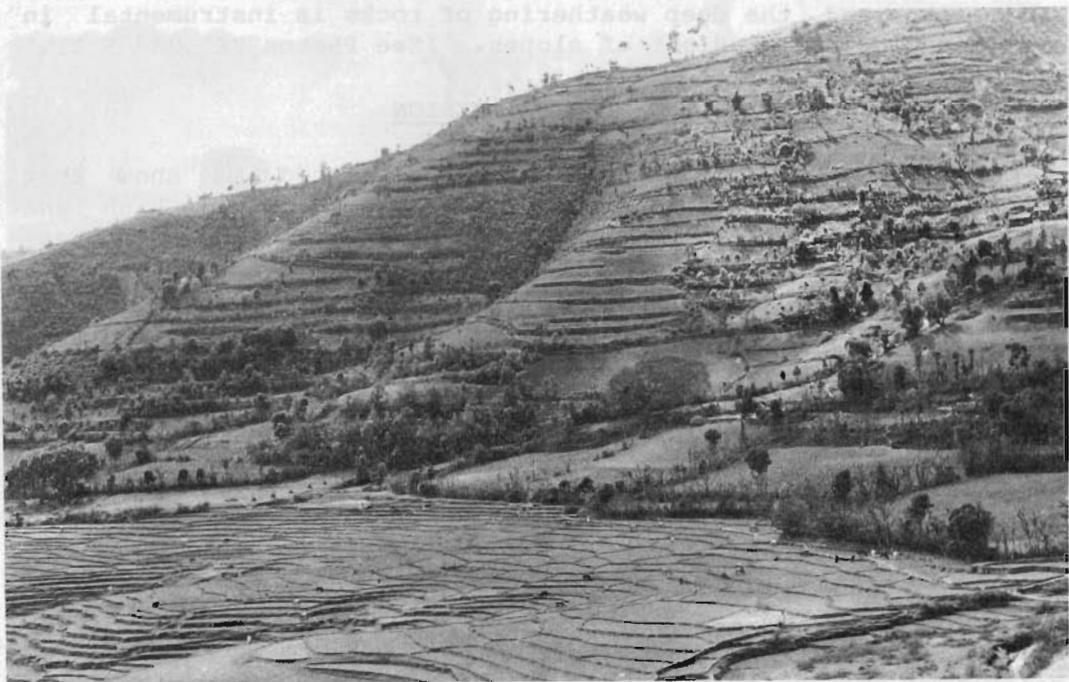
PHOTO XIII - South of Tansen, Palpa, Humid Subtropical Climate and a local absence of river cutting results in the deep chemical weathering of bedrock which produces a rounded convex landscape with average slopes less than 20 degrees.

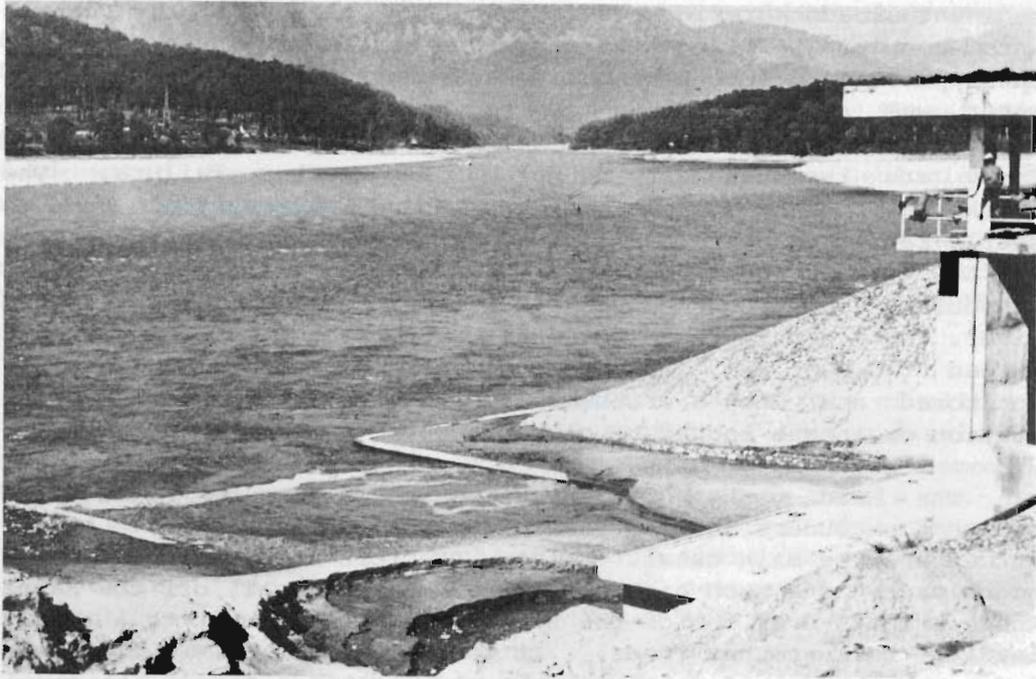
Photo XIV - Narayanghat, Chitwan District - Irrigation intake on Narayani River completely choked with sediment. A better design could have significantly reduced this sedimentation.

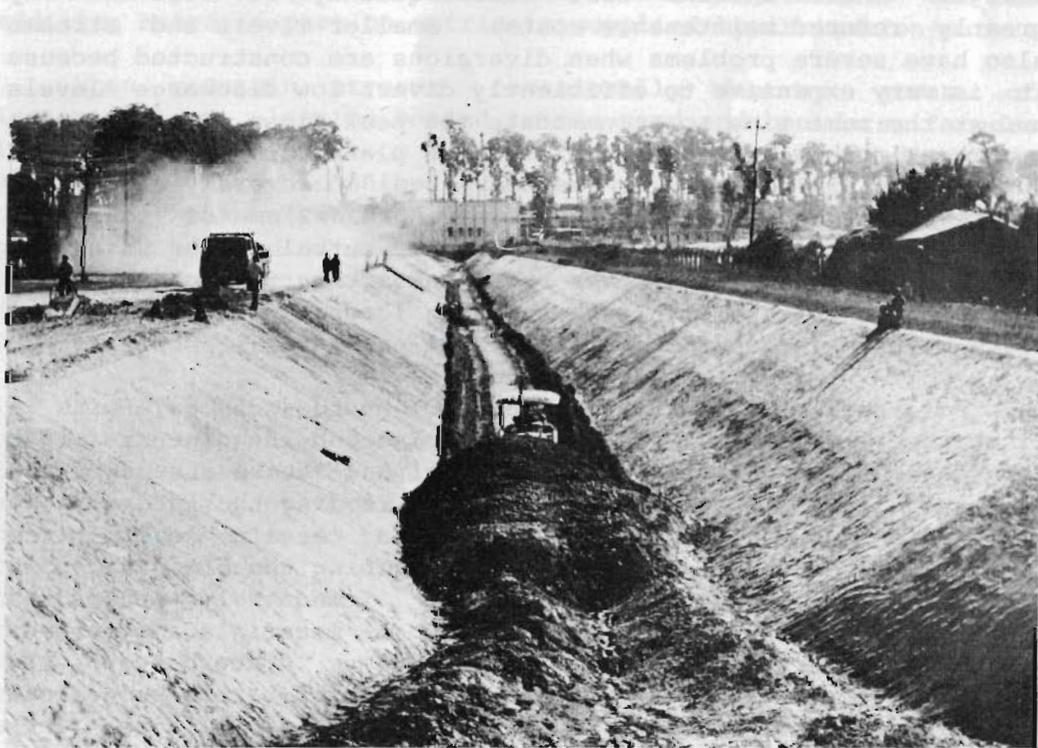
Photo XV Narayanghat, Chitwan District - Sediment removal from the main canal, Chitwan Irrigation Project. Over 2.5 meters of fine sand were deposited in this canal during the 1984 monsoon, completely blocking irrigation water flow. Better use of available data could have warned designers of such a hazard.

sediment loads entering the irrigation system. The main canals were completely filled with fine sand after only three months of such operation. (See Photo XV.) Damage was so extensive that no water was supplied to farmers for the 1985 winter irrigation season, only 8 months after the pumping station was opened. There are two lessons to be gained from such a failure. The intake was positioned in a backwater where sediment would tend to settle rather than be carried away by the river and the operators of the pumping station were maintaining inflexible pumping schedules, oblivious of the fluctuating sediment loads in the river. In a country such as Nepal, where sediment loads commonly exceed 10,000 ppm, river sediment concentrations must be monitored and when a critical level is exceeded, the pumping station or intake should be closed down.

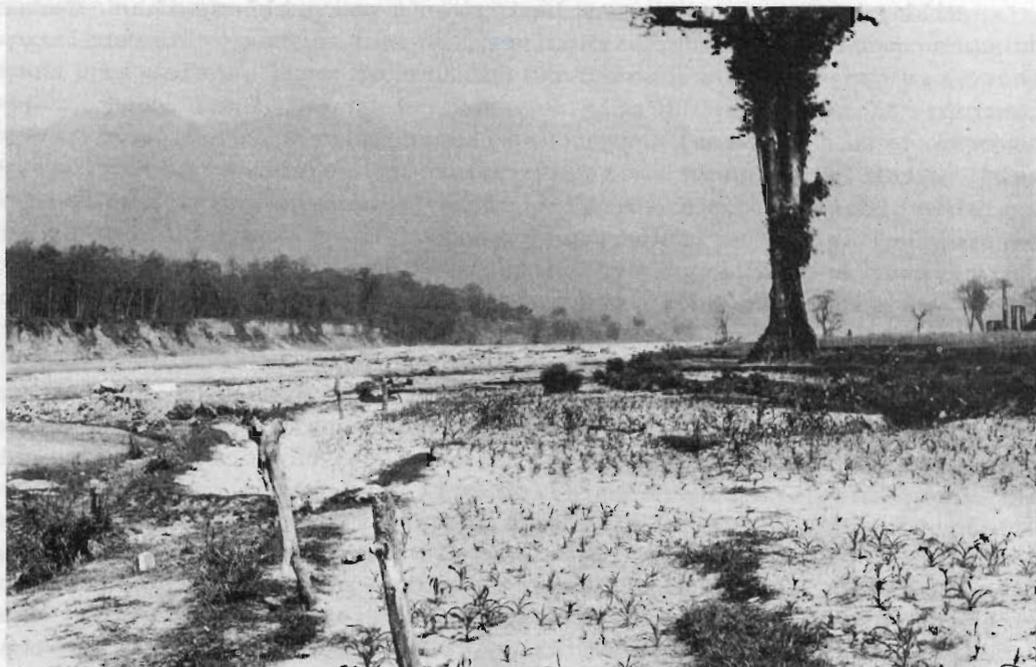
Photo XVI Waebater Village, Marin Khola, Sindhuli District. A long duration rainfall in September 1984 resulted in tremendous flood damage to farmland throughout the Sindhuli District. Here coarse sediment has been deposited on rice fields. This farmer has direct seeded the land with maize and over time it will be reclaimed for irrigated rice.

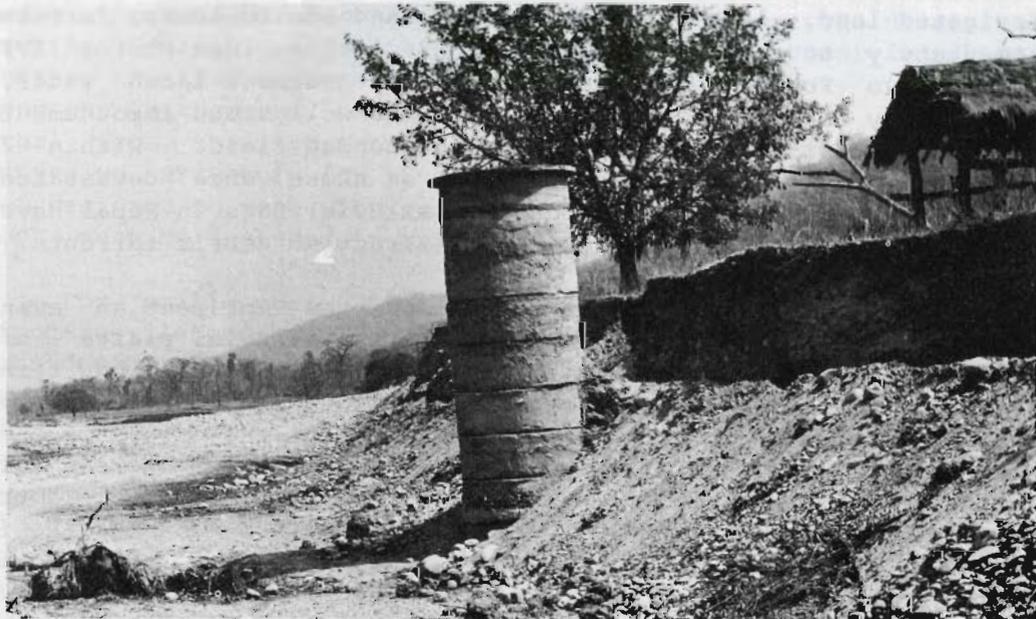
PHOTO XVII - Near Waebater Village, Marin Khola, Sindhuli District. River scouring has exposed 6 rings of this concrete lined well, leaving behind a monument to the fury of the Marin Khola in flood. Throughout the watershed, many river banks were eroded destroying many hectares of farmland.
