# Debris Flow Control and Management: Case Studies from the Sichuan and Yunnan Provinces of China

Wu Jishan<sup>1</sup>, Li Tianshi<sup>2</sup> and Yin Chongqing<sup>3</sup>

This paper discusses two successful examples where the debris flow hazard to mountain roads and land has been reduced, the first in Heisha River, Xichang, Sichuan province and the second in Laogan Ravine, Dongchuan, Yunnan province, both in China. The debris flow control project along the Heisha River was successfully completed in 1978 with an investment of US\$ 0.5 million. The Laogan Ravine project was completed in 1994 at a cost of US\$ 0.17 million. There have been no debris flows in these ravines since the projects were completed.

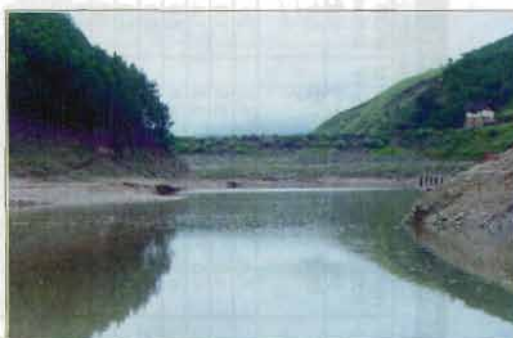
Figure 18.3: The flood regulating Qiyi reservoir constructed in the Luji Basin, in the upper reaches of the Heisha Ravine

A 23m high reservoir, the Qiyi reservoir, was built at the exit of the Luji Basin (Figures 18.3 and 18.4). The reservoir has a storage capacity of 656,000 m<sup>3</sup> and collects water from a 9.2 sq.km catchment area, 72% of the total Heisha Ravine catchment. During the rainy season the reservoir acts as a flood regulator. The 20-year-frequency flood peak discharge of 64.6 m<sup>3</sup>/s and 100-year-frequency of 110 m<sup>3</sup>/s can be reduced to 13.4 m<sup>3</sup>/s and 33.9 m<sup>3</sup>/s respectively when a storage capacity of 601,000 m<sup>3</sup> is used to regulate annual floods and hold the water (Table 18.3). Since the completion of the reservoir in 1972, the mainstream of the Heisha Ravine has not produced any substantial debris flows and neither has the Heisha River. The reservoir dam was made of earth using hammer-ball installation. This type of construction can easily be manipulated to drain sediment away. In the event of a 100-year-frequency flood, if in-reservoir discharge is 1 m<sup>3</sup>/s, the water level can be reduced to the normal level of 10.2m within 48 hours. Even in the highly unlikely event that a rainstorm of the same strength occurred the next day, the reservoir would still be safe.

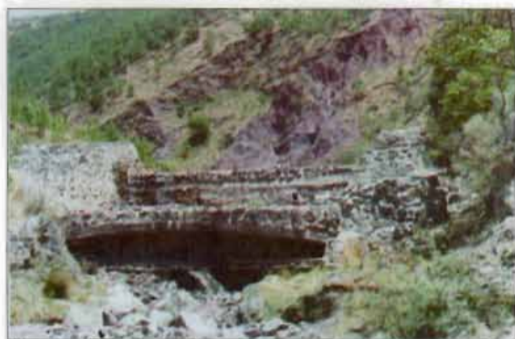
**Figure 18.6: Sediment trapping dam with single-arch foundation constructed across the main stream of the Heisha Ravine**

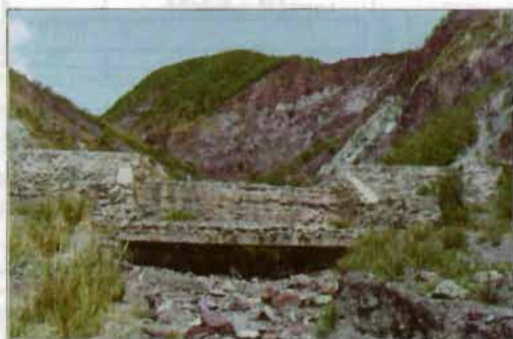
**Figure 18.7: Sediment trapping dam with plate foundation constructed in the landslide area of the mainstream of the Heisha Ravine**

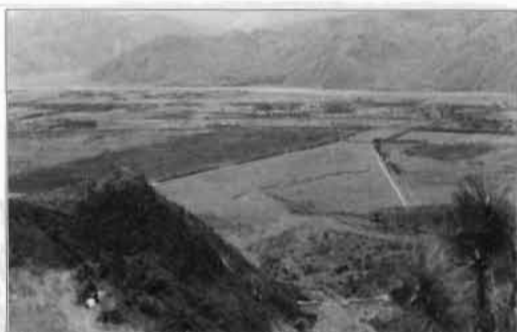
Figure 18.11: View of the diversion dyke build on the debris flow depositional fan of the Heisha Ravine

The diversion flume built in the lower reaches of the Heisha River was 2.9 km long. A 2.5 m high diversion dyke was built on both sides of the river (i.e., total length of dyke 5.8 km). The plan of the dyke is shown in Figure 18.10 and the completed dyke in Figure 18.11. Most of the dyke is earthen with the surface protected by cement masonry. There is a spillway in the upper section of the diversion dyke. When debris flows or flood levels in the flume reach a critical height, the spillway can be used to protect the dyke. Sediment exits in the middle and lower reaches are used to push the sediment away.

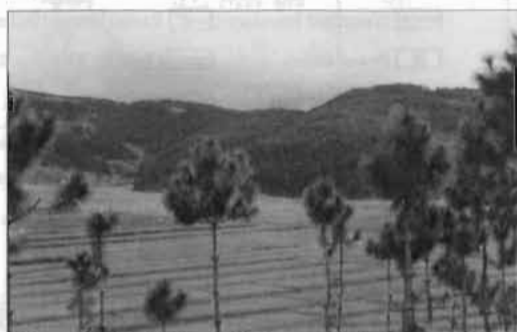
Figure 18.12: View of farmland terraced by the project in the Lujing Basin in the upper reaches of the Heisha River

One very important intervention was to improve the stability and reduce erosion rates in surrounding areas by changing the land use pattern. General erosion was reduced by replacing cultivated areas on steep slopes with forests. Cultivation was forbidden on slopes exceeding 25° and forests were planted in the middle and upper catchments. Fields were terraced, and strip field and cultivation along contour lines was encouraged. Fields on slopes of less than 25° on the alluvial fan of the Lujing Basin were terraced (Figure 18.12). Strip fields with straight ditches, roads, and trees were built on the old fan outside the diversion flume.

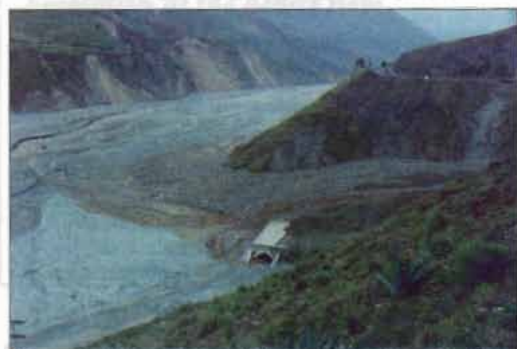
Figure 18.16: View of the covered tunnel and fan of the Laogan Ravine. The left outlet of the tunnel was silted up by about 3m as a result of the July 1987 flood

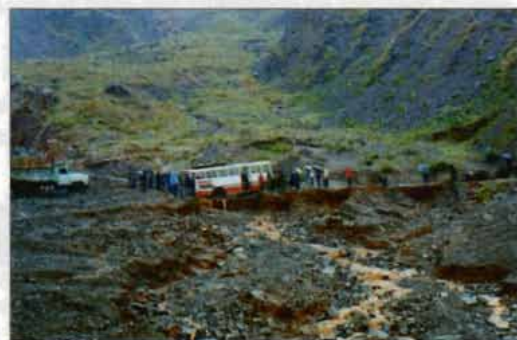
Figure 18.18: The causeway of the highway constructed over the destroyed bridge over the Laogan Ravine. The bridge was damaged by a debris flow in May 1990

The highway runs 80m upstream of the railway. In the beginning a small bridge was constructed across the ravine course, which was however soon destroyed. A pavement (causeway) was constructed over the destroyed bridge to allow debris to flow down it. A flood in May 1990 also damaged the causeway (Figure 18.18). The annual cost of repairing and maintaining this sec-

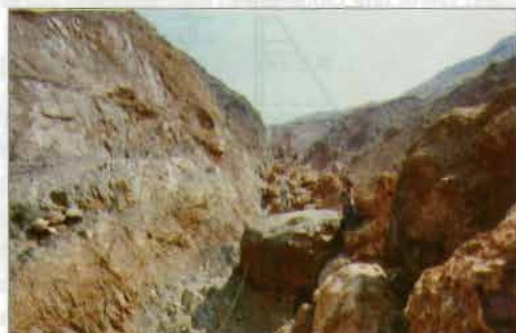
Figure 18.19: View of debris flow forming area in the upper lower reaches of the Laogan Ravine (looking upstream in 1988). In the past, abundant loose solid materials of landslide mass from here contributed to debris flows during heavy rain storms

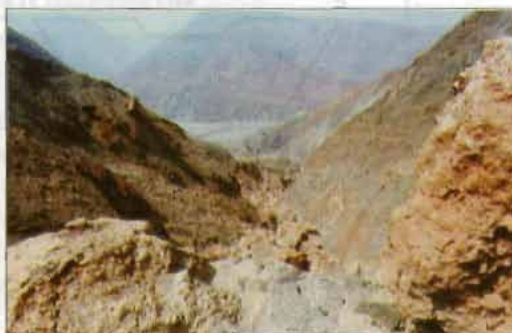
Figure 18.20: View of debris flow forming area of the Laogan Ravine (looking downstream in 1988). Bank erosion and collapses provided abundant loose materials to form debris flows.

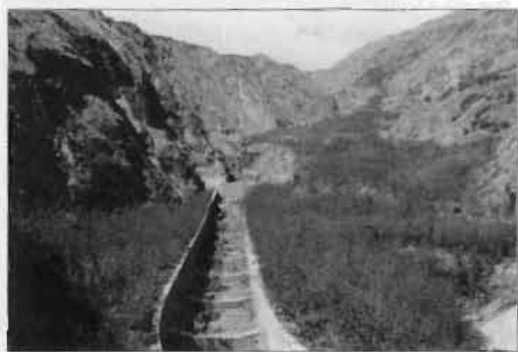
Figure 18.21: View of channelised ravine course (diversion flume), with scour-proof ribs and fixed-bed dams, and of bio-engineering structures in the valley of the Laogan Ravine

Bio-engineering was used to increase vegetation cover and prevent surface erosion. Afforestation was to improve the degraded mountain environment was the main approach used. Tree species were selected for planting on the bare mountain slopes in the middle and upper reaches as well as on the landslide mass in the lower reaches. A 130 ha area was planted in the middle reaches with the tree species *Robinia pseudoacacia*, *Albizia mollis*, *Cupressus funebris*, *Pinus yunnanensis*, and *Pinus armandii*. *Albizia mollis*, *Coris sinica* and other species were planted over an area of 29 ha in the landslide area of the upper and lower reaches (Figure 18.21).

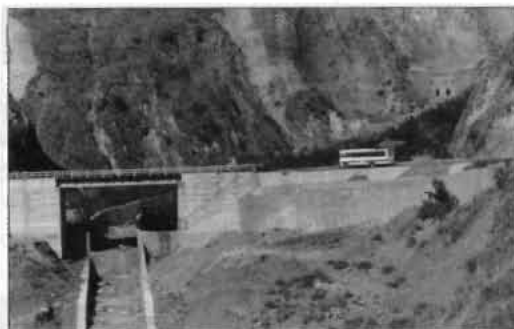
Figure 18.23: New bridge built in 1994 across the Laogan Ravine, the diversion flume can be seen under the bridge
