#### *Hazard Mapping in the Kulekhani Watershed*

### **Landslide Stabilisation Work in Nepal**

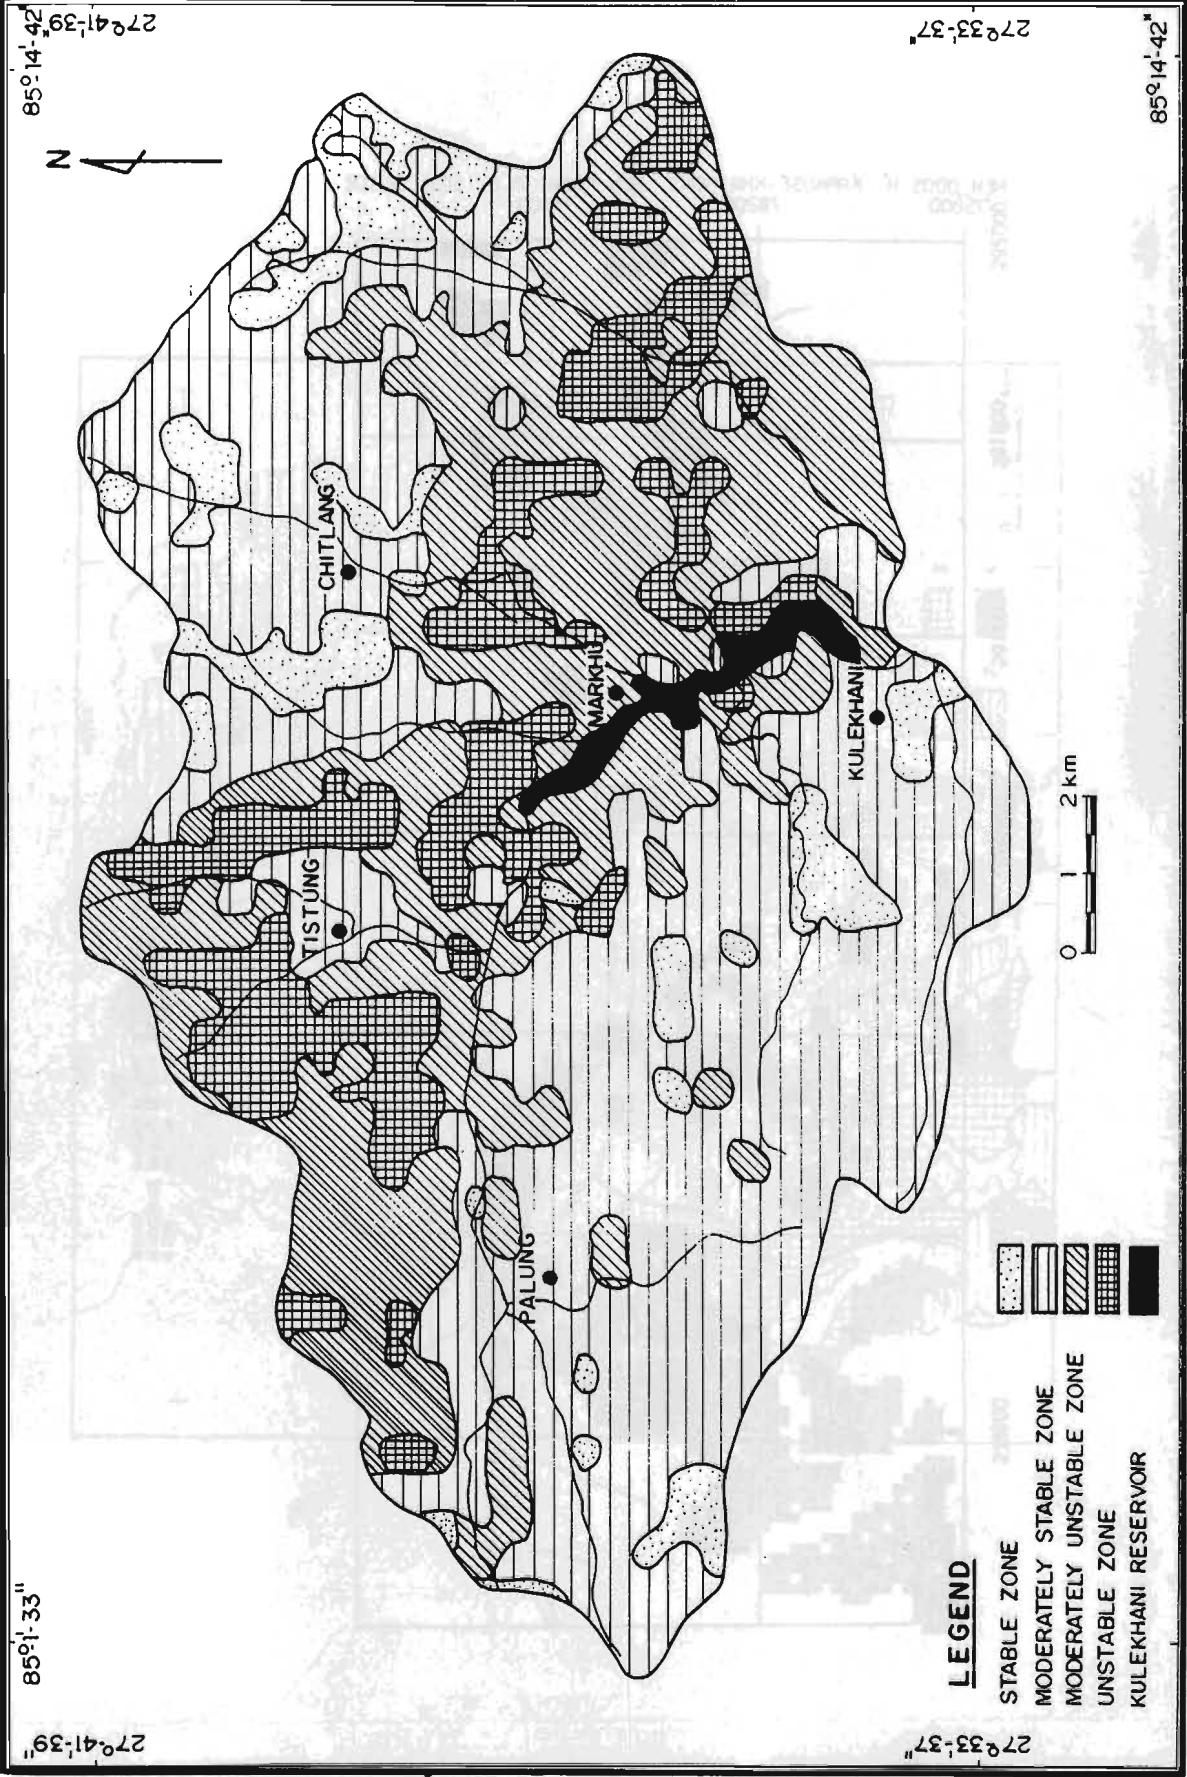
Figure 29: Hazard map of the Kulekhani Watershed (Nepal 1992, redrawn)

Nepal (1992) prepared a hazard map for the Kulekhani Watershed (Fig. 29). The map was prepared by combining the ratings from the landslide inventory map, slope map, and land-use map.

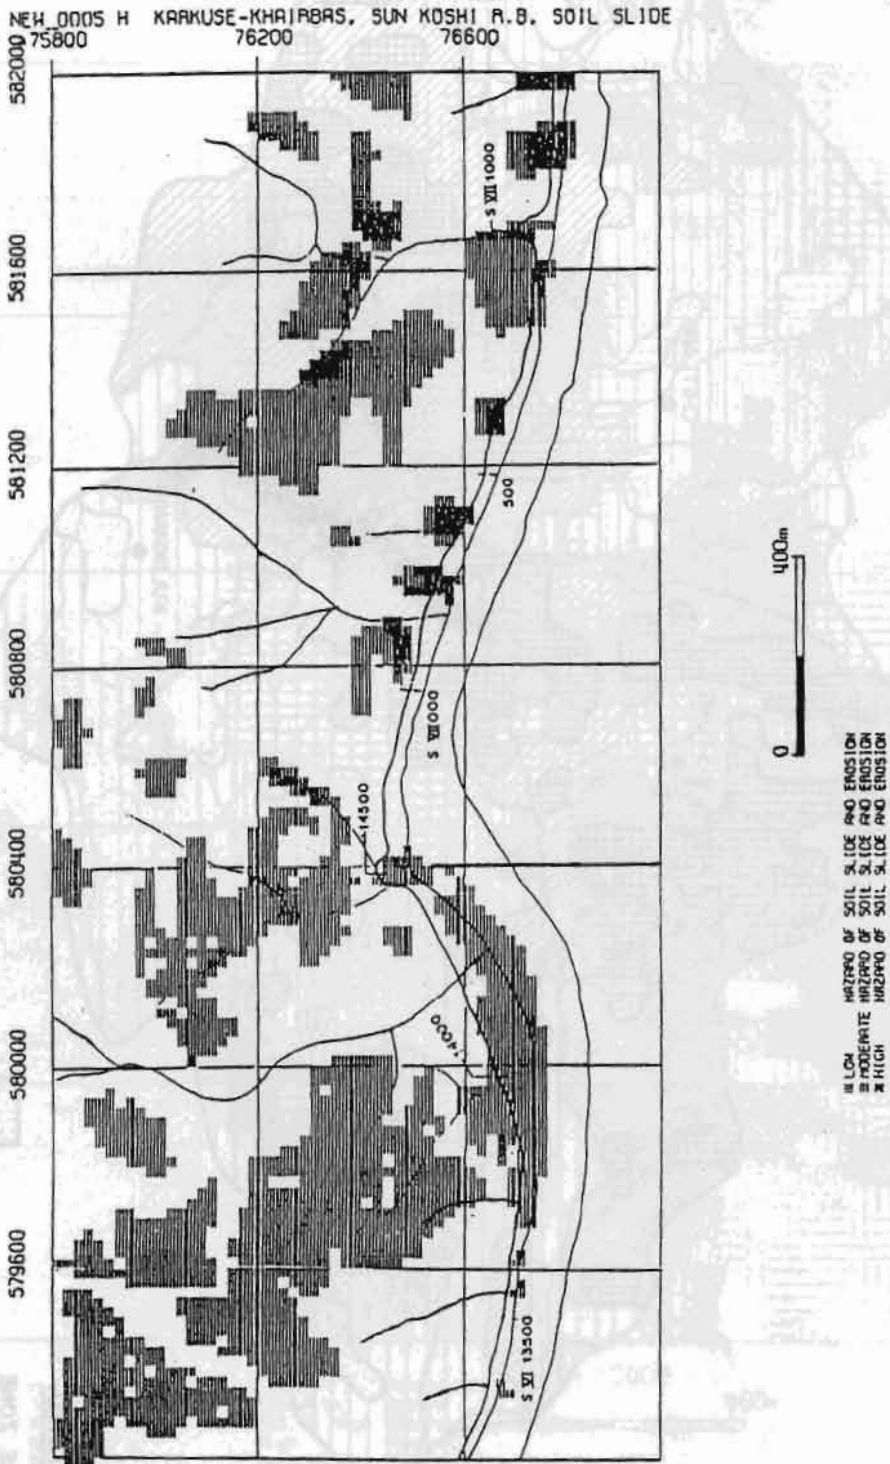
Figure 30: Soil slope hazard map of a part of the proposed Sagarmatha Road, Eastern Nepal (Dangol et al. 1993)

Detailed engineering-geological and geotechnical studies were carried out for the detailed survey and design of the Gaighat-Diktel-Okhaldhunga road in eastern Nepal. Computer-aided hazard maps were prepared for the entire road alignment (Fig. 30). The hazard mapping was based on the calculation of hazard ratings for each attribute that contributed to the hazard (Dangol et al. 1993b).

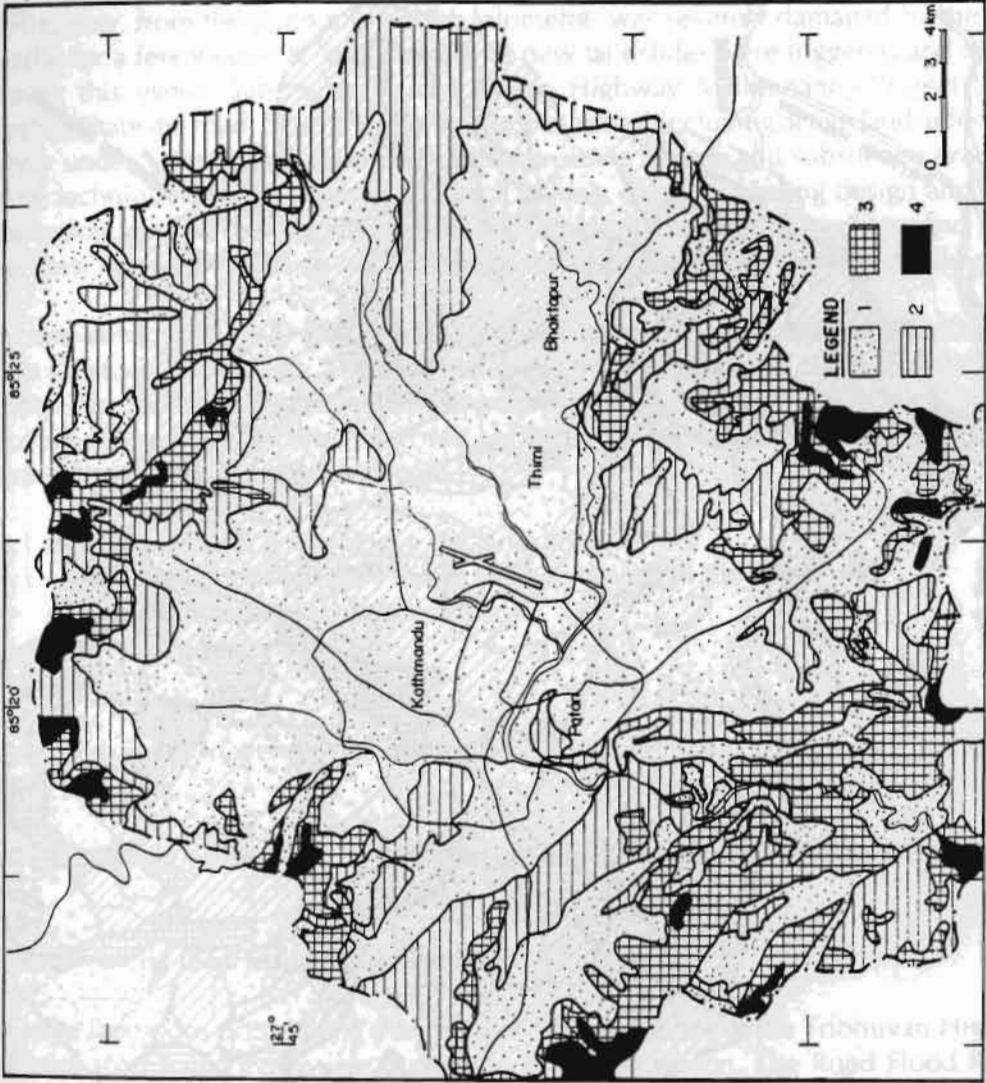
Figure 31: Landslide susceptibility map of Kathmandu Valley (MHPP 1993, redrawn)

1. Very low; 2. Low, 3. Medium, and 4. High landslide susceptibility

Landslide susceptibility mapping in Kathmandu Valley was carried out by the Ministry of Housing and Physical Planning (MHPP 1993). During that study, a landslide susceptibility map of Kathmandu Valley was prepared (Fig. 31). The slopes were classified into very low, low, medium, and high landslide susceptibility zones. Ives and Messerli (1981) also carried out mountain hazard mapping in the Kakani area to the north of Kathmandu Valley. This was an important undertaking and represents one of the early attempts at hazard mapping in Nepal.
