# Impact of Climate Change on Himalayan Glaciers and Glacial Lakes

Case Studies on GLOF and Associated  
Hazards in Nepal and Bhutan

Samjwal Ratna Bajracharya  
Pradeep Kumar Mool  
Basanta Raj Shrestha

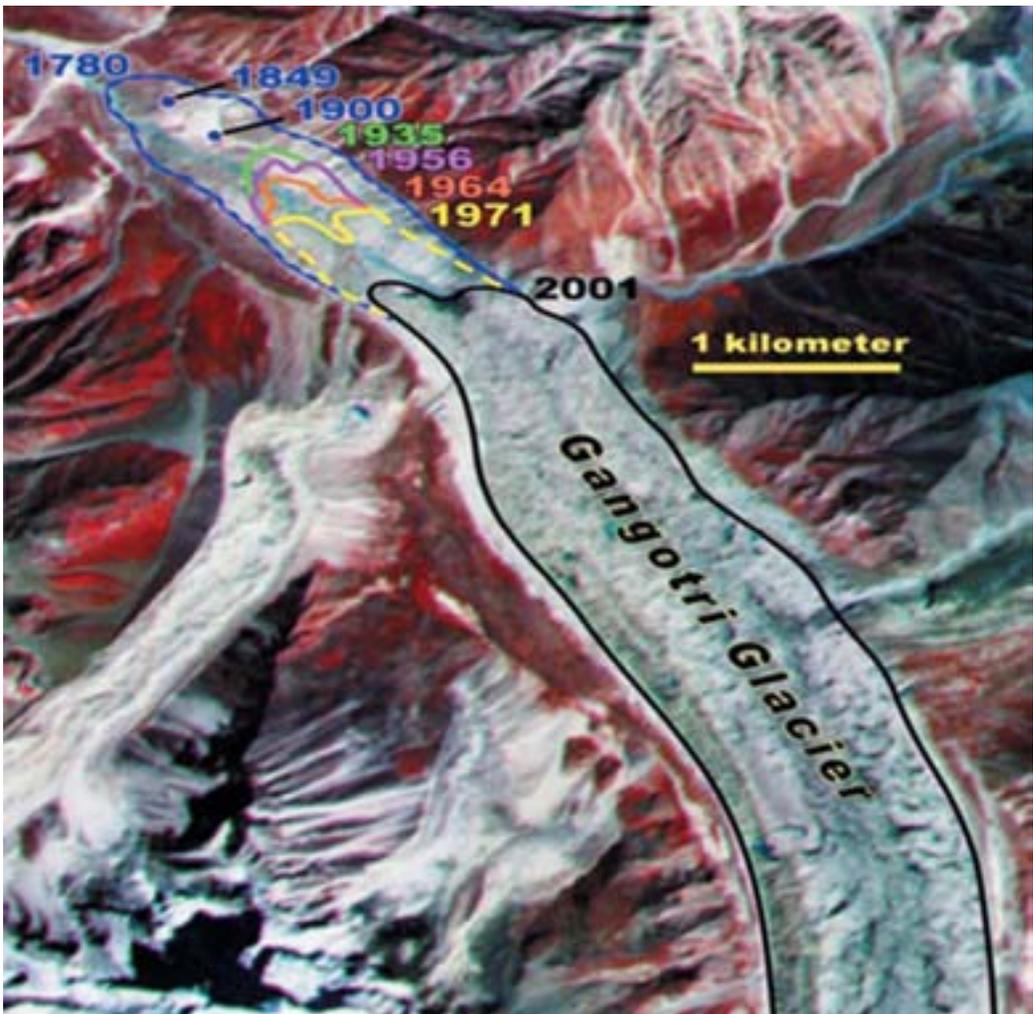
**Figure 2.6:** Retreat of the Gangotri glacier snout during the last 220 years (from 1780 AD to 2001)

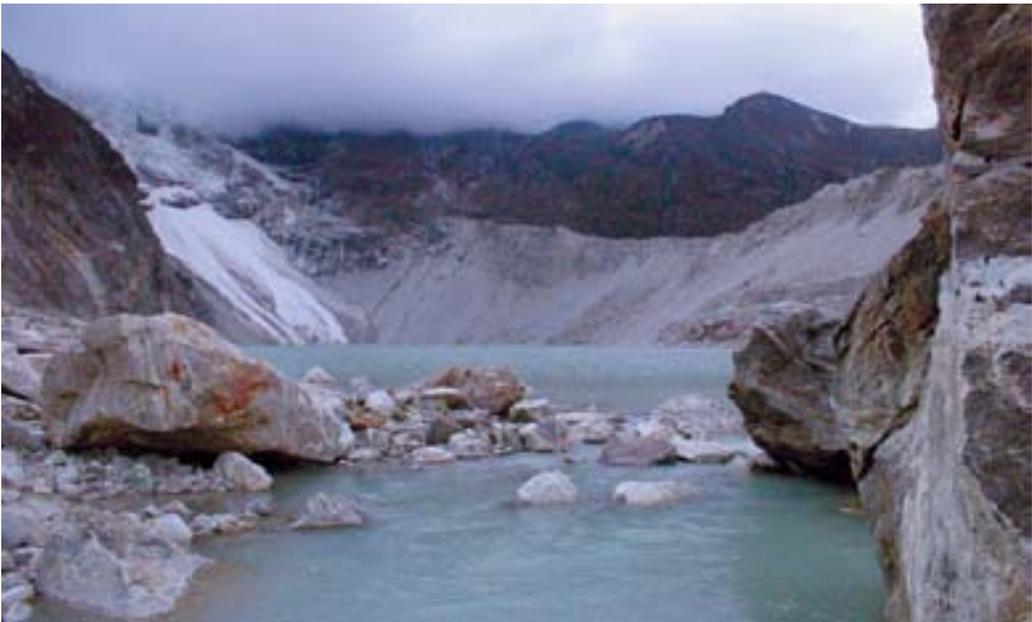
**Figure 3.3:** Outlet of Lake Dig Tsho after 1985 GLOF (10 Oct 2006)

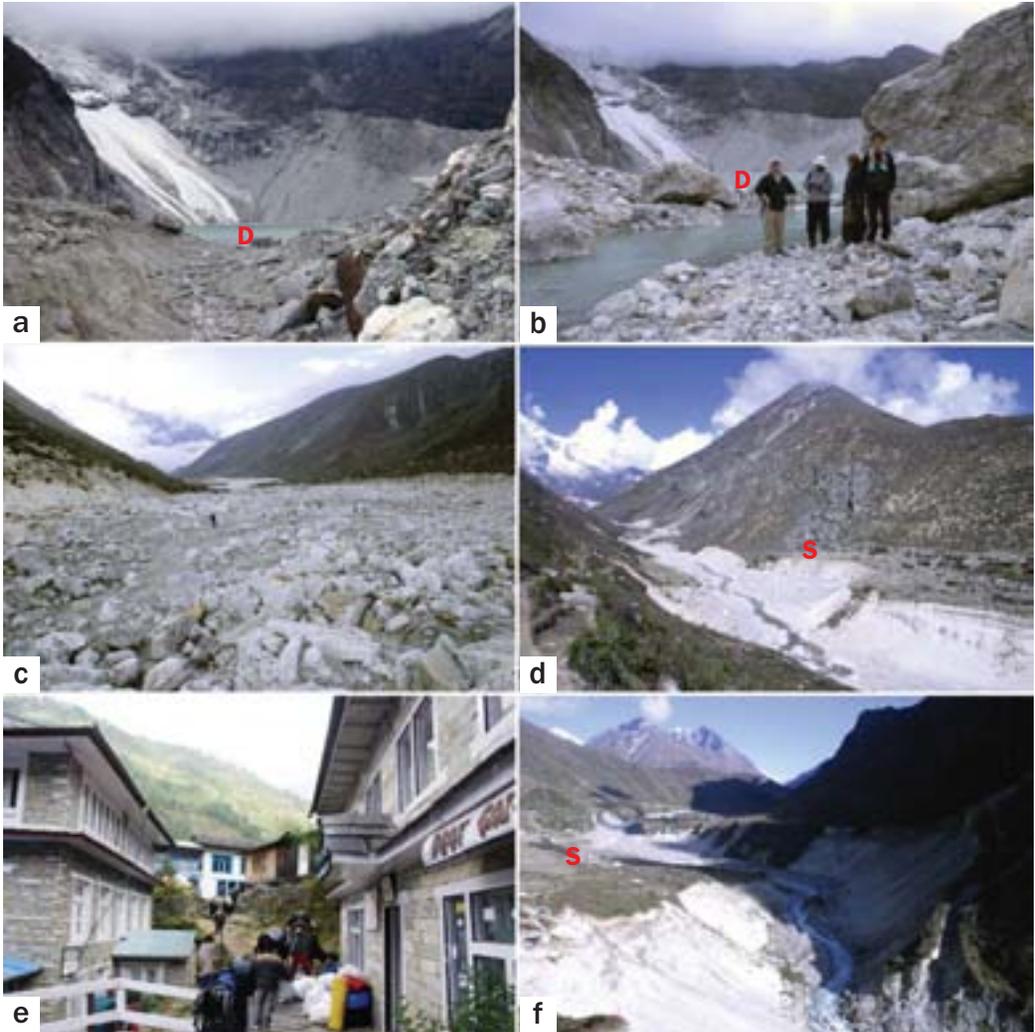
**Figure 3.7:** Lake Dig Tsho (D) in the Langmoche valley and settlements (S): a) Hanging Langmoche Glacier, Dig Tsho, and outlet of the lake after 1985 GLOF; b) Gentle gradient of the lake outlet through the debris; c) Wide valley downstream; d) Nearest settlement (about 3 km downstream) in the Langmoche valley; e) Phakding village situated on the lowest terrace of the Dudh Koshi River; f) Erosion from 1985 Dig Tsho GLOF at Thamo Teng village

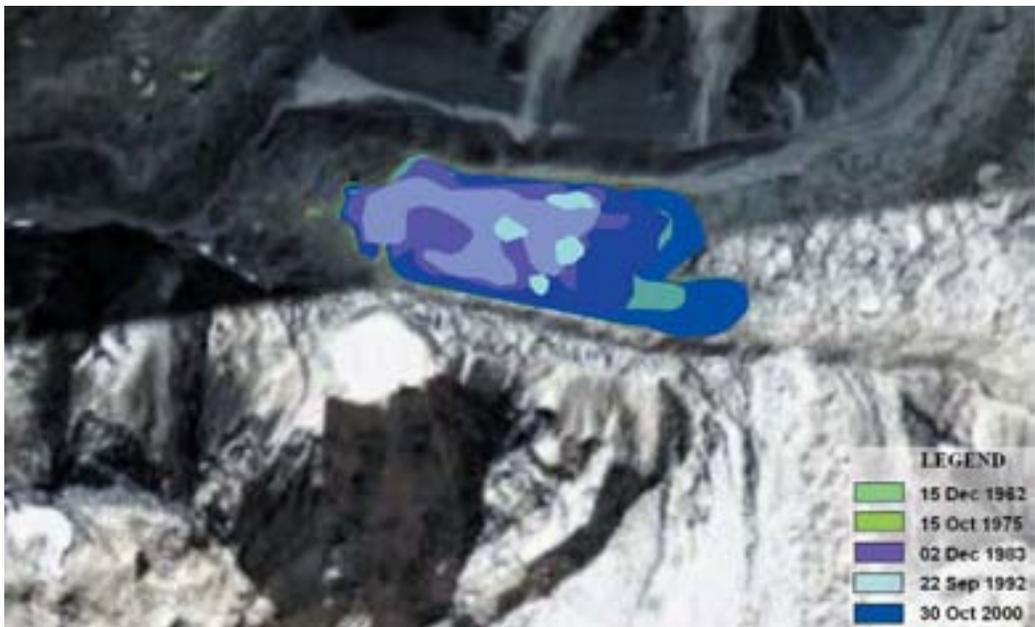
**Figure 3.10:** Development of Lake Imja Tsho from 1962 to 2006, base image IKONOS

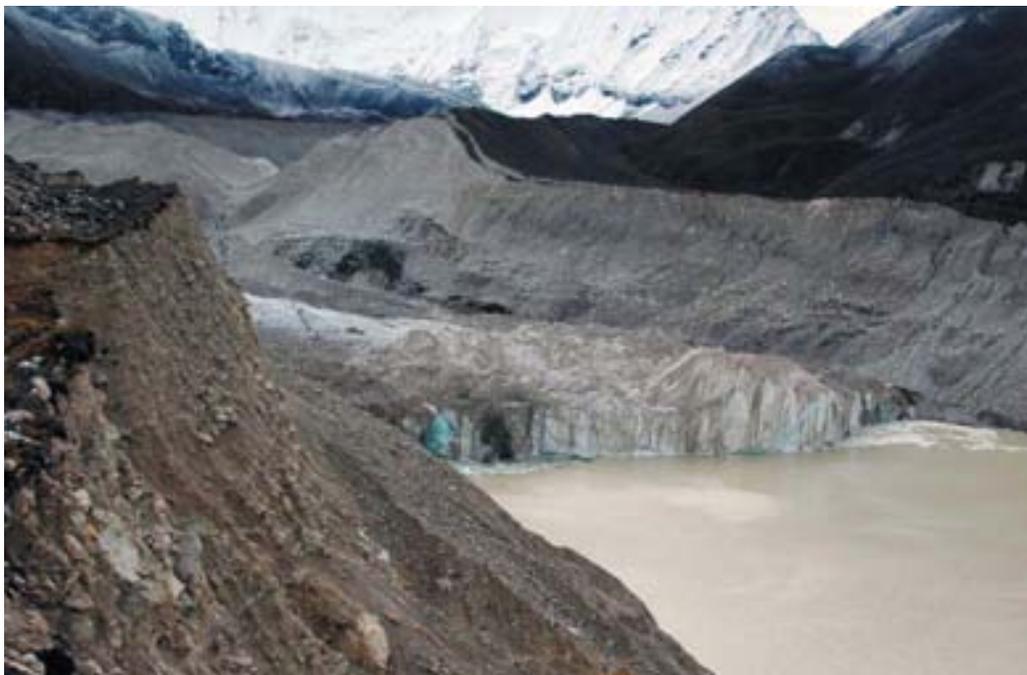
**Figure 3.16:** Ice cliff of Luggye glacier snout in contact with Lake Luggye Tso

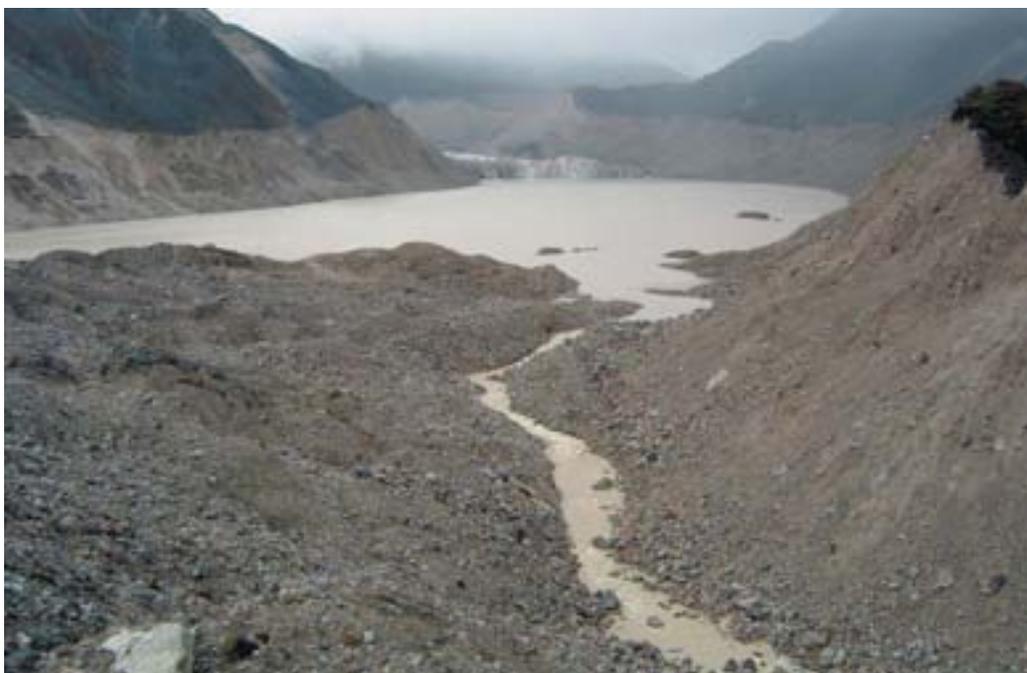
**Figure 3.17:** The outlet of Lake Luggye Tso through the end moraine

If the outlet of Lake Luggye Tso is blocked by landslides from the left lateral moraine it will cause the water level of the lake to rise, risking a GLOF event (Figure 3.17) with serious consequences for the Thorthormi lakes further downstream, especially since the Thorthormi glacier has already weakened the left lateral moraine (Ageta et al 2000). Austrian experts Leber and Hausler (2002) concur about the risk from Lake Luggye Tso. In fact, of the possible scenarios that this group examined during their risk assessment of the Luggye GLOF, the

blockage of the outlet by a landslide from the left lateral moraine was considered the “major risk” (Leber and Hausler 2002). This group recommended that the active sliding zone on the left lateral moraine be stabilised at the outlet to allow free flow of water from the lake. In contrast, Dorji (1996) observed no immediate GLOF risk from this lake because of its wide outlet channel. He commented that the risk of flood from this lake is not imminent as the outlet channel is wide enough to discharge any amount of water that will accumulate.

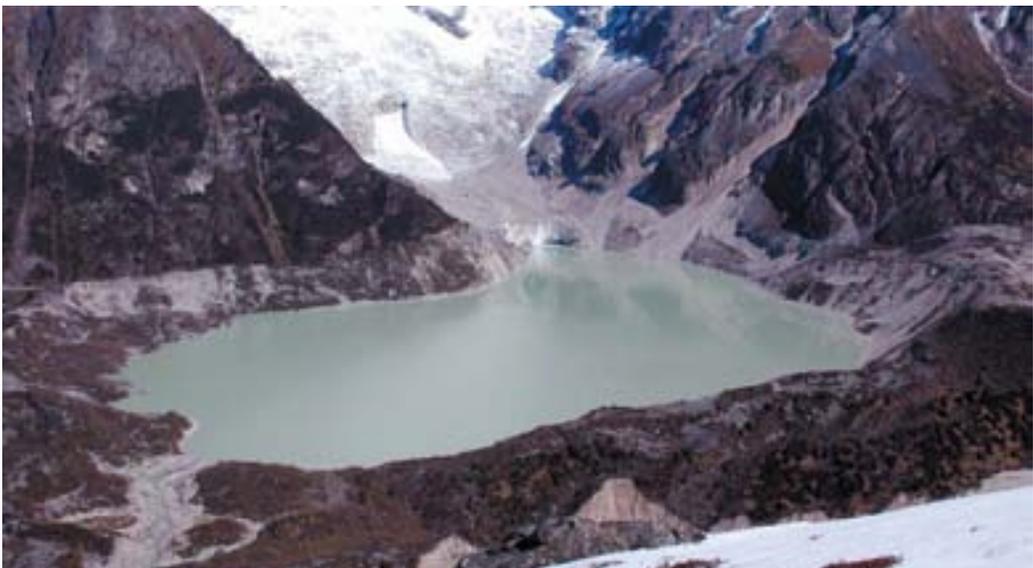
**Figure 3.18:** Lake Raphstreng Tso in contact with the glacier snout and outlet canal

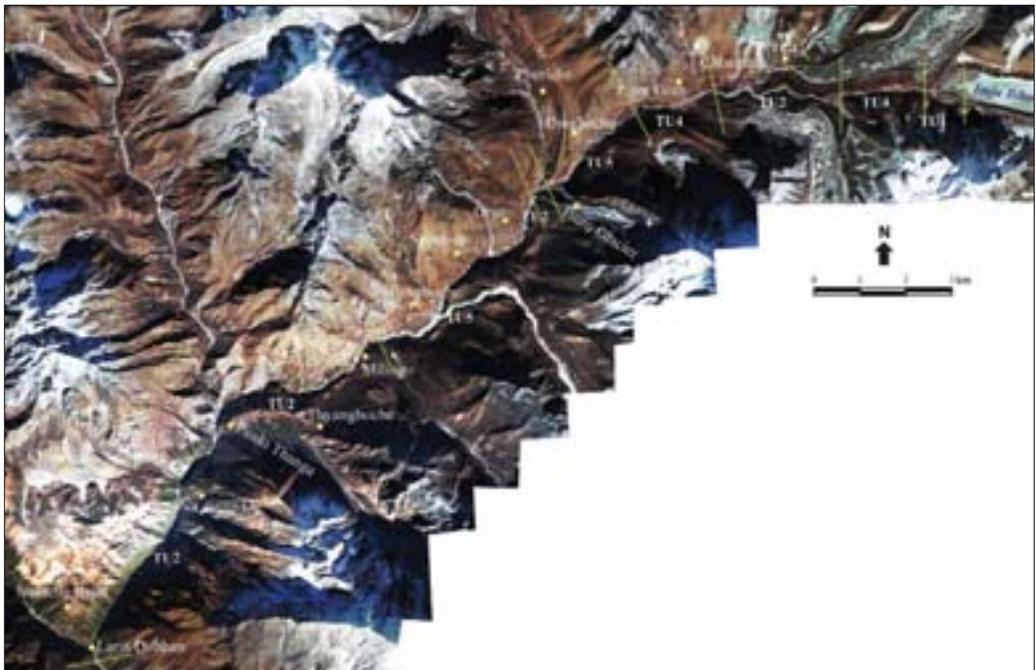
**Figure 5.3:** Terrain units (see Table 5.2) from Lake Imja Tsho to Namche Bazar (Larja Dobhan)

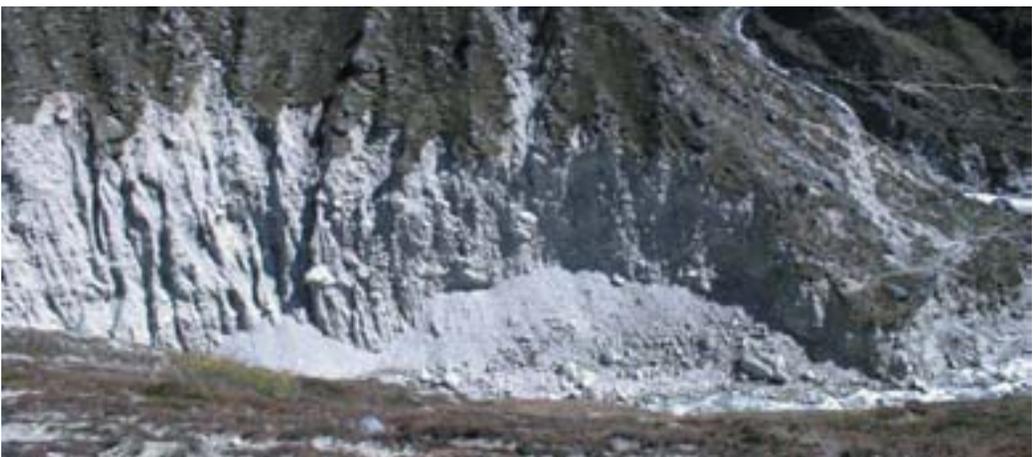
**Figure 5.14:** Bank erosion at the Bhote Koshi–Langmoche confluence

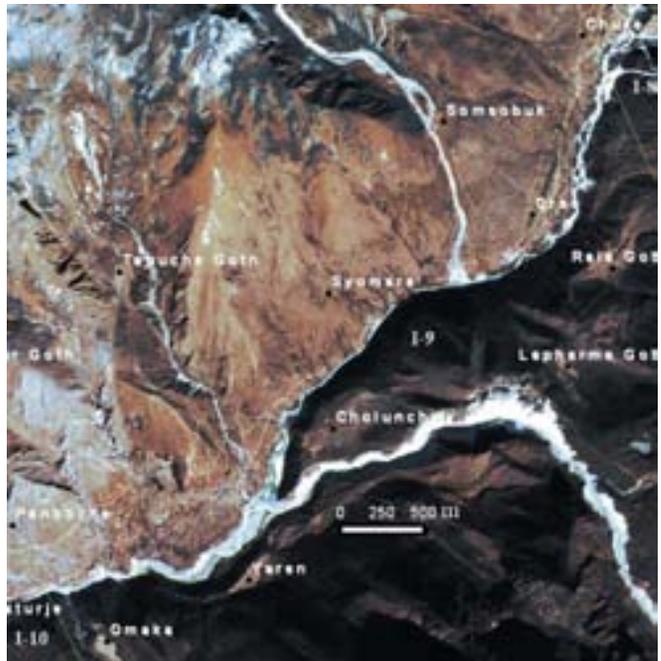
**Figure 5.35:** Concave bend of the Imja Khola at Syomare where bank scouring is expected in the case of a GLOF

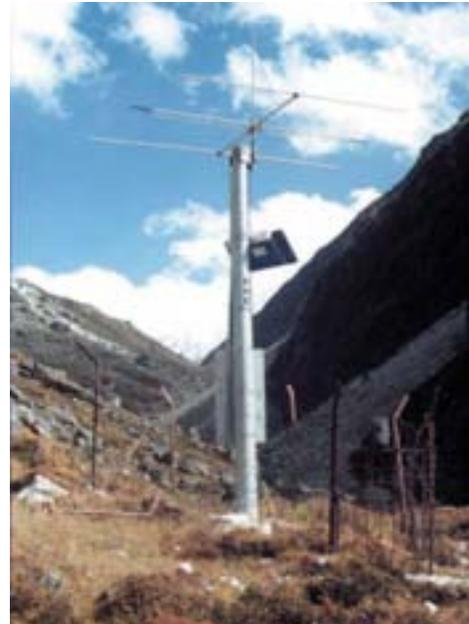
**Figure 6.1:** The transmitter station of Sangma Kharka outside Lake Tsho Rolpa receives signals from sensors and transmits to other remote warning stations.

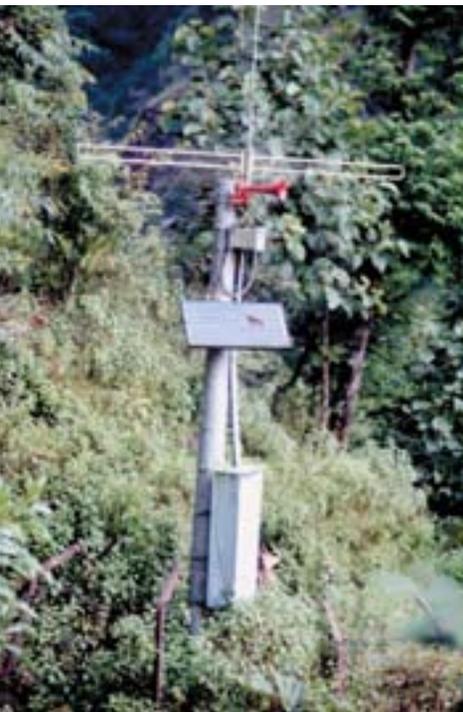
**Figure 6.2:** Early warning system installed at Gongar village. The systems consist of a solar panel, battery, antenna and amplifier with siren.

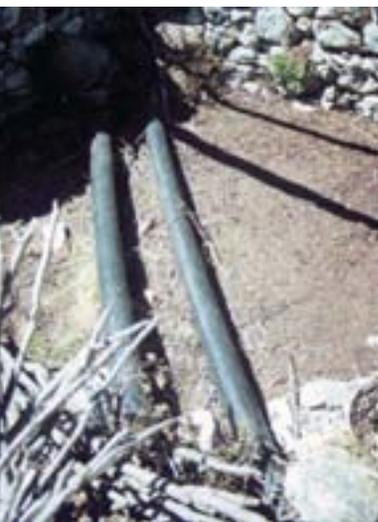
Figure 6.12: The test siphons lying in an open store in Naa village

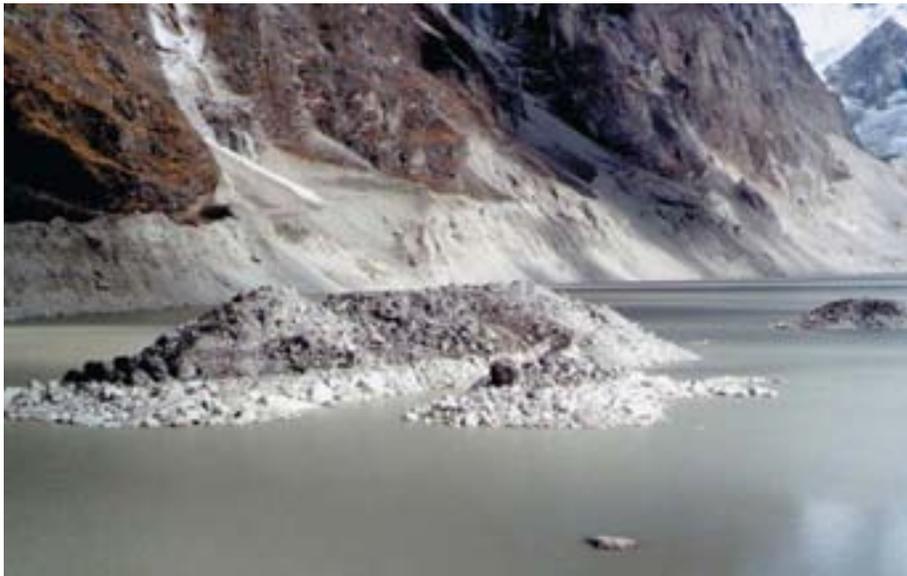
**Figure 6.19:** Watermarks on the islands located near the end moraine indicating the lowering of water level

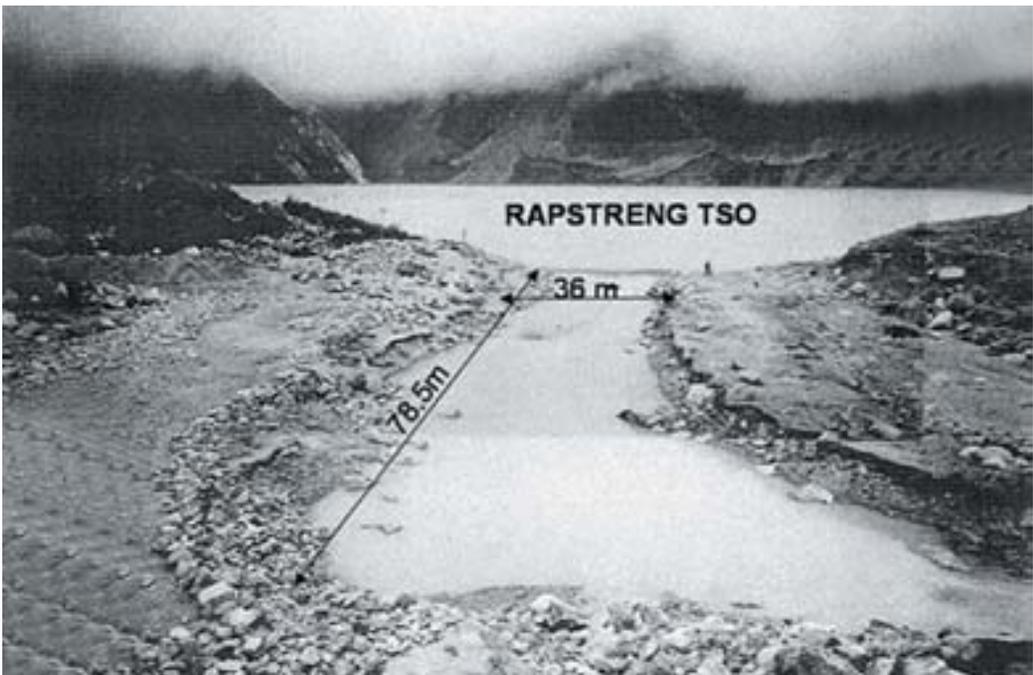
**Figure 6.20:** Raphstreng Tso outlet expanded by manually digging through the end moraine in 1998, see Figure 2.9 for location
