Chapter 3

Glacial Lakes in the Dudh Koshi Sub-basin of Nepal and Pho Chu Sub-basin of Bhutan

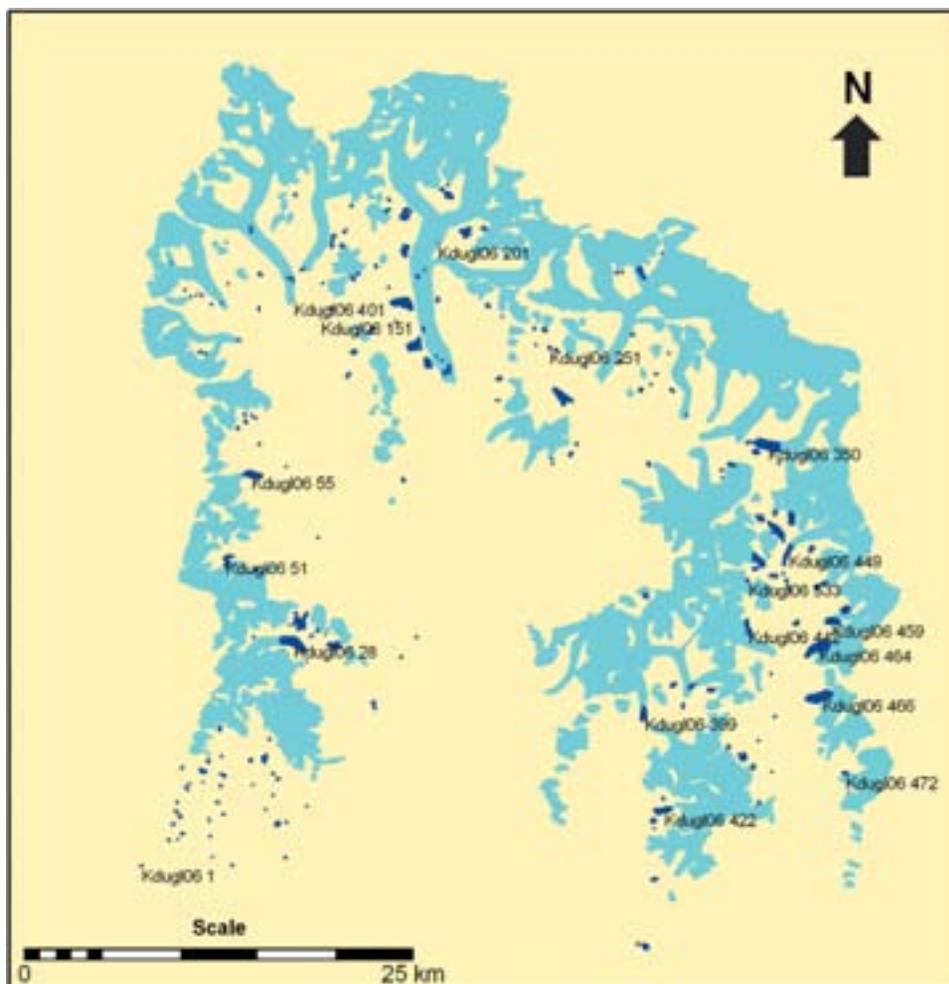
Figure 3.1: Glacial lakes in the Dudh Koshi sub-basin in 2001
 (Note: the numbering of lakes starts from the outlet of the major stream and proceeds clockwise round the basin.)

The Dudh Koshi sub-basin is the largest basin in Nepal. In terms of glacial lakes, it is perhaps the most densely glaciated region of the country (Bajracharya et al. 2004; Figure 3.1). Mool et al. (2001a) mapped 473 glacial lakes in this region using archival data from the 1960s, but by 2006 only 296 could be re-identified using NaturalVue images from EarthSat (Table 3.1). Of the 177 lakes that disappeared most were erosion lakes, the remainder being either supraglacial lakes or moraine-dammed lakes.

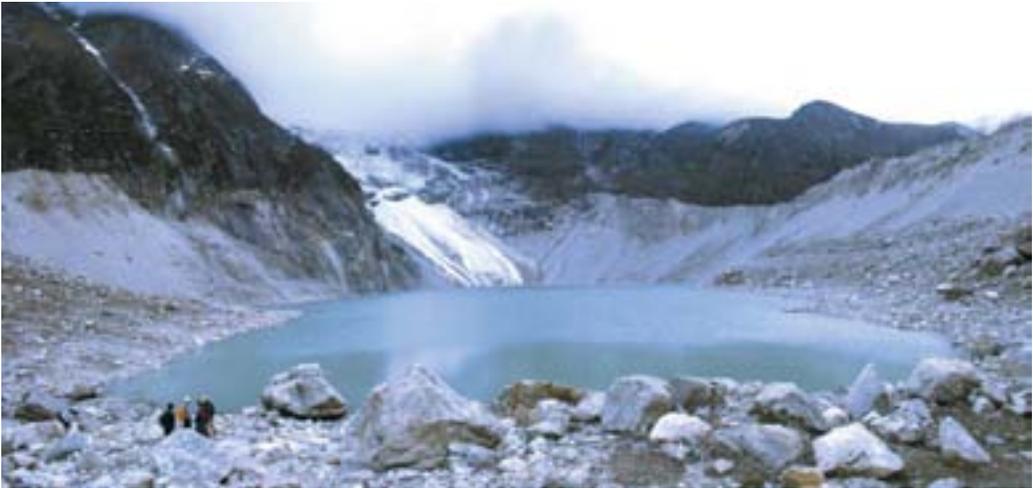
Figure 3.2: Lake Dig Tsho in the foreground and Langmoche Glacier in the background (10 Oct 2006)

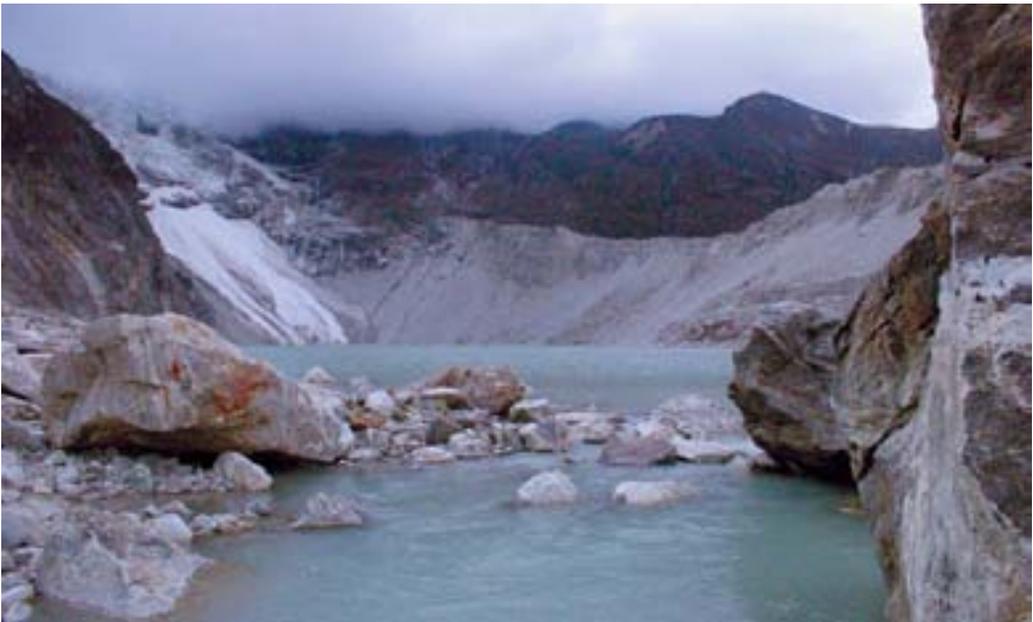
Figure 3.3: Outlet of Lake Dig Tsho after 1985 GLOF (10 Oct 2006)

The lake is believed to have been full to its rim just before the outbreak on 4 August 1985. The centre of the lake was estimated to have been 20m deep (WECS 1987). The lake was dammed by a 60m high moraine assumed to have been formed during the Little Ice Age; the estimated composition of the moraine consisted of boulders (20 per cent), cobbles (25 per cent), gravel (40 per cent), sand and silt (15 per cent). The river valley and lake outlet consist mainly of boulders and cobbles (Figure 3.3).

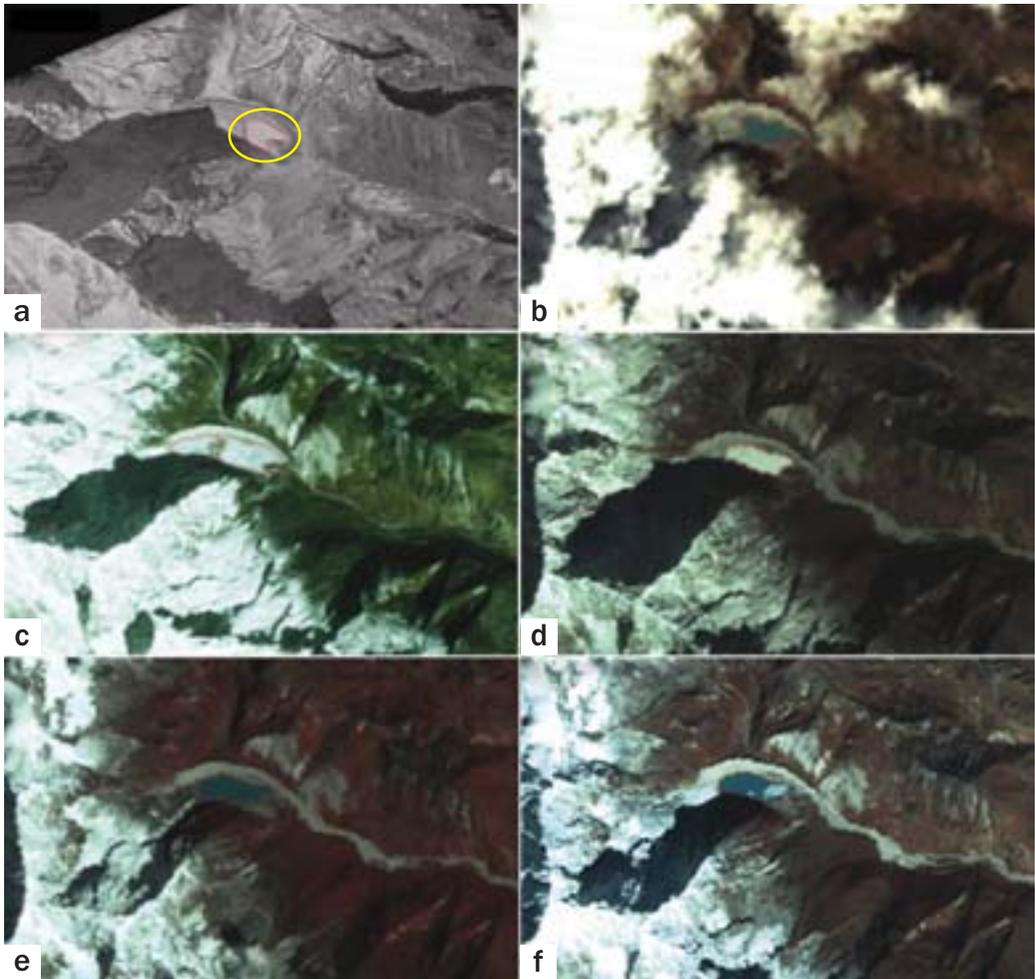
Figure 3.4: Lake Dig Tsho (D) in different satellite images taken between 1962 and 2000. Debris along the valley can be seen in the satellite images after 1985: a) Corona, 15 December 1962, b) Landsat MSS, 15 October 1975, c) Space Shuttle, 02 December 1983, d) Landsat5 TM, 11 December 1989, e) Landsat5 TM, 22 September 1992, f) Landsat7 etm+, 30 October, 2000

Fig	Year	Area (sq m)	Diff in area	Length (m)	Diff in length	
a.	1962	201,172		402		0.32 km
b.	1975	334,861	133,689	669	267	
c.	1983	597,923	263,062	1195	526	
d.	1989	315,865	-282,058	631	-564	Outburst in 1985
e.	1992	376,575	60,710	753	121	
f.	2000	361,867	-14,708	723	-29	
g.	2005	330,000		877		1.21 km

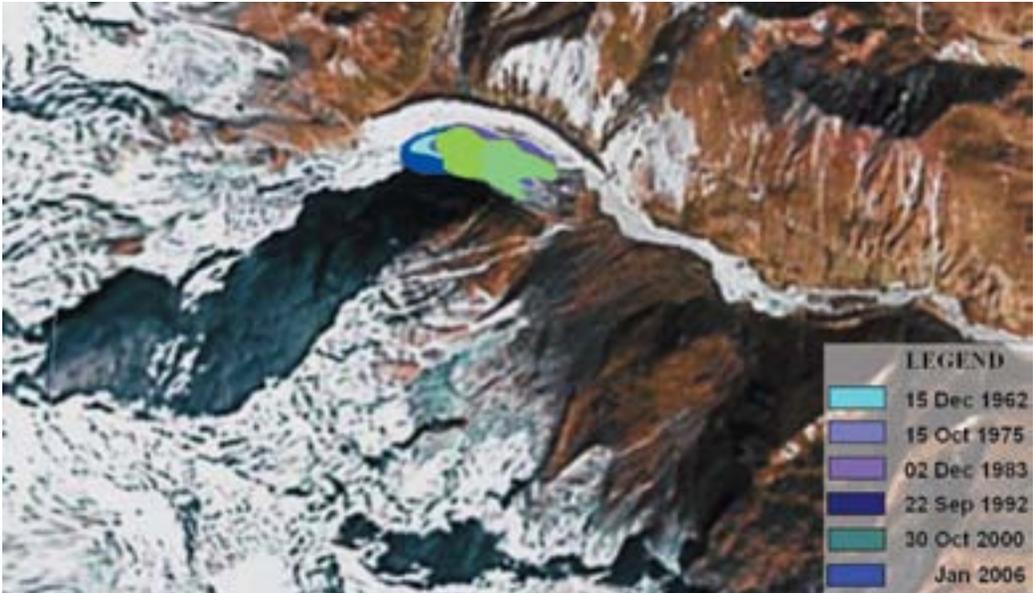
Figure 3.5: Development of Dig Tsho glacial lake between 1962 and 2005

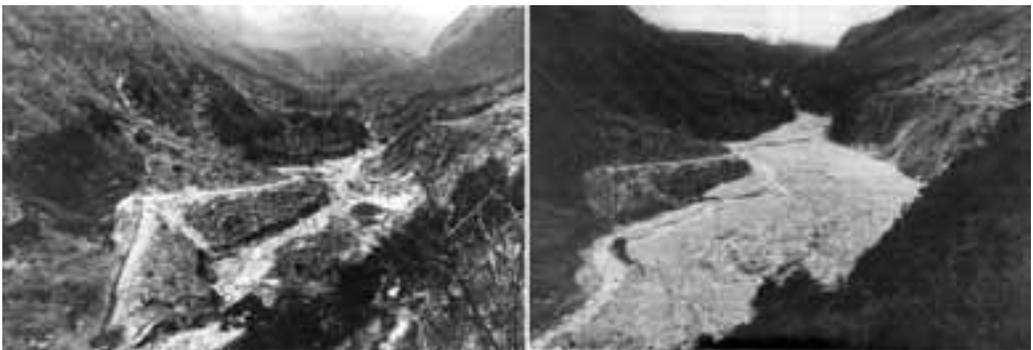
Figure 3.6: The Thame Hydropower Project a) before the GLOF (4 April 1985) and b) after the GLOF (10 October 1985)

Local witnesses reported that the flood surge front moved rather slowly down the valley as a huge black mass of water and debris. The mean velocity of the surge front was $4\text{--}5\text{ m}^3\text{s}^{-1}$ (Vuichard and Zimmermann 1987). In some places, people were able to cross the river over suspension bridges whilst the water rushed below. Multiple surges were also reported, for example, the bridges at Jorsalle, Phakding, and Jubing were not destroyed until 30–90 minutes after the passage of the initial surge. The most significant impact of the GLOF was the complete destruction of the newly built hydropower station at Thame, (Figure 3.6) which had cost an estimated US \$1.5 million.

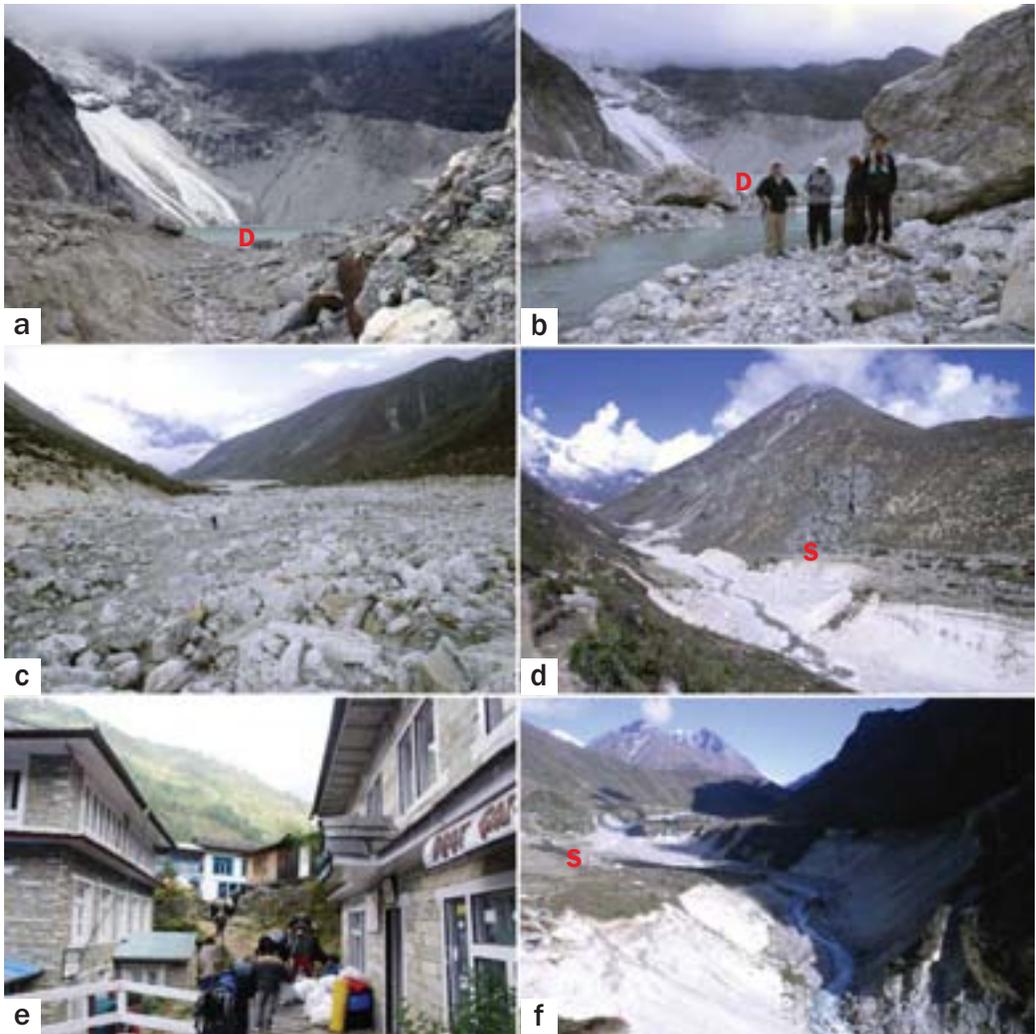
Figure 3.7: Lake Dig Tsho (D) in the Langmoche valley and settlements (S): a) Hanging Langmoche Glacier, Dig Tsho, and outlet of the lake after 1985 GLOF; b) Gentle gradient of the lake outlet through the debris; c) Wide valley downstream; d) Nearest settlement (about 3 km downstream) in the Langmoche valley; e) Phakding village situated on the lowest terrace of the Dudh Koshi River; f) Erosion from 1985 Dig Tsho GLOF at Thamo Teng village

Photos from a recent field study of the Lake Dig Tsho (Figure 3.7) reveal the following:

- Lake Dig Tsho shows evidence of past outburst events.
- The riverbed is composed mostly of boulders and cobbles.
- The lake is no longer hanging and the Langmoche River begins directly from the lake without any spillway.
- The Langmoche glacier (mother glacier of Lake Dig Tsho) is in a hanging position so avalanches or rock/ice falls cannot be discarded from the Langmoche glacier. Debris fall in the lake and possible splash of lake water overtopping the moraine could easily accommodate the debris flow as the outlet of the lake is wide enough.
- There is no indication of lateral moraine movement that could block the lake in the future.
- Available data shows no indication of lake growth since 1992. Further lake growth appears unlikely since the outlet is wide enough and the lake has extended down to the hard rock base glacier snout.

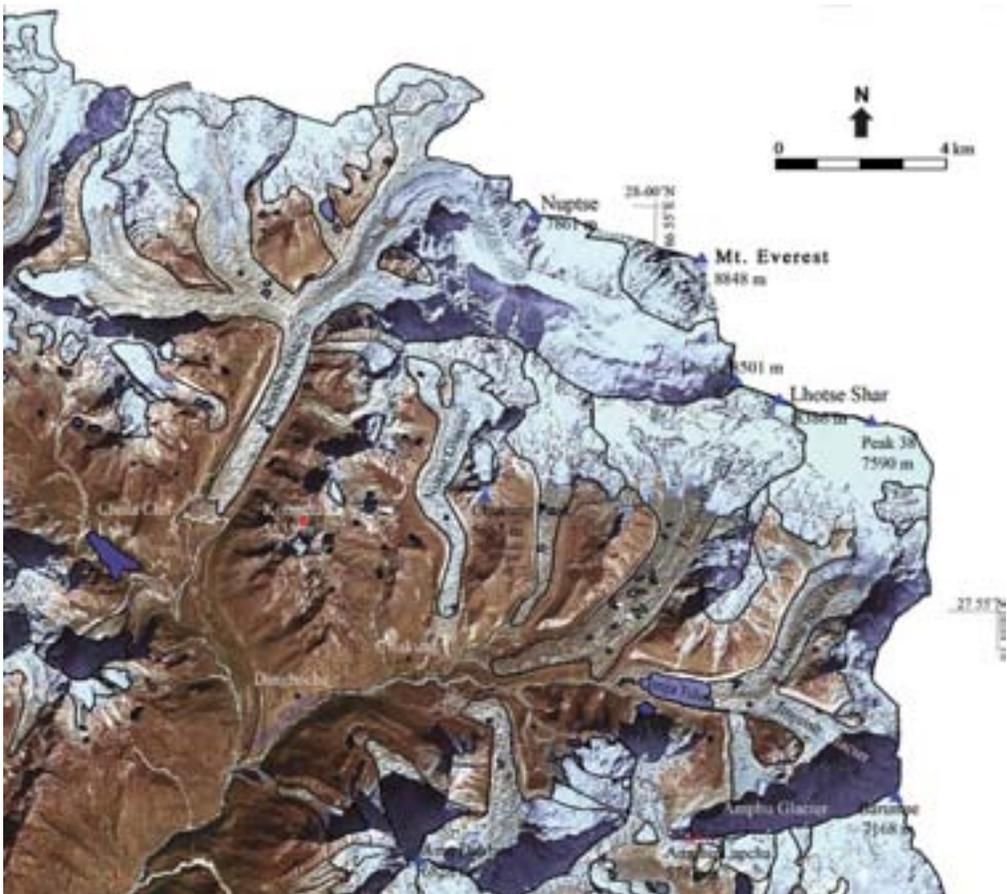
Figure 3.8: Lake Imja Tsho and surrounding glaciers, base image IKONOS

The catchment of Lake Imja Tsho occupies the northeastern part of the Dudh Koshi sub-basin. The lake itself is located at the toe of its parent glaciers (Imja and Lhotse Shar at $27^{\circ}59'17''$ N latitude and $86^{\circ}55'31''$ E longitude; Figure 3.9). The Lhotse Shar glacier flows in a south-westerly direction; its highest altitude is 7590m (Peak 38). The Imja glacier is oriented in a north-westerly direction and its highest altitude is 7168m (Peak Baruntse); the terminus of the Imja glacier itself is at about 5100m. These two glaciers coalesce approximately 3.5 km above the terminus and flow westwards just beneath the trekking path to Peak Imjatse (Island Peak 5173m). The Amphu Lapcha glacier, which flows in a northerly direction, is also in the vicinity and falls within the catchment of Imja Lake; however, it is not in direct contact with the lake itself.

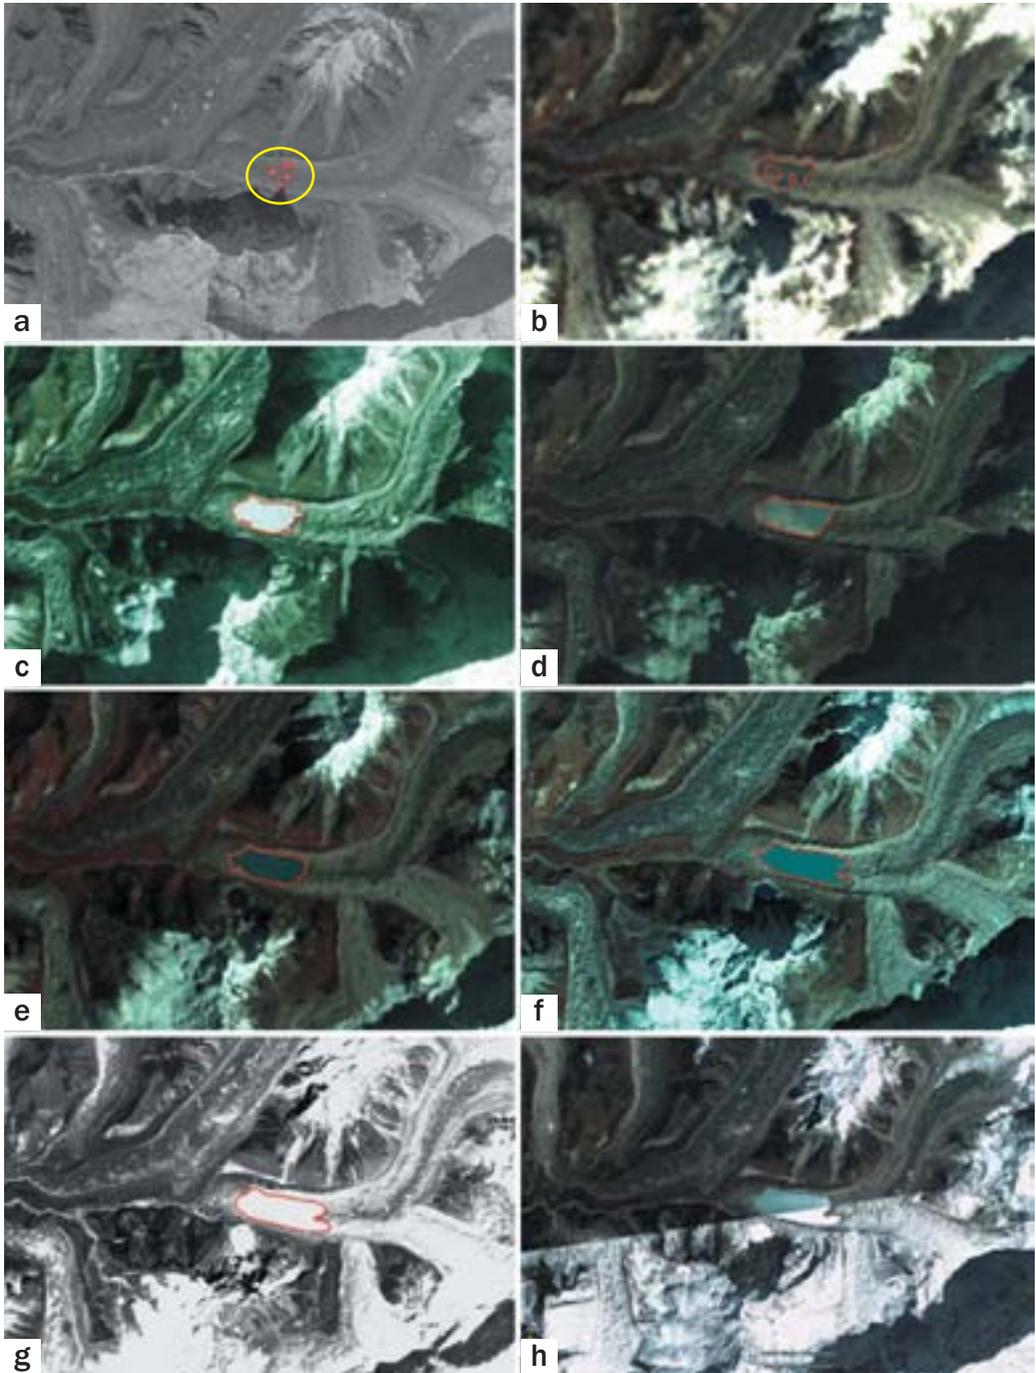
Figure 3.9: Satellite images taken on different dates showing the size of Lake Imja Tsho, see Table 3.6 for details: a) Corona (15 Dec 1962); b) Landsat MSS (15 Oct 1975); c) Sp. Shuttle (02 Dec 1983); d) Landsat5 TM (11 Dec 1989); e) Landsat5 TM (22 Sep 1992); f) Landsat 7 etm+ (30 Oct 2000); g) LISS 3 (19 March 2001); h) Google Earth (Jan 2006)

Satellite type and year	Area (sq m)	Area difference (sq m)	Length (m)	Length difference (m)	Total length difference (m)	Average growth rate (m/year)
Corona 1962	27,916		55			
Landsat MSS 1975	309,573	281,657	619	564		
Space Shuttle 1983	568,824	259,251	1137	518		
Landsat5 TM 1989	633,214	64,390	1266	129	1592*	42*
Landsat5 TM 1992	635,945	2,731	1271	5		
Landsat7 etm+ 2000	775,065	139,120	1550	279		
LISS3 2001	823,553	48,488	1647	97		
Google Earth 2006	940,722	117,169	2017	370	467**	74**

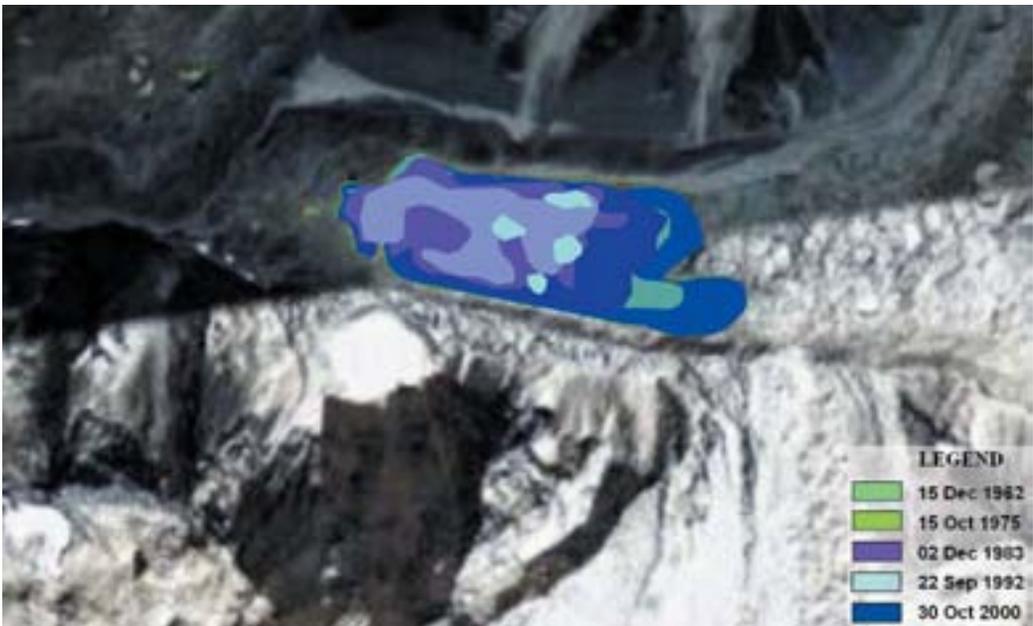
Figure 3.10: Development of Lake Imja Tsho from 1962 to 2006, base image IKONOS

A temporal series of satellite images (from 1962 to 2006) and field verification data show the expansion of the lake from 1962 (Figure 3.10). The lake expanded at an average rate of 42m per year between 1962 and 2001; from 2001 onwards, the rate of change increased to about 74m per year (Table 3.6). The lake has increased in area from 0.82 sq.km in 2001 to 0.94 sq.km in 2006 and in length from 1647 to 2017m during the same period. A recent field visit in October 2006 revealed extensive calving of the glacier snout. Field photographs show exposed ice cliffs in the glacier snout and many large icebergs on the lake (Figure 3.11). Since Lake Imja Tsho is growing so quickly, mitigation measures to reduce the GLOF risks are urgent.

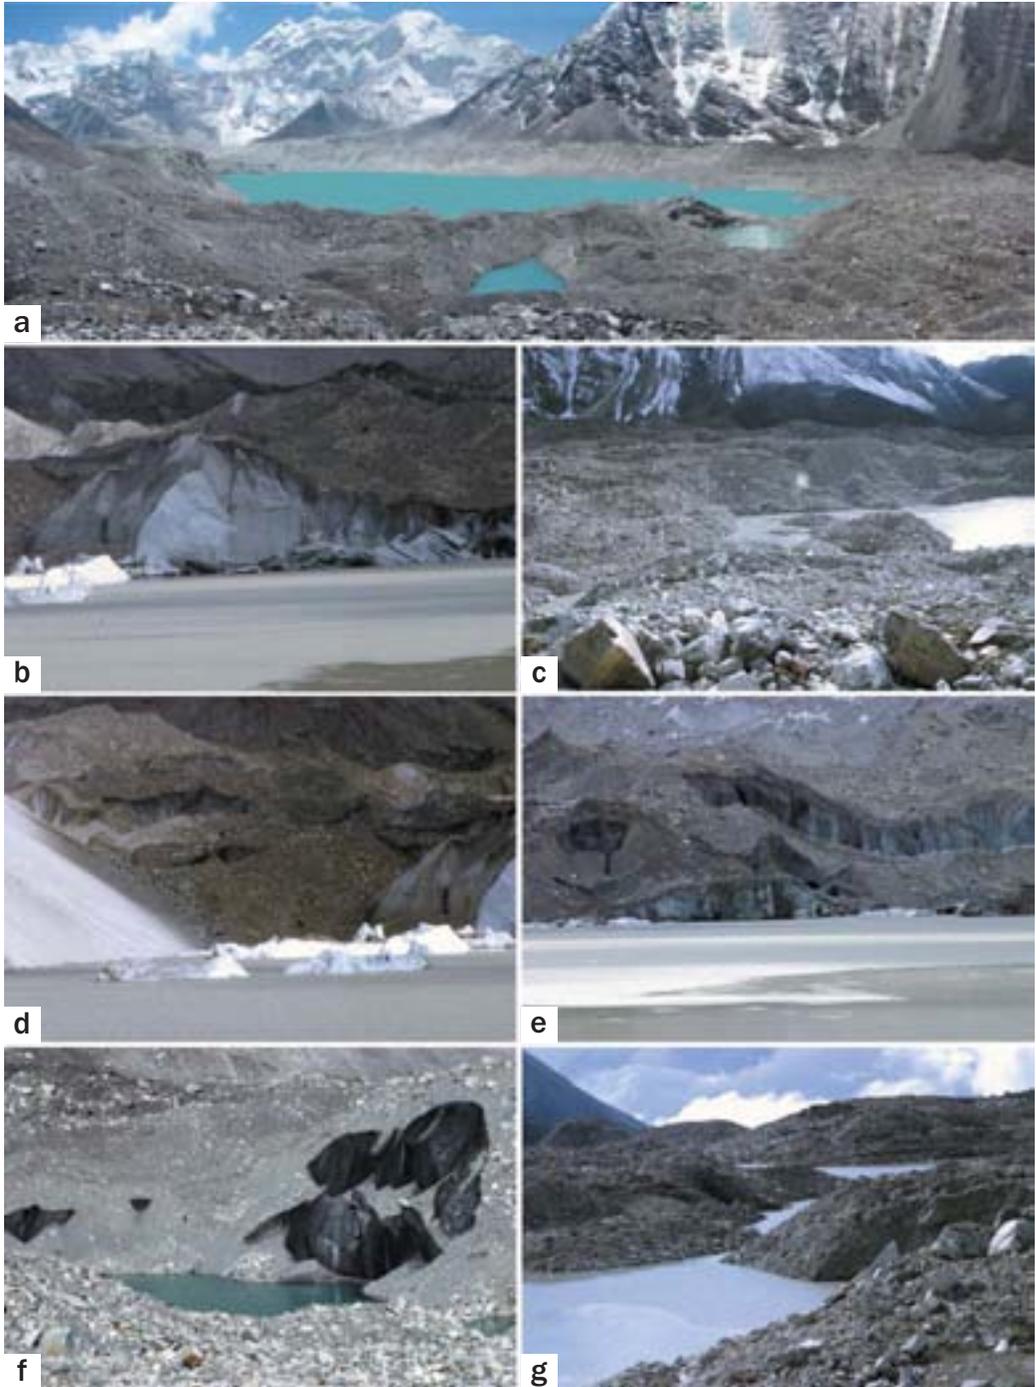
Figure 3.11: Lake Imja Tsho and surrounding environment (Photo: 15 Oct 2006): a) Panoramic view of Lake Imja Tsho; b) Ice cliff at the snout of Imja Glacier; c) Hummocky pattern of moraine indicating dead ice underneath; d) Ice scarps at the glacier snout and icebergs on lake; e) Ice cliff at the terminal moraine; f) Dead ice and a small supraglacial pond; g) Many connected supraglacial ponds

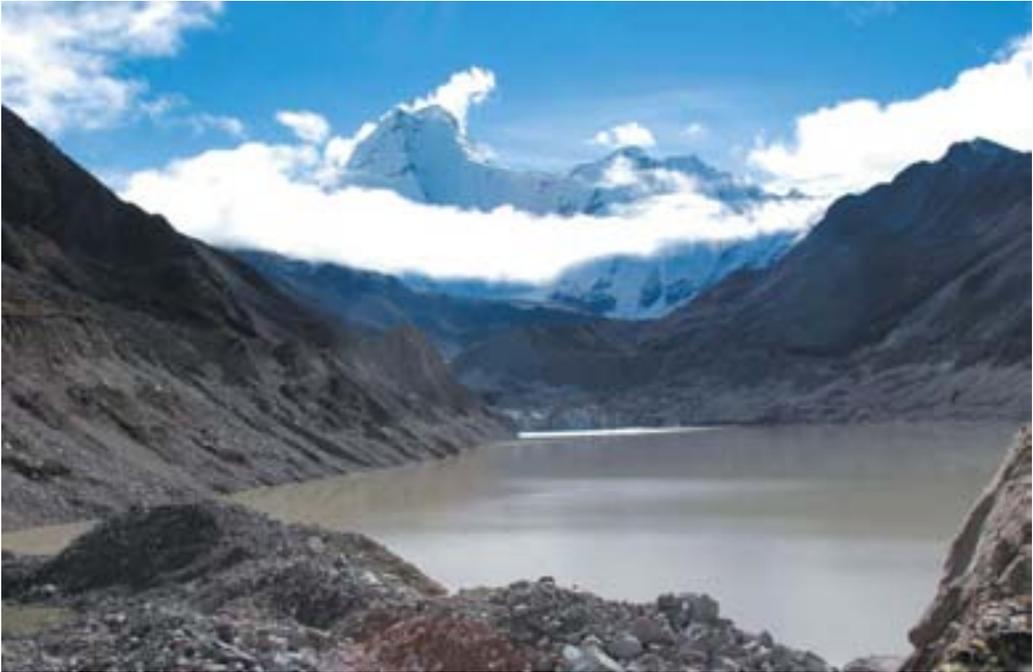
Figure 3.14: Panoramic view of Lake Luggye Tso and Peak Jamlhari in the background

Lake Luggye Tso (Pho_gl 210) is an end moraine-dammed lake in the Pho Chu basin of the Lunana region (Figure 3.14). As late as the 1950s, there were no indications of any lakes being associated with Luggye glacier. The first lake appeared only in 1967 (Gansser 1970) as a supraglacial lake and was measured to be 0.02 sq.km in 1968. Figure 3.15 shows the lake's development from 1967 to 1994. The depth of Luggye Lake was measured in 2000 and shown to be 142m. This glacial lake suffered an outburst event on 7th October 1994. The GLOF from Lake Luggye Tso caused much damage to the downstream valley, including the religiously important Punakha Dzong. After the breach, the lake continued to grow towards the glacier snout and the glacier continued to retreat; in 2001 the lake area measured 1.12 sq.km (Table 3.8). The exposure of ice cliffs on the glacier snout show calving, which contributes to the expansion of the lake towards the glacier (Figure 3.16). The outlet channel is at the same level as the lake surface and has a gentle slope. Evidenced by its bumpy topography, this terminal moraine has an ice core. Both the continuous sliding of the left lateral moraine at the outlet and the presence of an ice core contribute to the possibility of blocking of the previously breached outlet so that the lake could at some time in the future suffer another GLOF event (Figure 3.17).

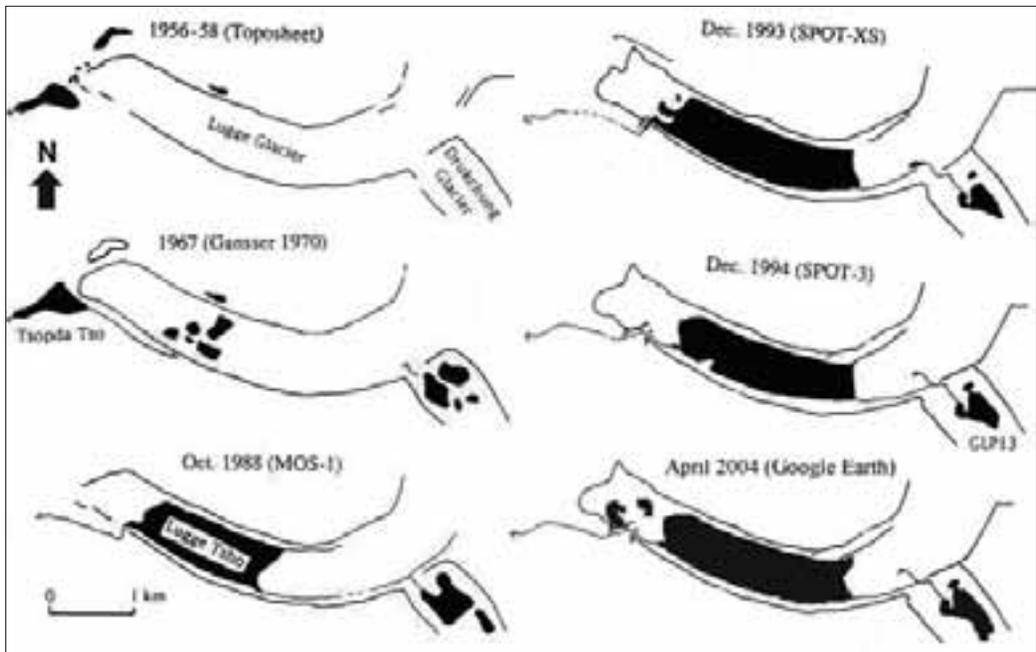
Figure 3.15: Expansion of Lake Luggye Tso (1956-2004) (modified from Ageta et al. 2000)

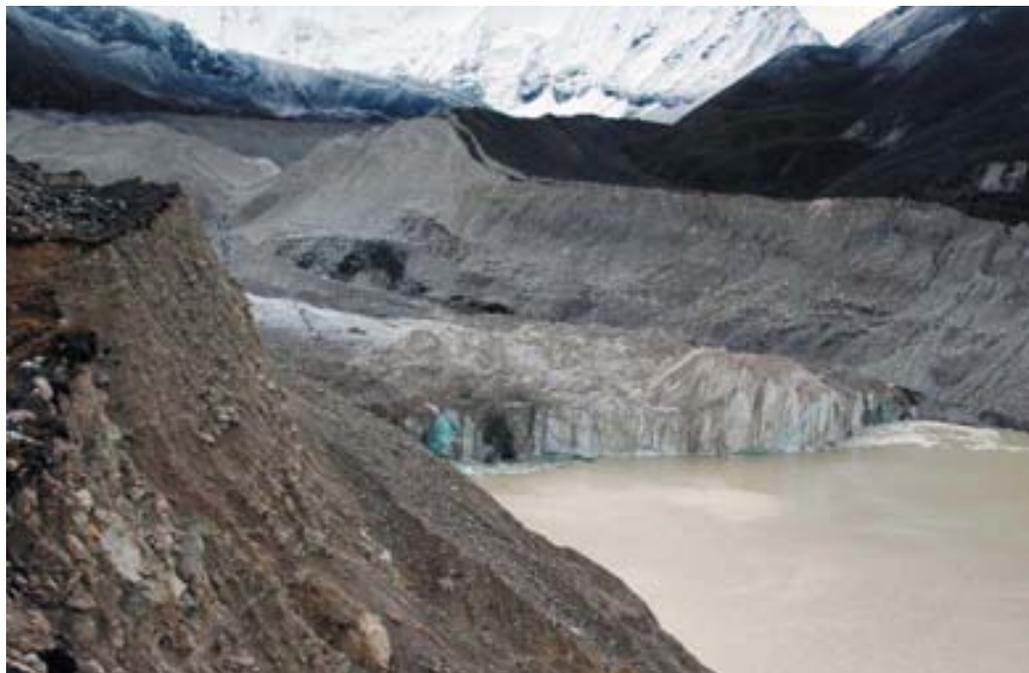
Figure 3.16: Ice cliff of Luggye glacier snout in contact with Lake Luggye Tso

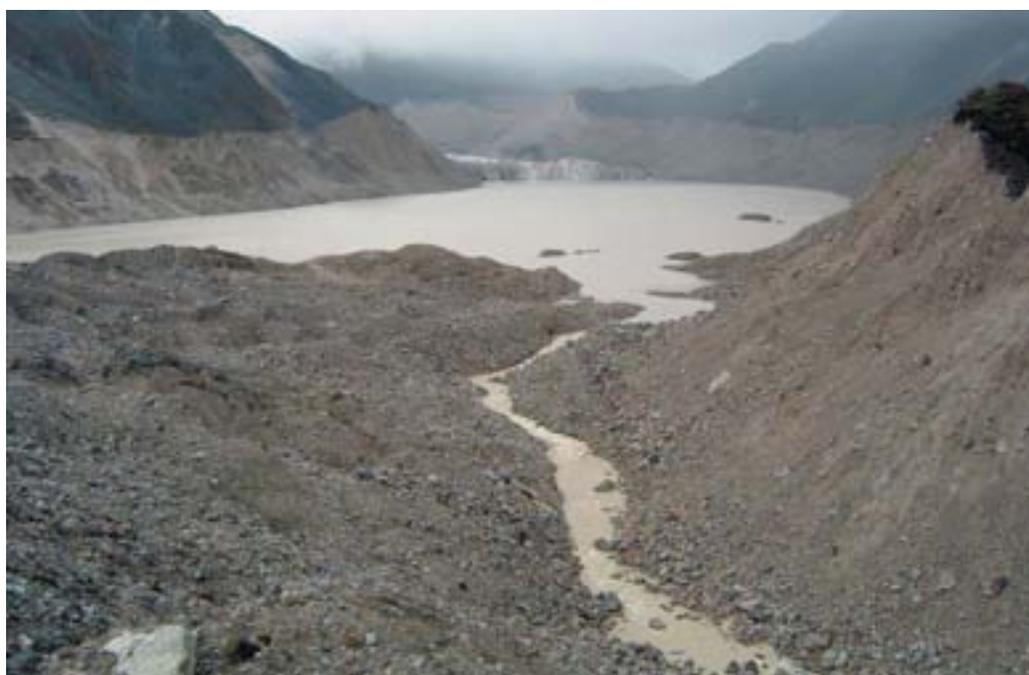
Figure 3.17: The outlet of Lake Luggye Tso through the end moraine

If the outlet of Lake Luggye Tso is blocked by landslides from the left lateral moraine it will cause the water level of the lake to rise, risking a GLOF event (Figure 3.17) with serious consequences for the Thorthormi lakes further downstream, especially since the Thorthormi glacier has already weakened the left lateral moraine (Ageta et al 2000). Austrian experts Leber and Hausler (2002) concur about the risk from Lake Luggye Tso. In fact, of the possible scenarios that this group examined during their risk assessment of the Luggye GLOF, the

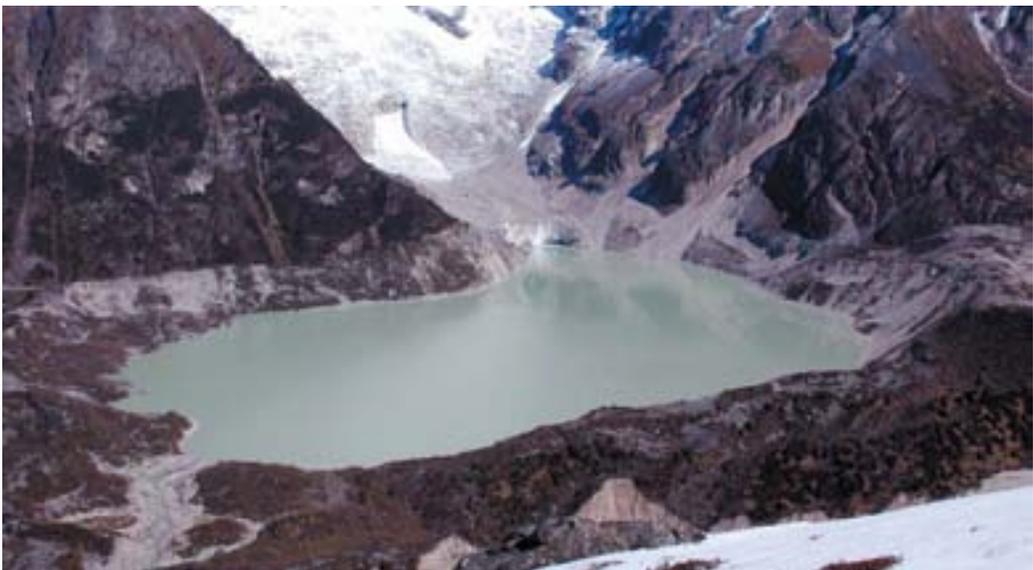
Figure 3.18: Lake Raphstreng Tso in contact with the glacier snout and outlet canal

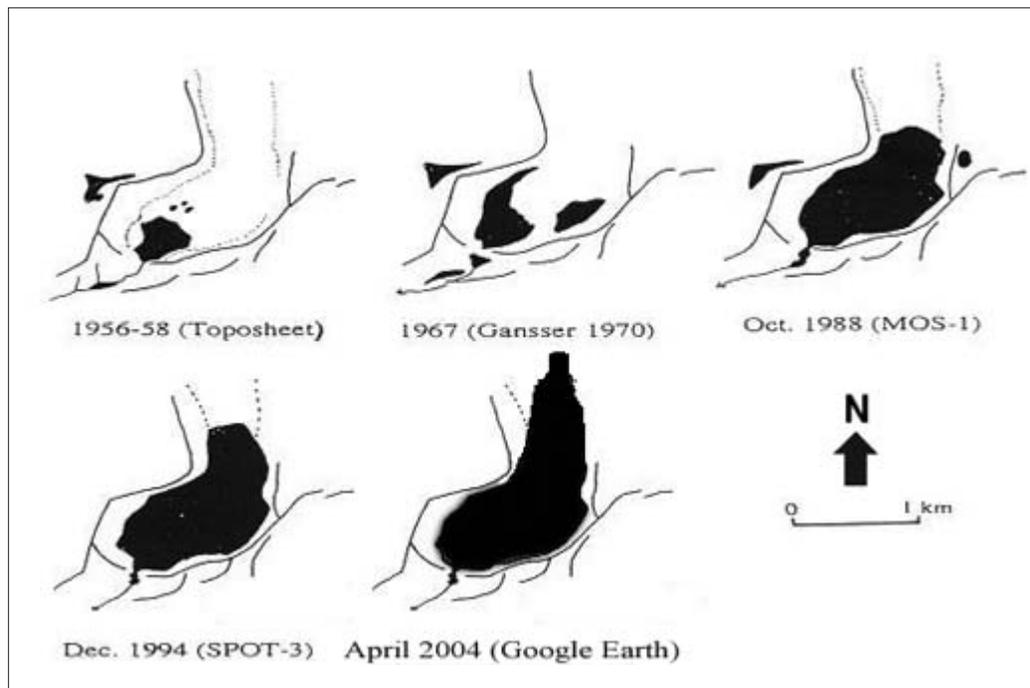
Figure 3.19: Expansion of Lake Raphstreng Tso (1956-2004) (modified from Ageta et al. 2000)

Lake Raphstreng Tso (Pho_gl 209) lies at an altitude of 4360m. This lake appeared as a supraglacial lake in a 1958 topographic map; topographic maps from 1960 showed that the lake’s area was 0.15 sq.km. In 1986 it was 1.65 km long, 0.96 km wide, and 80m deep (Sharma et al. 1986). Nine years later, the Indo-Bhutan Expedition of 1995 measured a maximum length of 1.94 km, width of 1.13 km, and depth of 107m (Figures 3.18 and 3.19) (Ageta et al 2000). The depth measured in 1999 was about 100m. Some researchers believe that the lake’s present dimensions represent its maximum since the upstream section has already reached the bedrock wall. However, field photographs show that the glacier snout is undergoing extensive calving and that the lake can still expand a few hundred more metres (Figures 3.20 to 3.23).

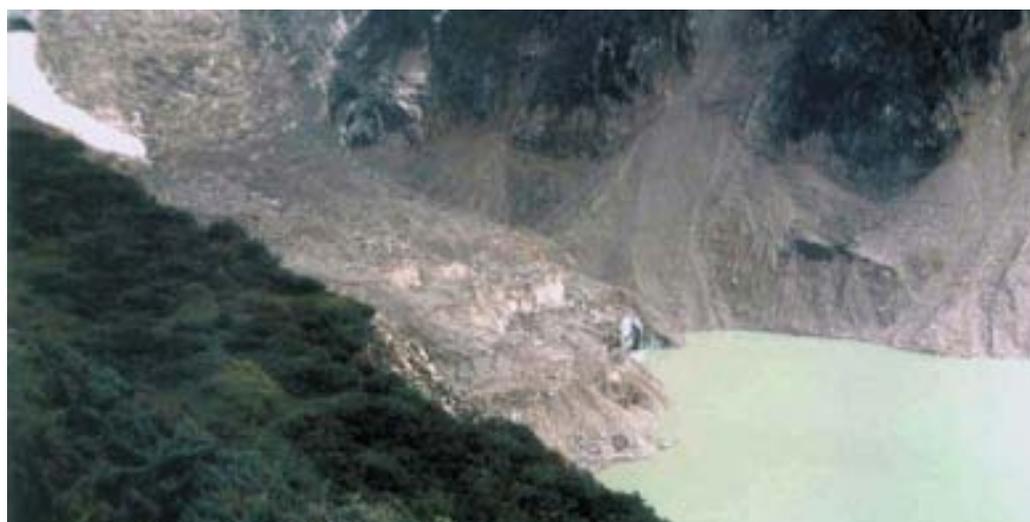
Figure 3.20: Calving of the Raphstreng glacier snout with the expansion of the lake in 2001

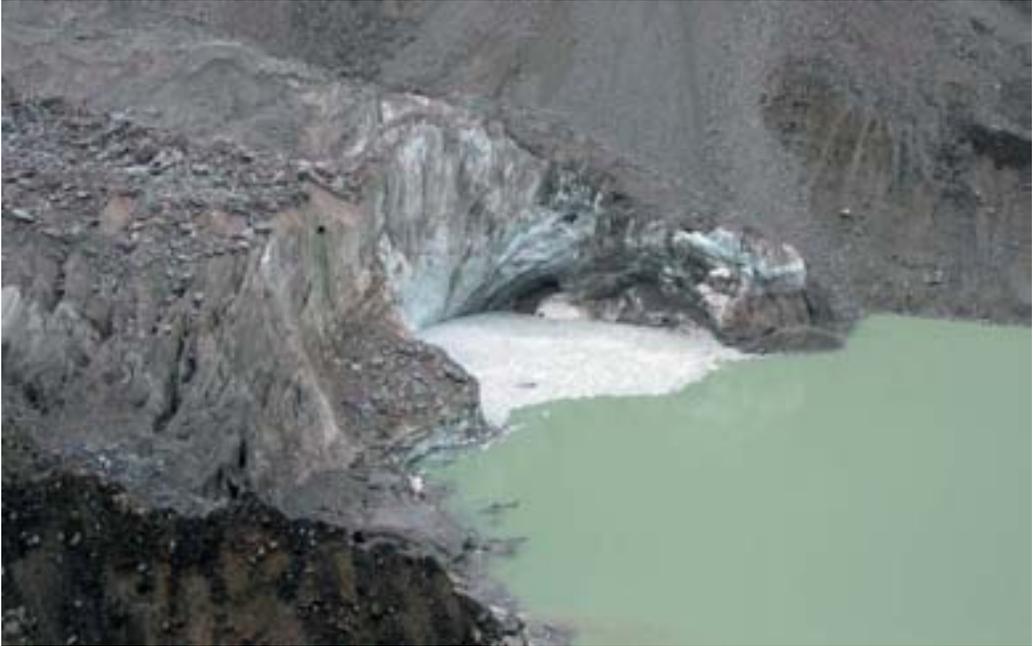
Figure 3.21: Raphstreng glacier snout undergoing active calving

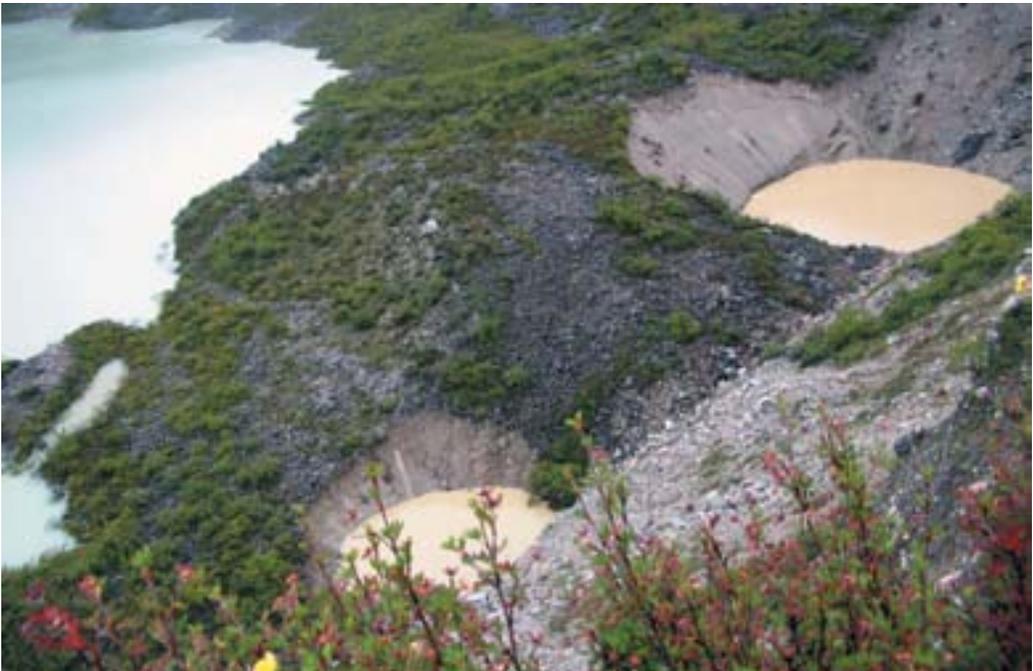
Figure 3.22: Lake Raphstreng Tso with newly formed supraglacial ponds on right lateral moraine.

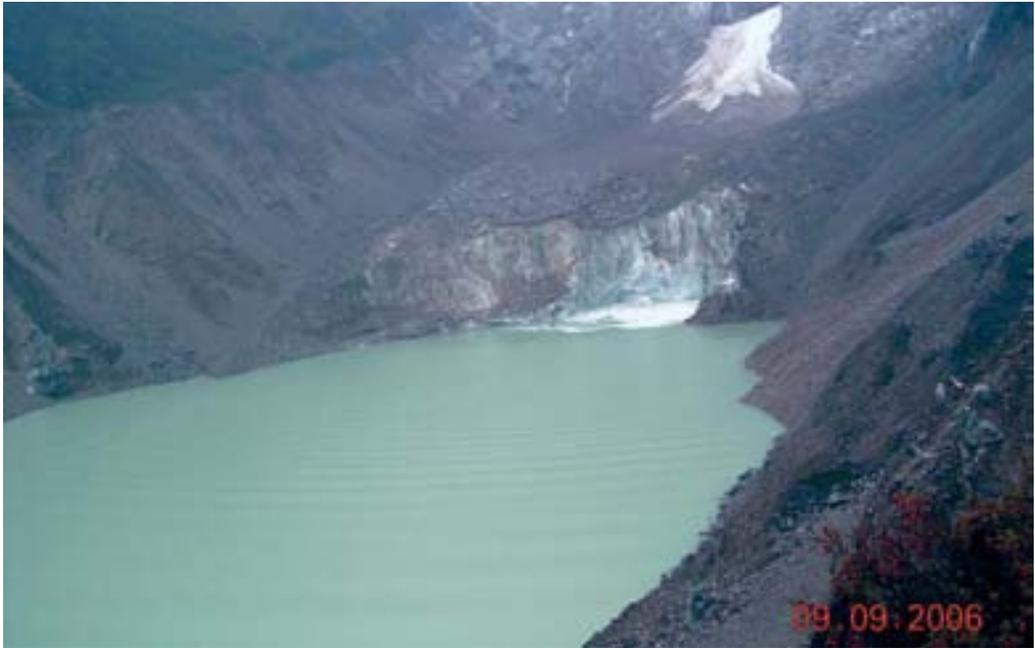
Figure 3.23: Lake Raphstreng Tso with glacier snout. The ripples on the water surface generated by falling ice blocks indicate the active calving of the glacier snout.

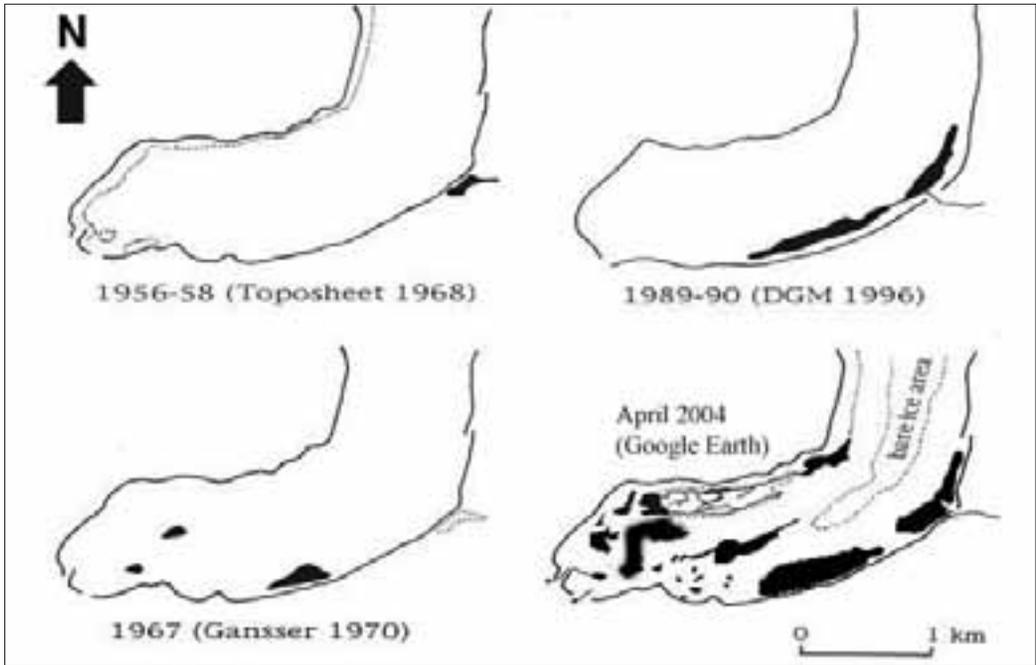
Figure 3.24: Expansion of Lake Thorthormi Tso (1956-2004) (modified from Ageta et al. 2000)

Figure 3.24 shows a time series expansion of the Thorthormi lakes from 1956 to 1993. Ageta et al (2000) reported supraglacial lakes on this huge debris-cover glacier in the 1990s. The continuing expansion of these supraglacial lakes was observed in 1998 during the first joint Japan-Bhutan field expedition. This growing lake has a potential for an outburst in the near future for several reasons (Figures 3.25 to 3.28). First, accelerated melting of the ice has been observed; second, there is only a gentle gradient at the snout region; third, the left lateral moraine ridge is being eroded by discharge water from the upstream Luggye Lake; finally, considerable seepage is seen from the left lateral moraine.

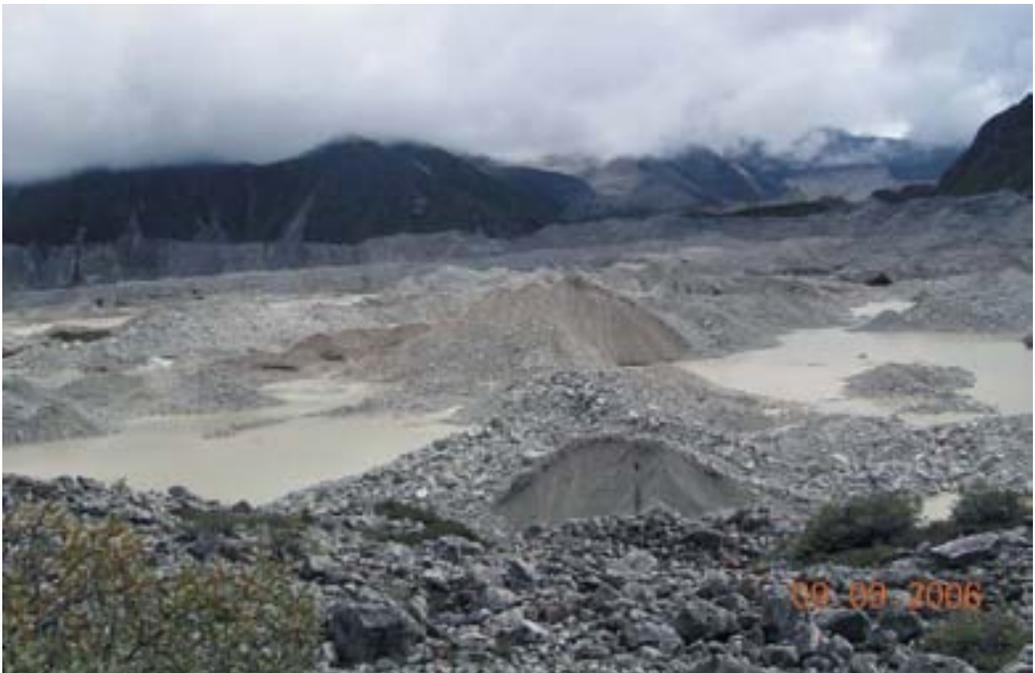
Figure 3.25: Supraglacial lakes formed in the Thorthormi glacier

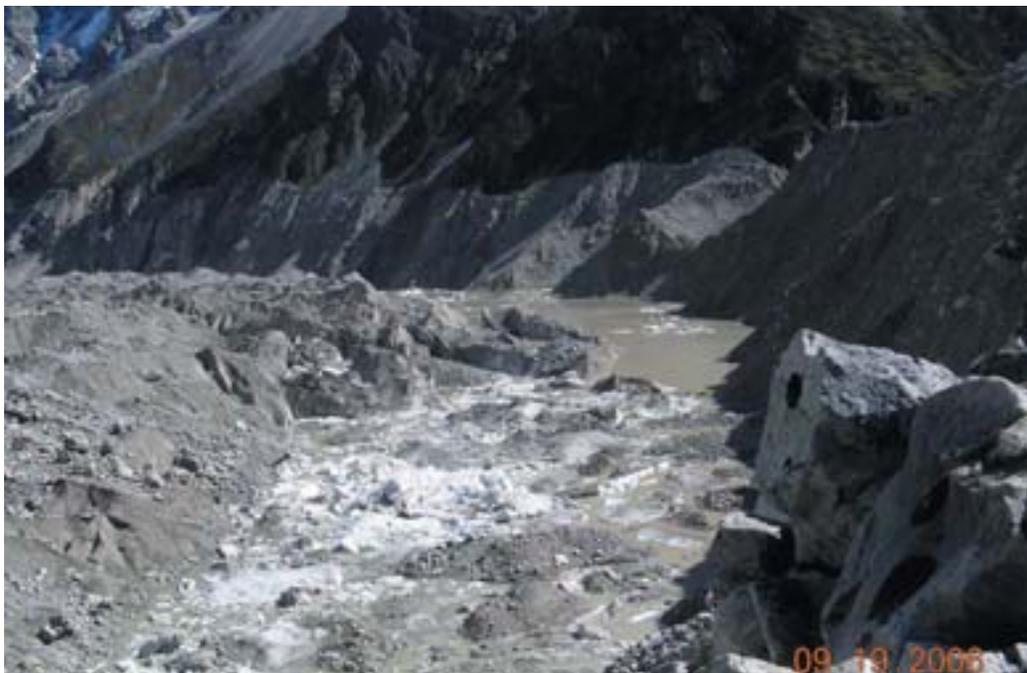
Figure 3.26: A glacial lake located in the Thorthormi glacier, near the inlet of Lake Luggye Tso

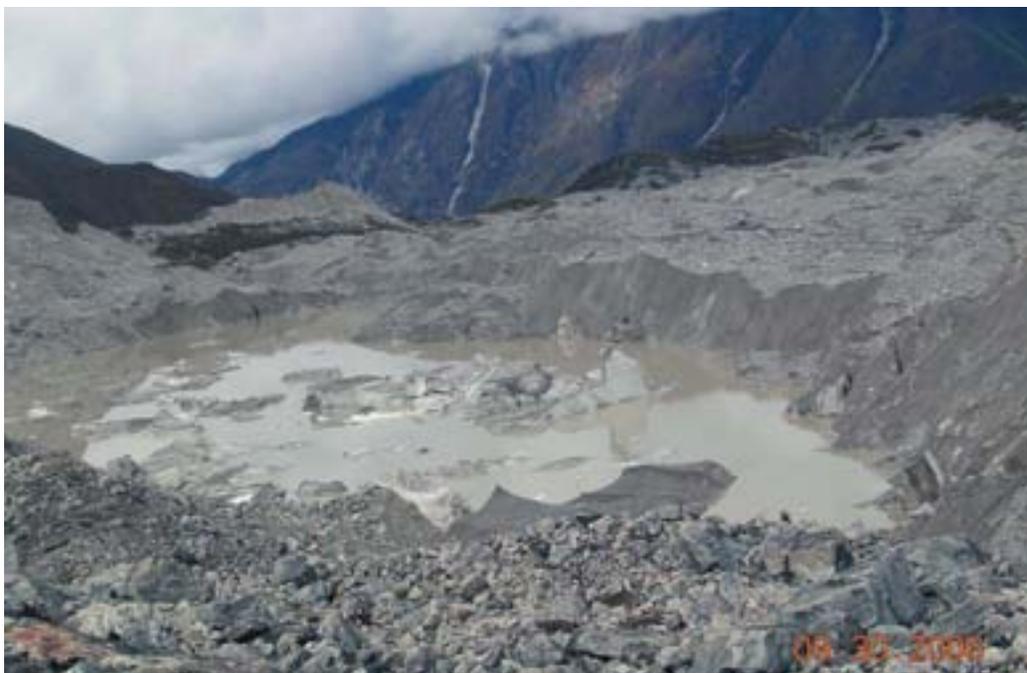
Figure 3.27: A supraglacial lake at the lower left side of the Thorthormi glacier

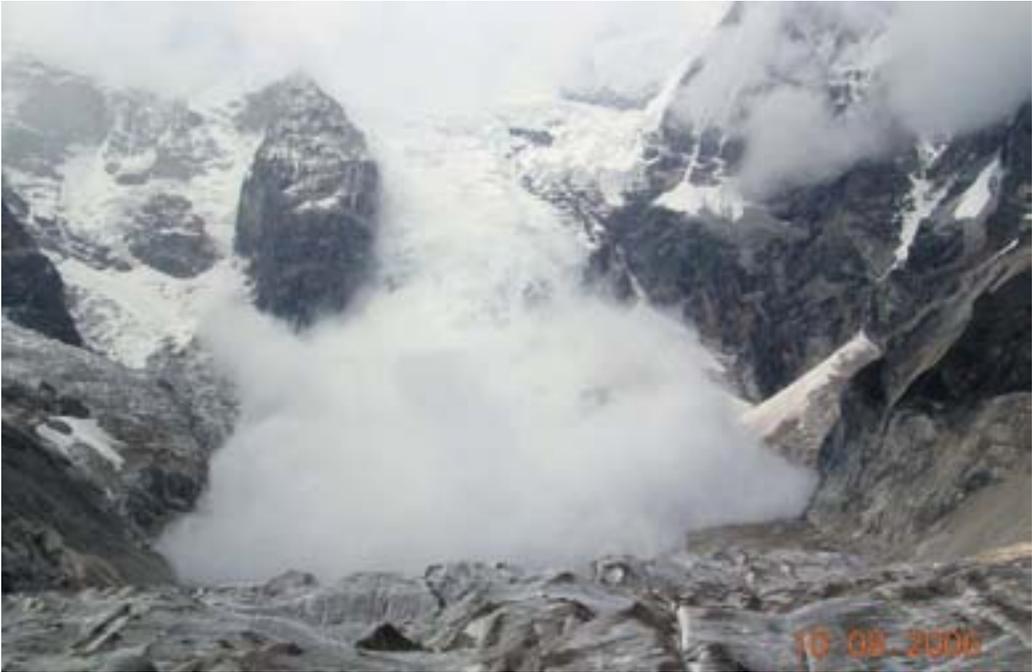
Figure 3.28: An avalanche at the accumulation zone of the Thorthormi glacier.
