Chapter 3

Glacial Lakes in the Dudh Koshi Sub-basin of Nepal and Pho Chu Sub-basin of Bhutan

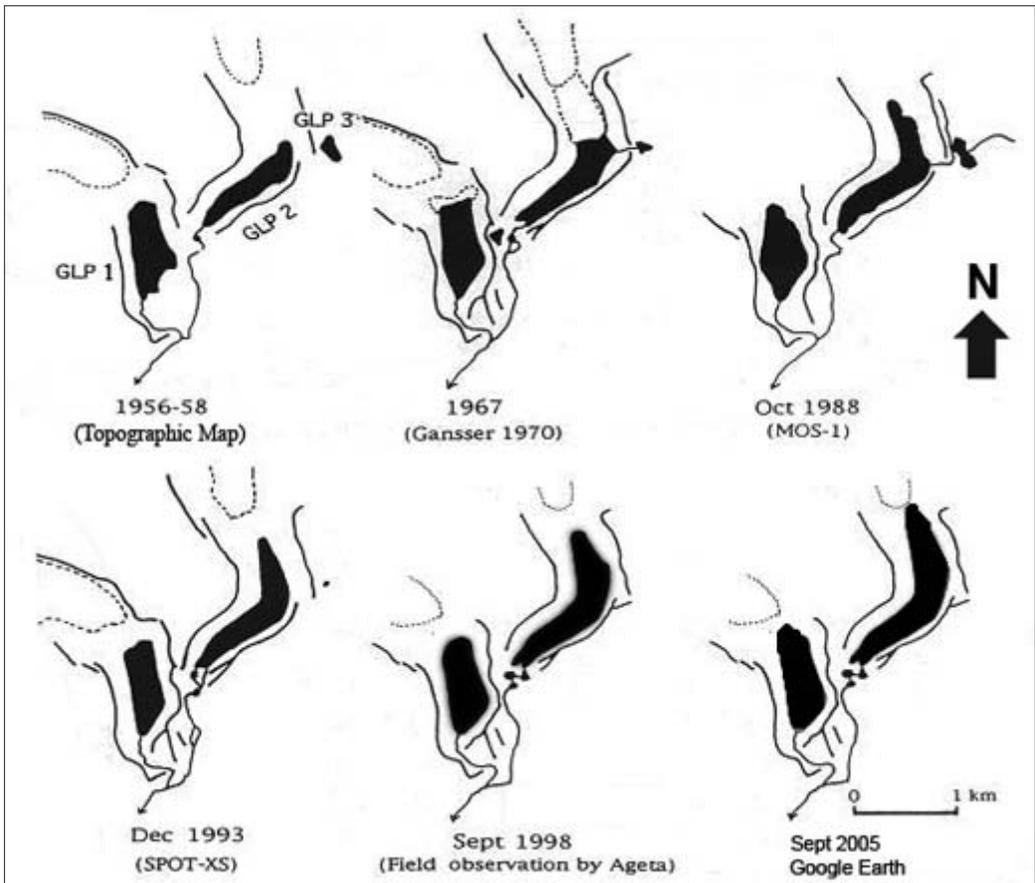
Figure 3.29: Expansion of Lake Tarina Tso (1956-2005) (modified from Ageta et al. 2000)

Lake Tarina Tso (GLP1 as designated by Ageta et al. (2000)) already existed, and was large enough to appear on the 1950 maps (Figure 3.29). GLP1 Lake in 1956/1958 to 1967 gave a clear indication of growing; according to the 1988 maps, however, the lake's shape changed but its size remained more or less constant. The 1989 maps show that the lake had

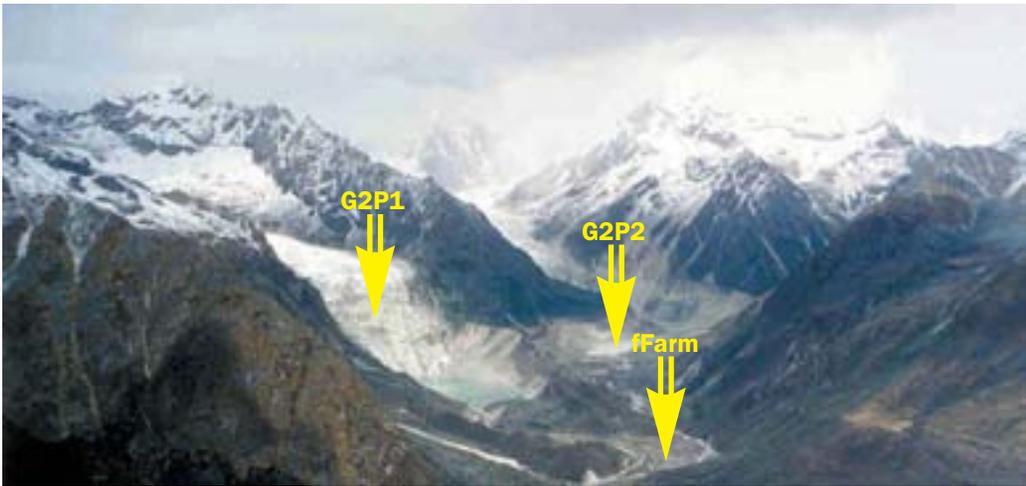
Figure 3.30: Lakes of Tarina and the surrounding glacial environment

As for Tarina II (GLP2), their worst-case scenarios included a chain reaction for a series of events from the glaciers and lakes above this main lake (Figure 3.30). The projected volume of water and sediment it could release to the downstream is estimated to be 3.4 million m³. However, Dorji (1996) expressed a different opinion and reported that the lakes are safe. In his own words, “Both the lakes in Tarina do not pose any threat of flood”.

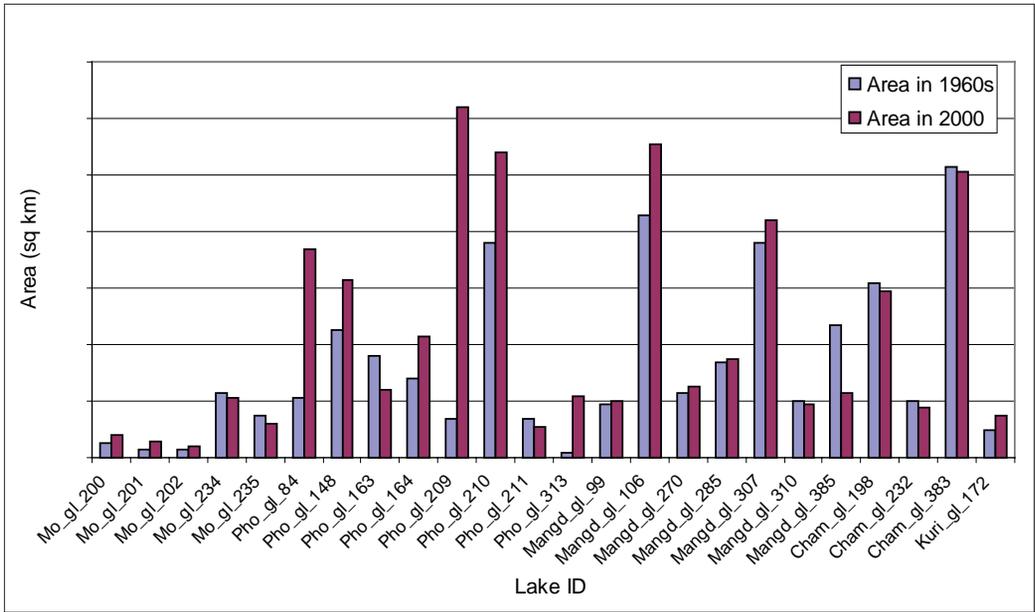
Figure 3.31: Area change of the 24 potentially dangerous lakes in Bhutan from the 1960s to 2001

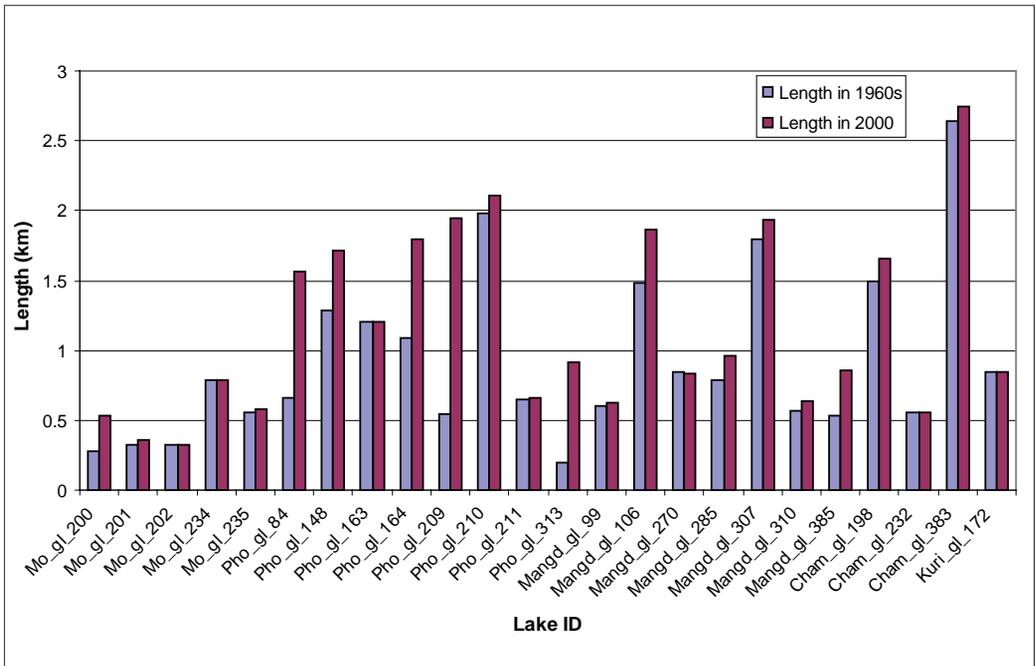
Figure 3.32: Length change of the 24 potentially dangerous lakes in Bhutan from the 1960s to 2001

Figure 3.32 shows the changes that have taken place in terms of length over the time period. In total 19 lakes increased and five lakes remained unchanged in length.
