THE FIELD TRIP

Observation of Glacial Deposits at Balephi

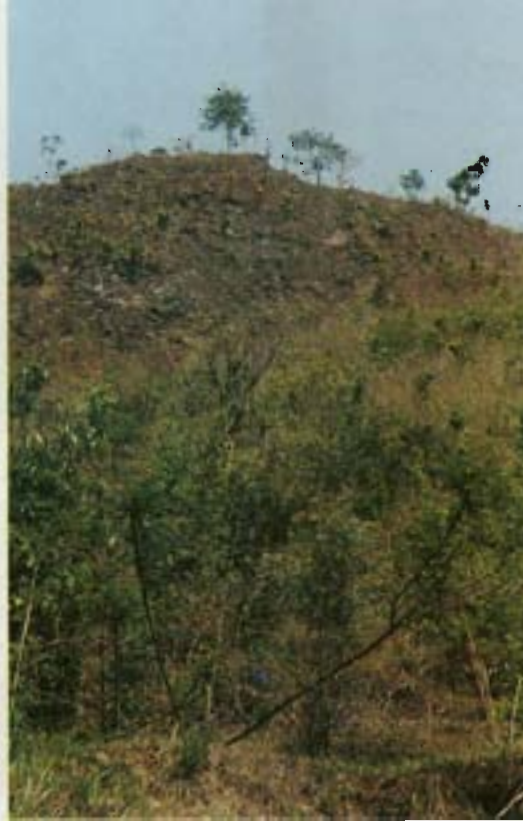
Plate 1

The first stop was at Kilometre 69. Dr. Pugin observed that this was the first sample of mixed glacial deposit soil in the valley. Horizontal drains had been built for stabilisation of the site. Dr. Pugin observed that along the river bank, the underlying deposits were probably of glacial origin (see plates 1 to 3).

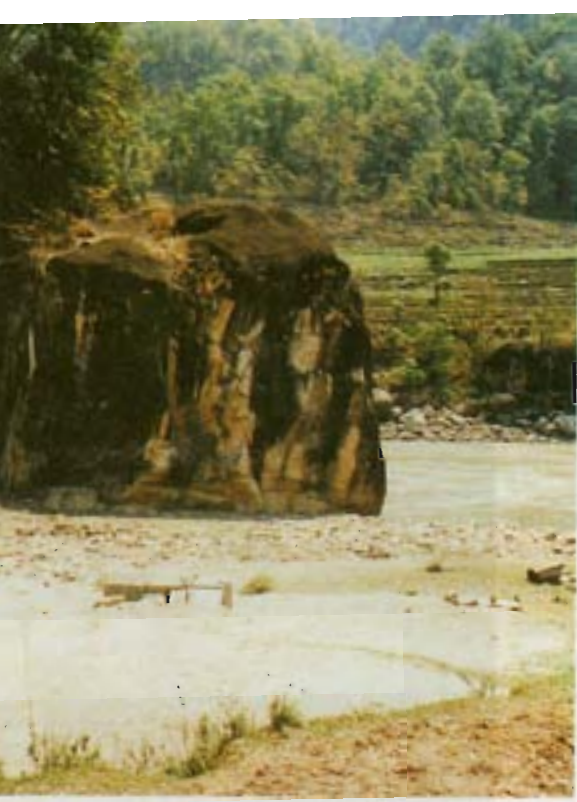
late 4

Three stops were made around the Balephi area. The huge boulder before Balephi, which was referred to by the local people as the *Pancha Kanya* (five virgins) rock, was referred to by the project team as the Hanuman boulder (see plate 4). It was estimated to weigh from 60,000 to 70,000 tons. It lies close to the highway near Km 71 and is constituted of augen gneiss; this type of rock outcrops 40km upstream in Kodari and

at shorter distances away (15-20km) in the tributaries of the Sunkoshi. The project hydrologists did not believe it possible that fluvial transportation had taken place over such distances; the river gradient was too low. This had led to the proposition that it could only have been transported by glacier. The geology differed from the surrounding rocks and from those at the roadside. At the stop made after Balephi, it was observed that, up to a depth of 80 metres, glacial materials had been found. Drastic changes in the profile of the bedrock had been observed between areas.

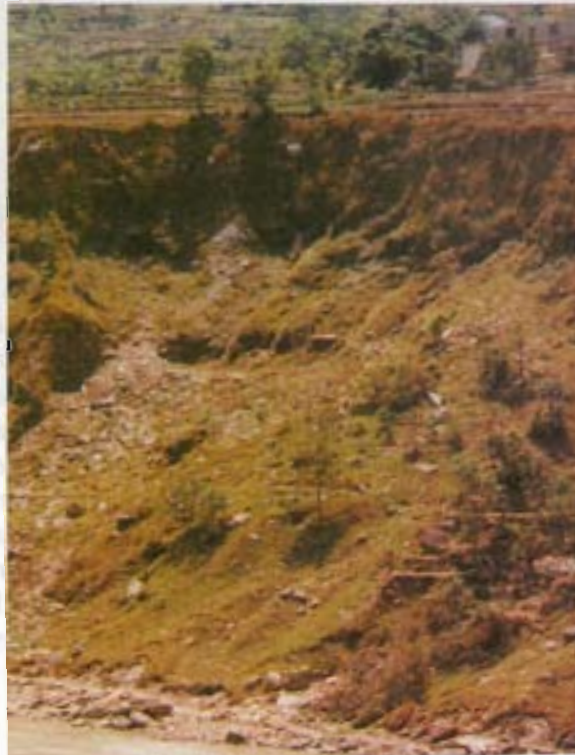
Plate 5

The group stopped at Km79 to observe a site just before Lamosangu where electrical sounding had been carried out up to 55 metres. There was a sizeable flat area. The deposits were diamict overlaid by interstratified gravel. Pollen (grass) associated with a steppic cold climate had been found in a pond sediment horizon. Soils found were associated with a cold climate and, up to 40 metres down, the soil had low resistivity. The total depth of deposits was not known but bedrock had not been detected up to 500 metres (see plate 5).
