Landslide Hazard Management and Control in Pakistan A Review

**M.H. Malik
and
S. Farooq**

Landslide Hazard Management and Control in Pakistan

A Review

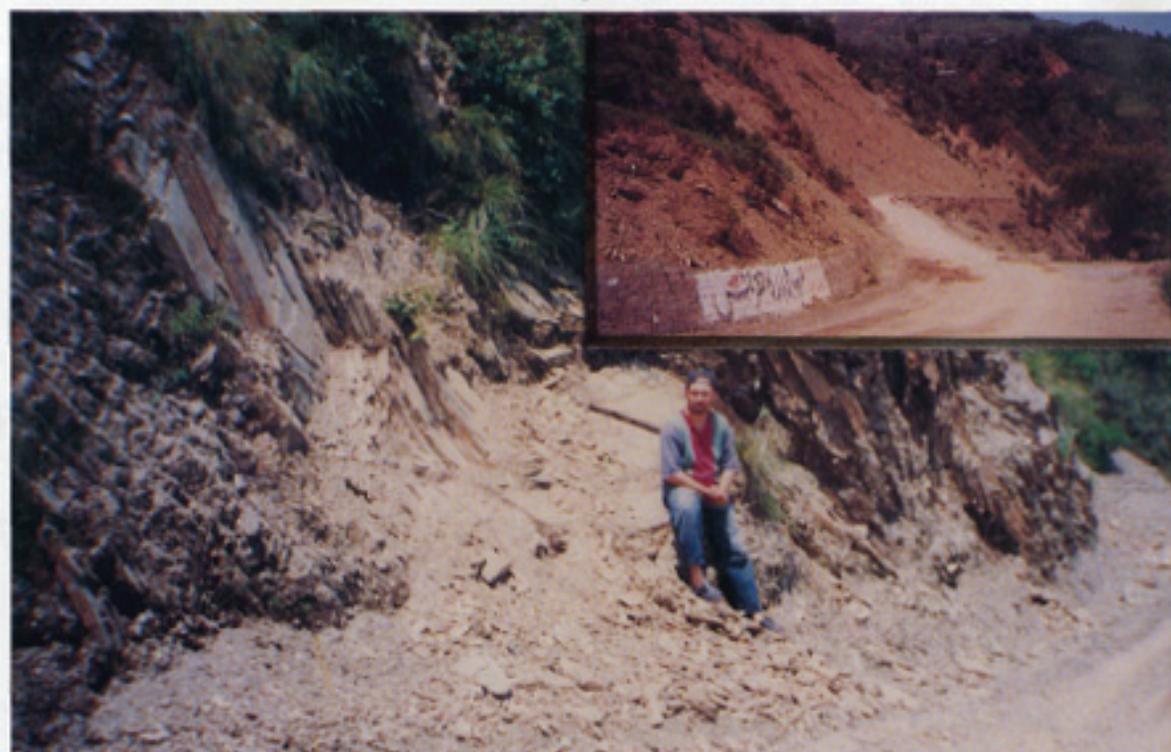
Cover Photograph: Plane failure in schists at Lower Gali, Muzaffarabad

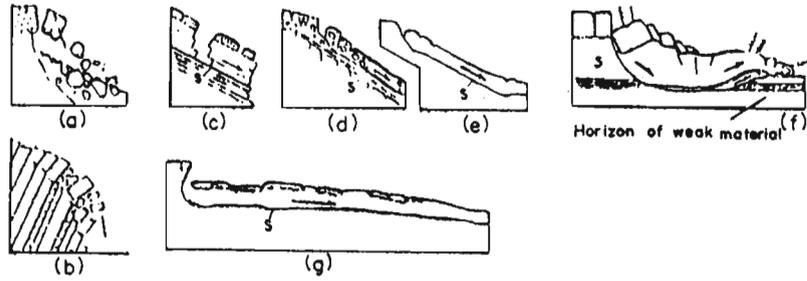
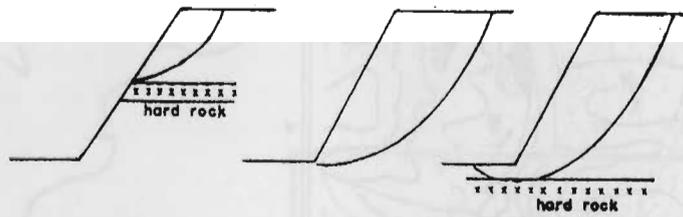
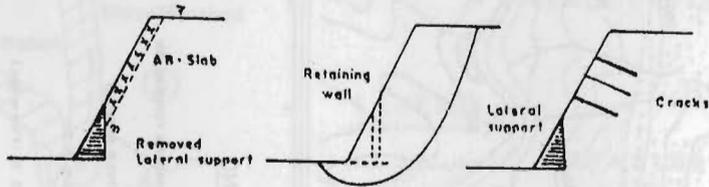
Figure 3: Different Types of Landslides and Slope Failures

- a) Rockfall
- b) Topple
- c) Translational
- d) Translational
- e) Translational
- f) Rotational
- g) Flow

- a) Face Failure
- b) Toe Failure
- c) Base Failure

- d) Slab Sliding
- e) Rotational Sliding
- f) Slope Cracking on Removal of Support of Base

Rockfalls occur due to loss of support, sliding, fracturing, or rotation of small rock units forming a part of the free face. They involve free falling of rock blocks of different sizes detached from rock slopes in the form of rolling or sliding downwards with a velocity of more than 28m/sec. When rock blocks, which are detached but perched on steep slopes, fall, they are categorised as 'secondary falls' (Hutchinson 1988). Rockfalls are small-scale displacements, involving a direct downward movement, resulting from lack of support from below due to differential weathering of softer materials or to physical undercutting of a rock face (Knill 1967). Rock faces marked by vertical or subvertical fractures fall as a result of slab failure due to water or ice pressure or by stress relief, whereby apertures of joints or fractures are further opened leaving the rock face a 'threatening rock' (Fig. 3a).

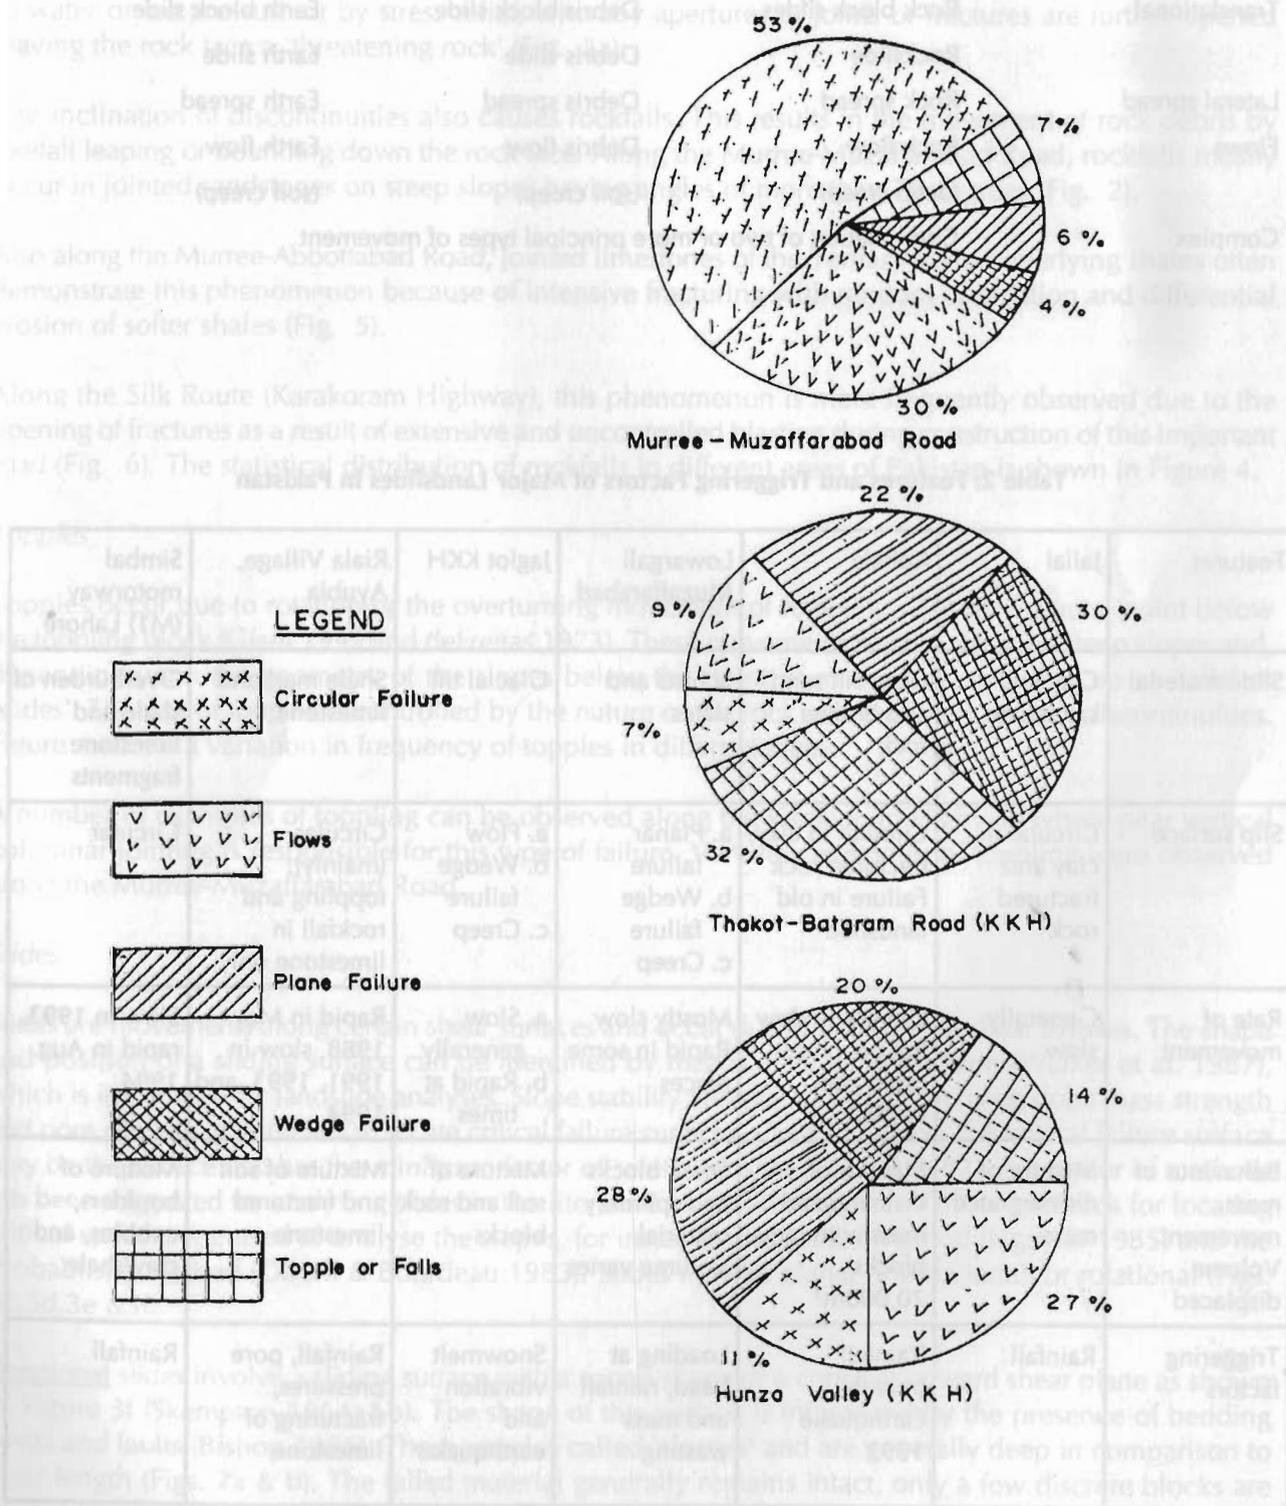
Figure 4: Statistical Distribution of Various Types of Landslides in Different Areas

Six basic types of slope movement, i.e., falls, topples, slides (translational and rotational), lateral spreads, flows, and complex (combination of two or more principal types of movement) have been referred to by Varnes (1978). This classification is most commonly used (Table 1) and is based on Sharpe (1938), supplemented by other sources Zischinsky (1966), Zaruba and Mencl (1969), Skempton and Hutchinson (1969), Nemcock et al. (1972), and deFreitas and Watters (1973). Most of these types of landslides were identified, documented, and investigated for analysis and statistical distribution (Fig. 4 and Table 2) in northern Pakistan.

Rotational slides are more frequent in the Mesozoic and Tertiary rocks of northern Pakistan (Fig. 4) where alternate hard and soft materials prevail either in the form of sandstone/shale or limestone/shale lithologies. Slides in such lithologies occur on slopes where relatively homogeneous materials or closely jointed rocks are present. A relationship between fracture spacing or fracture frequency with the sliding phenomenon has been established, particularly where thin and fractured sandstones are interbedded with shales.

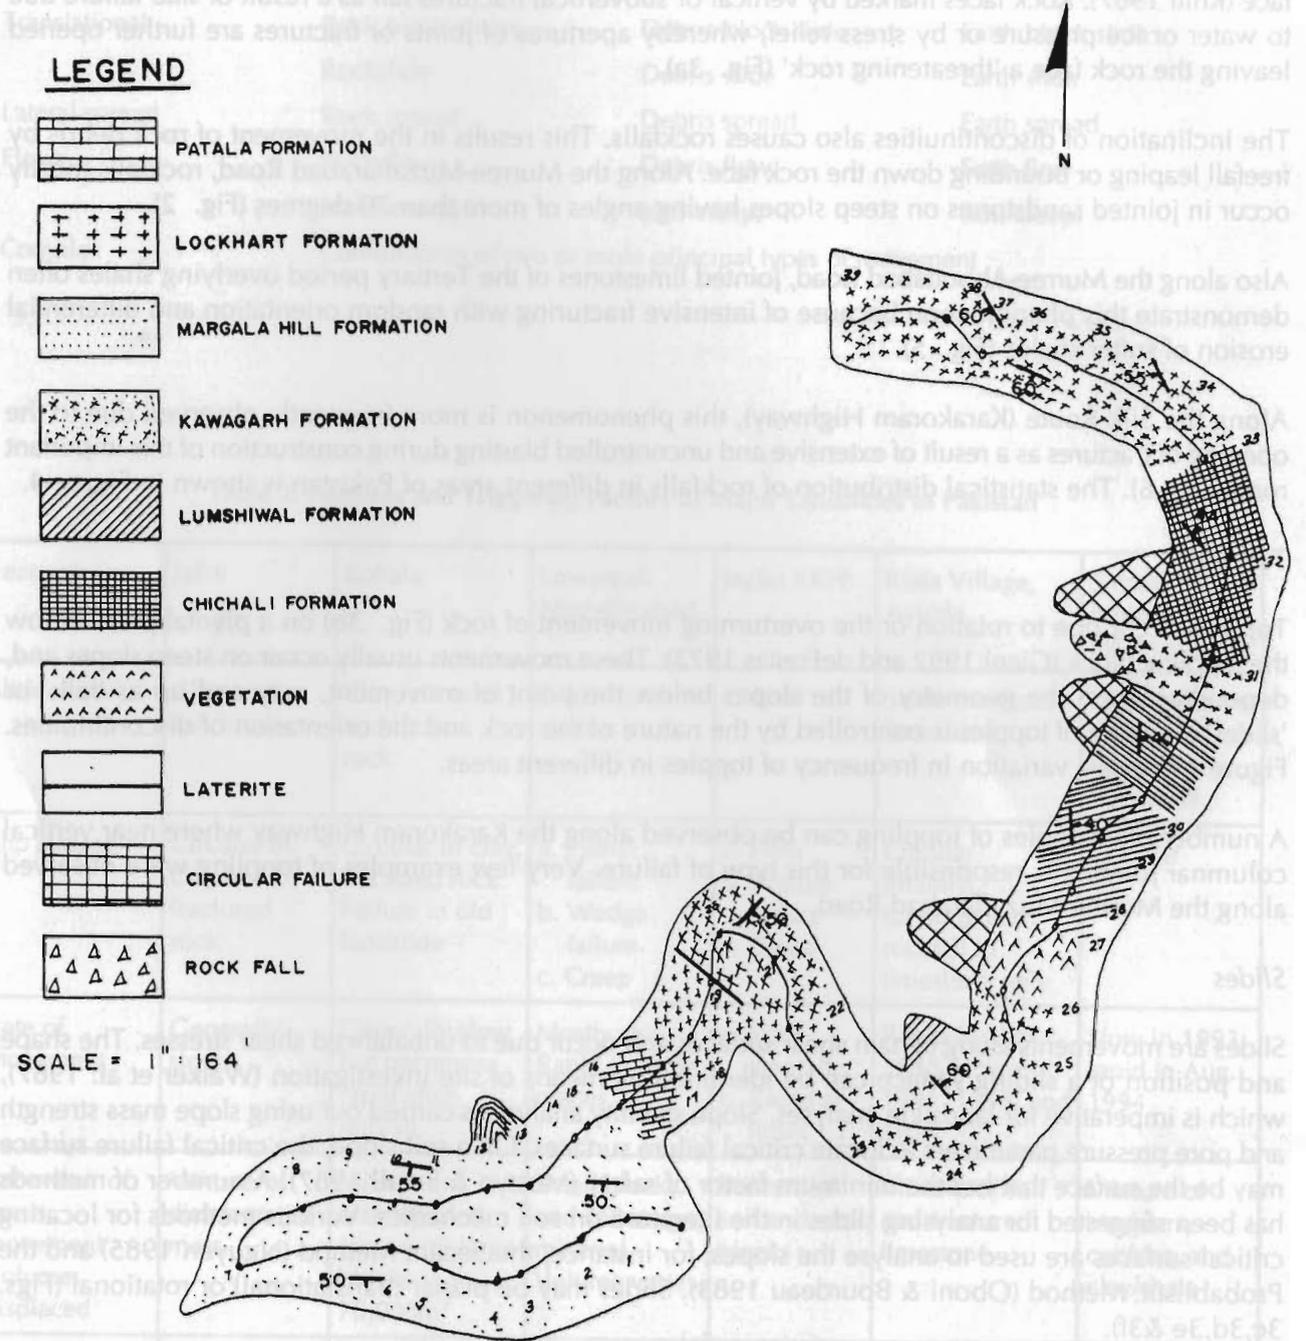
Figure 5: Geological and Landslide Inventory Map of Abandoned Road between Khera Gali and Changla Gali (Hazara)

Also along the Murree-Abbottabad Road, jointed limestones of the Tertiary period overlying shales often demonstrate this phenomenon because of intensive fracturing with random orientation and differential erosion of softer shales (Fig. 5).

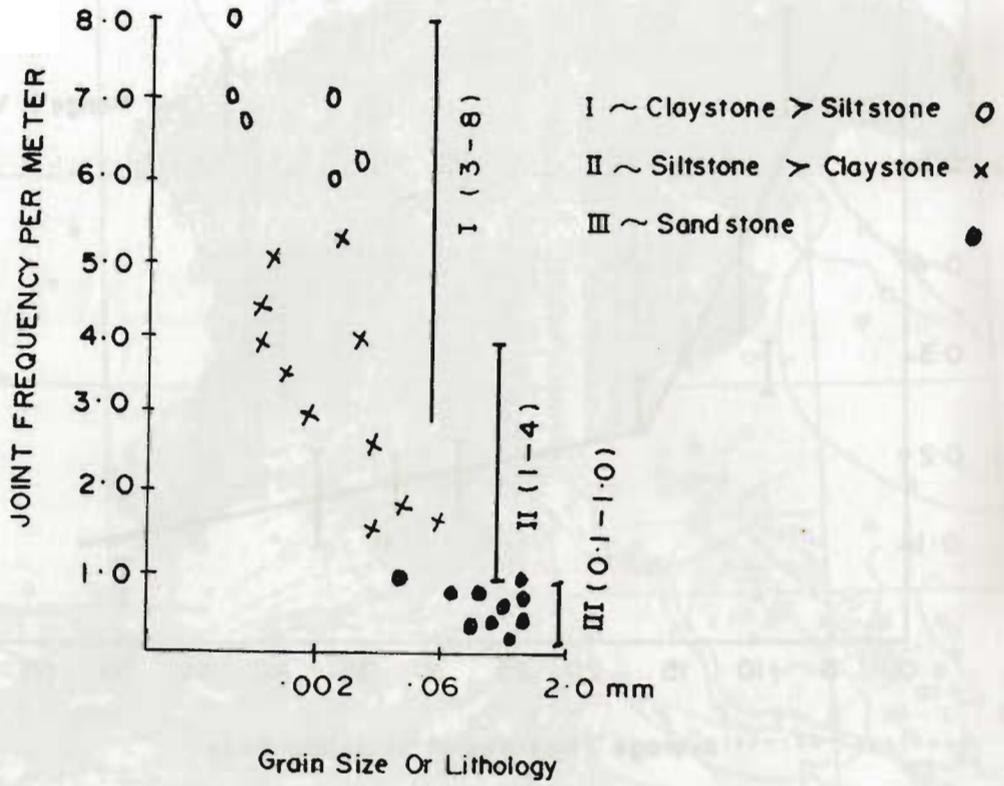
Figure 10: Joint Frequency vs Lithology

(Values in Brackets [Range in Frequency] Show Same Overlap - General Increase in Joint Frequency with Decrease in Grain Size is Prominent)

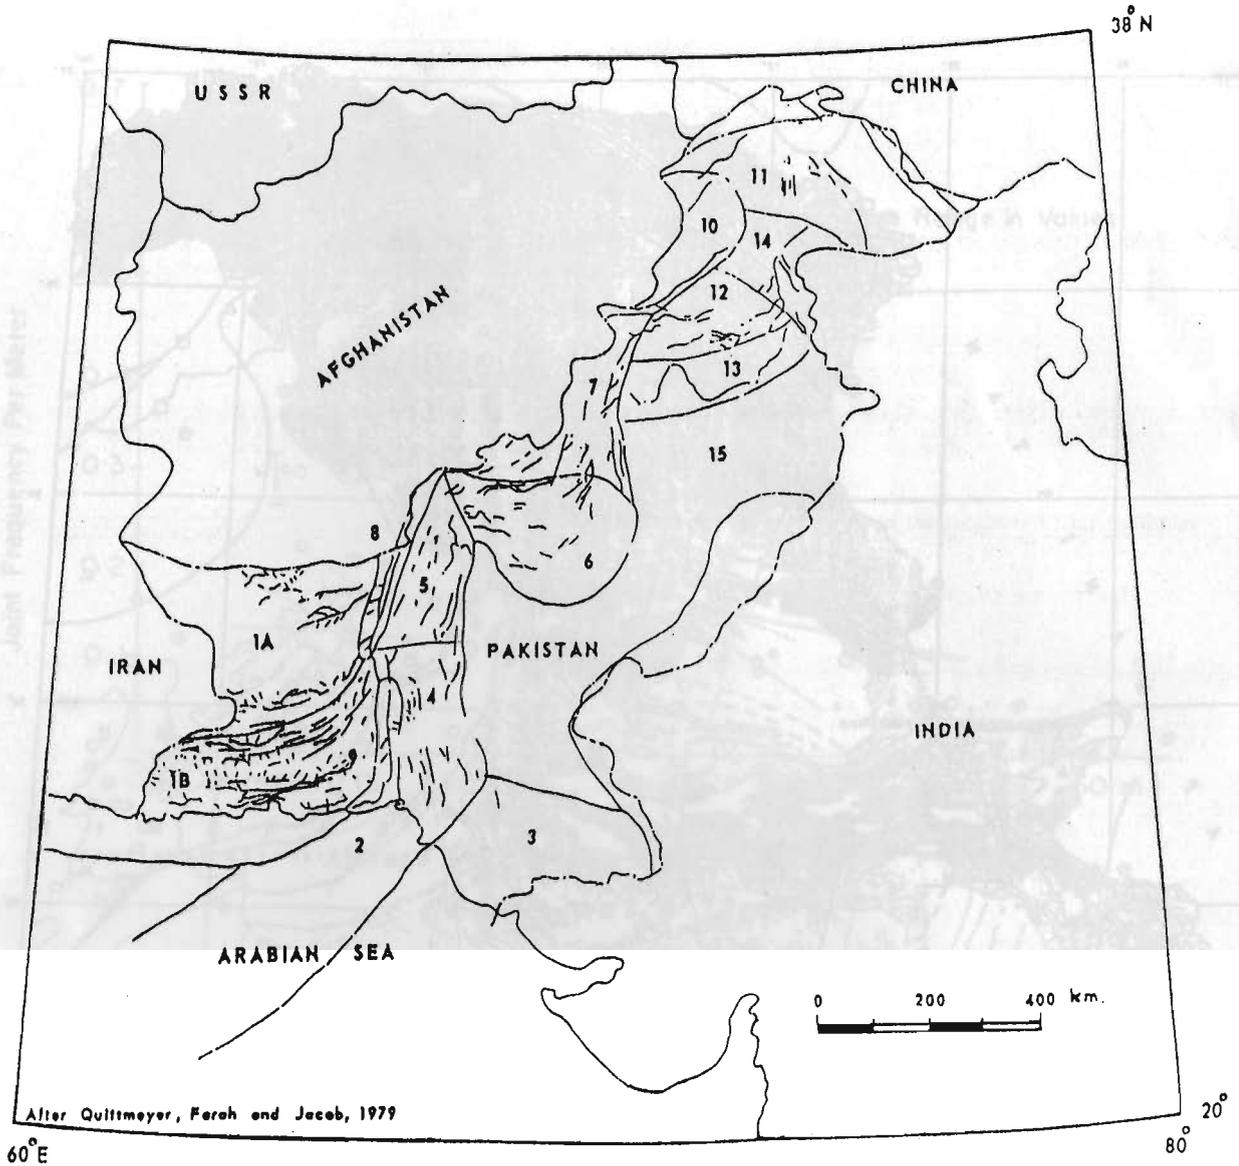
Figure 14(a): Seismotectonic Provinces of Pakistan

1. **Makran Region:** Characterised by low to moderate shallow seismicity; northward seismicity deeper. Several Recent active faults present.
2. **The Murray Ridge:** Along with Owen fracture zone exhibits low seismic activity.

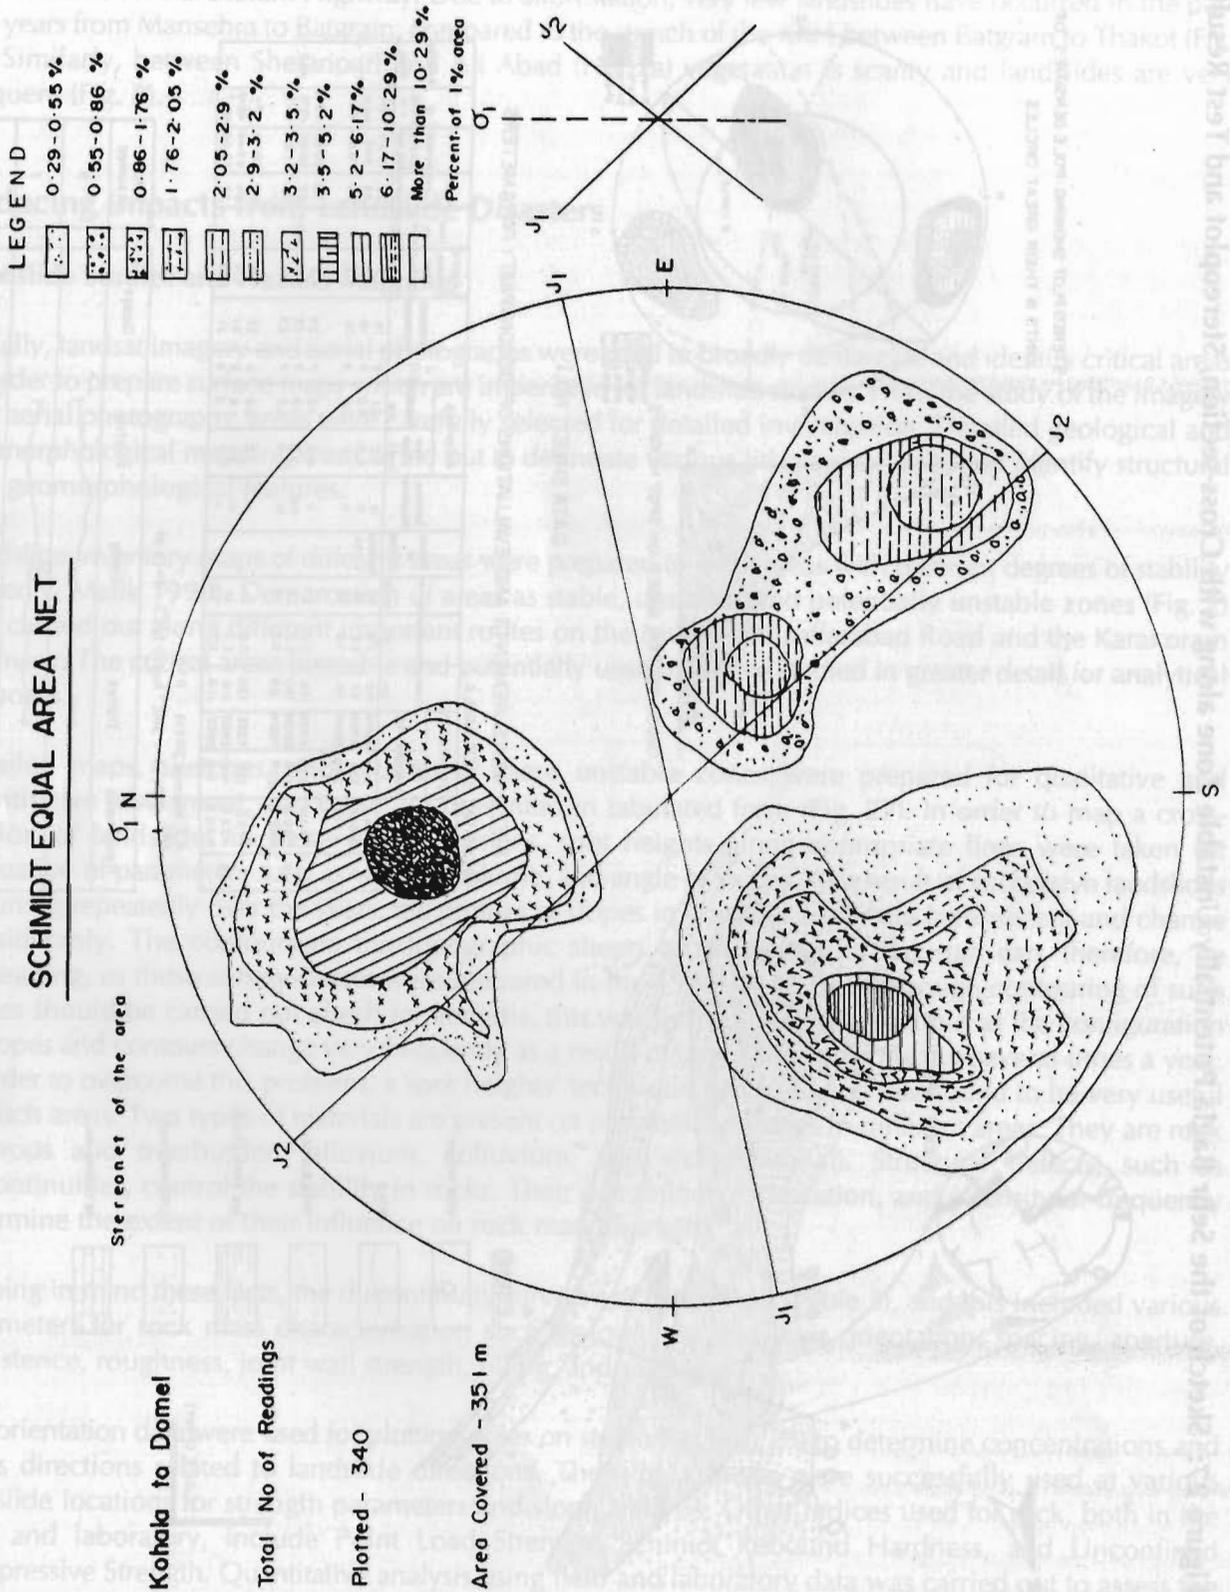
Figure 28: Stereoplot Showing Joint Sets and Direction of Principal Stress

The orientation data were used for plotting poles on stereonet (Fig. 28) to determine concentrations and stress directions related to landslide directions. These data sheets were successfully used at various landslide locations for strength parameters and slope analysis. Other indices used for rock, both in the field and laboratory, include Point Load Strength, Schmidt Rebound Hardness, and Unconfined Compressive Strength. Quantitative analysis using field and laboratory data was carried out to assess the sliding potential in various rock outcrops. Stability analysis using discontinuity data for plane and wedge failure gave values for factors of safety ranging from 0.3 to 1.0 indicating the likelihood of failures on widening or excavating of these slopes, because the excavations made at steeper angles will cause the discontinuities to daylight on slopes.

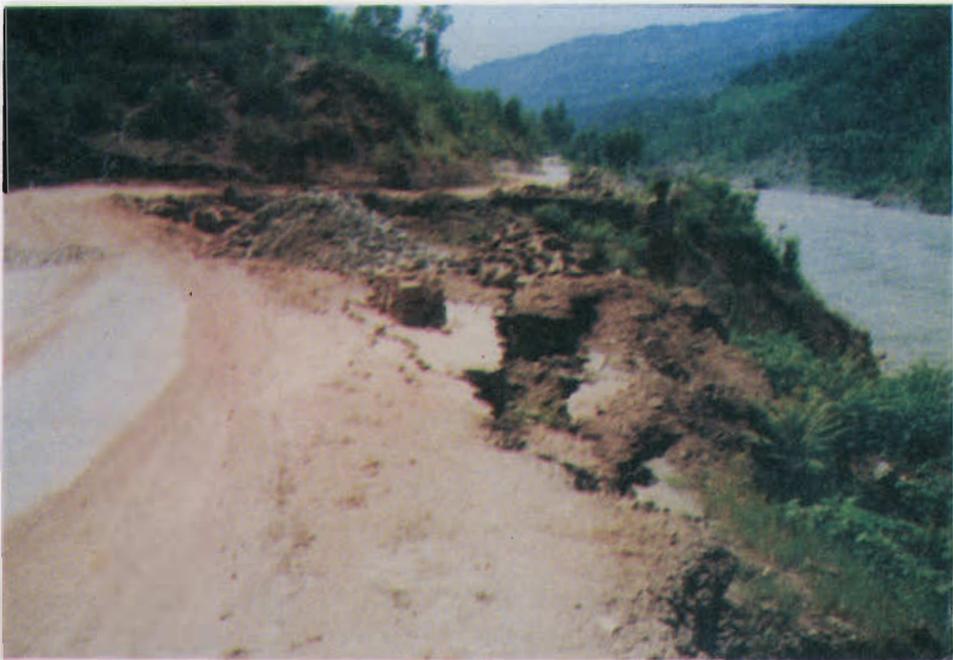
Plate 8: Initiation of failure of downslope due to absence of retaining wall

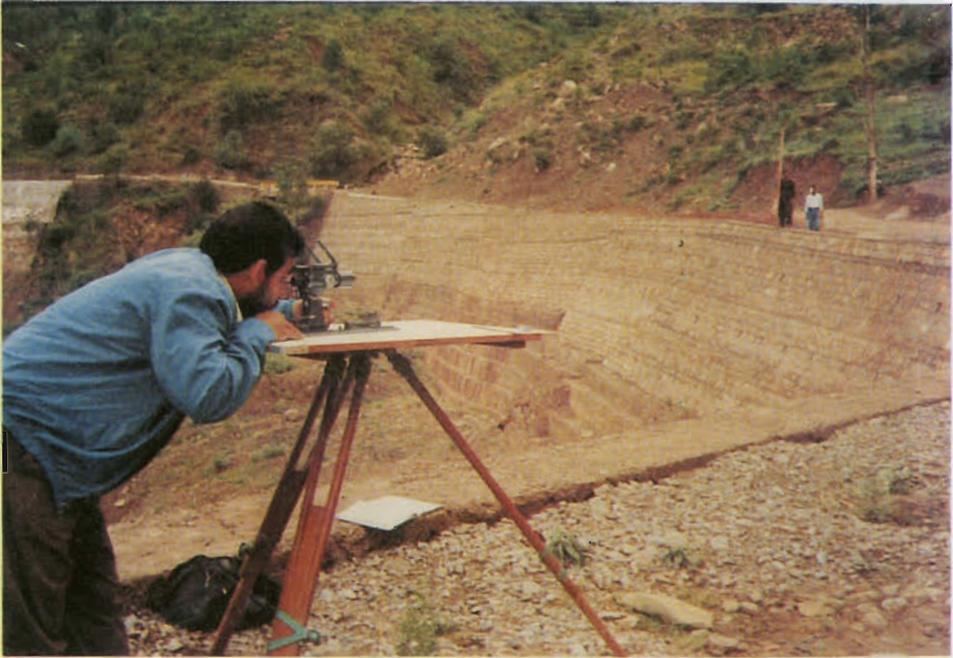
Plate 15: Plane table mapping in critical areas

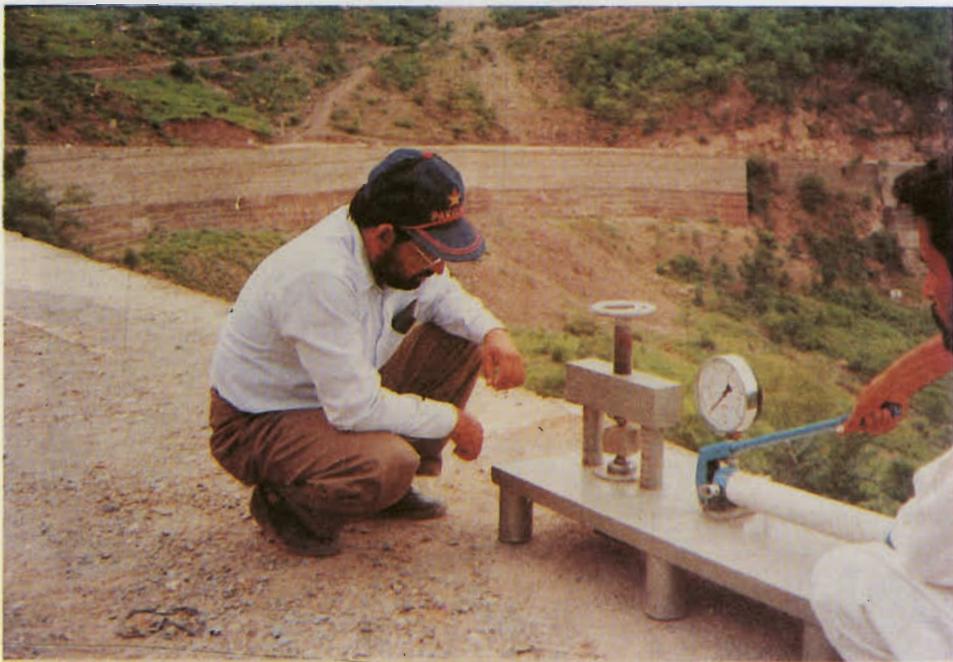
Plate 16: Point load testing of rock at site
