LANDSLIDE MANAGEMENT IN THE MOUNTAIN AREAS OF CHINA

ICIMOD OCCASIONAL PAPER NO. 15

This paper reviews the available information on the causes and impacts of landslides on mountain development and the techniques of landslide mitigation carried out in China. The purposes of the study are :

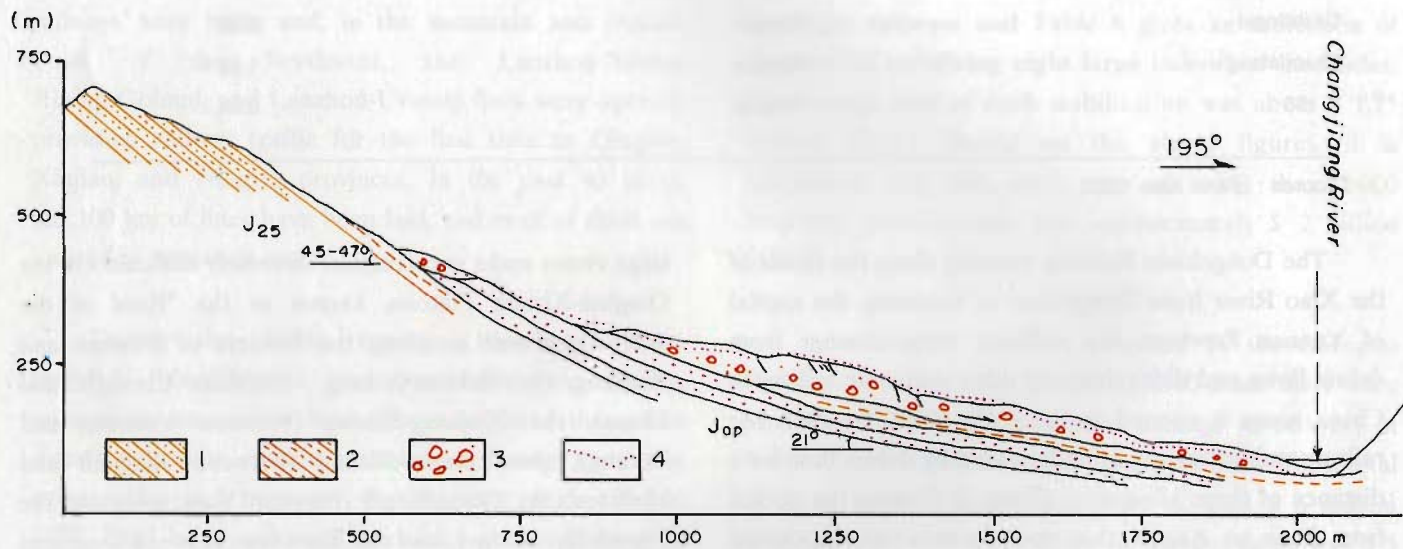
Figure 5: The Jipazi Slide (1982) on the North Bank of the Changjiang (Yangtze) River in Yunyang County, Sichuan

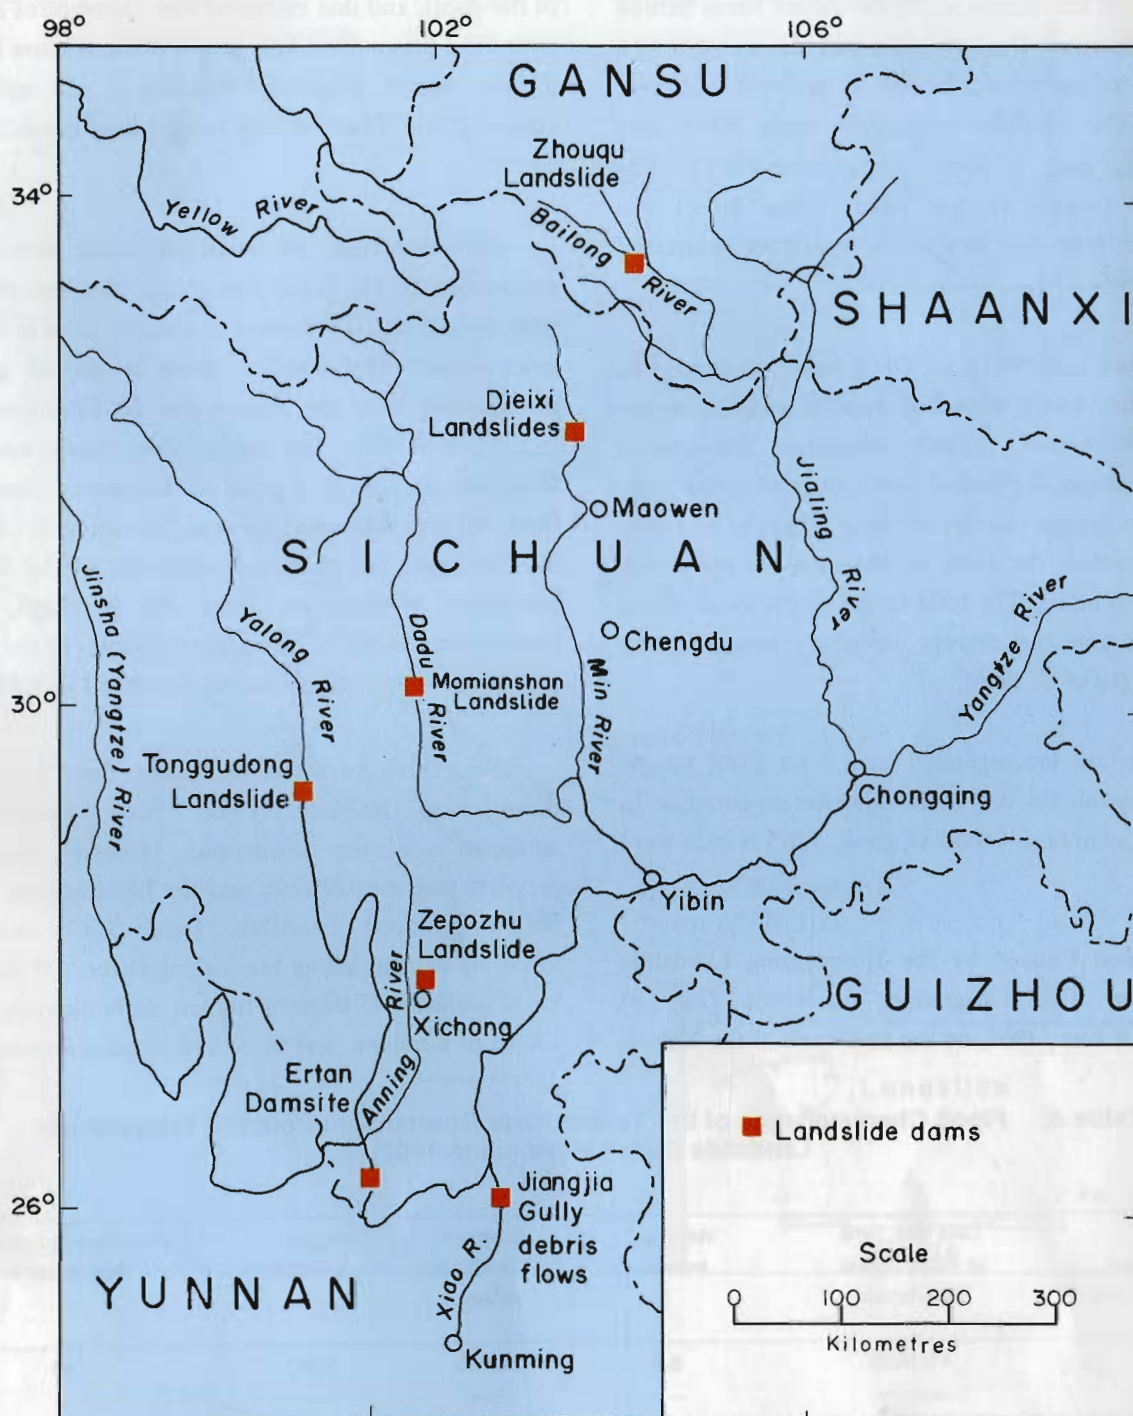
Figure 6: Map Showing Locations of Various Landslide Dams in the Hengduan Mountain Area, Southwest-Central China

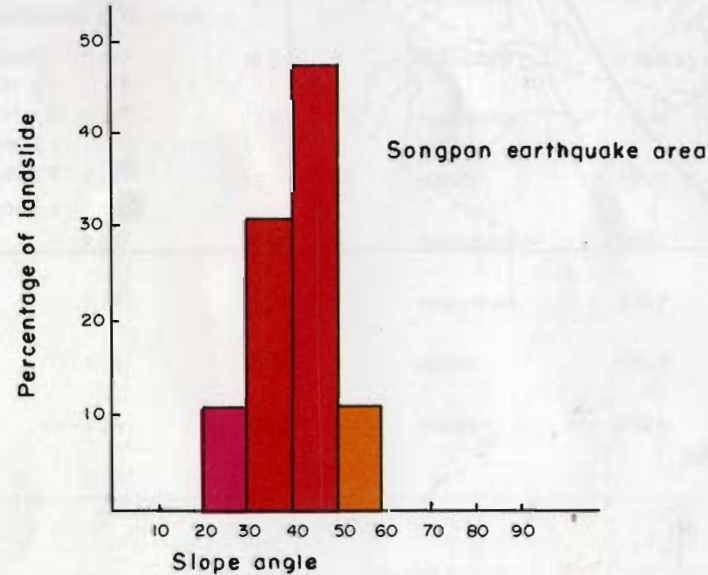
Figure 10: Relationship between Percentage of Earthquake-Induced Landslides and Slope Angle

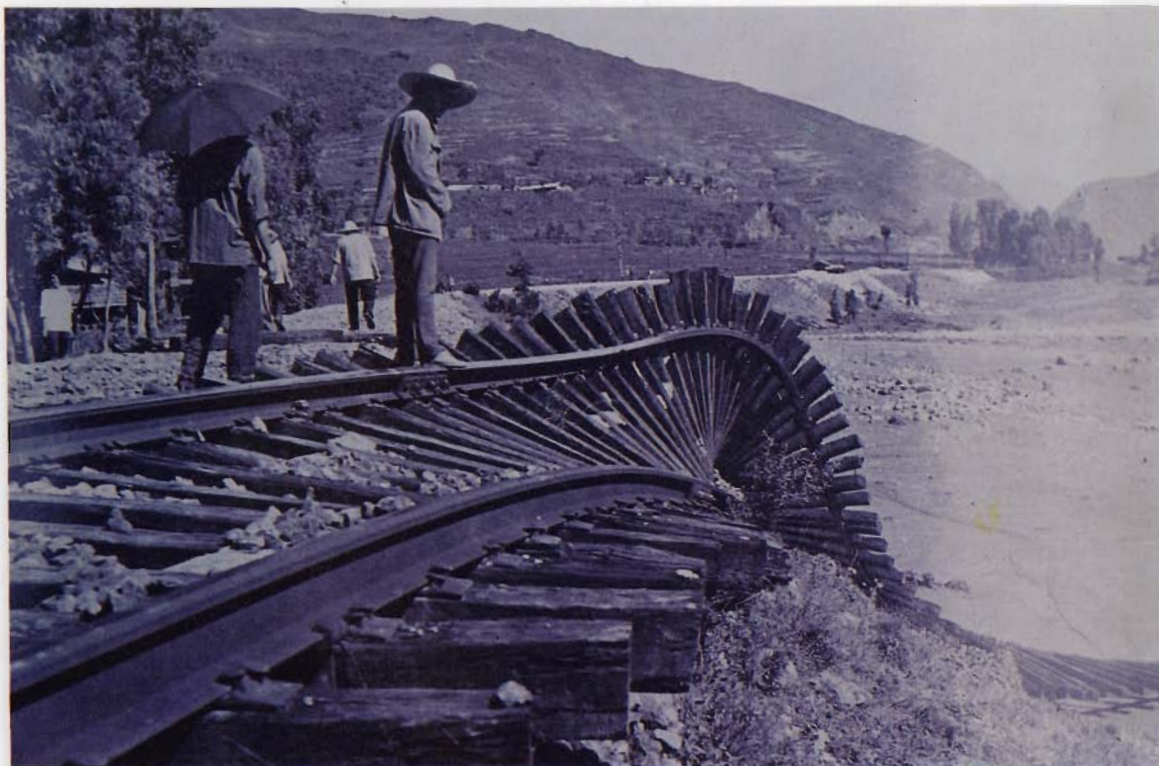
**Plate 1: View Looking Southwards from the Embankment of Dongchuan-Kunming Railway
Downstream from Dade Ravine, Yunnan Province**

The embankment was undermined by debris flow and flooding following breaching of a debris flow dam formed on 30 June, 1981. Courtesy of Yang Wenke

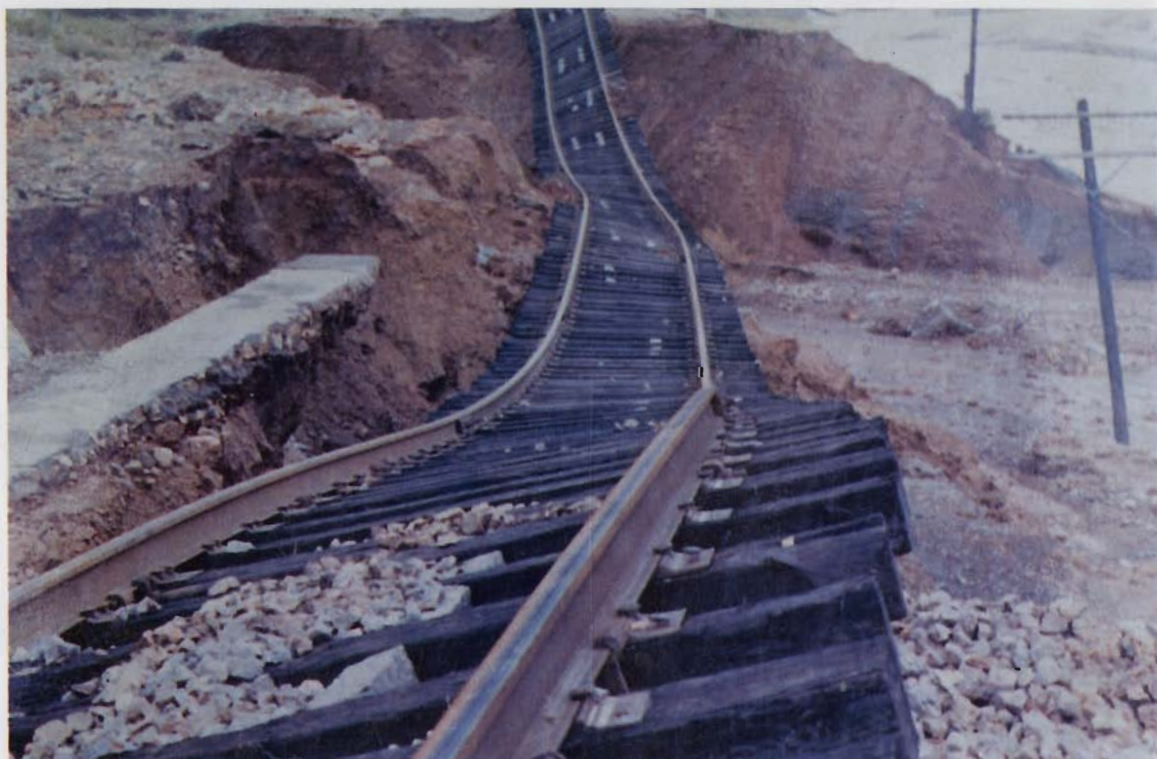
**Plate 2: Embankment of Dongchuan-Kunming Railway Destroyed by a Landslide near Laogan
on 1 July, 1985**

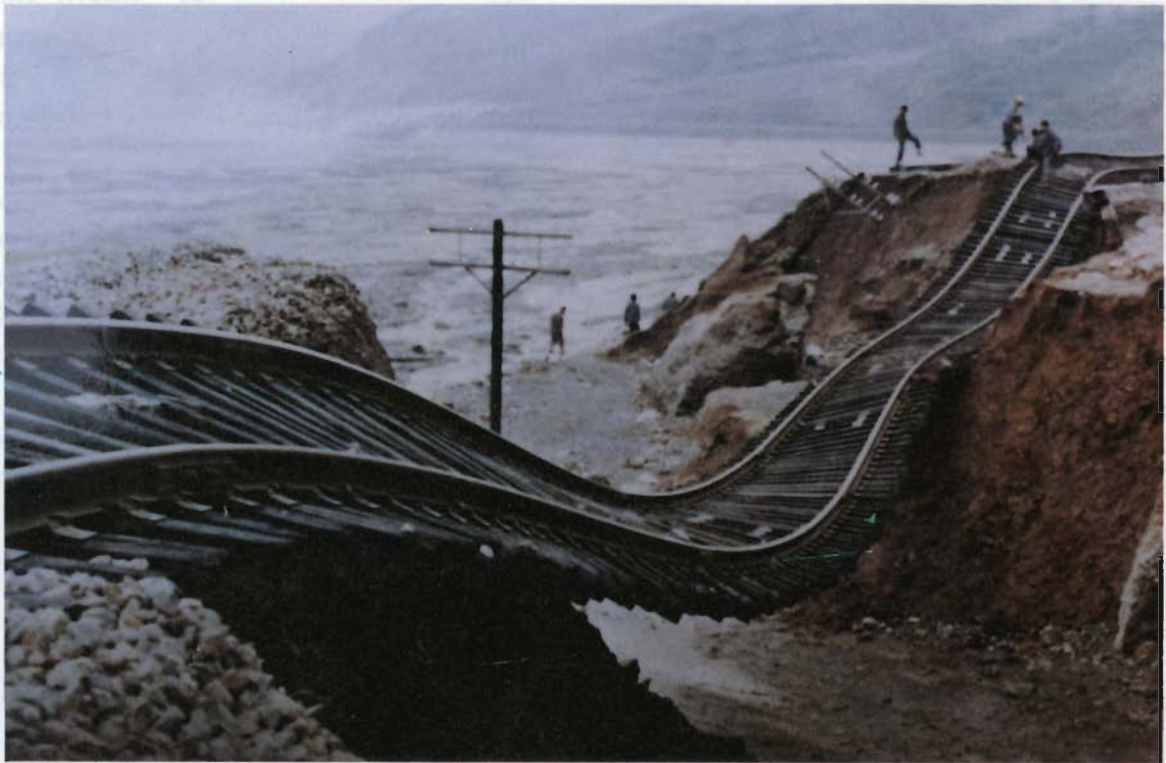
**Plate 3: Debris Flow Undermining the Embankment of Dongchuan-Kunming Railway
(1 July, 1985)**

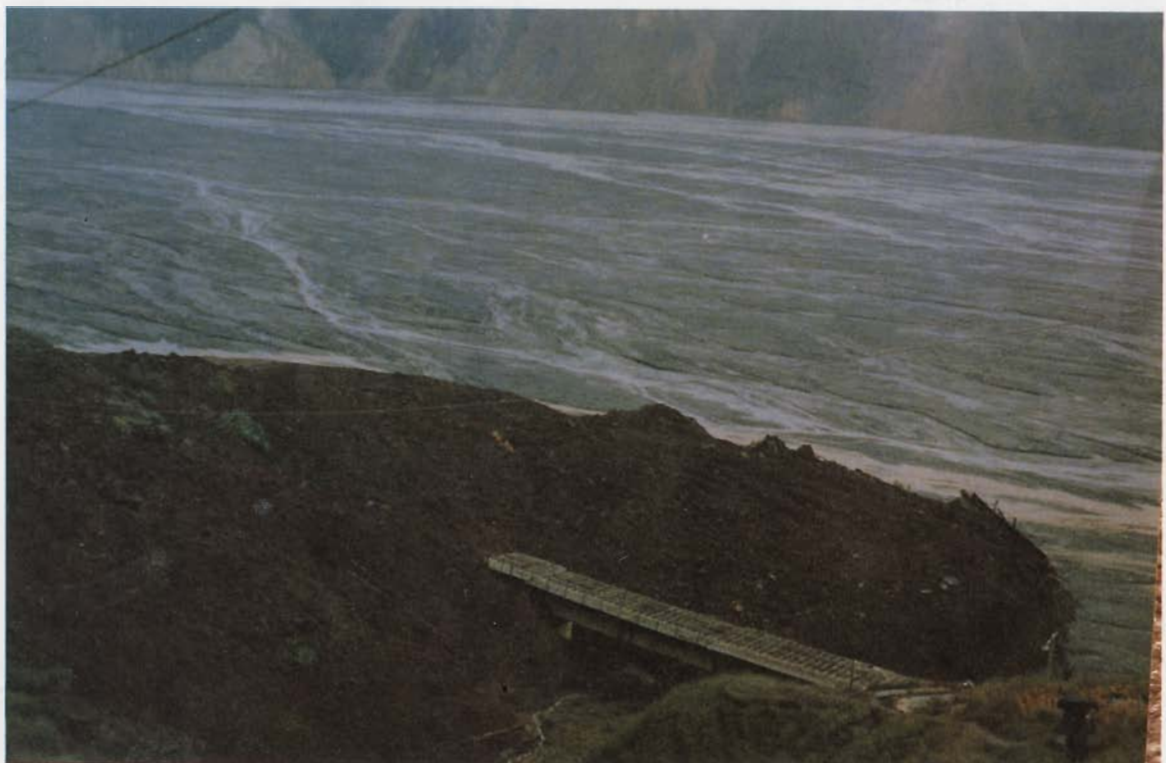
Plate 4 : Forward Movement of the Railway Embankment by 100m and Destruction of Two Railway Bridges at Dalisu in Dongchuan District (Oct. 6, 1986)

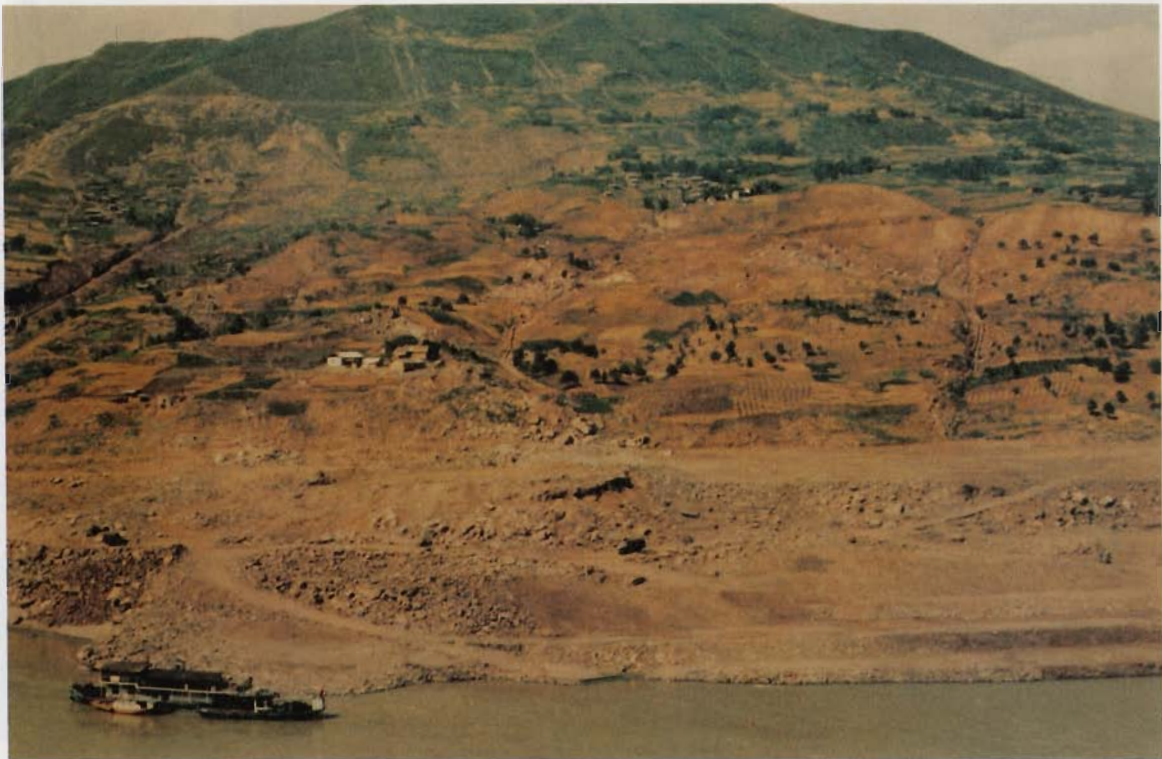
Plate 5: Looking North across the Changjiang River Towards the Jipazi Landslide

The total volume of the landslide is more than 15 million m^3 (centre). The front section of 2.3 million m^3 separated off from the slide channel and slid down below the flood level of the Changjiang River (foreground) to form low rapids that obstructed navigation for about 5 years. The photograph was taken in May, 1985, after stabilization of the landslide.

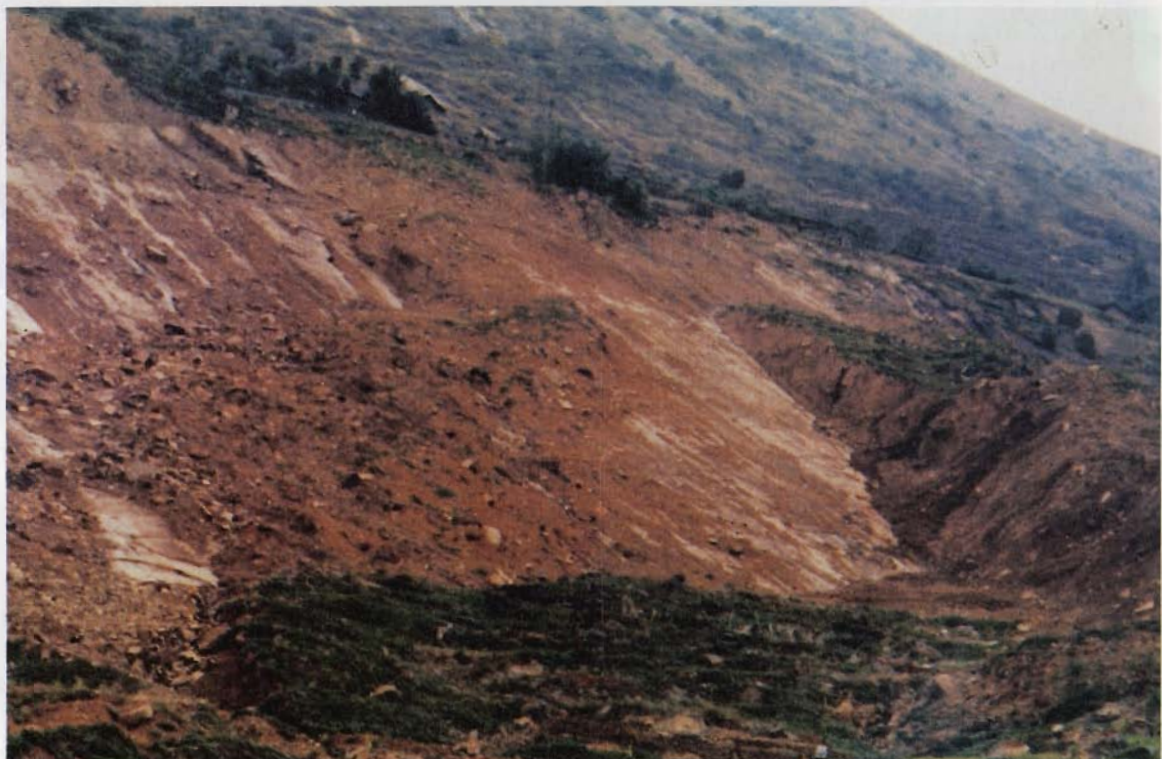
Plate 6: A Close View of the Upper Section of the Jipazi Landslide (Looking Northwards)

The sliding bed is composed of mudstone.

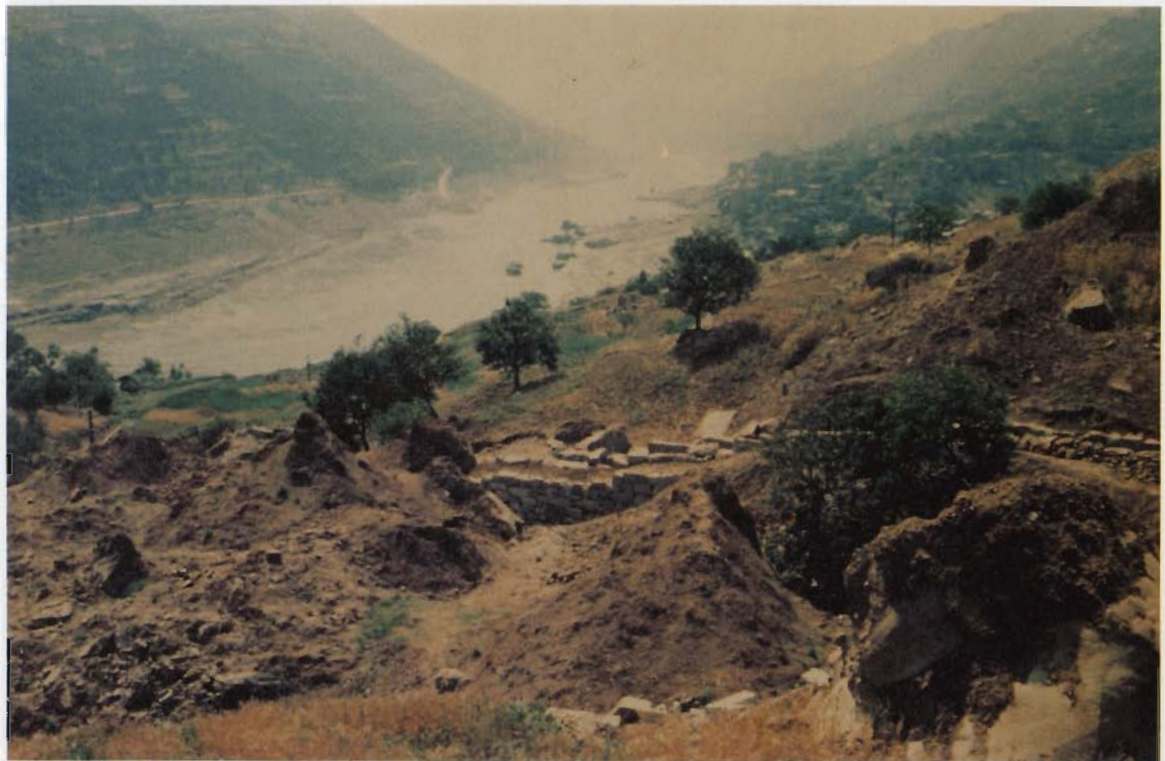
Plate 7: A Close View of the Middle Section of the Jipazi Landslide (Looking Southwards)

The landslide is shown in the foreground, the Changjiang River in the middle background, and the county site of Yangyang on the banks of the Changjiang River in the background - to the right.

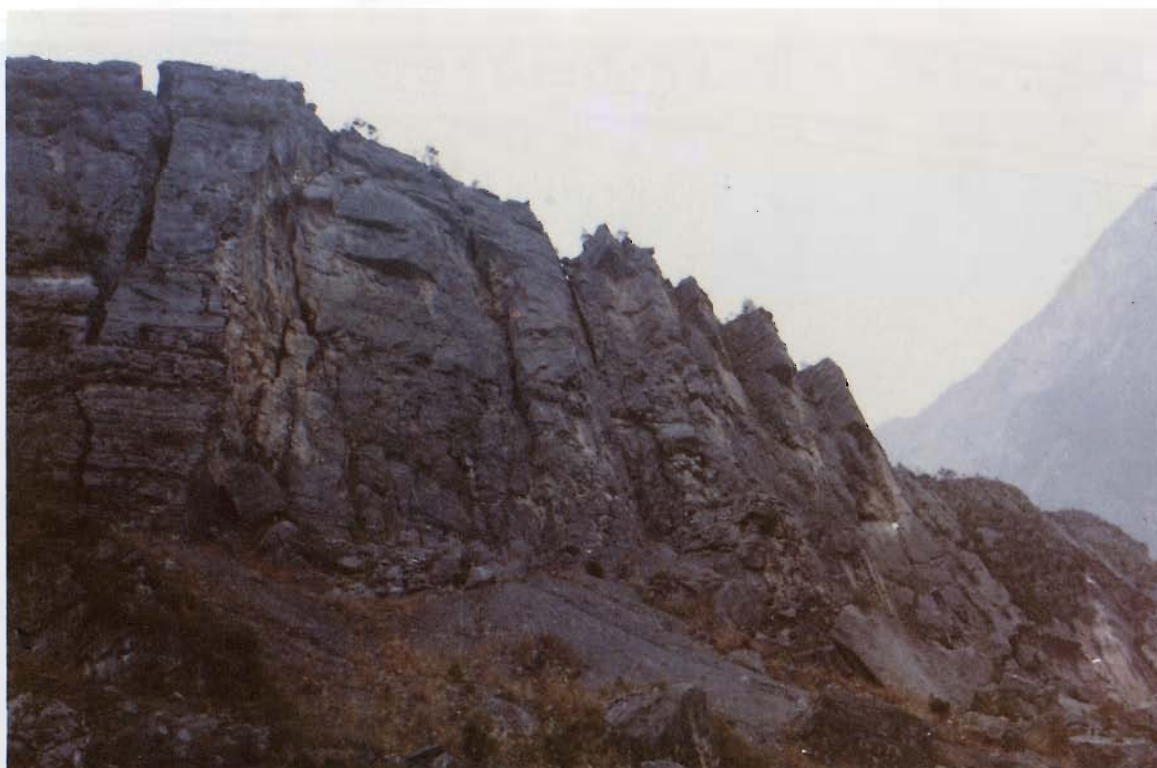
Plate 11: View from the East of the Lianziya Limestone Rockmass

The rockmass is located 27 km upstream from the Three Gorges Dam Site on the South Side of the Changjiang River directly across from the Xintan Landslide, (Hubei Province). The rockmass appears to be undergoing a slow geological process of toppling, sliding, or falling.

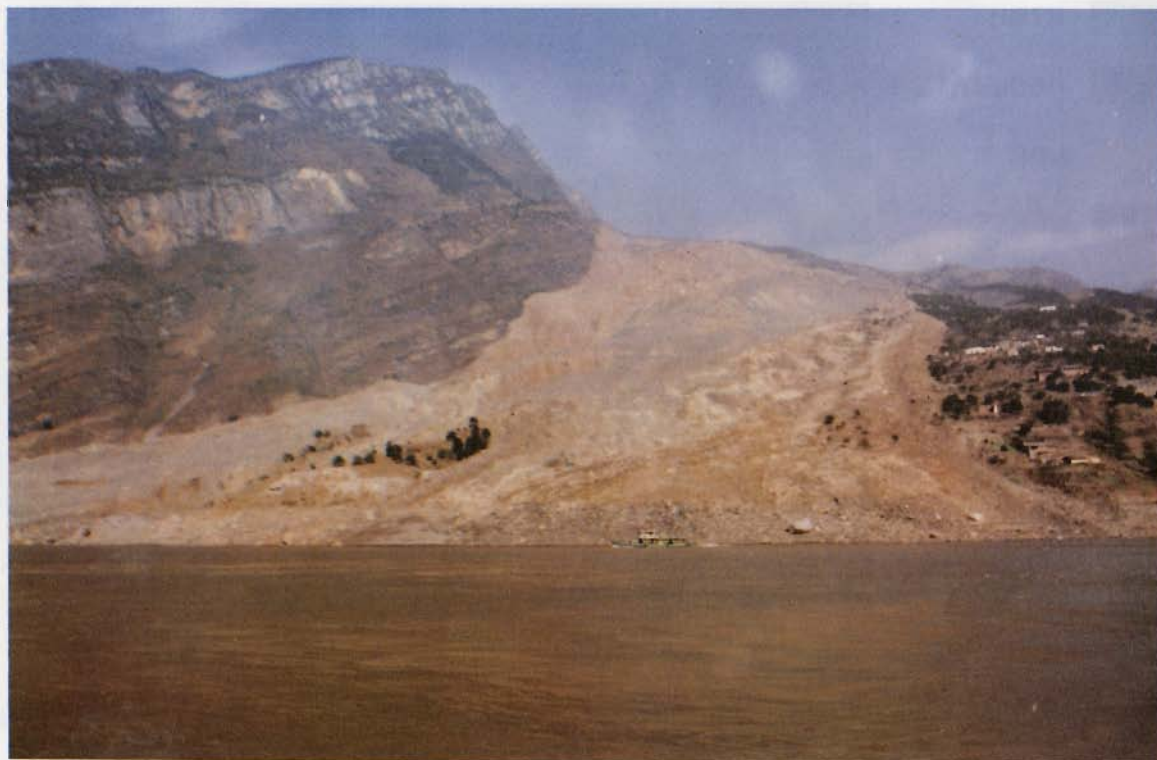
Plate 12a: Xintan Landslide on the North Bank of the Changjiang River

The landslide destroyed Xintan Town (middle background), Hubei Province

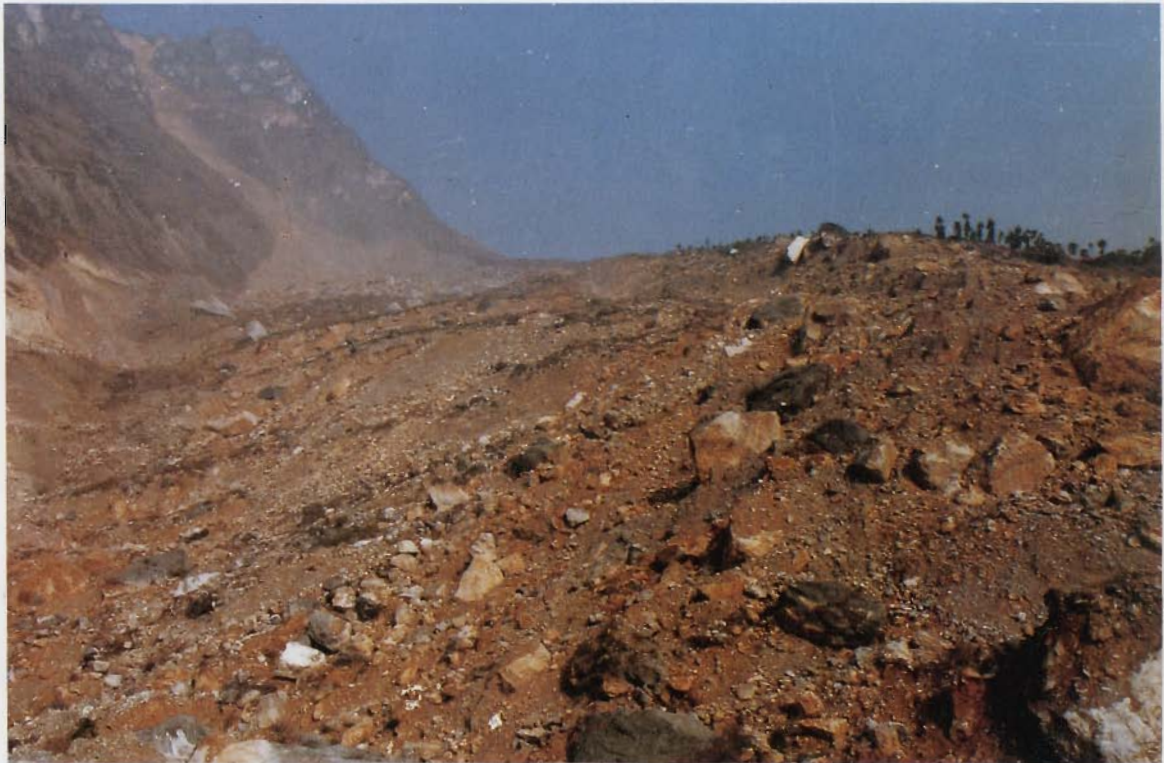
Plate 12b: A Close View Looking Northwards of the Upper Part of the Xintan Landslide

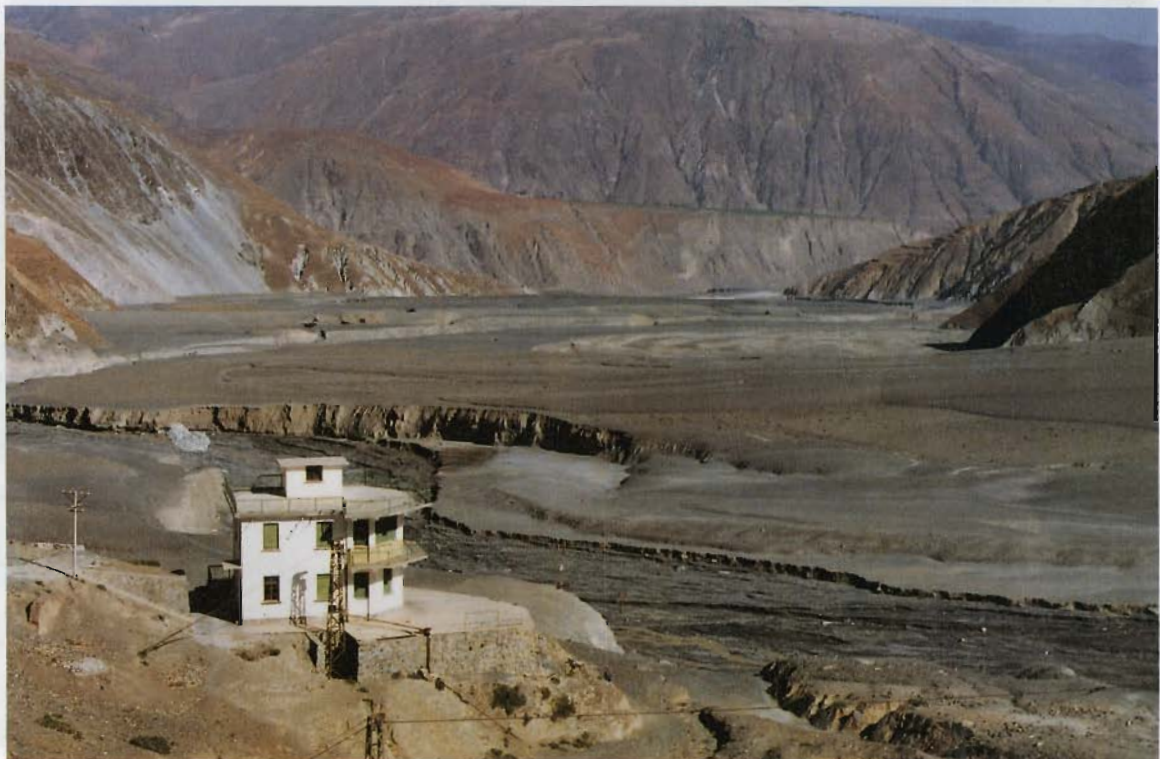
Plate 13: Dongchuan Debris Flow Observation Station Looking Westwards from the Lower Watershed of Jiangia Ravine

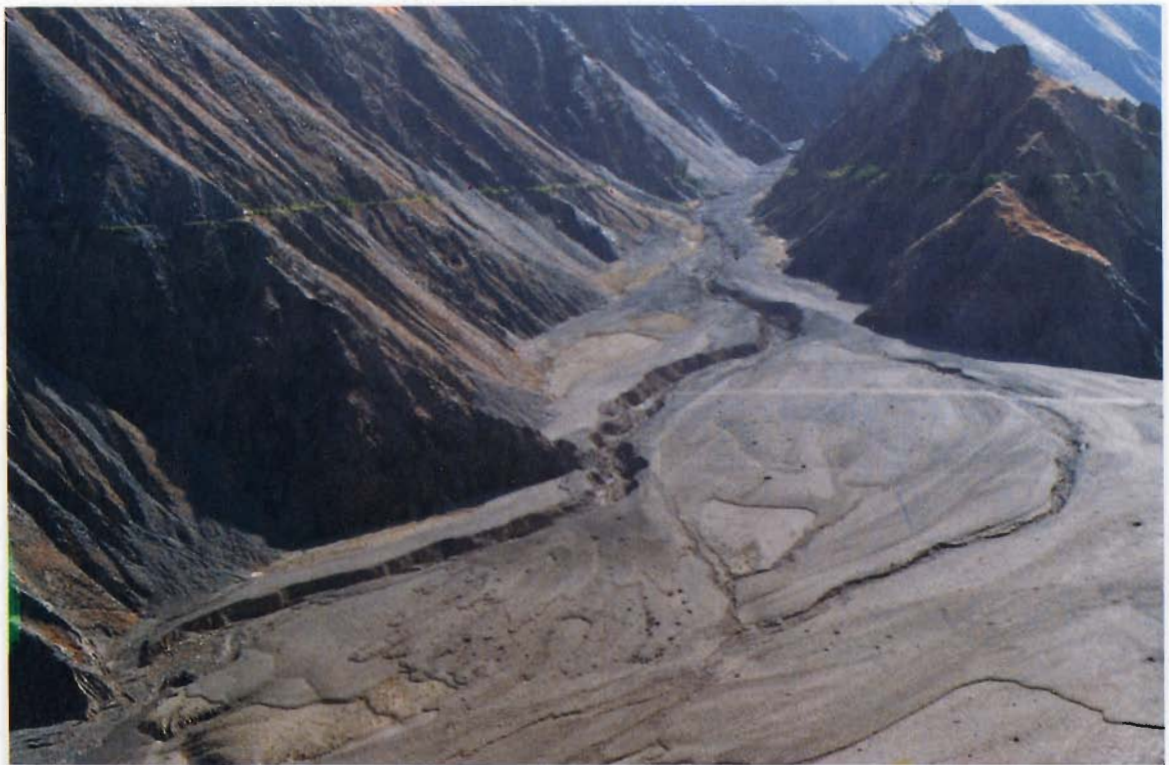
Plate 14: Debris Flow in the Watershed of Jiangjia Ravine

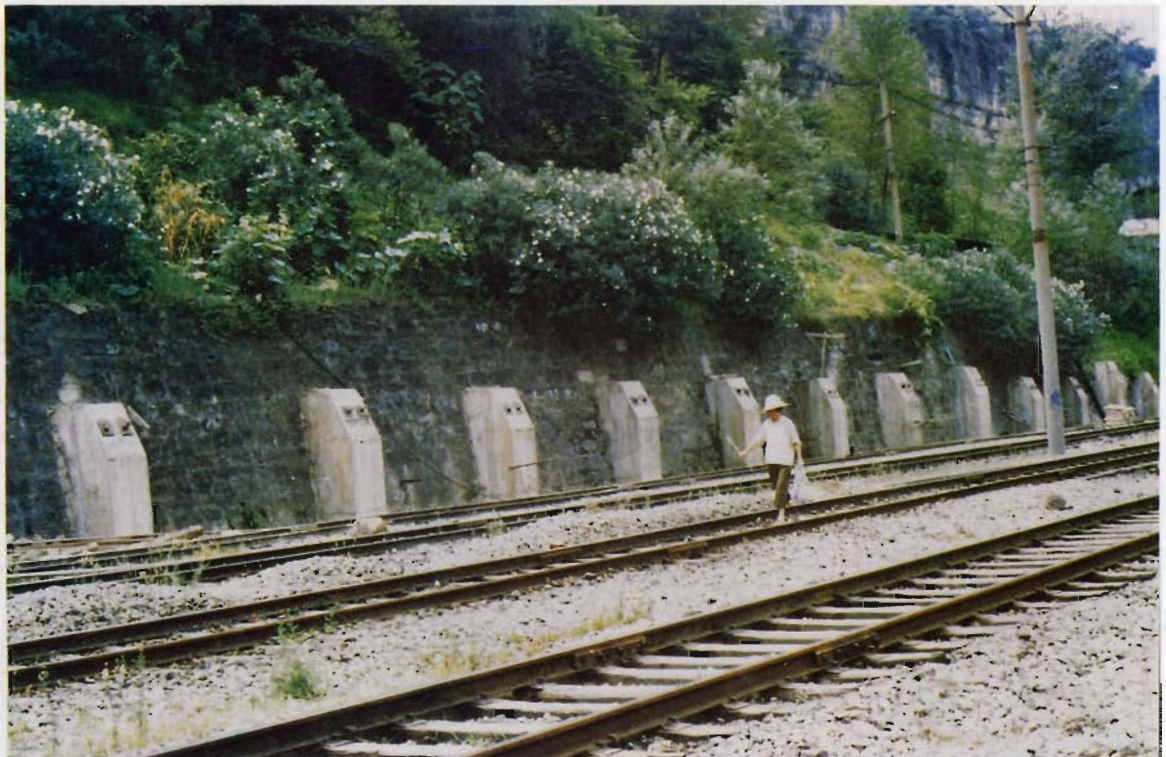
Plate 15: Control Works at the Jianjiyan Landslide, Songzao Coal Mining Area, Sichuan Province

The use of anchor-rope driven piles (centre, background) to stabilise landslides

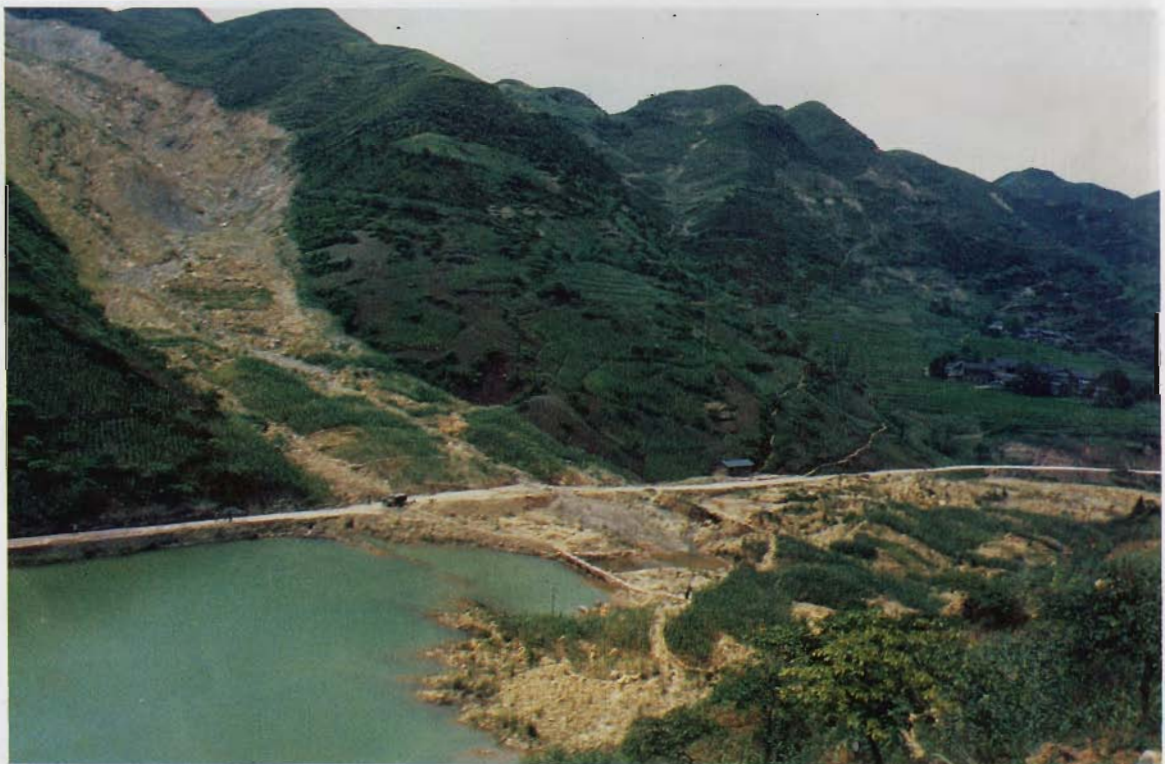
Plate 17: Looking Southwards from the Geling Landslide Dam (Sichuan Province)

The landslide dam formed in July 1982 during heavy rainstorms in Eastern Sichuan. This photograph shows the lake (foreground), remains of the Geling landslide dam (foreground), and the landslide (background).

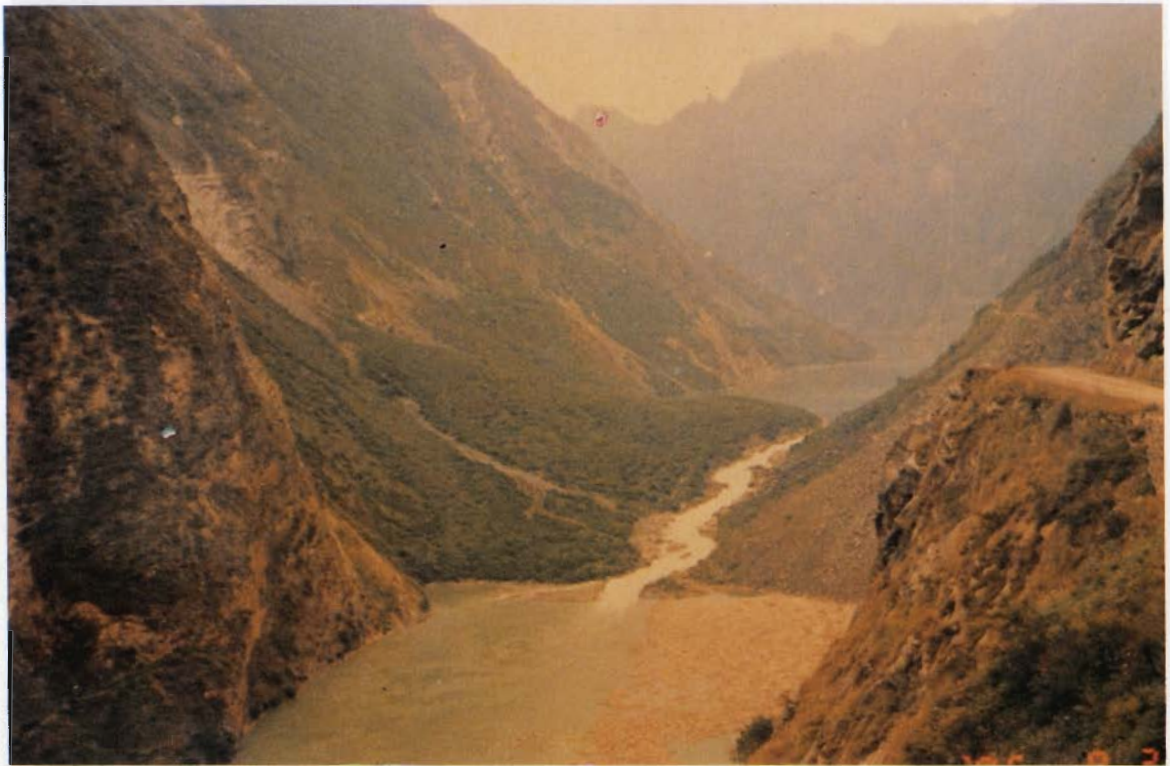
Plate 18: Yinping Landslide Dam (Sichuan Province)

Xiao Lake (foreground) is about 0.5 km wide here. The remains of the dam (centre) and Da Lake (middle ground) are shown as they were in 1985 (September) when this photograph was taken.

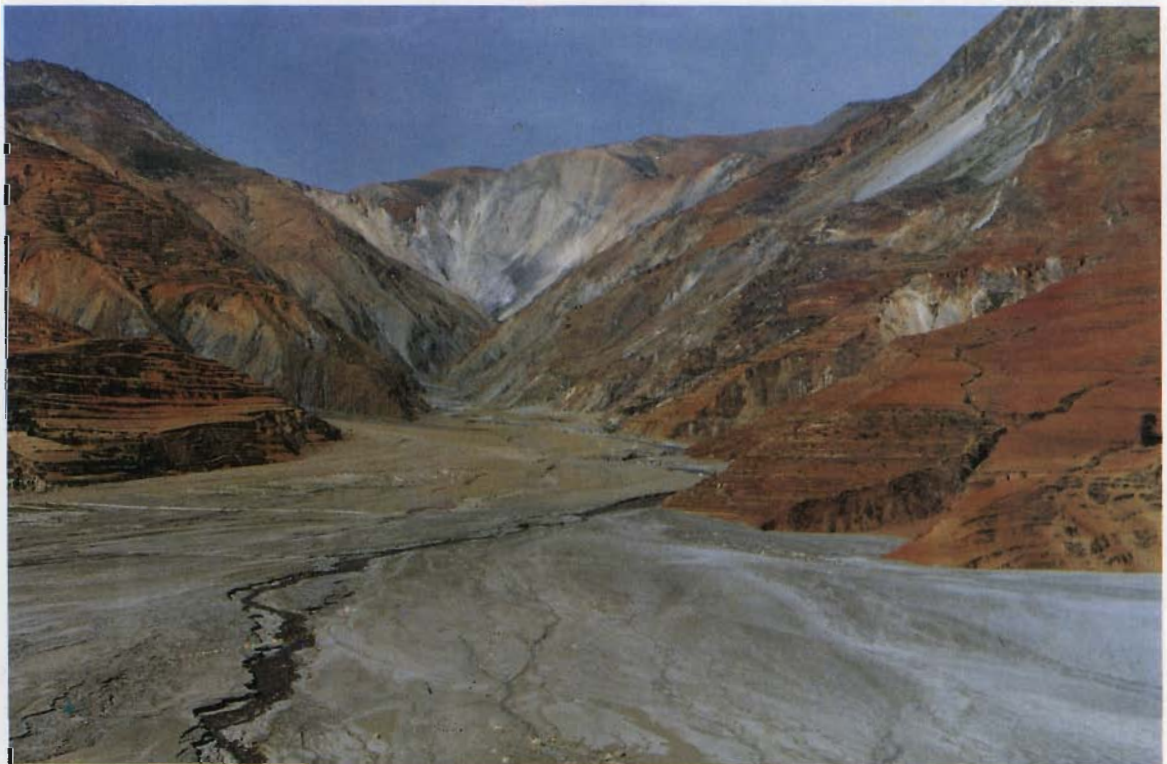
Plate 19: Landslide in Dabeini Ravine (Yunnan Province)

The landslide occurred at the head and on both sides of the valley, transporting large quantities of material into the ravines, and creating serious damage in the lower watersheds.

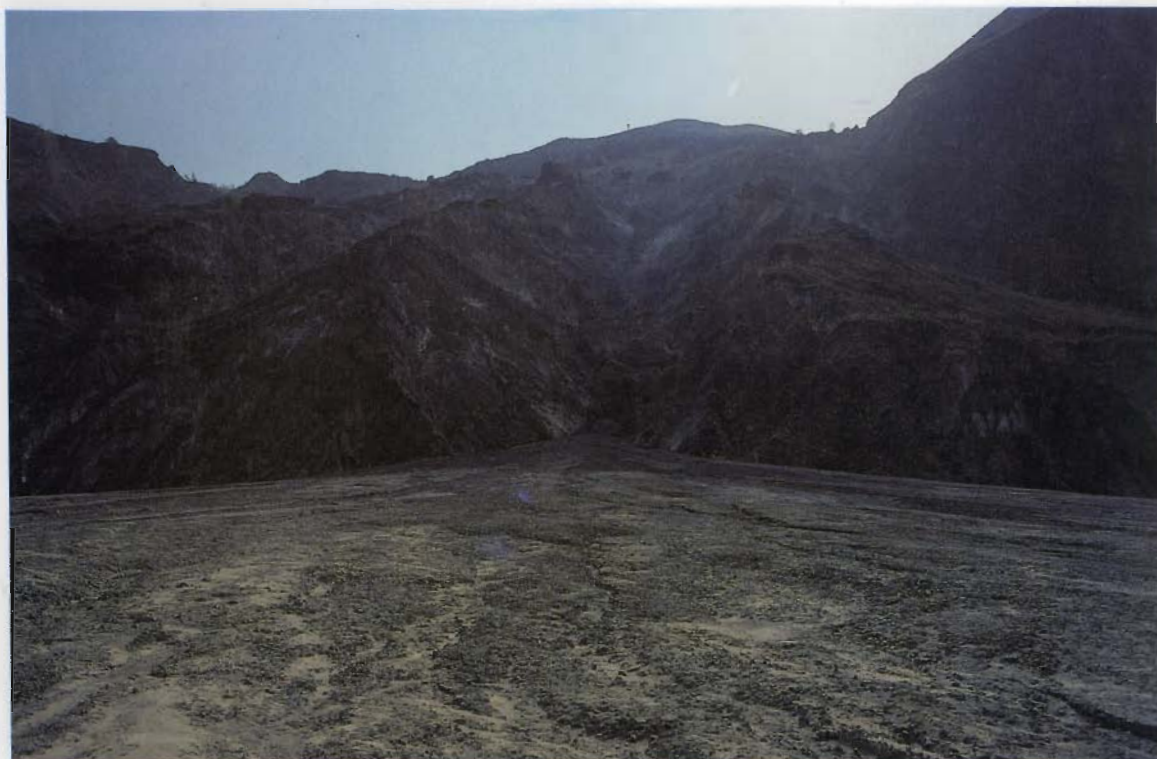
Plate 20: Landslides and Debris Flows in Xiaobeini Watershed (Yunnan Province)

Debris flow from the watershed temporarily blocked the Xiao River (immediate foreground). View looking westwards of large landslide above Xiabeini Ravine on hillside; alluvial fan of debris flow (centre).

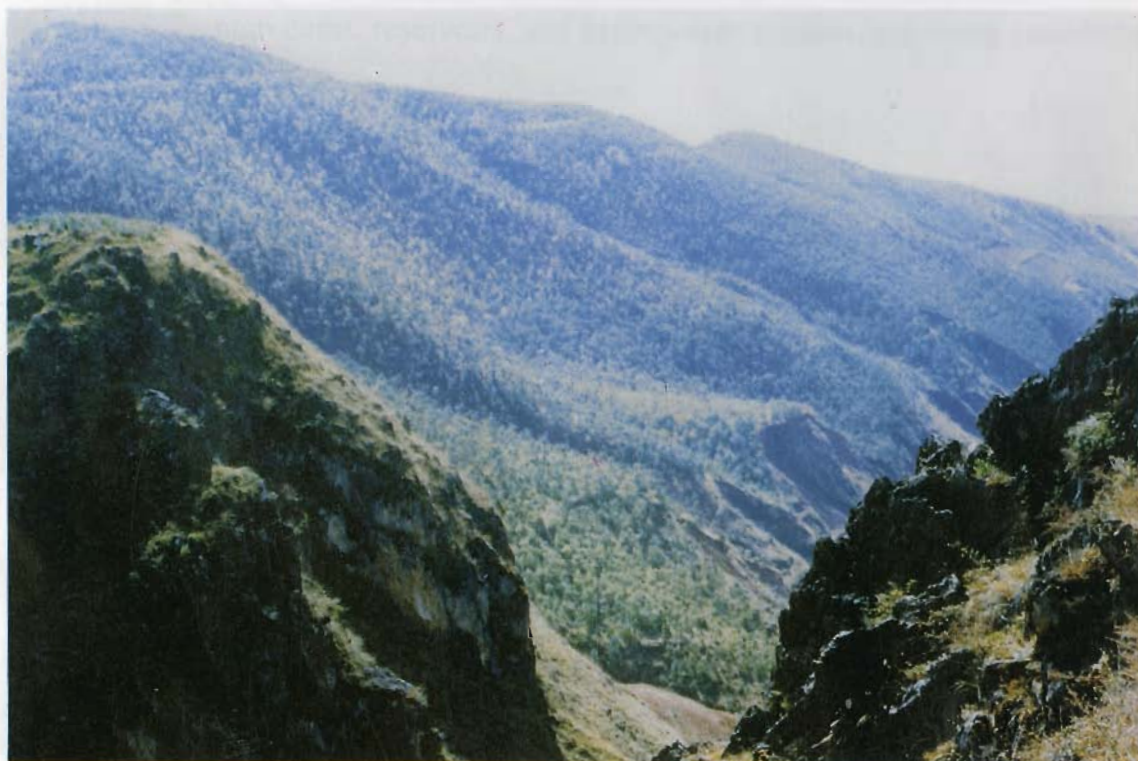
Plate 21: Reforestation in the Upper Watershed of the Dade Ravine (Yunnan Province)

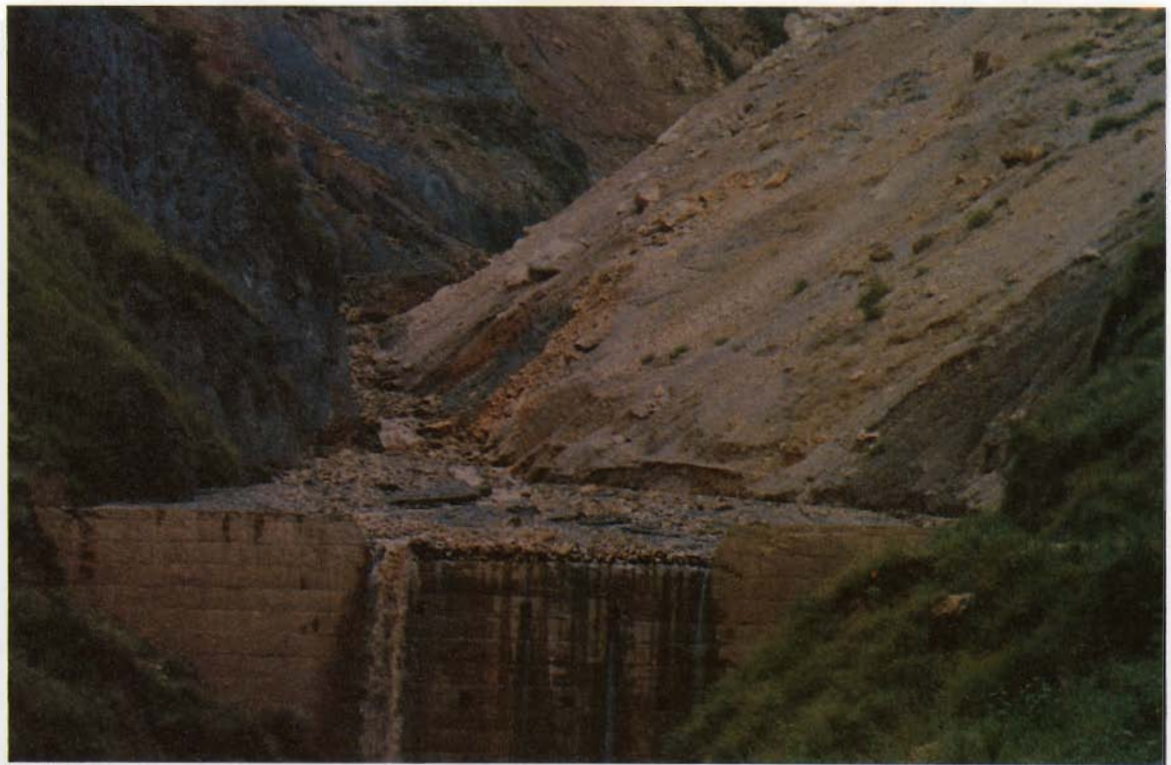
Plate 22: Check Dam in the Middle Watershed of Dade Ravine (Yunnan Province)
