INTRODUCTION

The commissioning of this report was prompted by the outbreak of a moraine-dammed lake below the Langmoche Glacier in Khumbu Himal, Nepal on 4 August 1985. The flood resulted in 4 or 5 deaths and destroyed the Namche Small Hydel Project, all the bridges, sections of trails, more than 30 houses and much arable land, for 40 km downstream on the Bhote Koshi/Dudh Koshi, (Galay 1985 ; Vuichard and Zimmermann 1986).

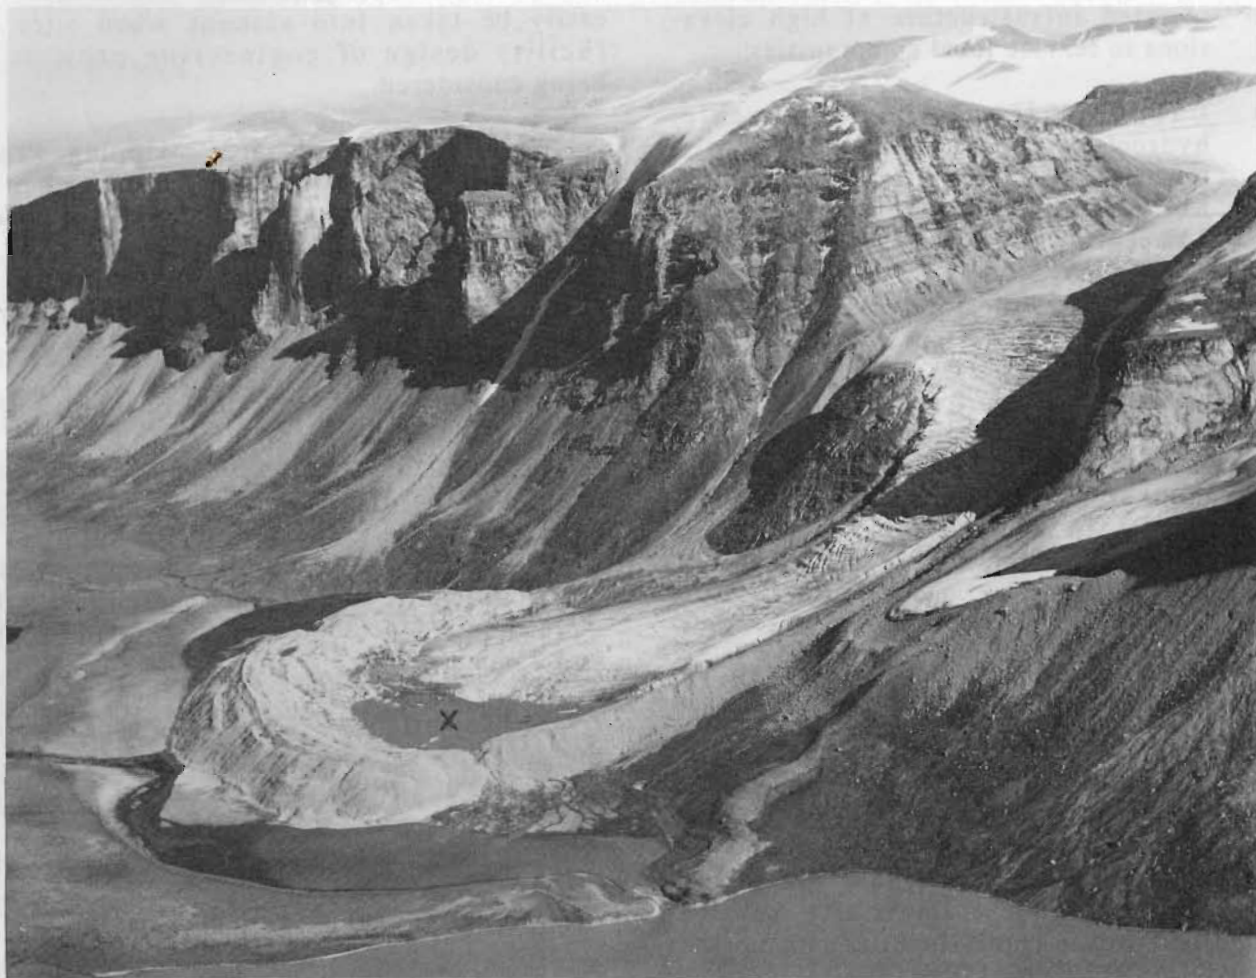
Plate 1. Small outlet glacier with end and lateral moraines, northeast Baffin Island. The lake (X) is a typical moraine-dammed lake, held up by an ice-cored system of end moraines that are 100 metres high.
