## THE NAMCHE SMALL HYDEL PROJECT, KHUMBU HIMAL

### Decision Making, Project Design, and Site Characteristics

### **Destruction of the Namche Hydel Project**

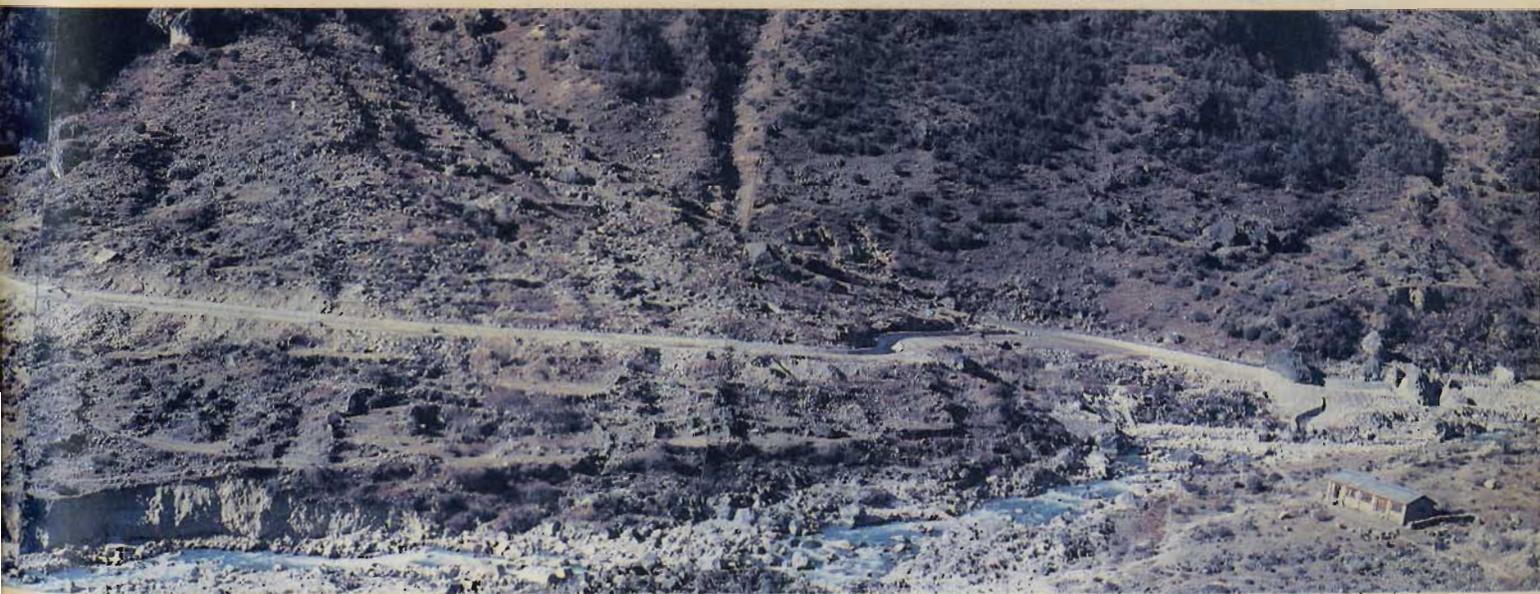
**Plate 4.** Panoramic view of the Namche Small Hydel Project site by Dr. Victor Galay in November 1984. The photographs are taken from the north side of the Bhote Koshi looking onto the debris cone. The headrace canal cuts conspicuously sub - horizontally across the fan. Undercutting of the fan has occurred during the preceding summer monsoon at (a) and (b).

The hydro-plant debris fan is marked by several conspicuous debris flow deposits and small torrent channels. The possibility of mudslide and soil creep occurrence was taken into account in the project design. Ground photographs, however, show that sections of the debris fan toe were being undercut by the Bhote Koshi prior to excavation and quite ex-

tensive undercutting is apparent in a November 1984 photograph when the excavation work was nearly complete (Plate 5, A & B).

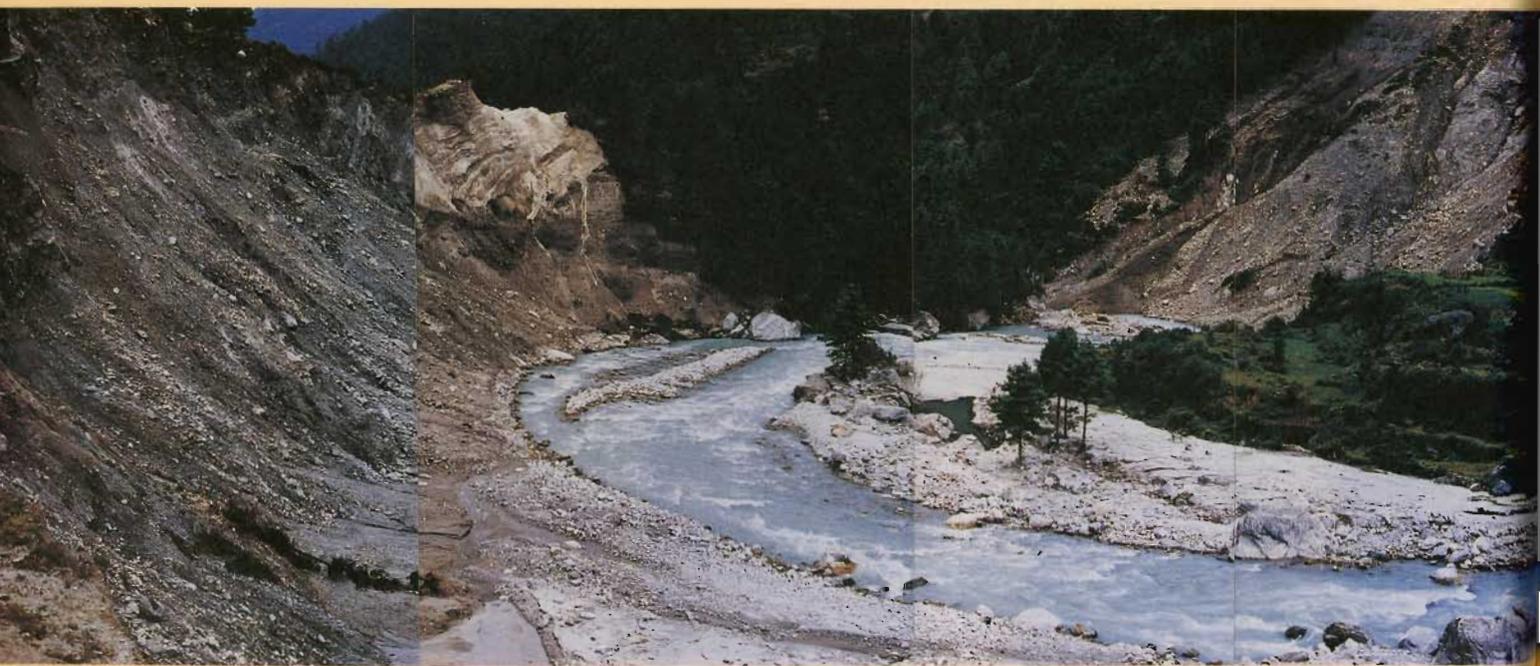
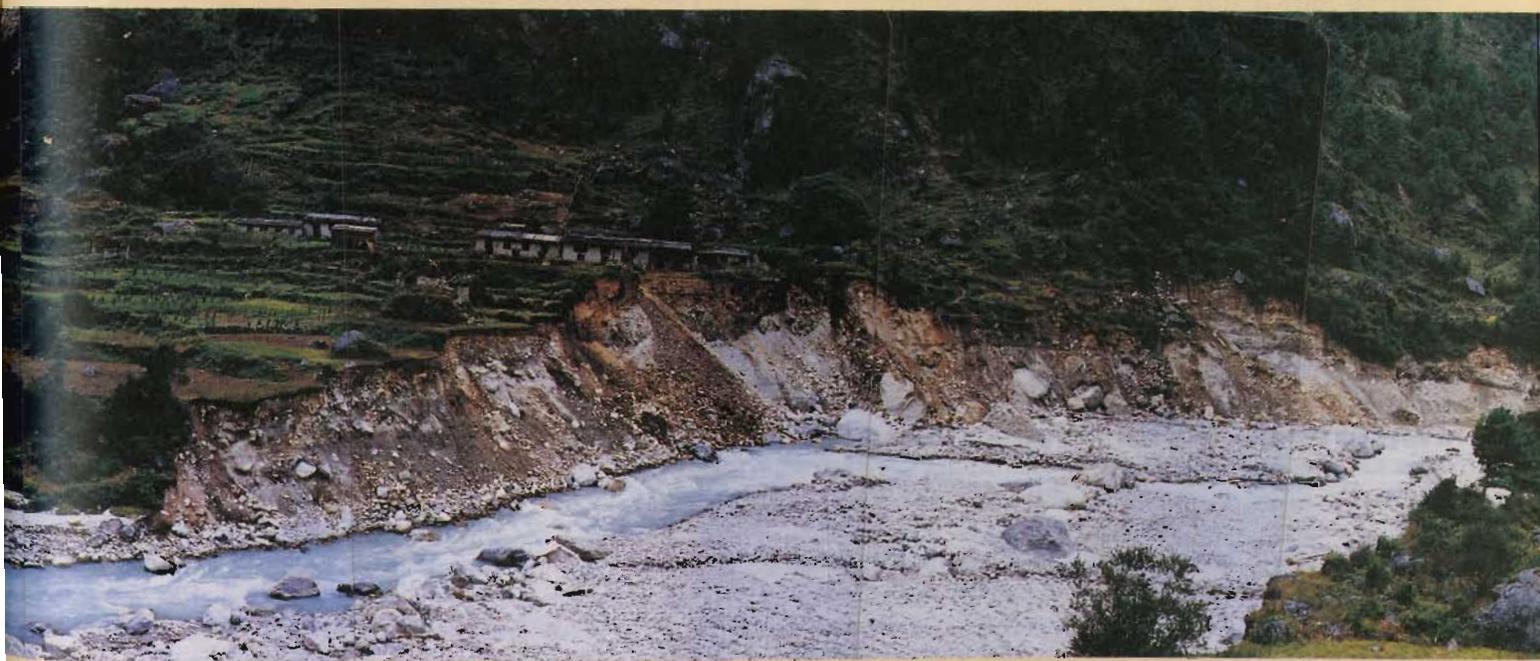
**Plate 5.** The Bhoté Koshi after the 4 August 1985, *jokulhlaup* showing aggradation and extensive bank undercutting and a large landslide.  
Photograph by Dr. Victor Galay.

The debris fan underwent extensive undercutting, erosion, and transport, with most of the erosion occurring in three distinct areas:

- o The vicinity of the weir and intake to the headrace canal;
- o The central tract of the toe;
- o The downstream tract in the vicinity of the power house site and tailrace.

Much erosion also took place on the north side of the stream. This erosion resulted in the total destruction of the weir and headrace intake, the upstream half of the headrace canal, the lower half of the penstock channel, the foundations for the power house, the tailrace, and the helicopter landing pad. In addition, the river channel, or flood plain, was extensively widened and heavily aggraded with three to seven metres of large-diameter debris. The character of the Bhote Koshi channel in this section, as well as that of the debris fan, has been totally changed. This has probably made the site unsuitable for any salvage or reconstruction action, even if it is assumed that the draining of Dig Tsho was a unique event and that there is no likelihood of future *jokulhlaup* occurring from any alternate source within the Bhote Koshi catchment. The latest report from the Small Hydel Development Board is that the feasibility of constructing several micro-power stations away from the main stream is being explored.
