THE LANGMOCHE DISASTER, 4 AUGUST 1985

Characteristics of Langmoche and Triggering Mechanism

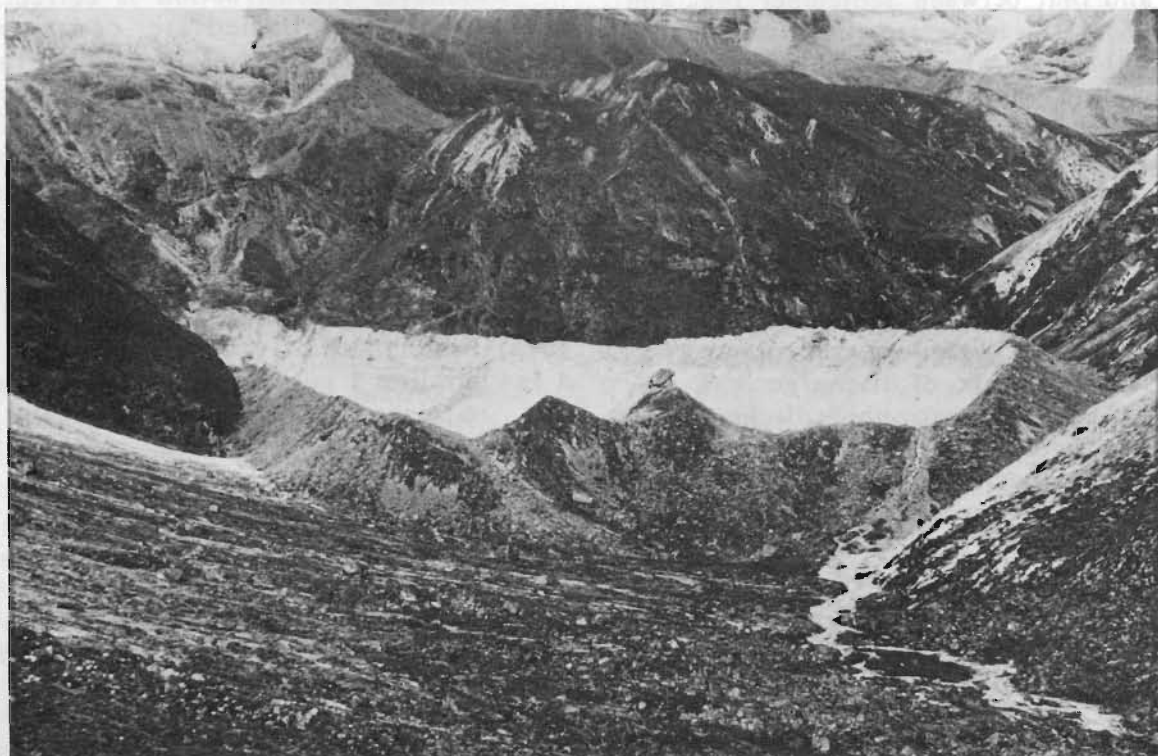
Plate 6. A wide angle view of Dig Tsho, and the intact curve of the end moraines with the small stream draining from it.
Photograph by M. Zimmermann, 3 September 1982.

A photograph taken on 3 Sept. 1982 (Plate 6) by M. Zimmermann clearly shows Dig Tsho. Furthermore, it can be seen that on that date the lake level was coincident with the lowest point of its end moraine dam across which a small stream discharged. Drainage also may have occurred by seepage through the lower part of the moraine. The intact end moraine and small outflow stream are also apparent.

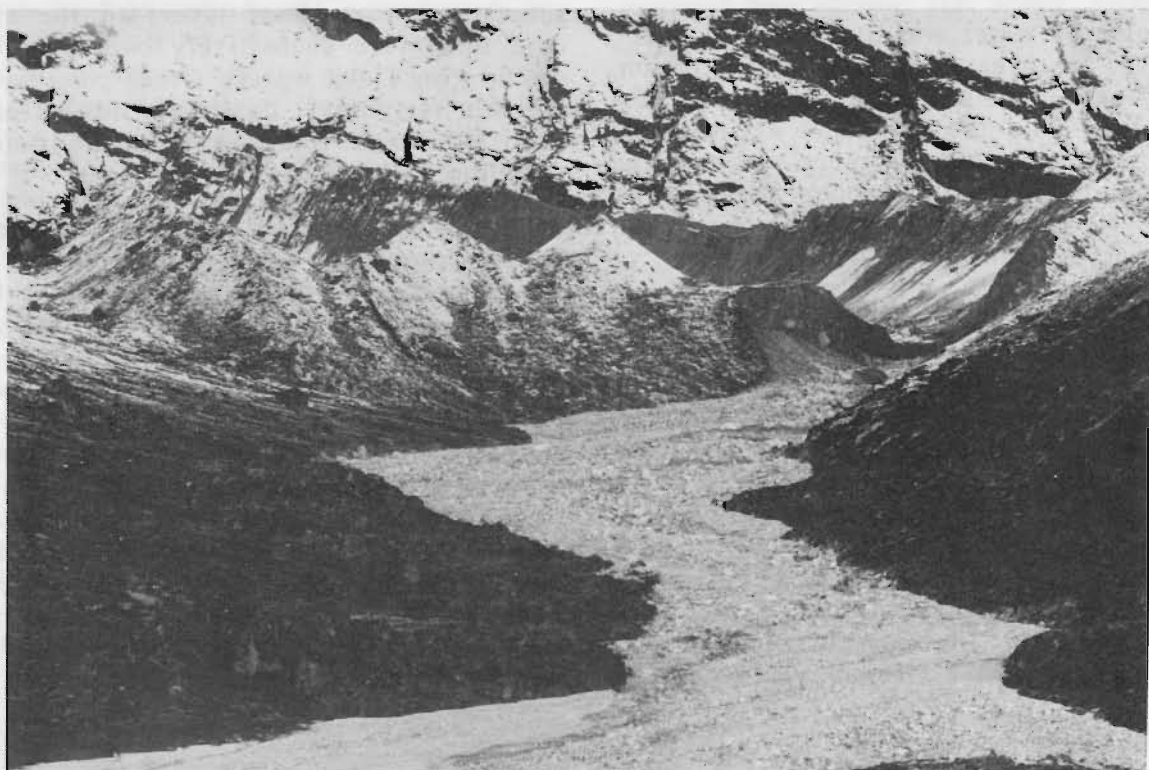
Plate 7. Similar view to 6., but taken after the 4 August 1985 *jokulhlaup* showing the breach in the end moraine of the Langmoche Glacier.
Photograph by D. Vuichard.

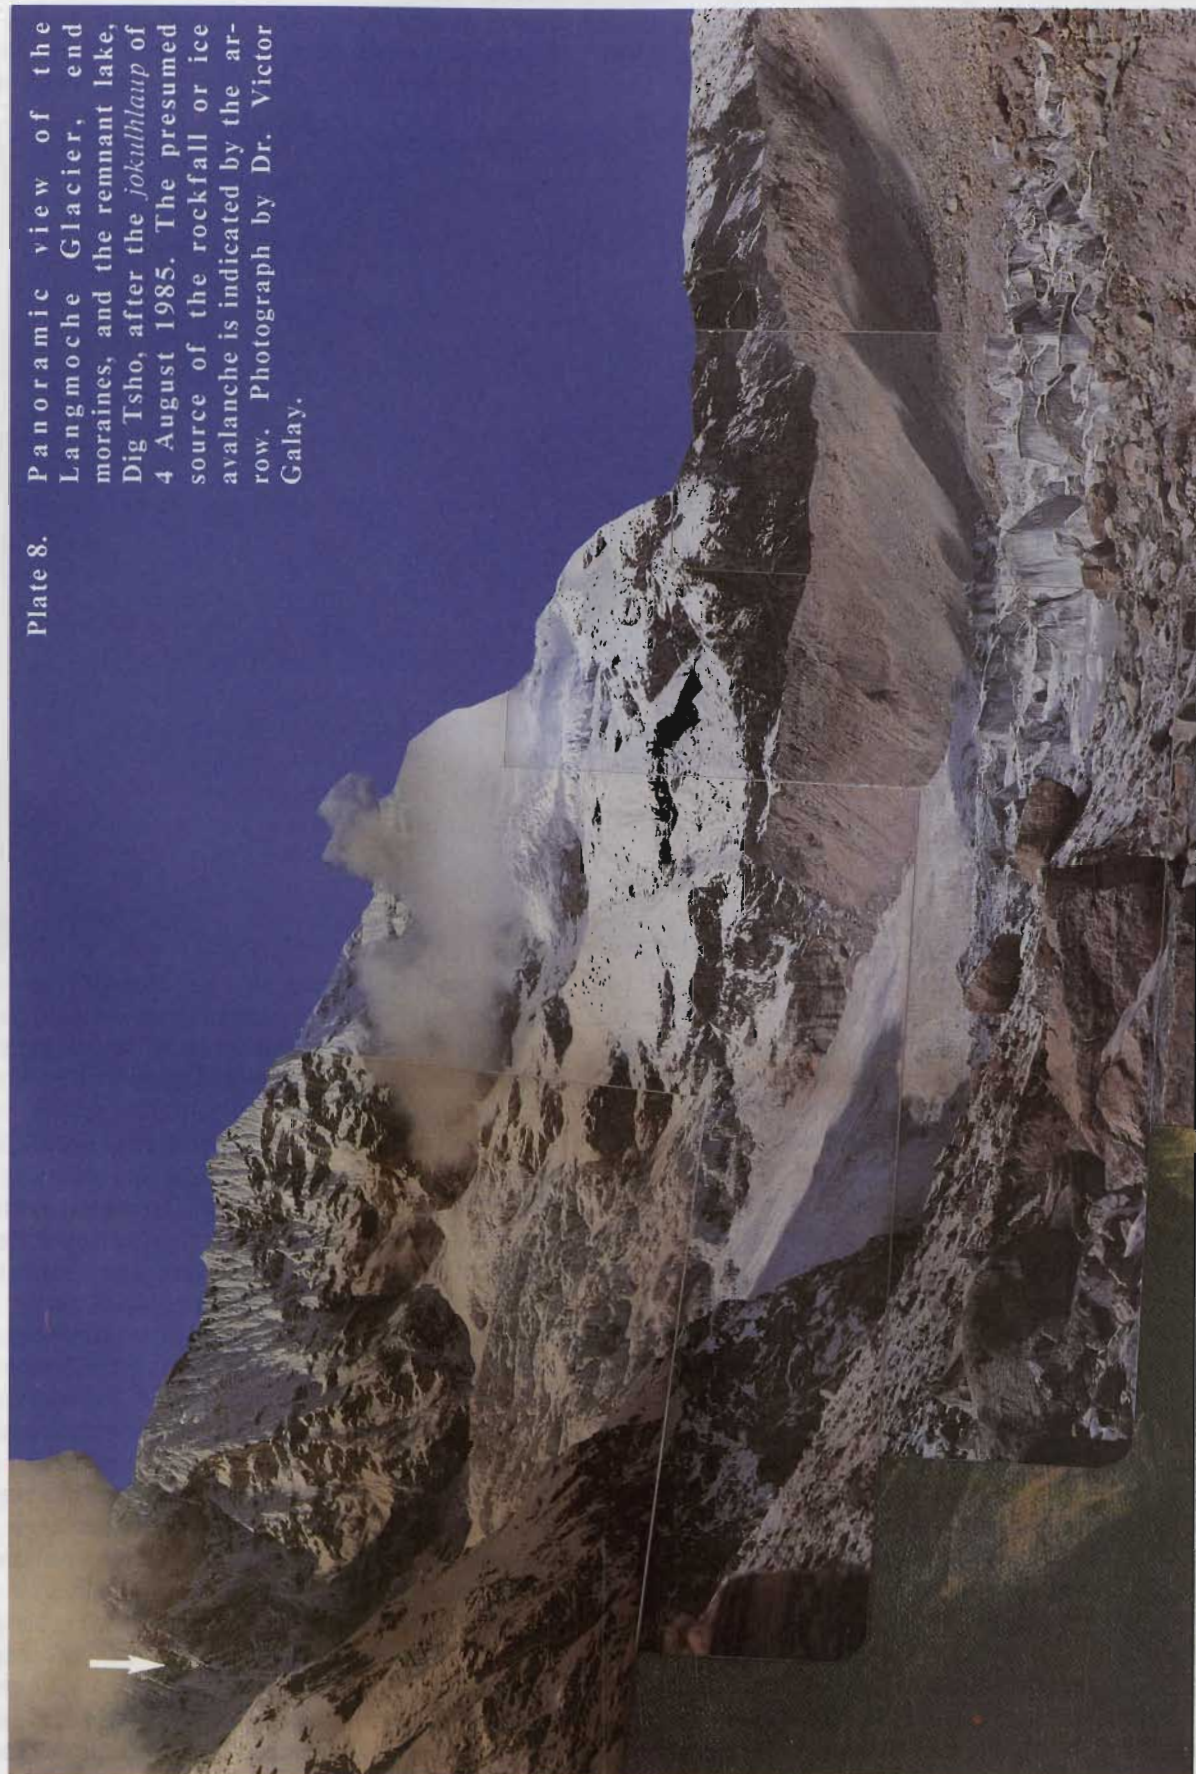
Plate 8. Panoramic view of the Langmoche Glacier, end moraines, and the remnant lake, Dig Tsho, after the *jokulhlaup* of 4 August 1985. The presumed source of the rockfall or ice avalanche is indicated by the arrow. Photograph by Dr. Victor Galay.

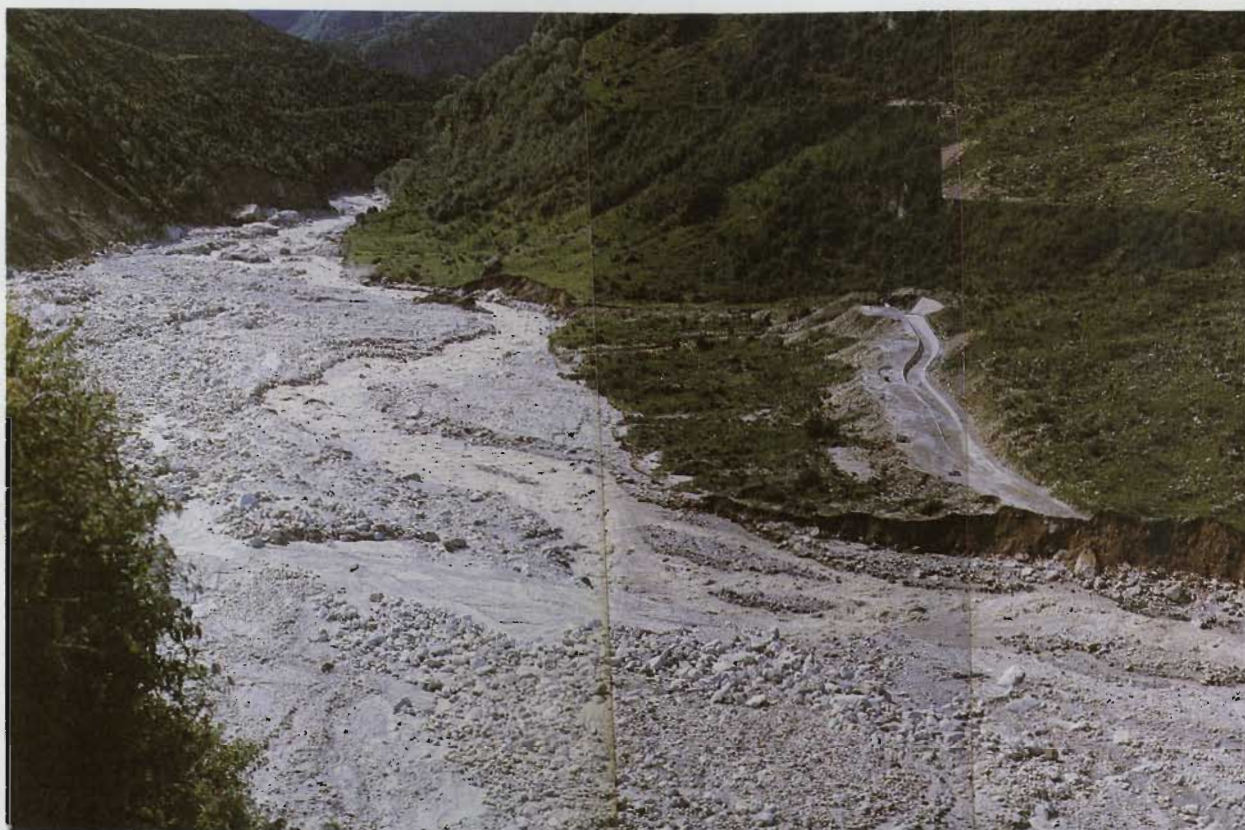
Plate 9. Channel of the Bhote Koshi in the vicinity of the hydel project after the 4 August 1985, *jokulhlaup*. Note the extensive aggradation as well as heavy erosion (of the debris fan) in the same stretch. Photograph by Dr. Victor Galay.

Massive changes occurred in the riverbed over most of the distance between Dig Tsho and the Sun Koshi confluence. This was due to a combination of erosion and deposition, both within the same stretch of river (Plate 5) and in successive sections depending on channel and valley characteristics. Large and medium sized debris flows were touched off by lateral erosion in numerous localities (Plate 9) and innumerable small slumps occurred (cover plate).

The local communities, of necessity, replaced the eroded sections of trail. These emergency efforts were piecemeal and uncoordinated, and the end result was less than satisfactory (Plate 9). For instance, seven acci-
