Relationships Between Landsliding and Land Use in the Likhu Khola Drainage Basin, Middle Hills, Nepal

Source: Mountain Research and Development, 22(1) : 48-55

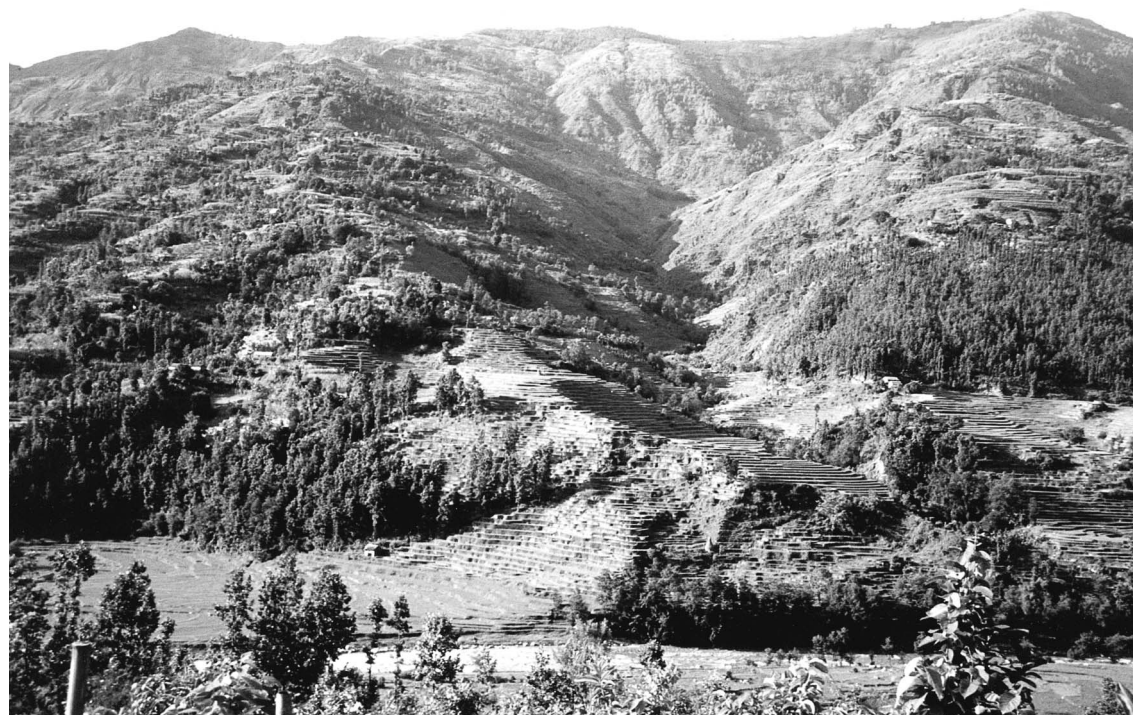
FIGURE 3 General view of the Dee subcatchment of the Likhu Khola (visible in the foreground), with *khet* terraces on the lower slopes and patches of woodland and *bari* terraces on the higher slopes. A few landslide scars are visible. (Photo by John Gerrard)

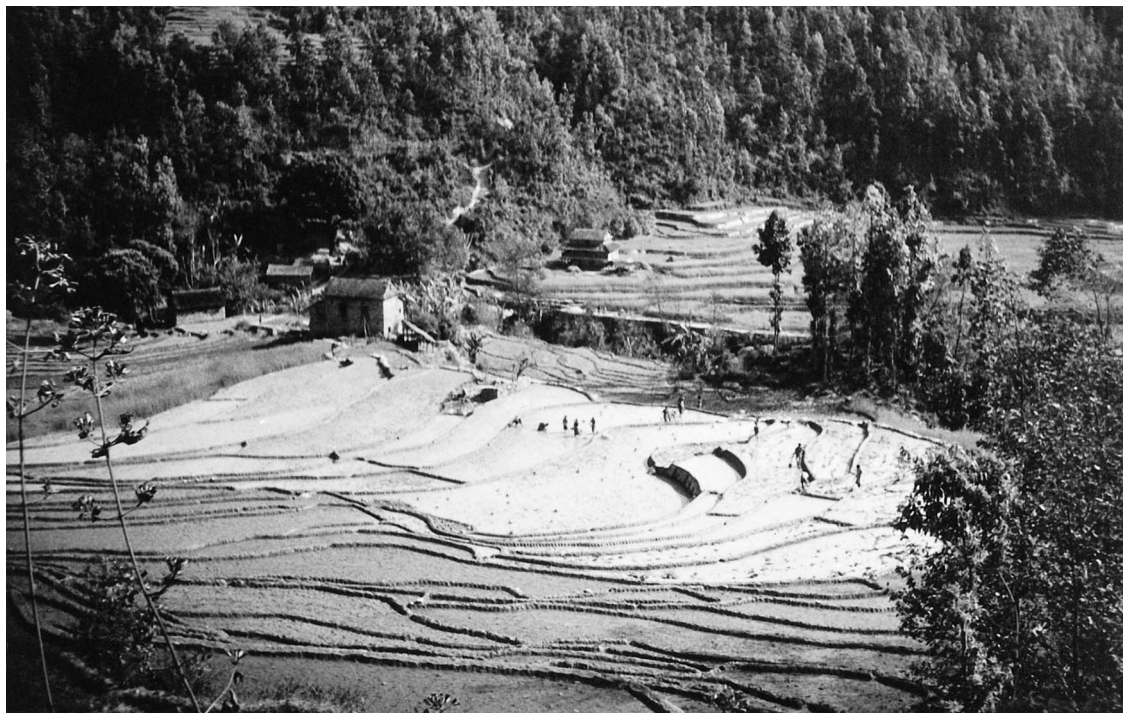
FIGURE 4 Rice transplanting on *khet* terraces low down on the valley side. Remnants of *sal* woodland in the background, in various states of degradation. (Photo by John Gerrard)
