Understanding Flash Flood Hazards

For proper flash flood management, practitioners must understand the factors that cause flash floods. The main processes causing flash floods in the HKH region are intense rainfall, landslide dam outburst, and glacial lake outburst. This chapter describes the physical factors causing these and gives some examples.

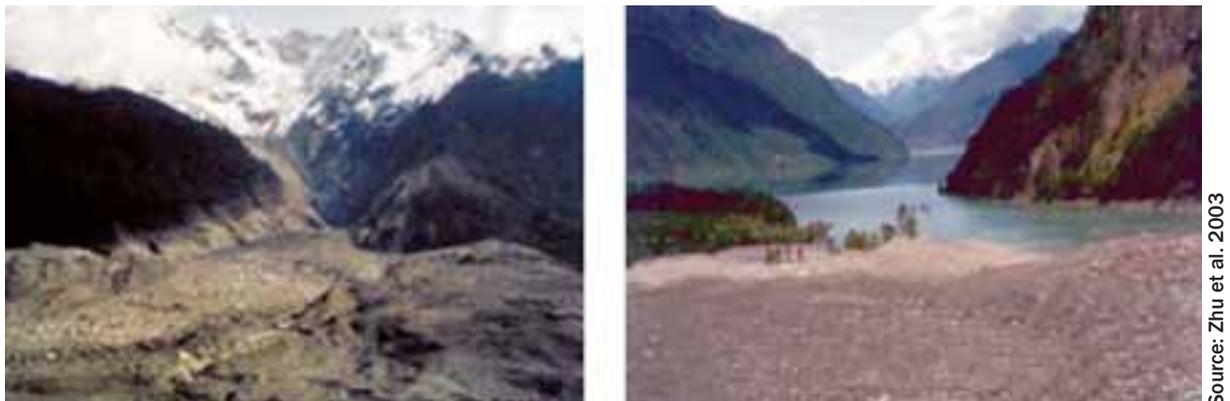
Figure 13: The Zhamulongba landslide that blocked the Yigongzanghu River (left) and the landslide dammed lake across the Yigongzanghu River (right)

One of the most striking examples of a LDOF is that of the Yigong River in eastern Tibet. As a result of sudden temperature increase, a huge amount of snow and ice melted in the region, and a massive, complex landslide occurred on 9 April 2000 in the upper part of the Zhamulongba watershed on the Yigong River, a tributary of the Yarlung Zangbo River. About 300 million cubic metres of displaced debris, soil, and ice dammed the Yigong River (Figure 13). In eight minutes a 100m high, 1.5 km wide (along the river), and 2.6 km long (across the river) landslide dam was created. The Type III landslide dam had a volume of 300 million m³ (Shang et al. 2003). The dam blocked the Yigong River, and, due to an inflow of about 100 m³/s from Yigong River, the lake level rose by about one metre per day. An attempt was made to dig a large trench and release the water from the lake, but it failed to avert the outburst. The outburst occurred on 10 June 2000 and created a huge flash flood downstream. The maximum depth of the flood was 57m, the maximum velocity was 11.0 m/s, and the flood was 1.26x10⁵ m³/s. The peak flood was 36 times greater than the normal flood. Tongmai Bridge, the highway between Yigong Tea Farming Base and Pailong County, and two suspension bridges in Medong County were all destroyed by the flood, but no injuries or deaths occurred on Chinese territory (Figure 14). On the Indian side of the border, however, damage from the flash flood from the dam failure was of a scale seldom seen before and resulted in the death of 30 people, with more than 100 people missing. The flood in the Brahmaputra River as it entered India was 1.35x10⁵ m³/s (Zhu and Li 2000; Zhu et al. 2003). More than 50,000 people in five districts of Arunachal Pradesh, India, were rendered homeless by the flash flood, and more than 20 large bridges, lifelines for the people, were washed away. The total economic loss was estimated at more than one billion rupees (22.9 million US dollars).

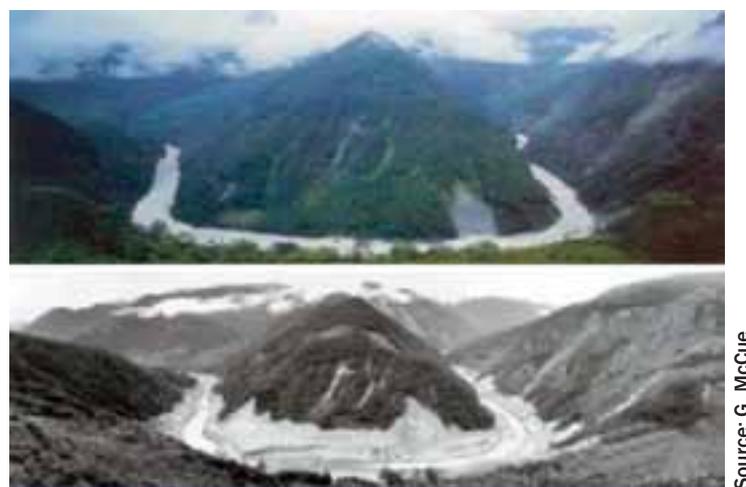
Figure 14: The Palung Zambo River, a tributary of the Yigongzanghu River, before (top) and after (bottom) the Zhamulongba landslide dam outburst of 10 June 2000

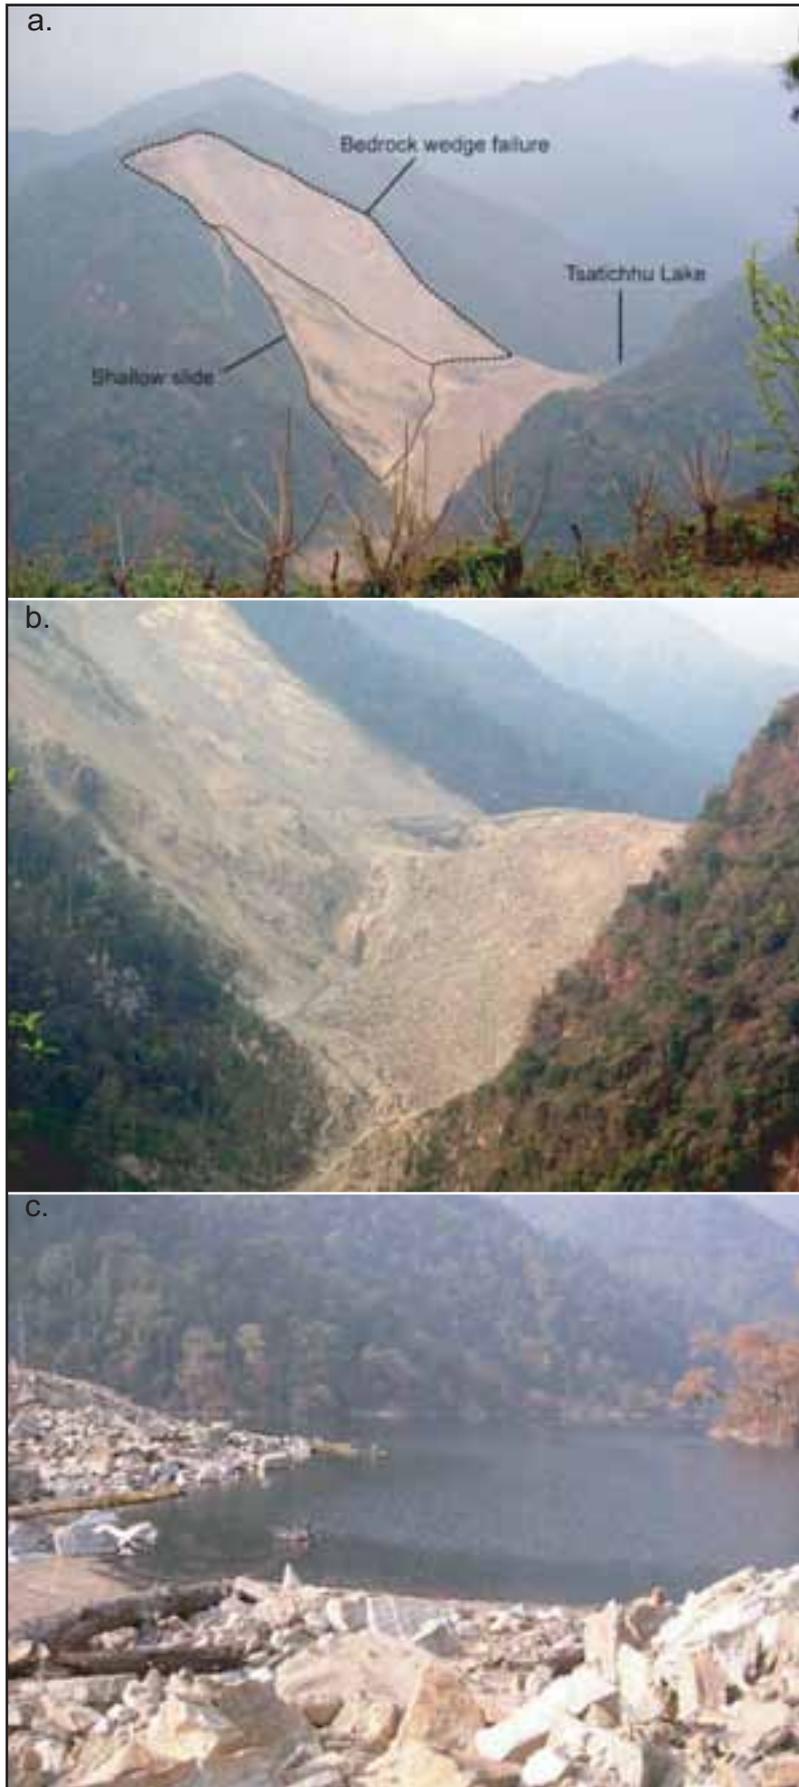
Figure 15: Tsatichhu landslide dam: a. the source area of the landslide; b. detailed view of the dam; c. Tsatichhu lake

The landslide dammed the Tsatichhu River and formed a lake referred to as Tsatichhu Lake (Figure 15). The lake extended 1 km up-valley, and had an estimated volume of $4\text{-}7 \times 10^6 \text{ m}^3$ at its full level. A small surface outflow occurred in December 2003, but did not cause failure of the dam. There was also significant seepage through the dam, which together with the surface outflow maintained equilibrium with the river inflow of $0.53 \text{ m}^3/\text{s}$.

The dam survived for 10 months. From 15 to 21 May 2004, heavy rainfall caused some material from the downstream face of the dam to fail, but did not cause a major failure. On 10 July 2004, a major failure of the dam occurred after a period of prolonged intense rainfall. The exact process of the failure is unknown although it is suggested that a combination of downstream slope failure and overtopping was the cause. The failure caused an enormous flood downstream. The mass of debris blocked the Kurichu River for 45 minutes. After 80 minutes the flood arrived at Kurichu Hydropower Plant 35 km downstream, where the peak discharge was $5900 \text{ m}^3/\text{s}$. Later calculations estimated the peak discharge at the outflow at $7700 \text{ m}^3/\text{s}$. The flood wave was up to 20m high. Due to the 10 months' gap between the formation and failure of the dam, the Department of Energy had sufficient time to put an early warning system into place, which resulted in timely warning to the hydropower plant. Pre-lowering of the water level enabled the reservoir to cater to the flood with only minor damage to the infrastructure. This flash flood did not result in any human casualties, although loss of agricultural land was significant (Xu et al. 2006). A significant section of road into the Autosho village at the confluence of Tsatichhu/Wabrangchhu and Kurichhu was completely destroyed.

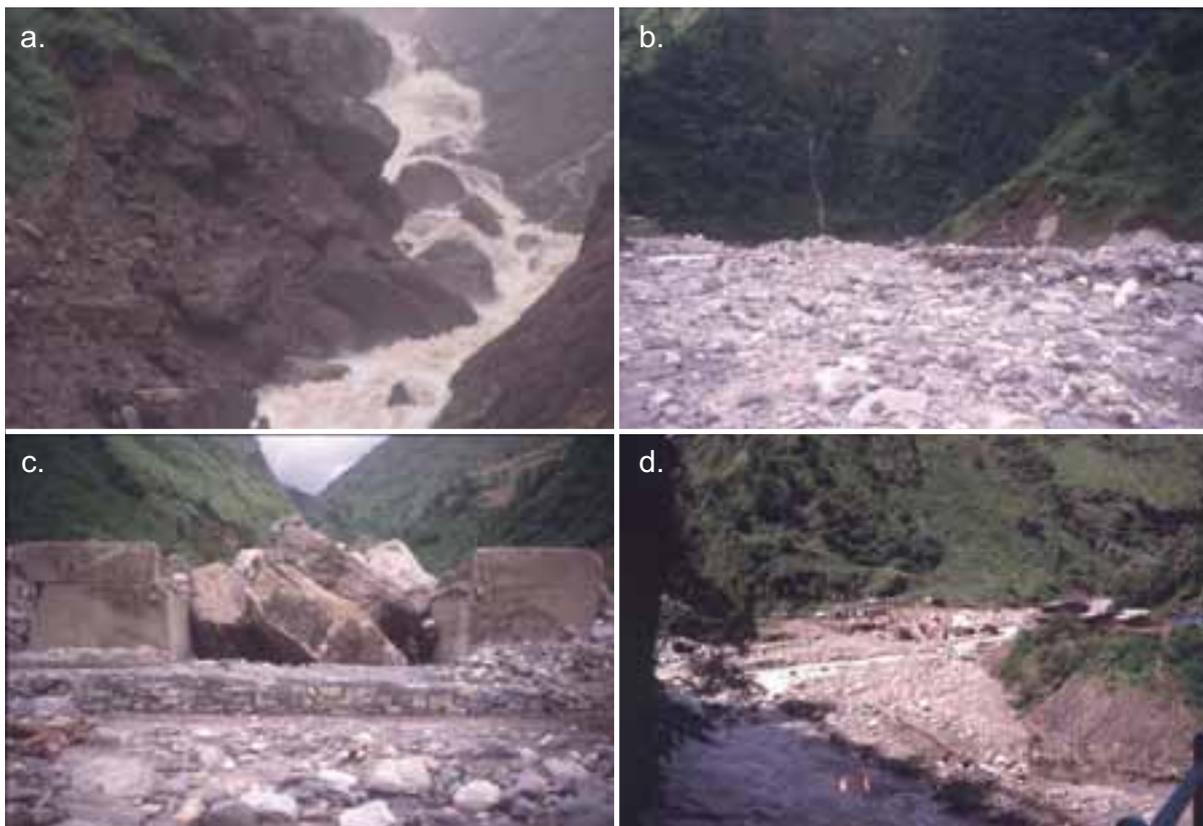
Figure 17: a. Bhairabkunda Khola a few days after the LDOF; b. debris deposited by the LDOF; c. large boulders trapped at the highway bridge; and d. Larcha village destroyed by the flash flood

Bhairabkunda Khola was dammed in 1996. The landslide dam outburst flood destroyed 22 houses and killed 54 people in Larcha village. The highway bridge was swept away by the flash flood (Figure 17).

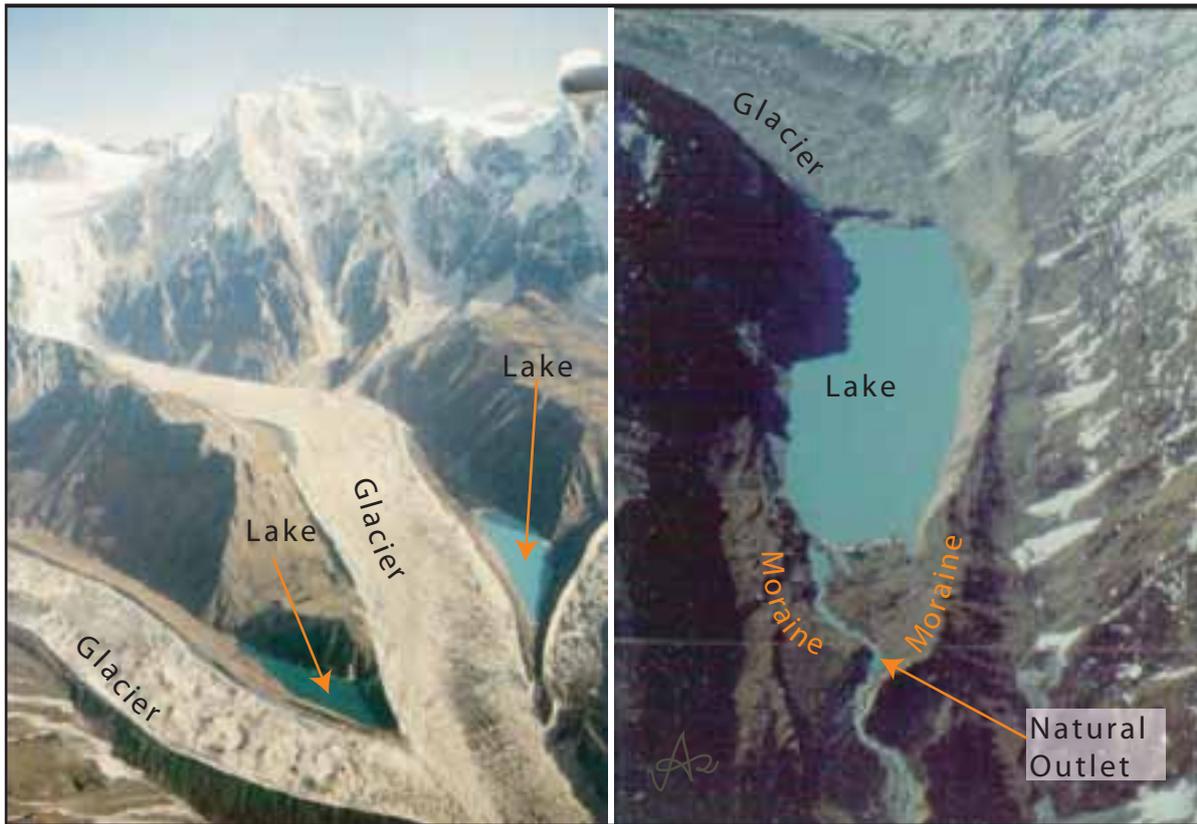
Figure 19: Typical ice-dammed (left) and moraine-dammed (right) lakes

Depending on the juxtaposition of the lake with respect to the glacier, the lakes can be supraglacial, englacial, or marginal. Figures 18 and 19 show schematic and real representations of typical locations of ice-dammed and moraine-dammed lakes.
