3 Early Warning Systems, Monitoring, and GLOF Mitigation

Monitoring and early warning systems

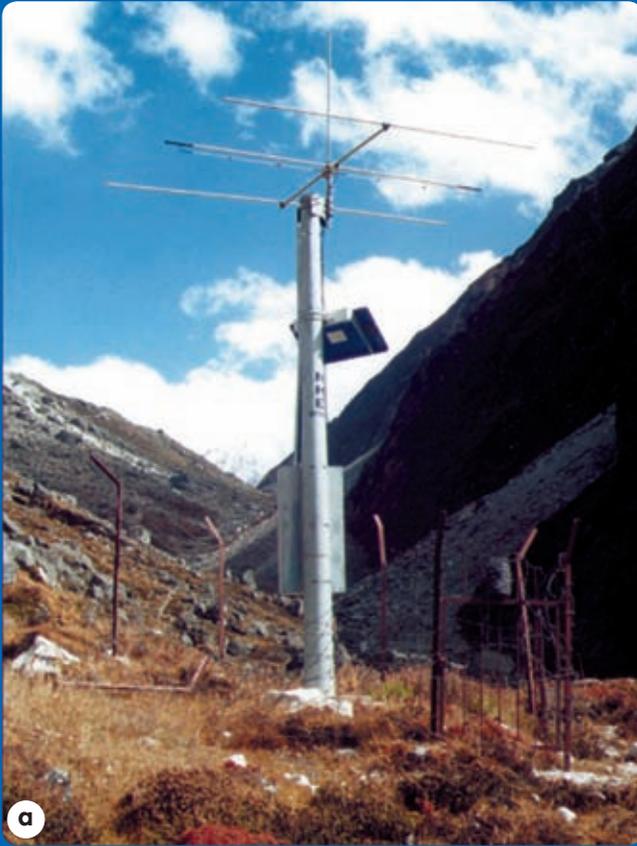
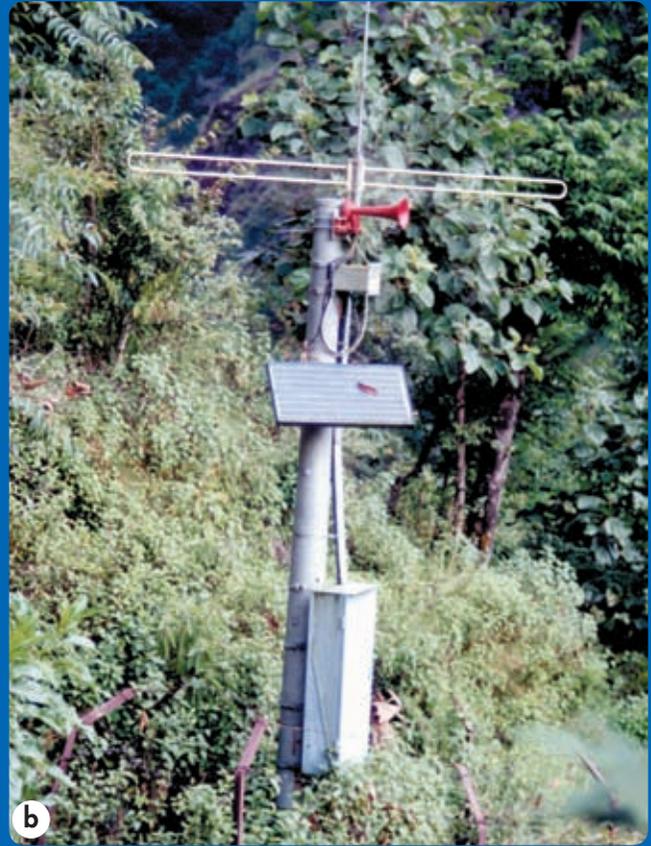
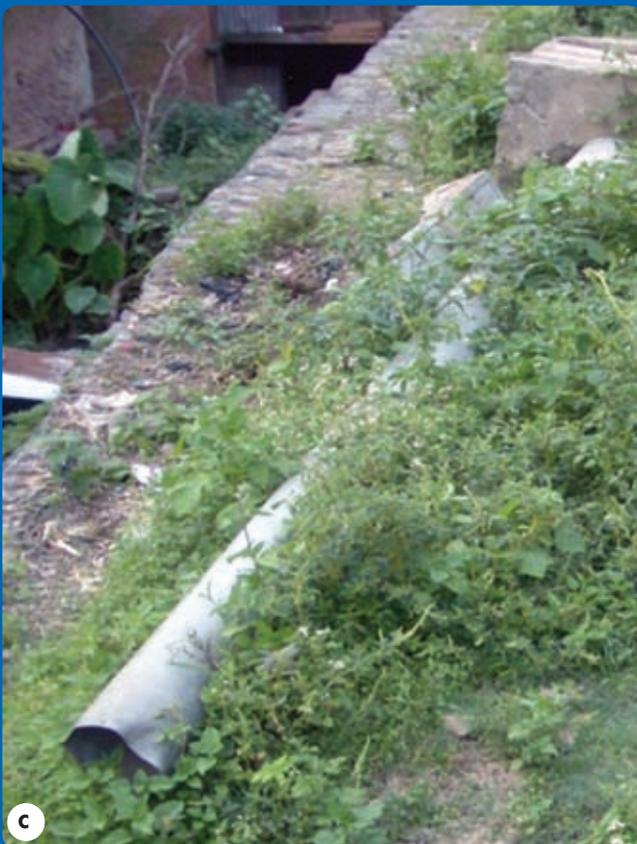
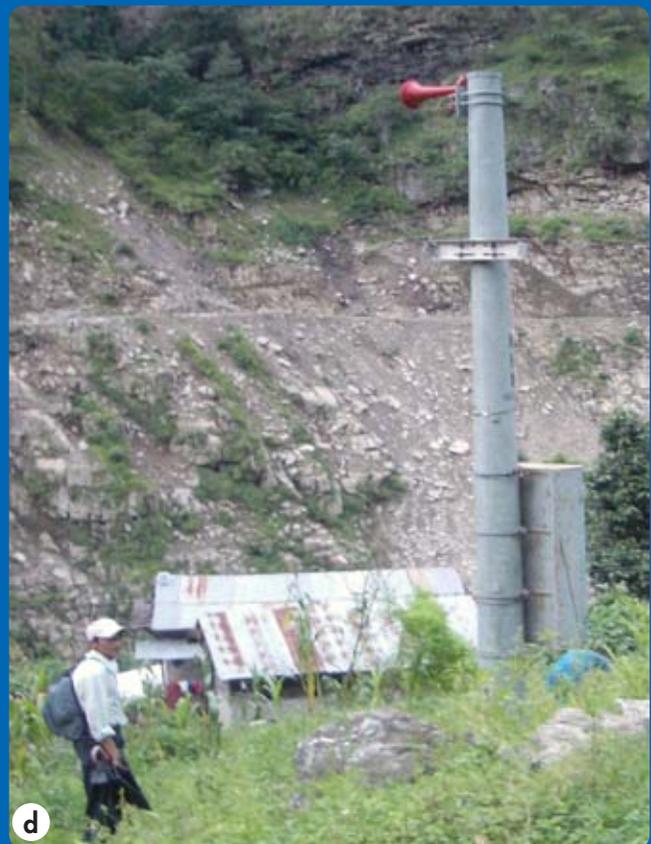
Figure 5: **The Tsho Rolpa/Tamakoshi valley early warning system:** a) Sangma Kharka transmitter station outside lake Tsho Rolpa receives signals from sensors and transmits to other remote warning stations; b) the warning and relay station Gongar village, comprising solar panel, battery, antenna and amplifier with siren; c) destroyed siren pole at Sigati village; d) damaged siren at Borle village

The GLOF sensing system consisted of six water level sensors installed along the right bank of the river channel immediately downstream of the lake outlet at Sangma Kharka; this was designed to detect the onset of a breach. Three sensors were connected by armoured and shielded cables to each of the two independently functioning transmitting stations (Figure 5a) located at a higher elevation and within 80 m of the sensors. Each sensor was located at a different elevation above the previous high water mark such that different sensors would be able to indicate any progressively rising river stages. Thus, the sensing system would detect the occurrence of a GLOF immediately and signal directly to all warning stations located downstream within two minutes of initiation of a flood. The remote station at Naa village had the dual function of forming part of the GLOF sensing system and providing local warning to the village residents.

The warning system consisted of 19 warning and relay stations installed at the 17 villages of the Rolwaling and Tamakoshi valleys (Figure 5b). The warning stations located in the villages had Meteor Communication Corporation (MCC) 545-transceiver units mounted on 4.67m self-supporting standard galvanised iron power poles. The antennae were mounted on extensions to the poles approximately 5 m above the ground. Lightning rods and solar panels were mounted on the same poles. MCC 545 units, with battery and relay for the horns, were mounted inside sheet metal boxes with lockable shelters, also attached to the poles. All cables were protected by plastic conduits, covered by galvanised sheet metal and strapped to the poles. Air-powered horns, designed to operate off charged air cylinders for a period of two minutes, with a reserve for an additional one to two minutes, were also mounted on the poles. The air horns could provide a sound of 80 dB up to a minimum distance of 150 m under the most adverse conditions. They were backed up by electric horns which could operate for four minutes. The GLOF warning systems were based on 'extended line of sight' (ELOS) VHF radio technology. The warning signal would be transmitted via ELOS ground wave signals from remote station to remote station down the valley. Thus, an early warning signal would be triggered automatically if a GLOF was detected.

By 2002, four years after establishment, the early warning system was no longer operating (Figures 5c,d) despite the fact that it was a robust system commissioned with the latest technology. Lack of participation by the local communities and disruption of communications during Nepal's long period of political uncertainty, appears to have led to the system being ignored and then destroyed, with components being taken to use for other purposes locally. The people in the area thought that the lake had been reduced to a safe level and lost interest in the warning system. The tendency towards ignoring the importance of early warning was further intensified by the incidence of false alarms (Khanal et al. 2009).

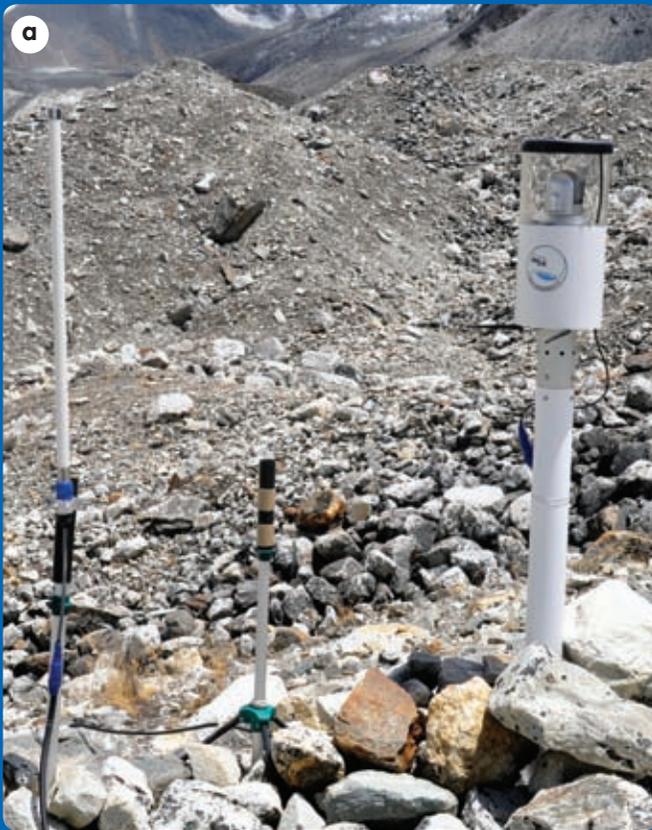
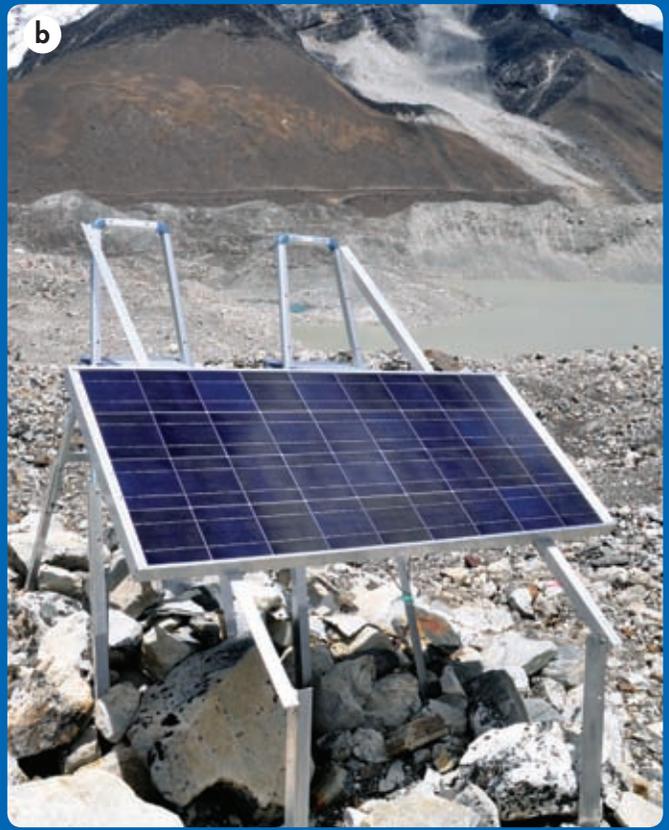
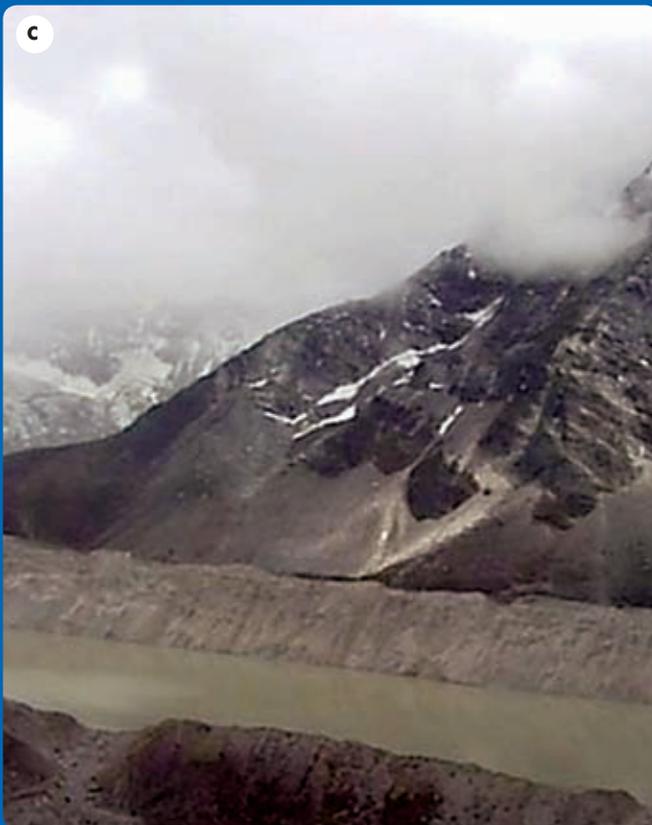
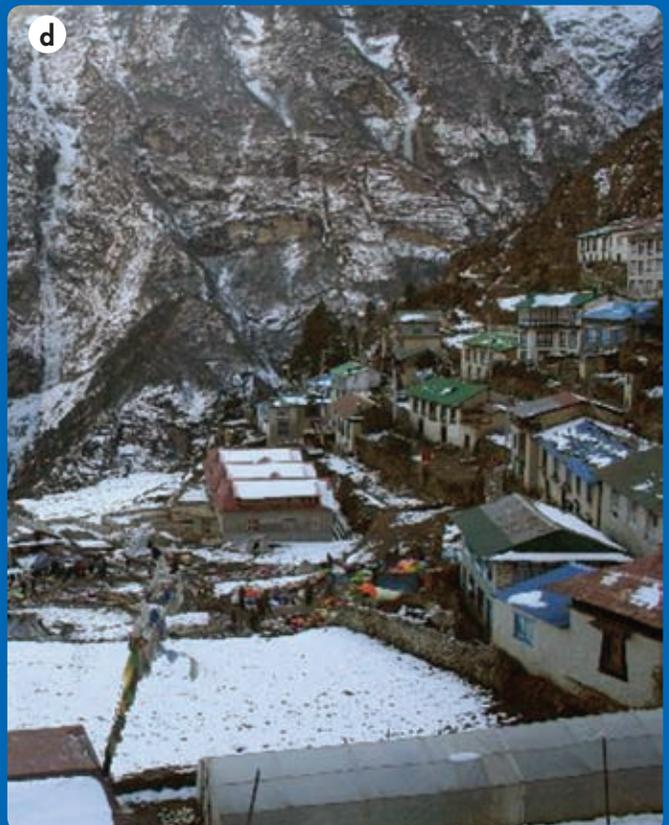
Figure 6: **Monitoring of Imja glacial lake:** a) field server the lake (2009); b) solar panel for field server (2009); c) part of image from field server at lake (26 June 2009); d) part of image from field server at Namche Bazar (1 Jan 2010)

Imja glacial lake has been one of the fastest growing lakes in the Himalayas and ICIMOD has been monitoring the lake as a basis for devising an early warning system. A remote sensing system (using geo-ICT tools and techniques) was developed in cooperation with the Department of National Parks and Wildlife Conservation (DNPWC) and Keio University of Japan (Bajracharya 2009). Two monitoring devices or field servers – the Internet field observation robot (Figures 6a,b) – were installed on the lake shore at 5,000 masl and close to the nearest big settlement, Namche Bazaar, in 2007 by a team led by Keio University, with other researchers from the National Agricultural Research Centre, Japan. It was connected to the Internet in collaboration with the Asia Pacific Advanced Network (APAN) and Nepal Research and Education Network (NREN). The field servers capture time lapse images of the lake and Namche Bazaar (Figures 6c, d) and meteorological data. These are transferred in real-time by Wi-Fi to a server located in Japan at <http://fsds.dc.affrc.go.jp/data4/Himalayan/> (Asia Disaster Report 2007).
