## Rehabilitation of degraded communal grazing land

**Rehabilitation measures, including eyebrow pits and live fencing, were implemented on degraded communal grazing land to reestablish a protective vegetative cover**

**WOCAT database reference:** QT NEP13

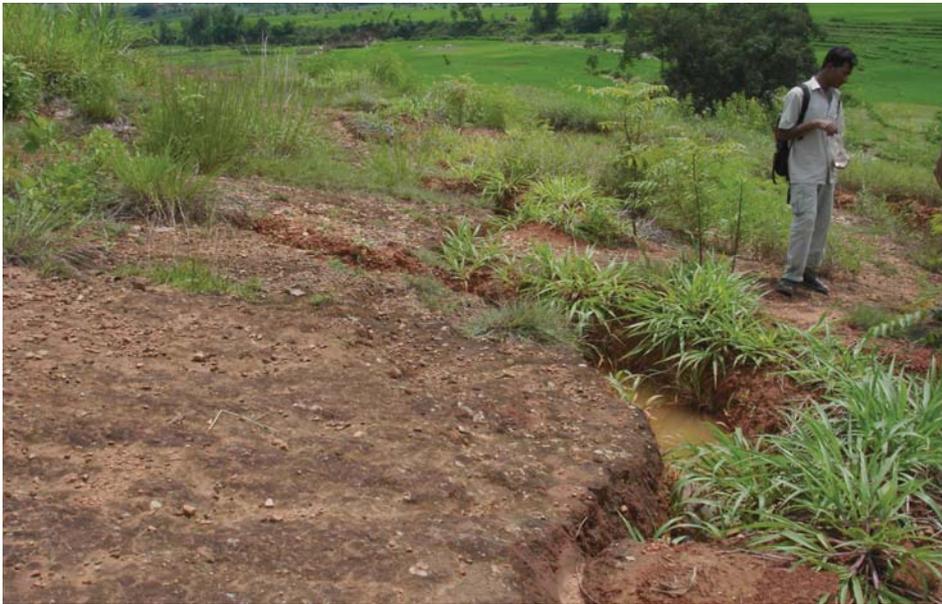
**Left:** Eyebrow pit and drainage trench with grasses along the ridges of eyebrows and trenches (K.M. Sthapit)

About 130 eyebrow pits were dug, together with catch drainage trenches. Several species of grass and fodder were planted along the ridges of the eyebrows and drainage trenches. Contour hedgerows were established between the eyebrow pits and trenches, and trees were planted just below the pits. The maintenance is quite easy: the vegetation needs to be cut back from time to time and the pits cleaned before the pre-monsoon period. The remaining bare areas should be revisited each year and replanted.

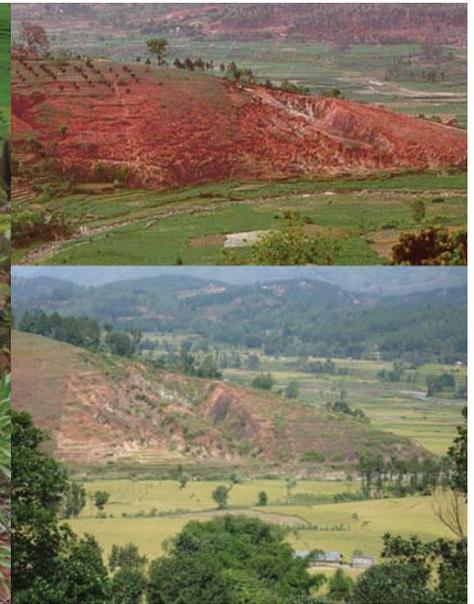
**Right:** View of degraded site before rehabilitation (PARDYP photo file) and after two years of rehabilitation (K.M. Sthapit)

+ + + Improved soil cover: about 80% of bare land covered by the various grasses  
 + + + Increased soil moisture  
 + + ■ Reduced soil loss  
 + + ■ More efficient drainage of excess water  
 + + ■ Biodiversity enhanced
