## Gully plugging using check dams

### Small dam structures constructed across erosion gullies

**WOCAT database reference:** QT NEP14

**Location:** Dhotra village, Jhikhu Khola watershed, Kabhrepalanchok, Nepal

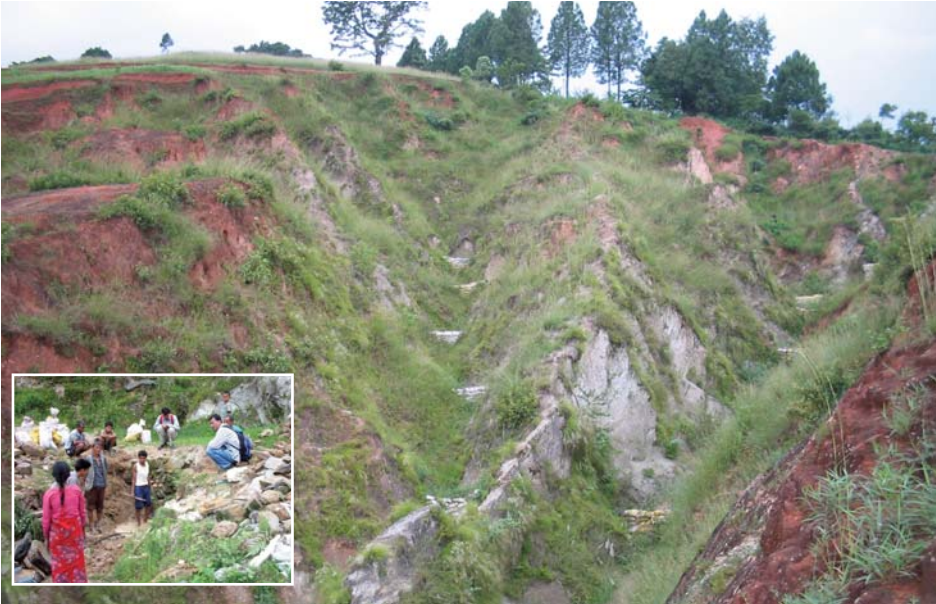
**Left:** View of the case study gullies with check dams; inset – local people building the check dams (PARDYP)

The check dams were made of old cement bags filled with soil and were 1m high with 0.5m deep foundations. The check dams were spaced so that a line joining the top of two adjacent dams had about a 3% slope gradient. Twenty-four check dams were built in the two gullies using a total of 2400 filled cement bags. Forty clumps of bamboo were planted between the dams for stabilisation.

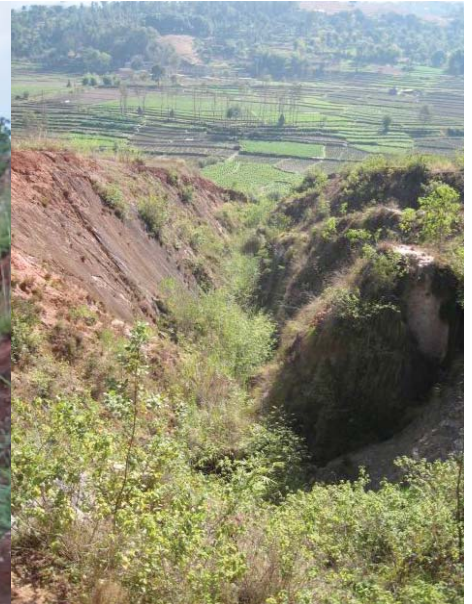
**Right:** One of the gullies two years after the check dams were built (S.K. Bhuchar)
