## Drinking water quality improvement through conservation measures

### Structural and vegetative measures to improve the quality of drinking water contaminated due to poor sanitation and seepage

**WOCAT database reference:** QT NEP17

**Location:** Dhotra village, Jhikhu Khola watershed, Kabhrepalanchok district, Nepal

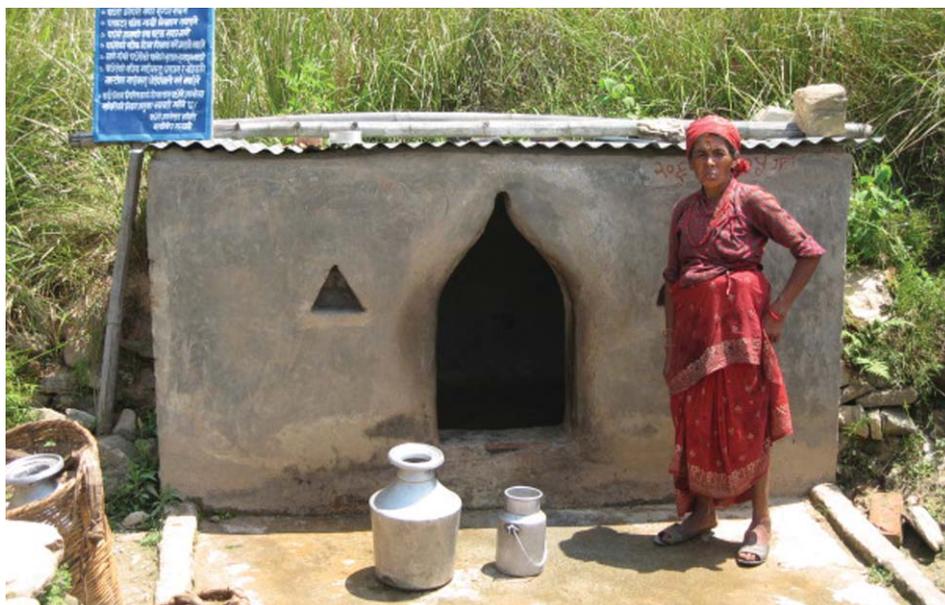
**Left:** Brick-cement walled spring box (check dams were established to prevent surface water flowing directly into the spring and contaminating it) (Sanjeev Bhuchar)

A spring user group was formed. With project help, it built a walled structure (a spring box) over the spring and check dams around the spring, and planted grasses around the spring box and trees in the catchment. These measures prevented the direct flow of surface water into the spring thus reducing contamination and turbidity. Users built a 1.8m long, 1m wide and 1.5m high spring box with a zinc sheeted roof. Check dams were built across the surrounding gullies and rills. A main 2.5m long, 0.5m wide, and 1m high check dam was constructed near the source to prevent surface runoff from entering the spring. A drainage channel was made to drain off wastewater. Vetiver grass seedlings were planted around the spring box and trees were planted in the adjoining catchment. These activities were carried out at the beginning of the rainy season.

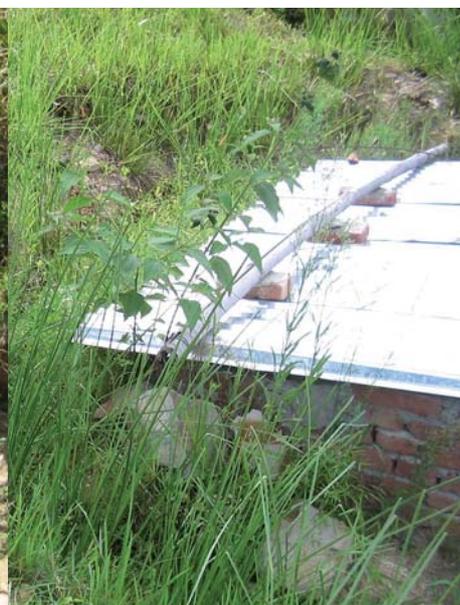
**Right:** Grass seedlings planted around the spring box (Madhav Dhakal)
