Riverbank protection

Local materials and knowledge can be used to construct low-cost structural measures that help to prevent the erosion of riverbanks and the loss of agricultural and residential land.

WOCAT database reference: QT NEP 28

Location: Gobardiha-9, Madhabpur, Dang District, Nepal

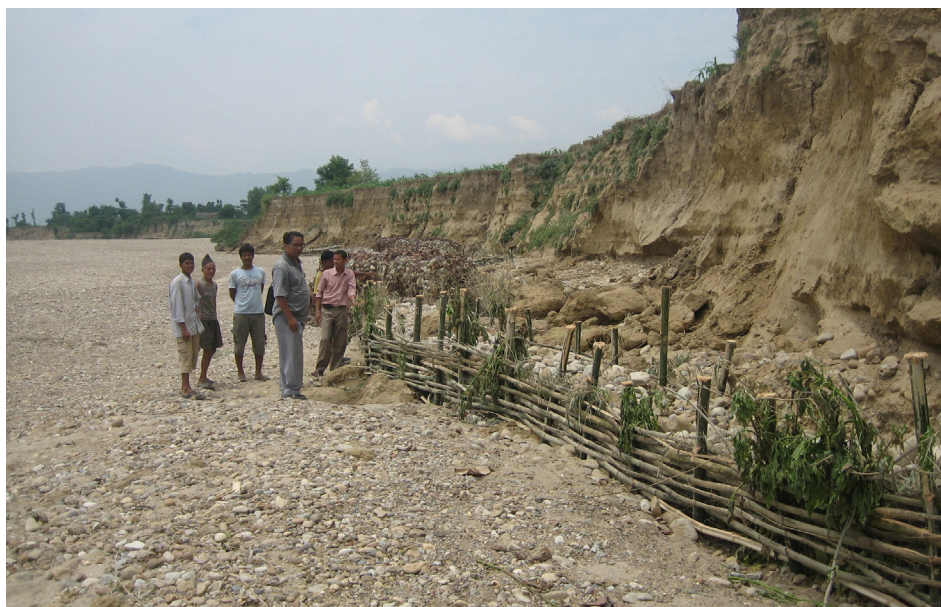
Left: The same riverbank area as on the right after a check dam (bamboo poles and brushwood) and spur (gabion boxes filled with river stones) were constructed using local measures. (Udhaw B Ghimire)

Communities have developed local measures to help protect the riverbanks and to prevent further erosion and cutting. This technology uses both structural and vegetative measures to help control the erosion and protect both agricultural land and settlement areas from flooding. Check dams are placed at intervals to divert water, additional support is provided by spurs. Bamboo rhizomes are planted between them and Napier grass (*Pennisetum purpureum*) is planted at the back of the structures so that as the plants grow their roots help to anchor the structure. The washed out areas can be used to generate some income by planting them with greenery and fruit trees. The site needs to be monitored annually and where necessary the structures either need to be repaired or supplemented by building additional structures.

A community of 47 households has agreed to use this technology to help prevent soil erosion caused by flooding. The community had started to implement local measures to minimize riverbank cutting but the efforts were not successful. The systematic introduction of well-planned gabion spurs and bamboo check dams constructed using only locally available materials, has been successful. The community is convinced that this technology is beneficial and they will continue to propagate it themselves as needed.

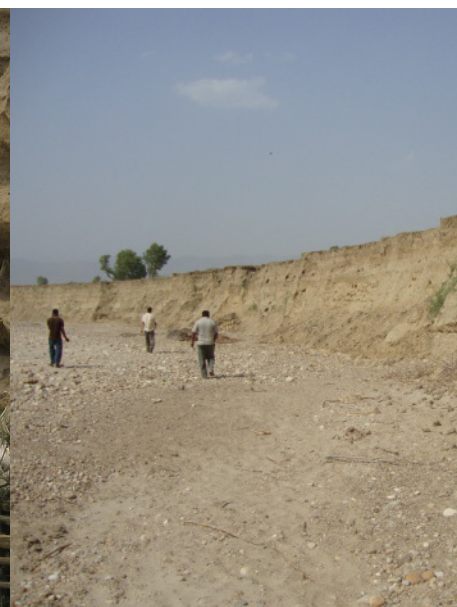
Right: An eroded riverbank in Dang District (Udhaw B Ghimire)

Riverbank cutting occurs naturally along the rivers that run along the foothills of the Chure (Siwalik) range in Nepal when the stream collides with the river bank or the bank is eroded by water coming from agricultural land above the affected area. When riverbank cutting occurs, it leaves behind an eroded area shaped like a small cliff. This erosion takes place naturally and is difficult to stop because the site is devoid of natural vegetation. It is important to undertake conservation measures because when the riverbank is eroded it damages agricultural land and decreases soil fertility. When the productivity of the land is decreased it affects the lives and livelihoods of nearby communities most of whom are subsistence farmers.
