Technology - Rehabilitation of degraded communal grazing land, QT NEP13

**Rehabilitation of degraded communal grazing land**  
Nepal: शहिवन समुदायिक बगर भुमि पुनर्वसन कार्यक्रम

Approach - Local initiatives for rehabilitating degraded communal grazing land, QA NEP13

**Local initiatives for rehabilitating degraded communal grazing land**  
Nepal: शहिवन समुदायिक बगर भुमि पुनर्वसन कार्यक्रम

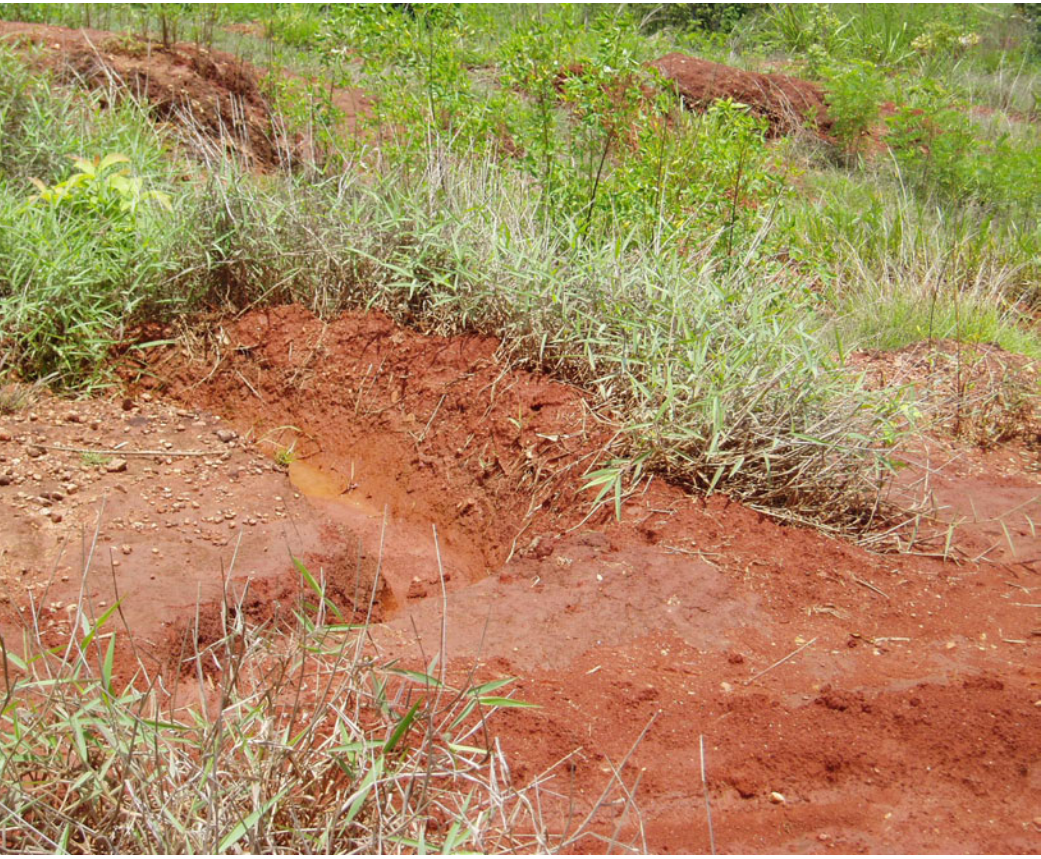
Eyebrow pit and drainage trench with grasses along the ridges of eyebrows and trenches

About 130 eyebrow pits were dug, together with catch drainage trenches. Several species of grass and fodder were planted along the ridges of the eyebrow and drainage trenches. Contour hedgerows were established between the eyebrow pits and trenches, and trees were planted just below the pits. The maintenance is quite easy: the vegetation needs to be cut back from time to time and the pits cleaned before the pre-monsoon period. The remaining bare areas should be revisited each year and replanted.

Left: Eyebrow pit and drainage trench with grasses along the ridges of eyebrows and trenches (K.M. Shrestha)

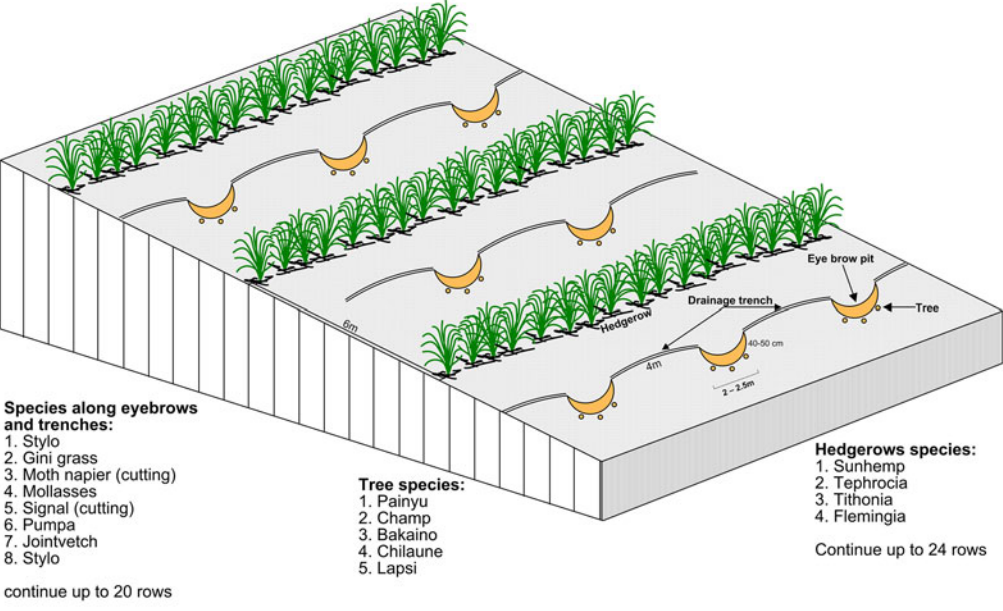
Layout of vegetative and structural measures

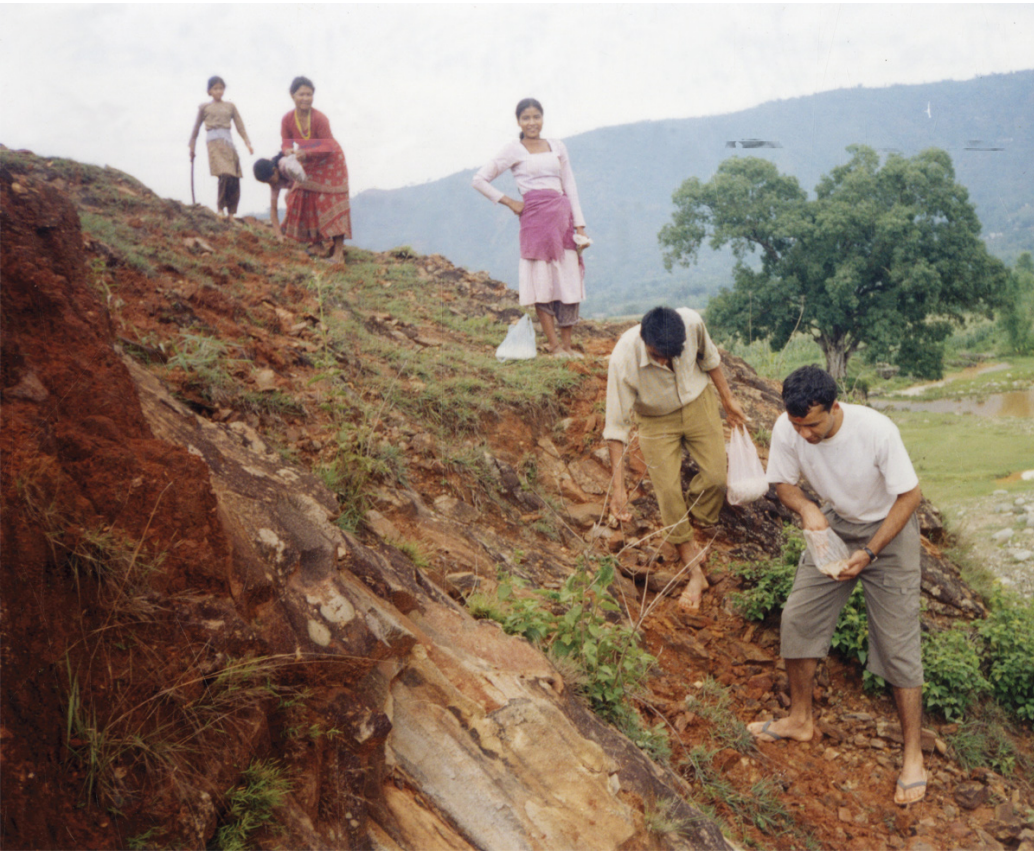
Land users sowing seeds of grass and hedgerow species

A needs assessment with the local people identified the most useful tree species. They entrusted the selection of appropriate grass and hedgerow species to the project's expertise. Project staff arrange for planting materials and logistical support, and showed villagers how to make eyebrow pits, plant hedgerows, and plug gullies. About 450 villagers participated in the rehabilitation activities with women contributing more than half of the labour. They worked four hours a day for 16 mornings.

Right: Land users covering seeds of grass and hedgerow species (PARDYP)
