The Role of Extreme Weather Events, Mass Movements, and Land Use Changes in Increasing Natural Hazards

*A Report of the Preliminary Field Assessment and Workshop on
Causes of the Recent Damage Incurred in South-Central Nepal (July 19-20, 1993)*

**International Centre for Integrated Mountain Development
1993**

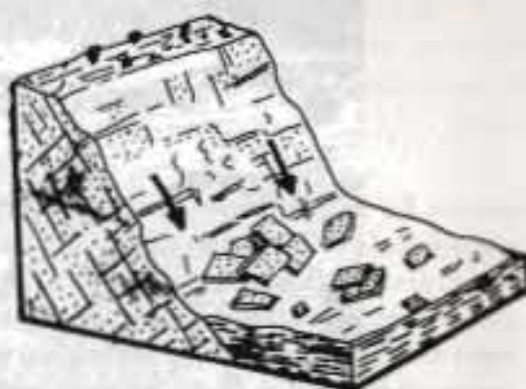
Figure 2.6: Sketch of a Plane Rockslide

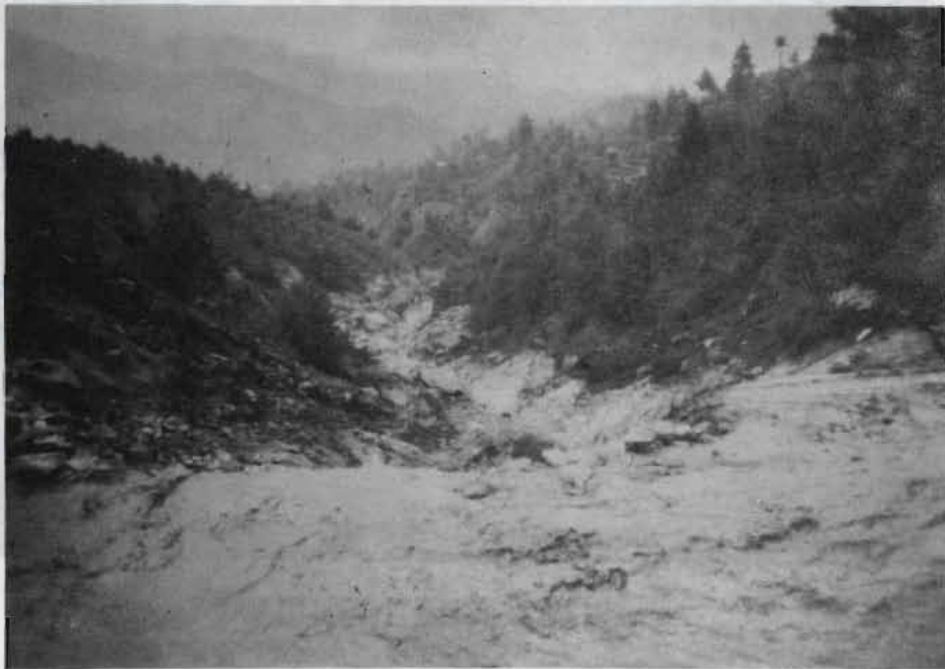
Steep gradient of the Kitini *Khola* viewing north. Notice the cascading flow!

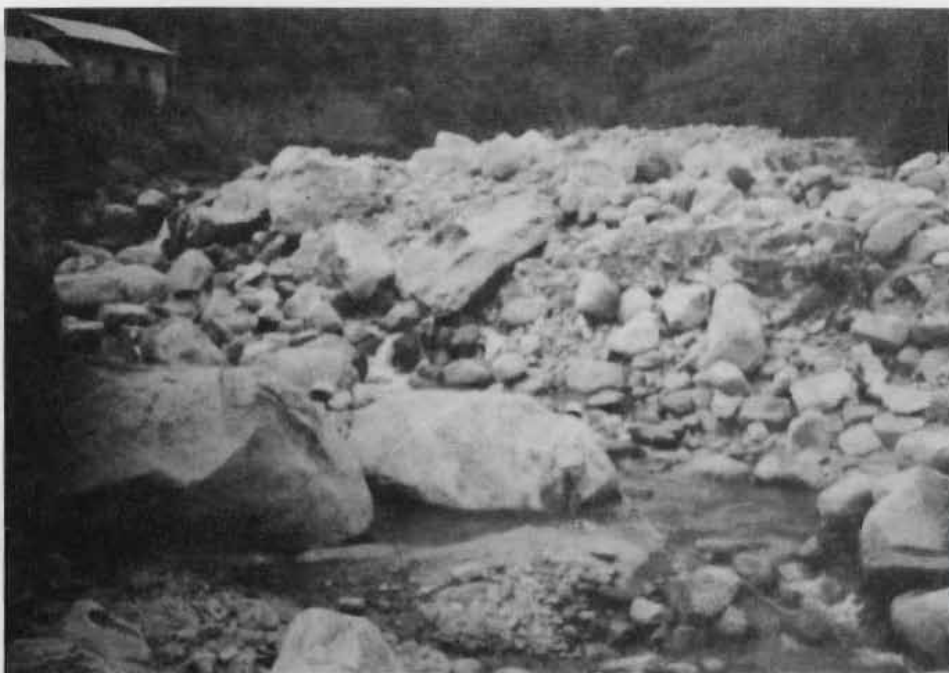
The aftermath of the event along the Kitini course. Notice what a close shave it was for the surviving houses!

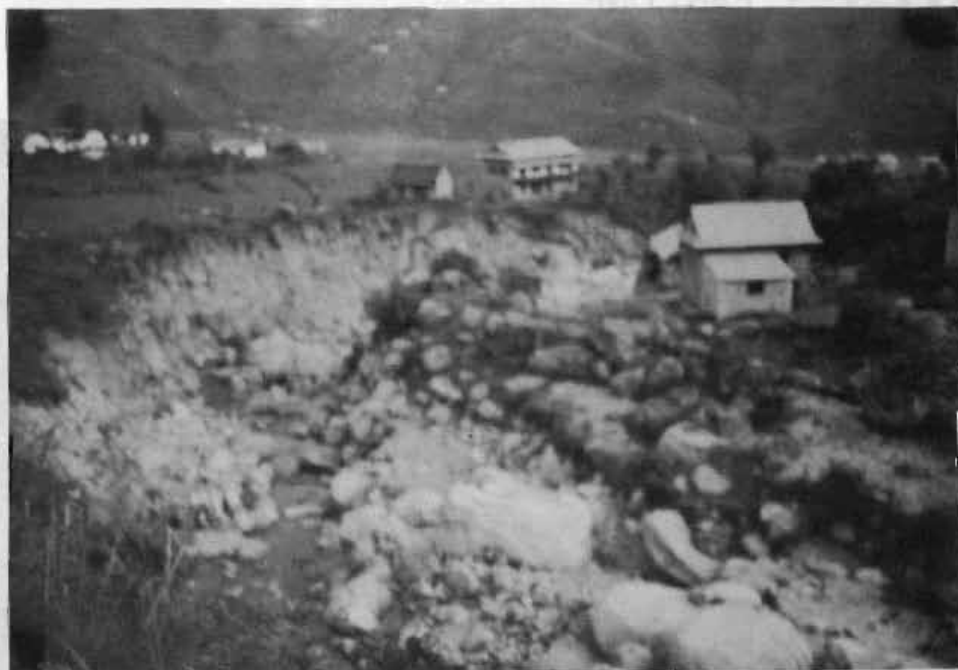
Scouring and deep cutting of flashy channels

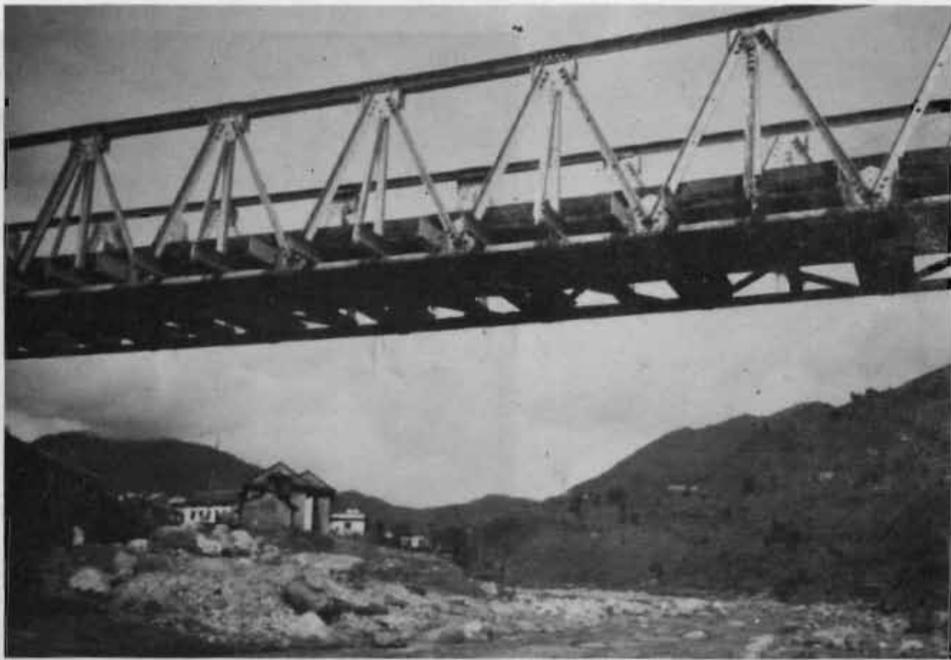
High floods touched the bridge level. Notice the weeds entangled on the railings.

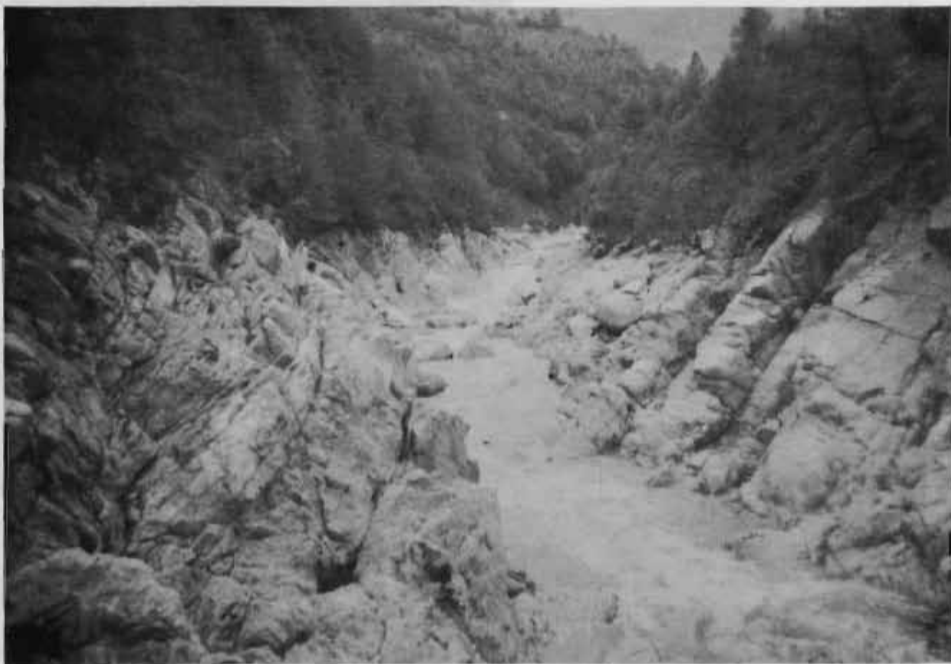
The scraped banks of the Palung Khola by the debris flow

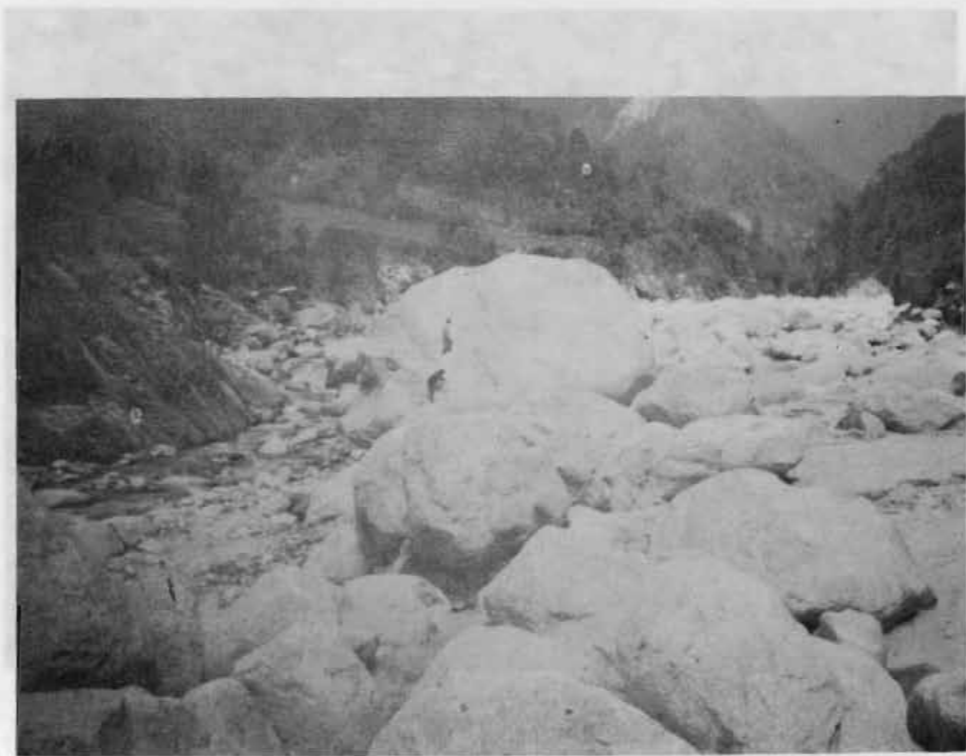
Gigantic boulder slumped in the Mandu Khola. These boulders will be transported as debris flow in future events.

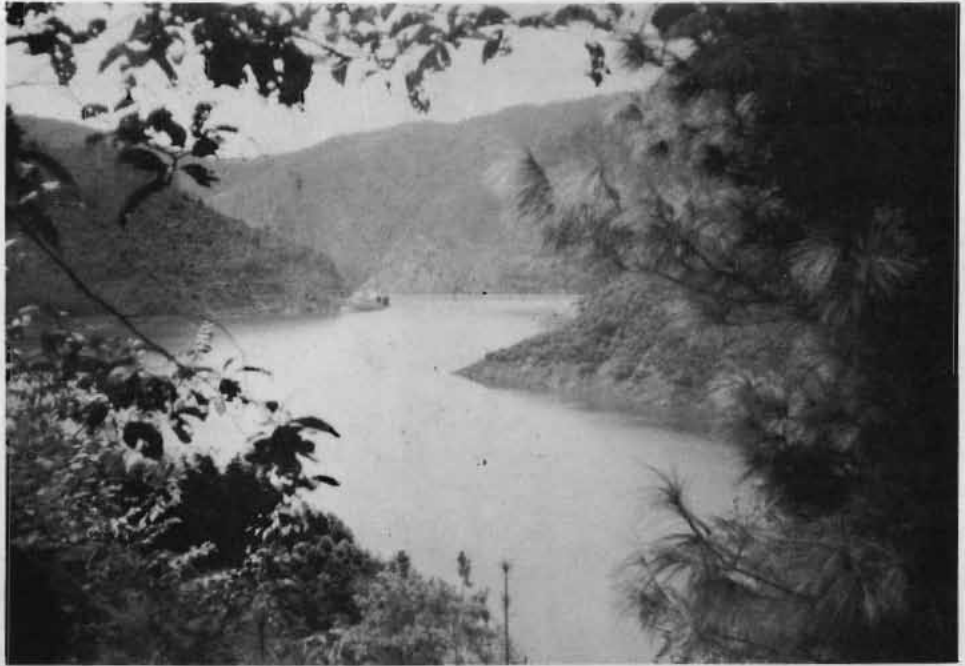
The Kulekhani Reservoir is becoming heavily sedimented.

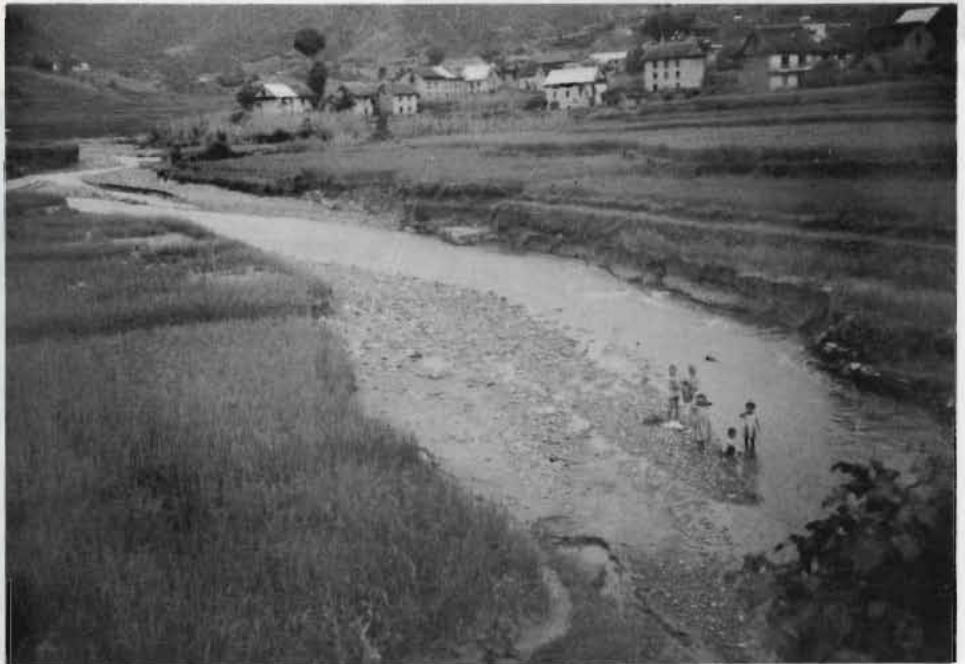
The Tistung Khola surprisingly was less subjected to flooding in spite of an over 500 mm precipitation record upstream. Perhaps the terraced fields in the wide valley have temporarily detained the downpour.

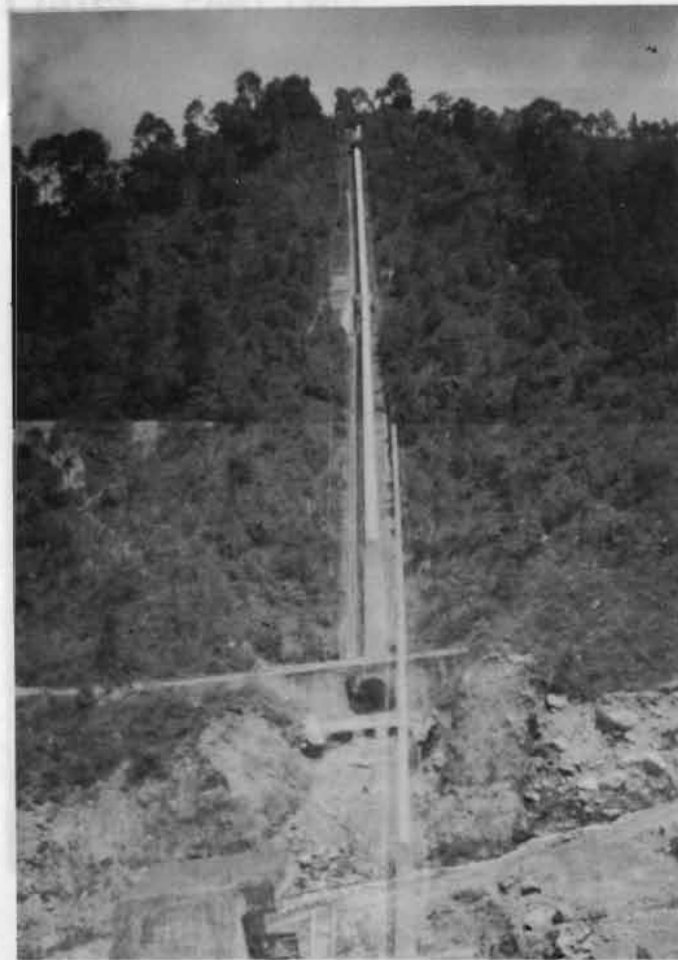
The smashed penstock
by the debris flow
at Jurikot

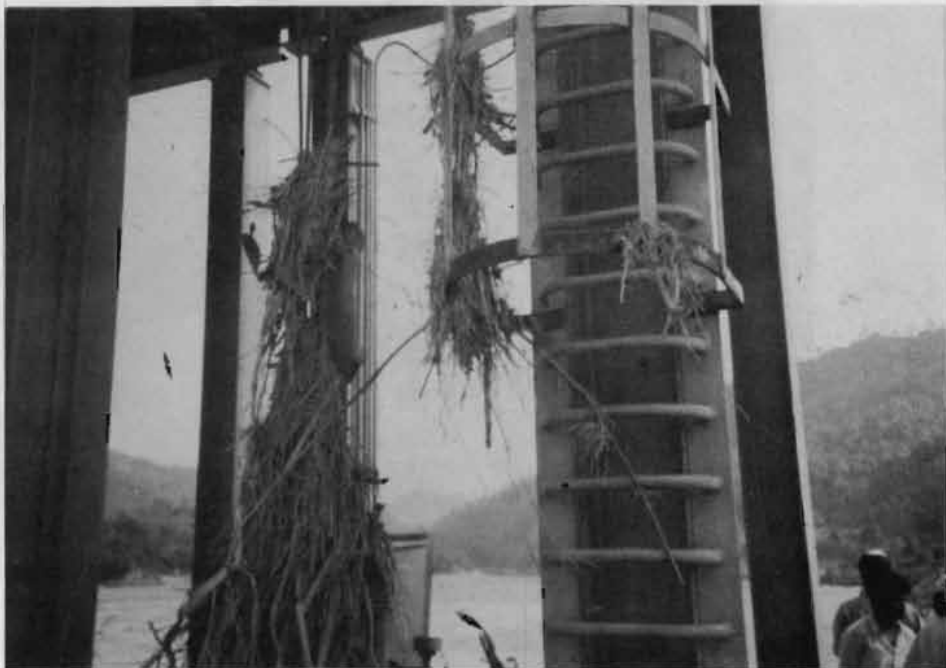
Debris entangled above the gates

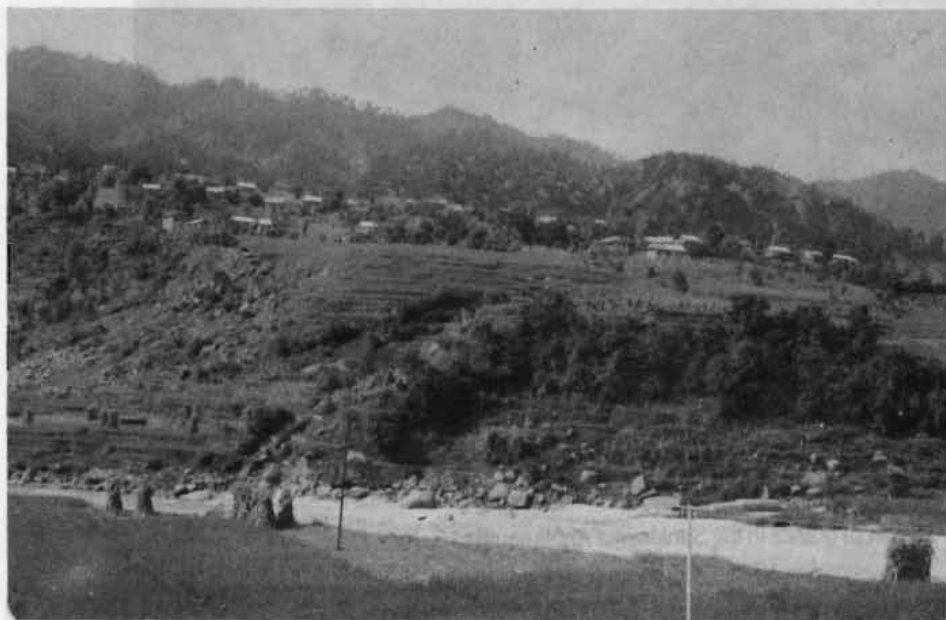
Plate 1: The Middle Hills of Palung and Daman are made up of granite and Kitni Village is on an old alluvial fan. Notice the numerous landslide scars on hillslopes after the floods on July 19 and 20. View towards the west

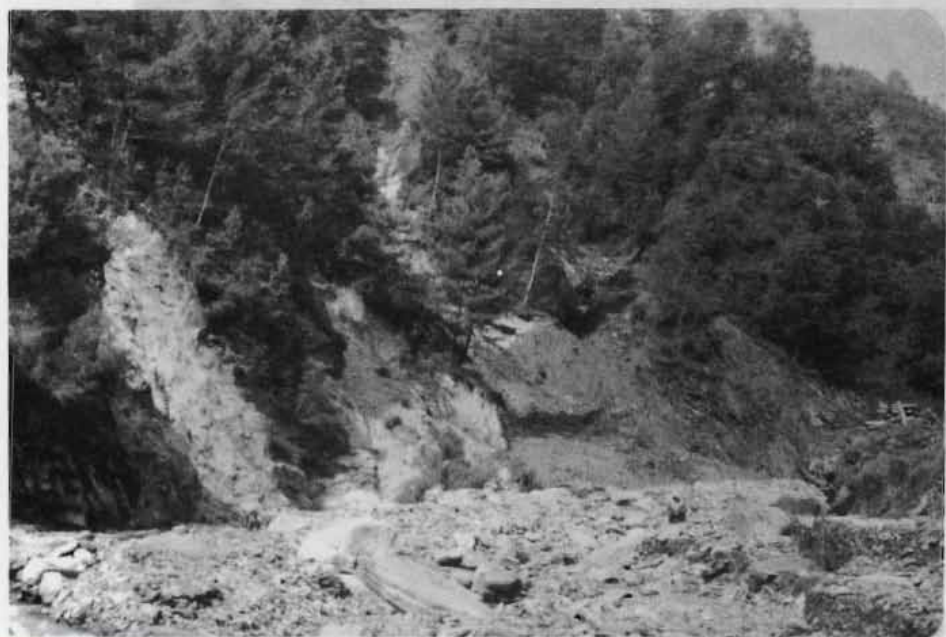
Plate 2: The contact between Palung granite (white) and the schist and quartzites of the Kulekhani Formation (grey) as observed near the Sankhamul Khola, east of Okhargaun. View towards the west

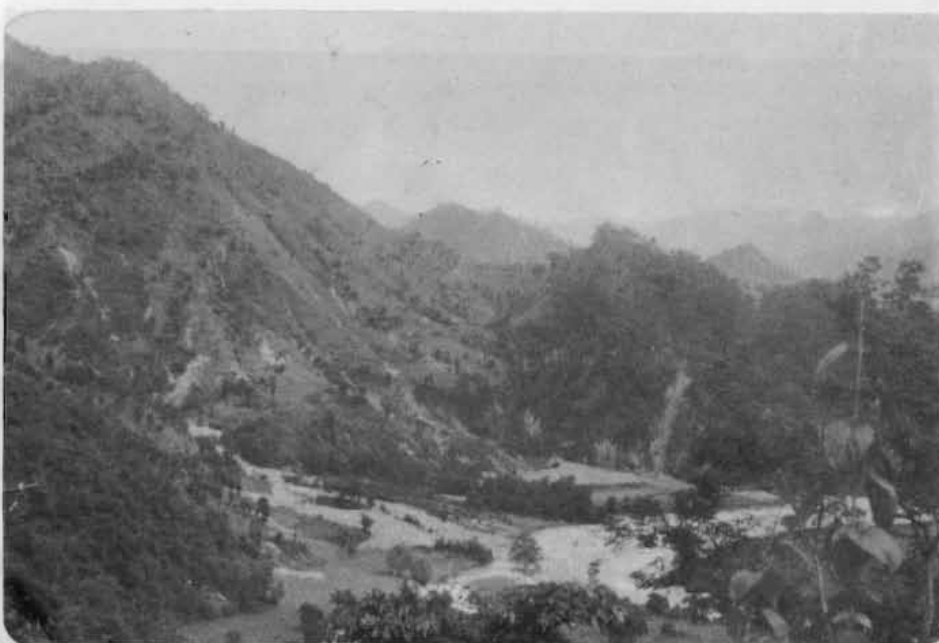
Plate 6: The Main Boundary Thrust as observed at Luinche. The fault is passing through the saddle along the gully. Notice also several soil slides and debris fans. View towards the east

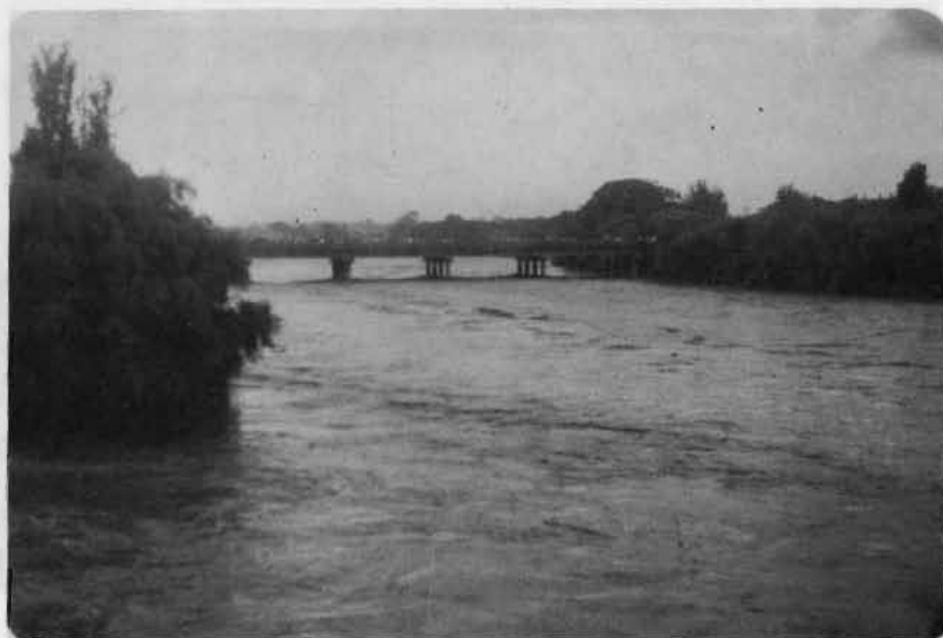
Plate 8: The Flooded Bagmati River at Balkhu on July 19, 1993. The Balkhu Khola is to the left. View towards the north

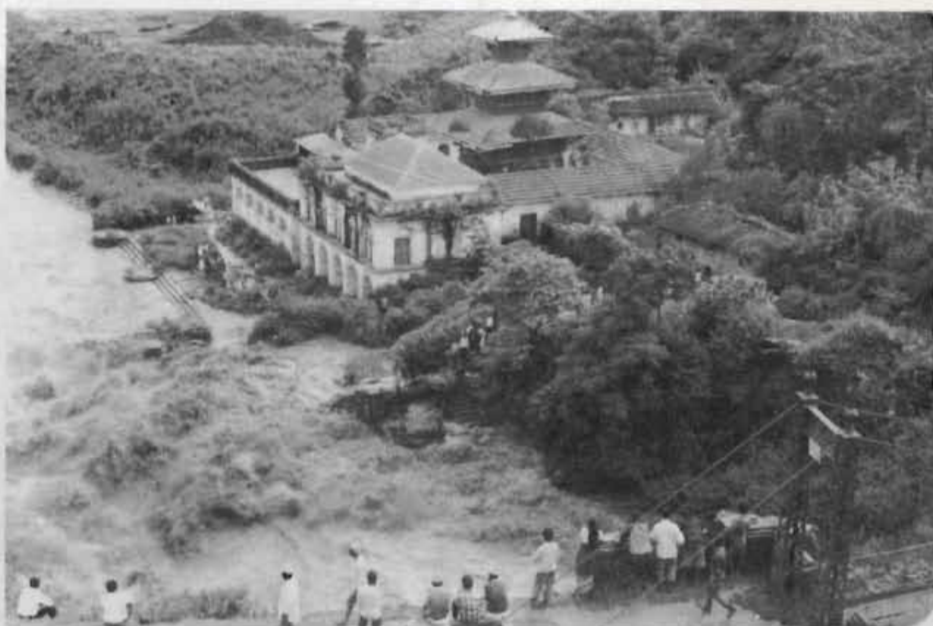
Plate 9: Flooding of the Bagmati River near Chobhar Gorge on August 9, 1993. Notice the overtopping of the right bank near the temple. View towards the south

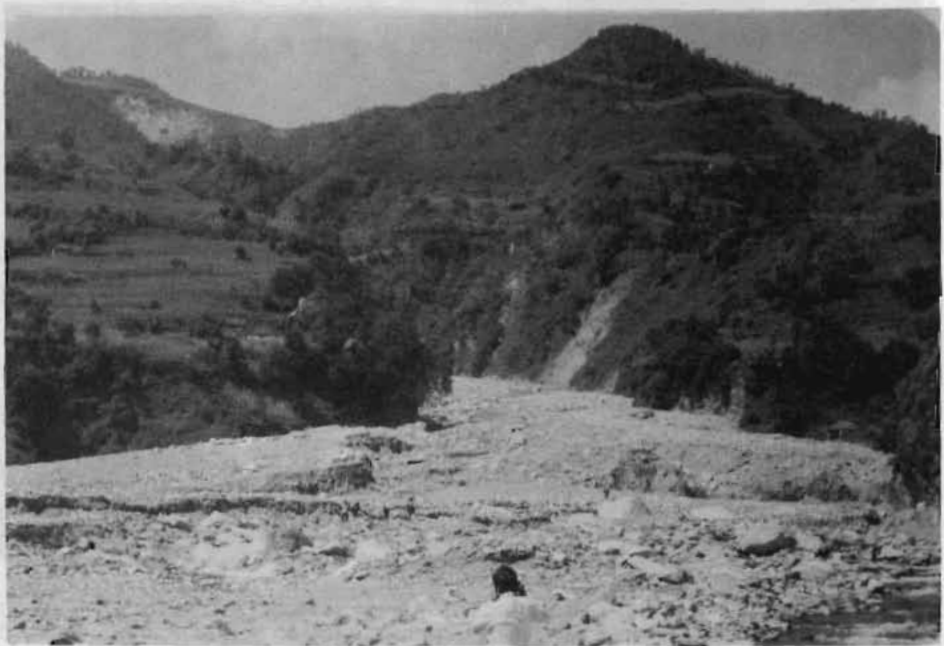
Plate 11: The debris fan on the Dhital *Khola* between Sulikot and Thulotar. Notice a rockslide upstream on the left bank and the old elevated river terraces of the Kulekhani *Khola* on both banks. View towards the west

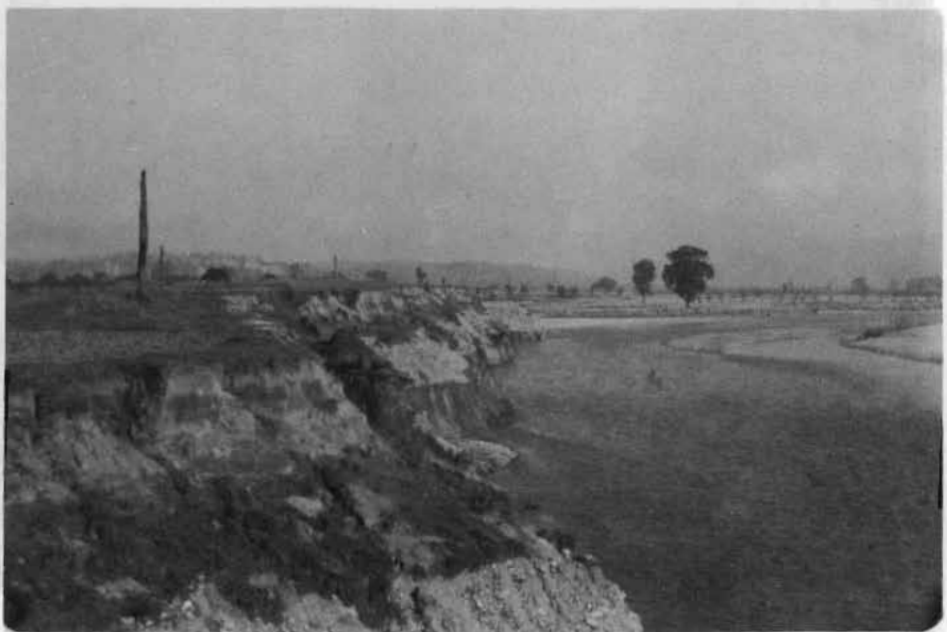
Plate 12: The Bagmati River and its floodplain at Rai *Gaun*. At present, the river channel is about 20m below the high flood level of July 21, 1993 (cliff to the left). View towards the north

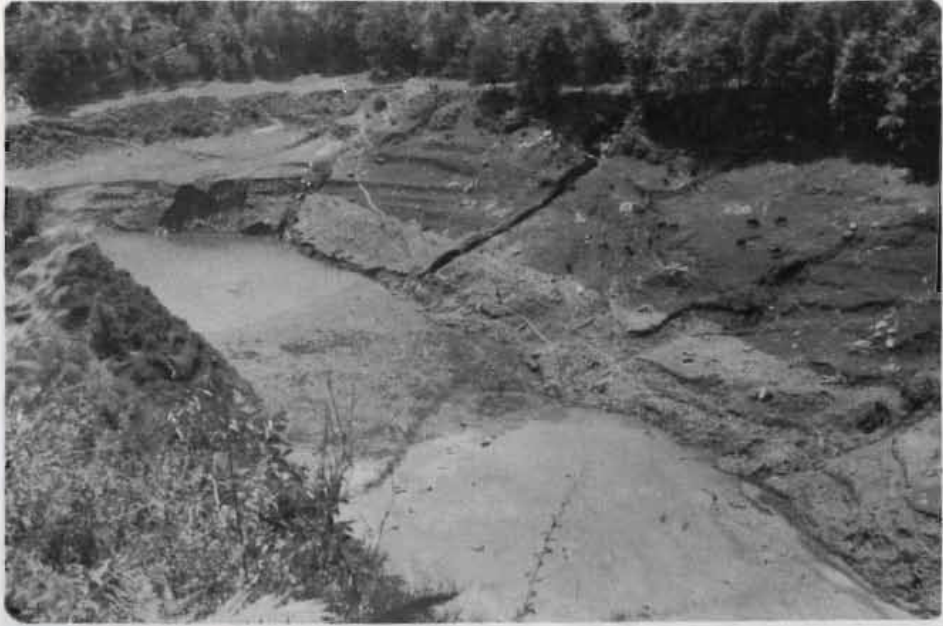
Plate 15: The wood debris brought by the Chitlang *Khola* into the Kulekhani water reservoir. Notice also the high flood mark on the right bank. View towards the south-west

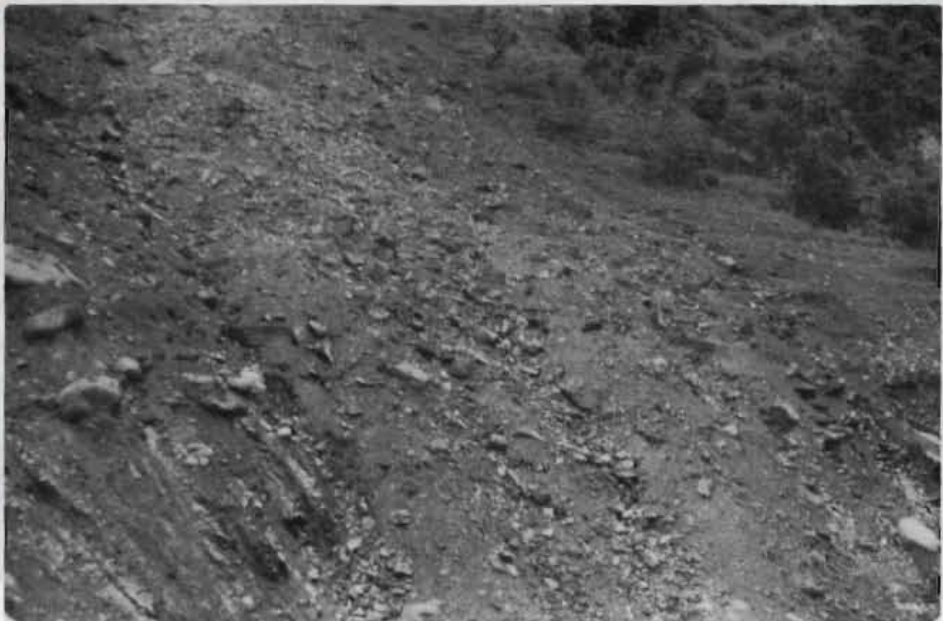
Plate 16: Debris slide . View towards the west

The Kunchhal-Kulekhani gravelled road was damaged considerably on several stretches. The descent from Kunchhal to the village of Tistung is one of the severely affected areas (Plate 16). There are several soil slides and torrential gullies. The road to the east of Taukhel, on the right bank of the Bisinkhel *Khola*, was severely damaged (Plate 26) by river scouring and steep, cut slope failures. A small landslide dam (already breached) was observed in the Bisinkhel *Khola* (Fig. 2.2, Plate 27). The failure is a plane rockslide in the slate and marble. The road is also severely damaged about two kilometres east of Markhu by the Chitlang *Khola*.

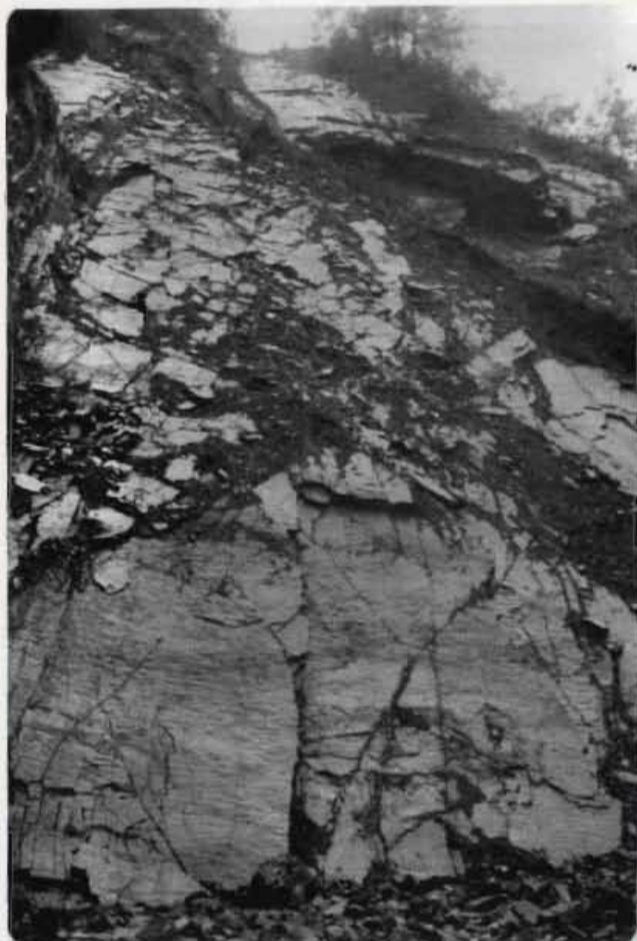
◀ Plate 17: A Plane rockslide on the Tribhuvan Highway in the Tistung Formation near Kulgaon. View towards the south-west

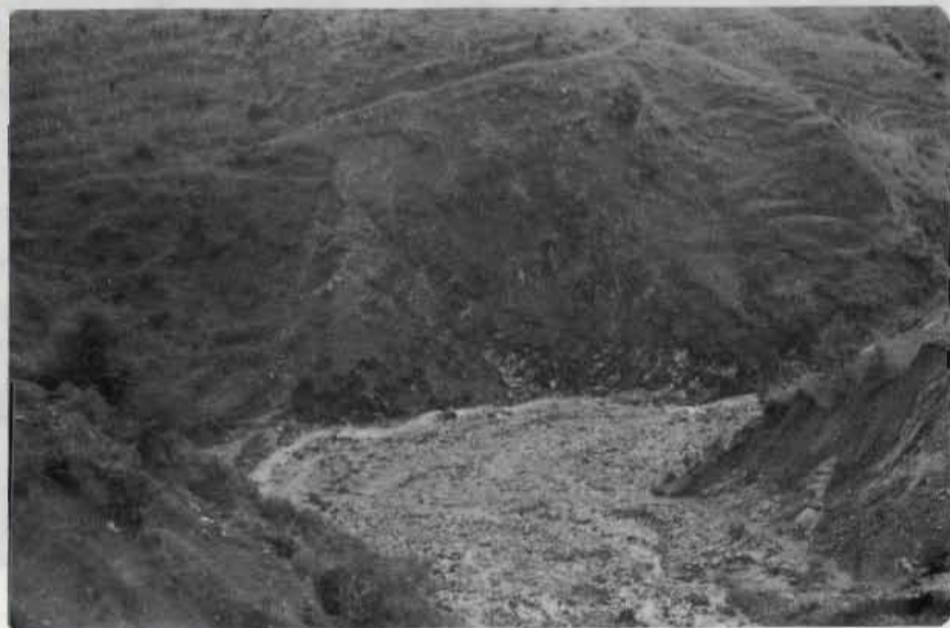
Plate 18: Debris flow and rockslide in the very fractured and cleaved slate and quartzite of the Tistung Formation, west of Kulgaon, the Tribhuvan Highway. View towards the east

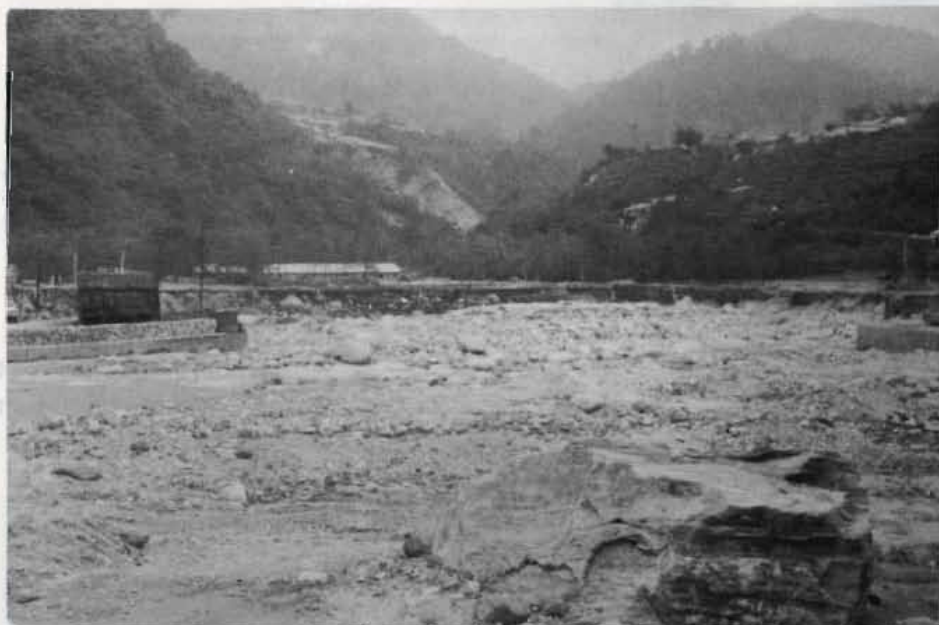
Plate 19: The site of a washed-out bridge at Bhainse Dobhan. View towards the north

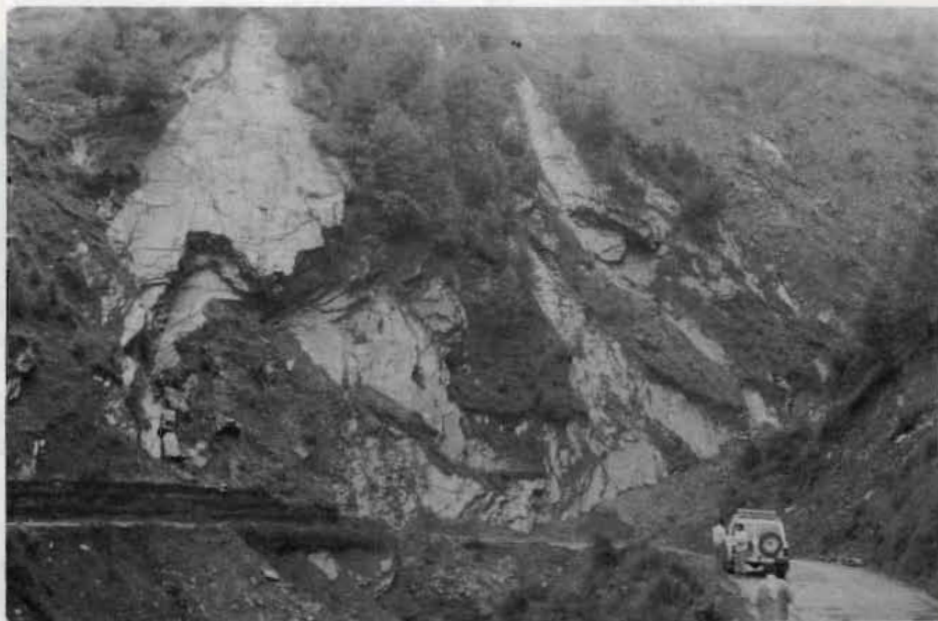
Plate 21: The plane rockslide on the Tistung Formation, near Kulgaun, Km 64, on the Tribhuvan Highway. View towards the south-west

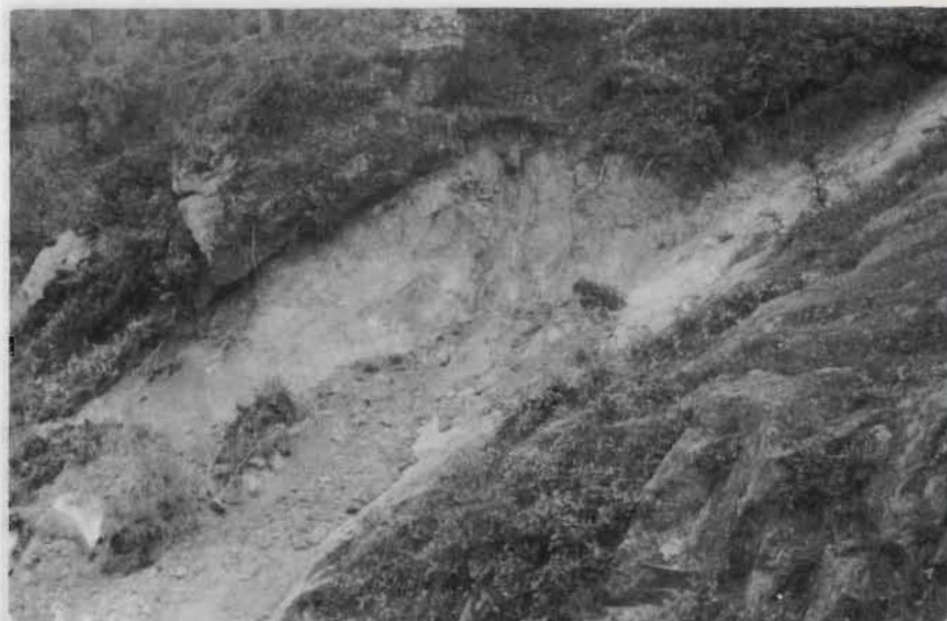
Plate 22: The wedge rockslide on the moderately to highly weathered granite, the Tribhuvan Highway north of Sikharkot. View towards the south

In a 2,185m stretch (Fig. 2.12), there were about 44 rock- and soil slides (Plate 22) and four major torrential gullies (Plate 23). The total surface area around the road was about 297,500 square metres and the landslides occupied 109,200 square metres, in which the total displaced material (excluding the gully erosion) was 161,000 cubic metres. This works out at 0.54 cubic metres per square metre (i.e. $1680 \times 0.54 = 907 \text{ kg/m}^2$) of the total area. The landslides and gullies occupied about 36 per cent of the total surface area. The average depth of failure was 1.5 m, whereas the average natural slope was 31 degrees and the failed slope in the central part was 41

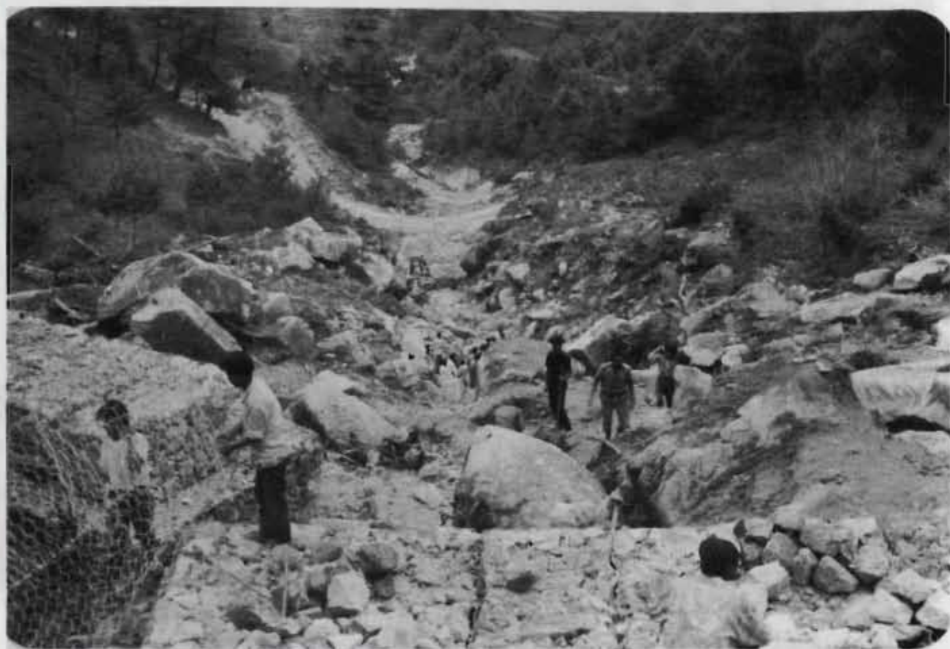
Plate 23: The torrential gully (a tributary to the Kitni Kholā) on the road north of Sikharkot. View towards the south

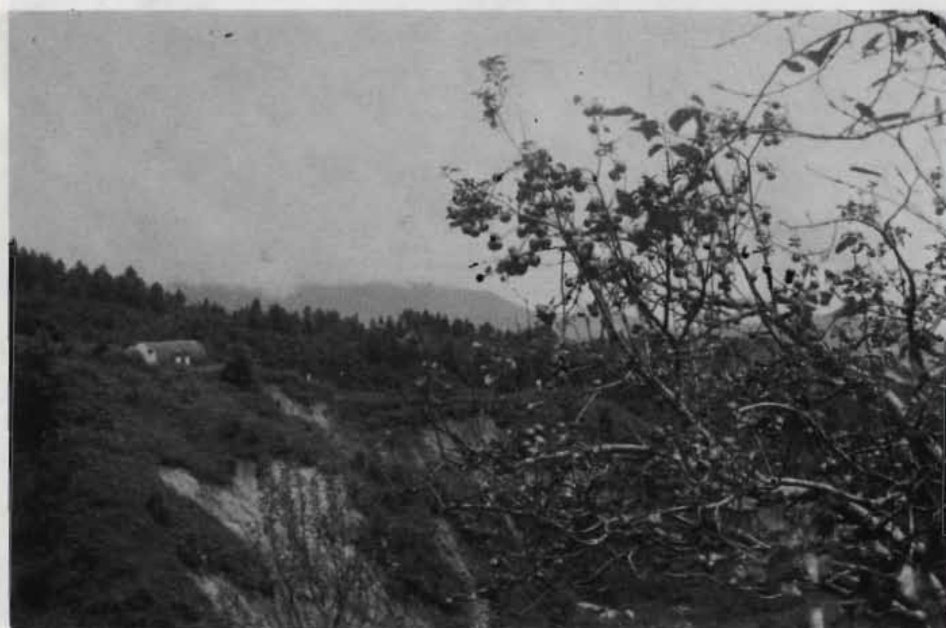
Plate 24: The soil slides at the Daman Horticultural Farm. View towards the east

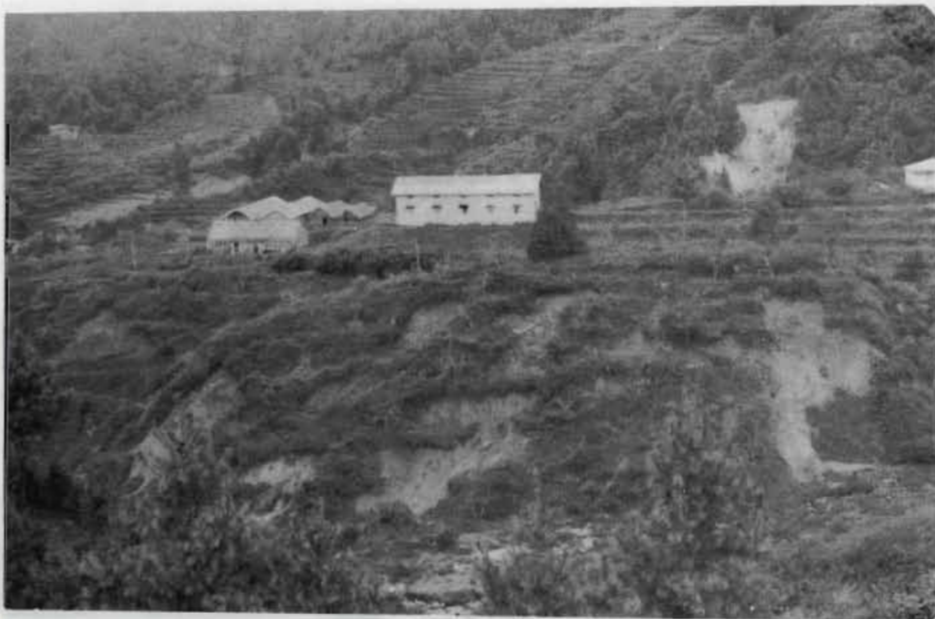
Plate 25: The shallow soil slides and slumps at the Daman Horticultural Farm. View towards the south

There were about 73 landslides (Plate 25) and 12 gullies (Fig. 2.14) within a total area of 51,600 square metres. The total rock/soil displaced was 34,100 cubic metres, of which the landslide contributed to 31,800 cubic metres and the gully erosion yielded 2,300 cubic metres. The area covered by landslides totalled 11,650 square metres (i.e., 22.6% of the total area). The average depth of failure was 0.8 m. The soil displaced (including gully erosion) was 0.61 cubic metres per square metre (i.e., $1,680 \times 0.61 = 1014 \text{ kg/m}^2$) of the total surface area.

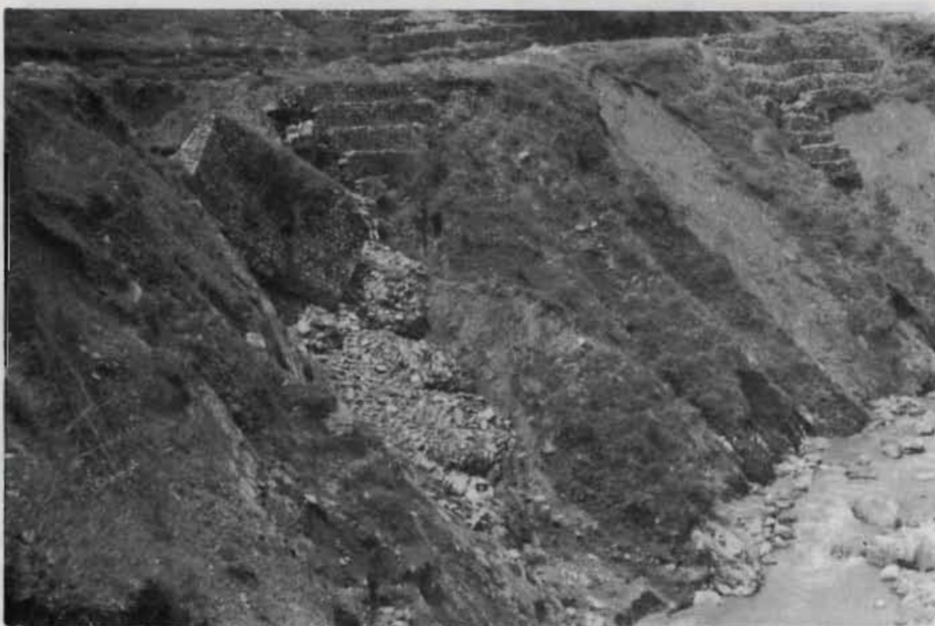
Plate 26: The damaged road and retaining wall on the right bank of the Bisinkhel Khola. View towards the north

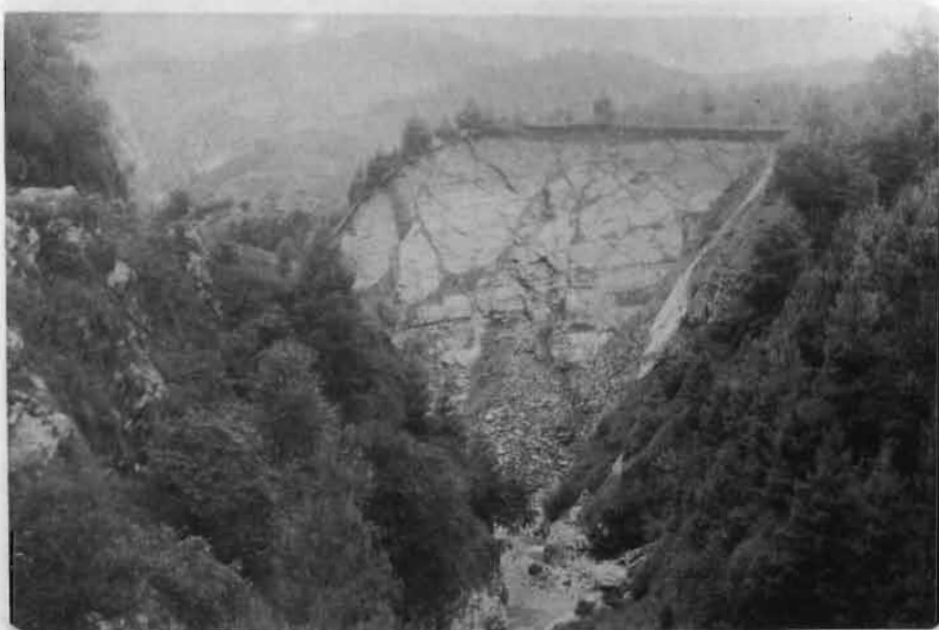
Plate 27: The plane and wedge rockslides on the right bank of the Bisinkhel *Khola* which dammed the stream. View towards the south

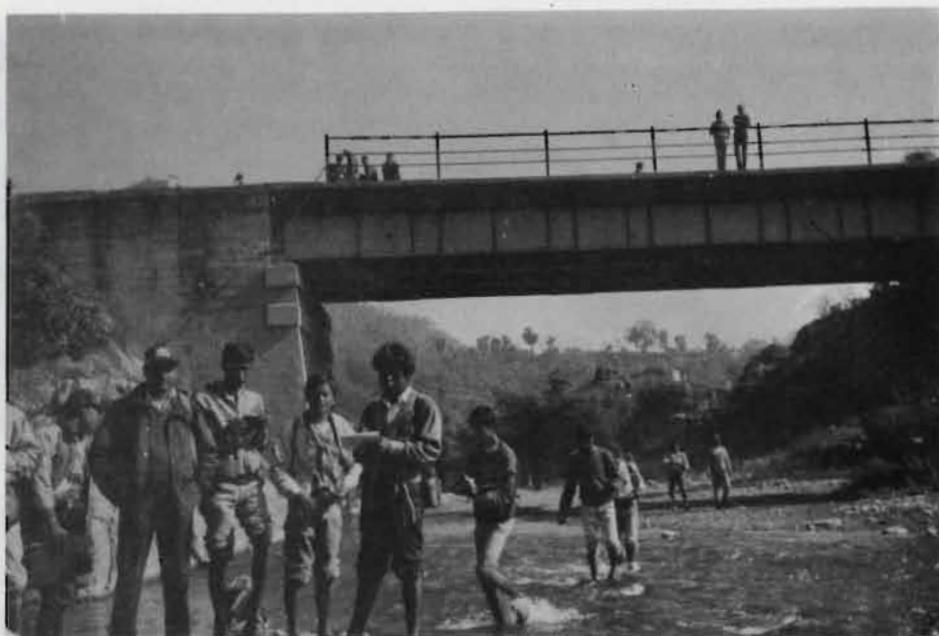
Plate 28: The previous (washed out) bridge over the Malekhu *Khola*, as observed on January, 1990. View towards the east. Courtesy T.R. Paudel.

Considerable damage to the Prithvi Highway was incurred by floods, debris flows, and landslides. According to the data provided by the Department of Roads, the cost of the damage along the Prithvi Highway is estimated to be about 572 million rupees. Twenty-two metres of the Malekhu *Khola* Bridge (Plate 28) with a total span of 44 m were washed away (Plate 29). Similarly, the Belkhu *Khola* Bridge, with a total span of 66 m, and 66 m of the Agra *Khola* Bridge, with a total span of 88 m (Plate 30) were destroyed.

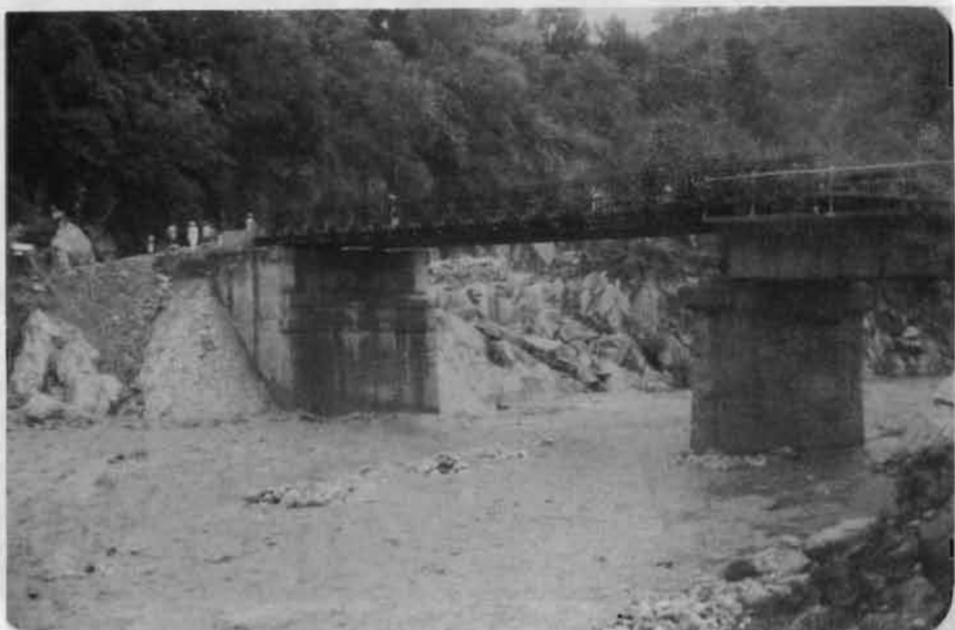
Plate 29: The partially damaged bridge over the Malekhu *Khola* replaced by a Bailey bridge. View towards the east

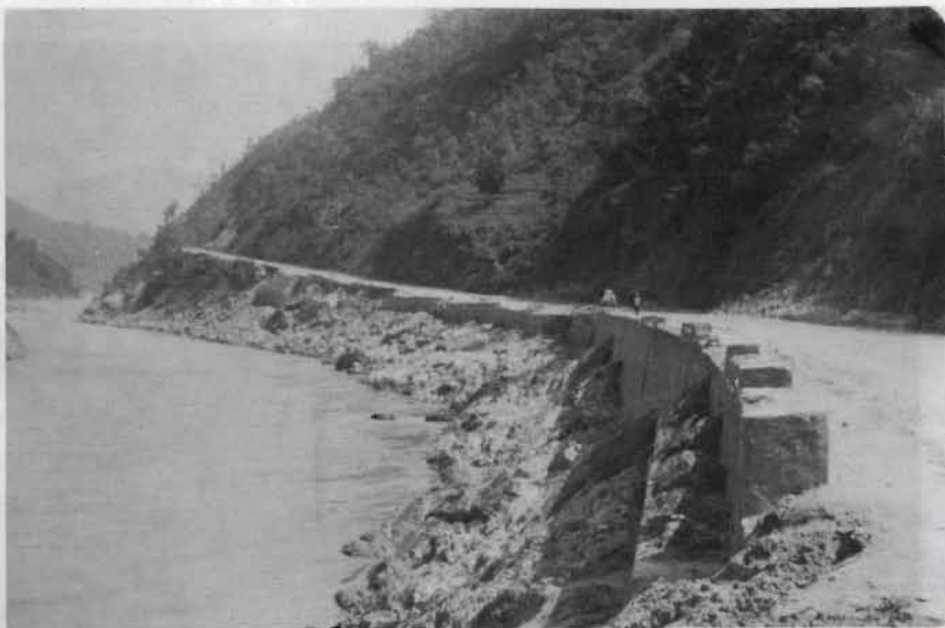
Plate 31: The Prithvi Highway to the east of Jogimara. Notice the thick silt and sand deposits on the road and washed out retaining walls. View towards the south-east

In several areas, the highway is very close to the river. In such areas, the river scoured the road and deposited from one to three metres of sand and gravel (Plate 31). Several suspension bridges were also either washed away or severely damaged during the same event. On the other hand, the flood, and rock- and soil slides damaged the road and adjacent slopes at Naubise, Galchhi (Plate 32), around Mahadev Besi, Belkhu, Gajuri, Malekhu, Benighat, Bishal Tar, and Jogimara. During the same event, the Blue Heaven Restaurant, situated on the left bank of the Trishuli River, about 500 m west of Malekhu, was washed away completely. A long stretch of the river terrace on the right bank of the Trishuli River to the west of Belkhu was scoured (Plate 33).

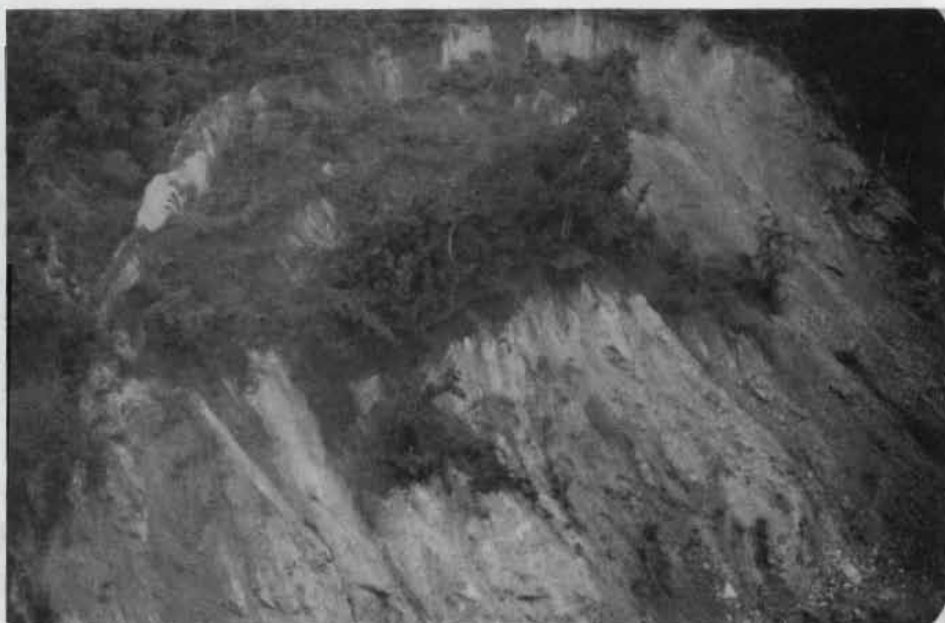
Plate 32: A large debris slide on the right bank of the Mahesh *Khola* at Galchhi. View towards the north
