The Role of Extreme Weather Events, Mass Movements, and Land Use Changes in Increasing Natural Hazards

*A Report of the Preliminary Field Assessment and Workshop on
Causes of the Recent Damage Incurred in South-Central Nepal (July 19-20, 1993)*

**International Centre for Integrated Mountain Development
1993**

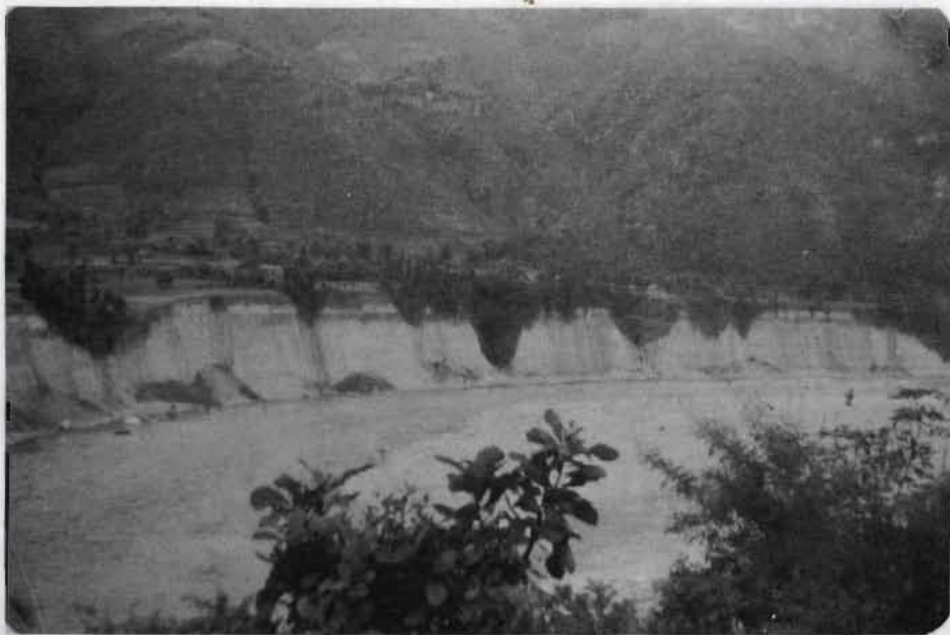
Plate 33: A long stretch of the right bank of the Trishuli River, west of Belkhu, scoured by the flood. View towards the north-east

In several areas, the highway is very close to the river. In such areas, the river scoured the road and deposited from one to three metres of sand and gravel (Plate 31). Several suspension bridges were also either washed away or severely damaged during the same event. On the other hand, the flood, and rock- and soil slides damaged the road and adjacent slopes at Naubise, Galchhi (Plate 32), around Mahadev Besi, Belkhu, Gajuri, Malekhu, Benighat, Bishal Tar, and Jogimara. During the same event, the Blue Heaven Restaurant, situated on the left bank of the Trishuli River, about 500 m west of Malekhu, was washed away completely. A long stretch of the river terrace on the right bank of the Trishuli River to the west of Belkhu was scoured (Plate 33).

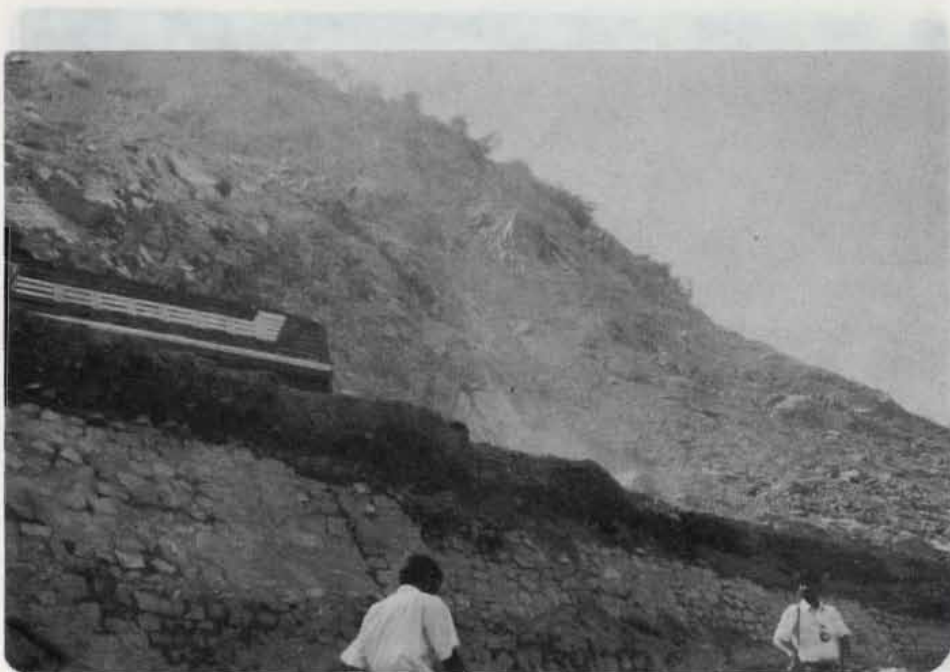
Plate 34: The rockslide at Jogimara. View towards the south-west

The Jogimara landslide (Plate 34) is probably the most hazardous landslide on the Prithvi Highway. It has carried several buses into the Trishuli River and hundreds of people have lost their lives. The slide is located on the left bank of the Trishuli River on the Benighat Slates and Jhiku Limestone bands. The rocks are extremely jointed and the joint spacings vary from a few centimetres to tens of centimetres in the slate and from tens of centimetres to a few metres in the limestone. The approach road to the limestone quarry and the blasting in the area have further aggravated the situation. The natural slope is from 40 degrees to vertical and the failed slope is about 30 degrees.

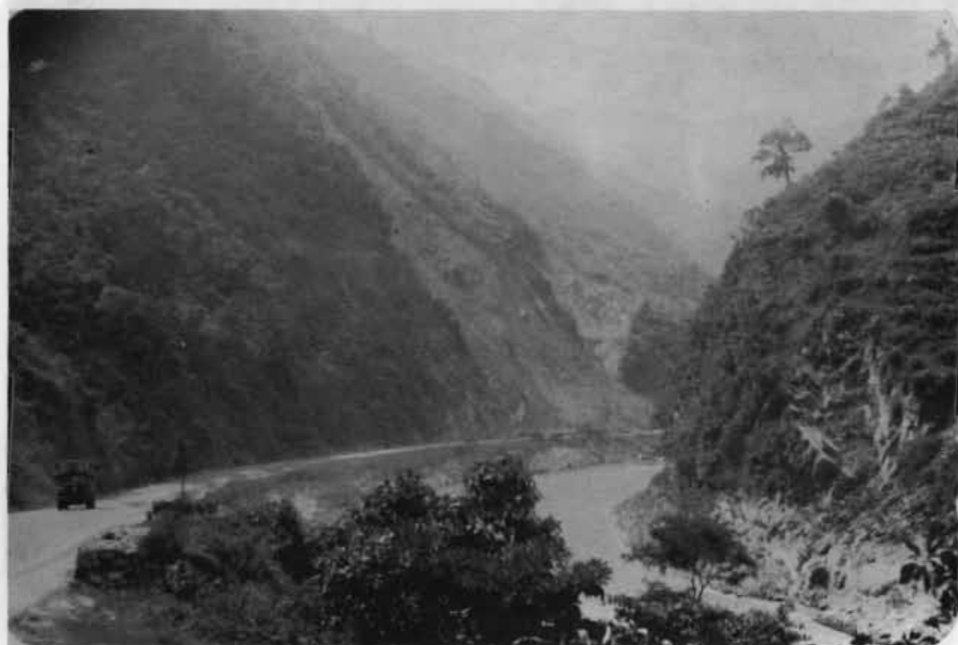
Plate 35: The Jogimara rockslide in slates and limestone. A stone quarry is also seen on the right bank. View towards the south-west

Statistical analysis of more than 100 joints revealed that there were five distinct sets of joints in the rock. One set is parallel to the cleavage and bedding, the two mutually perpendicular sets are extension joints and two sets are represented by shear joints. Stereographic projection of the joint sets (Fig. 2.15) clearly shows a high degree of hazard for plane rockslide along the joint plane with attitudes of $39^\circ/56^\circ$ and a wedge rockslide formed by three joints: $39^\circ/56^\circ$, $122^\circ/31^\circ$, and $198^\circ/72^\circ$ (Plate 35).

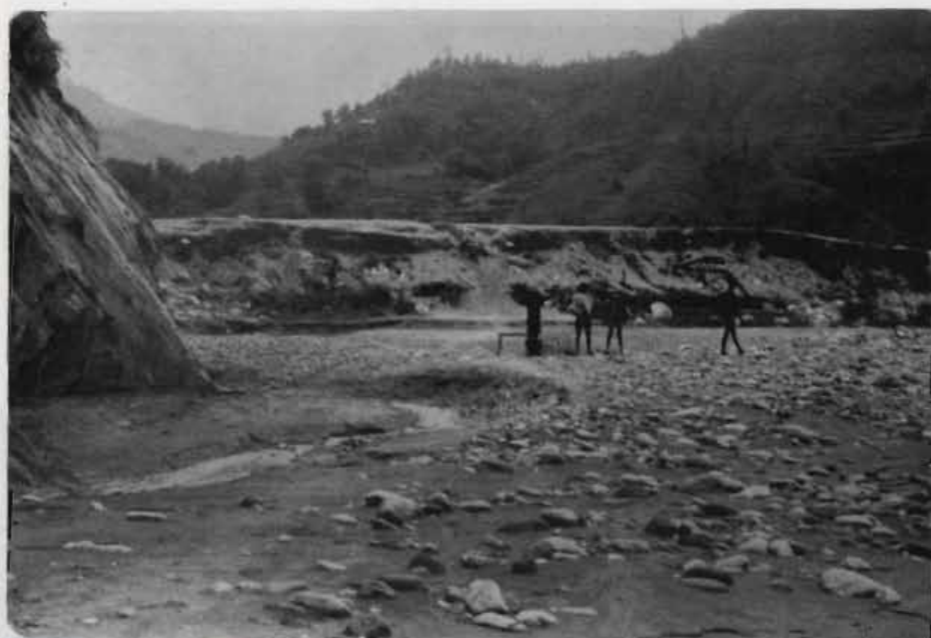
Plate 36: About three metres of thick sand and gravel bed deposited on the former cultivated floodplain (marked by a strip of grass) on the Malekhu Khola, about 200 m upstream from Malekhu. View towards the south-east

The rainstorm triggered off numerous rock- and soil slides in the watersheds of the Malekhu, Belkhu, and Agra Khola. Debris torrents and fans seem to have blocked the tributaries, partially resulting in huge debris flows in them. The amount of debris was so great that it formed about six-metre high terraces on the Agra Khola, and about three-metre high terraces on the Malekhu Khola (Plate 36) where three-metre to 10-metre long boulders were seen.

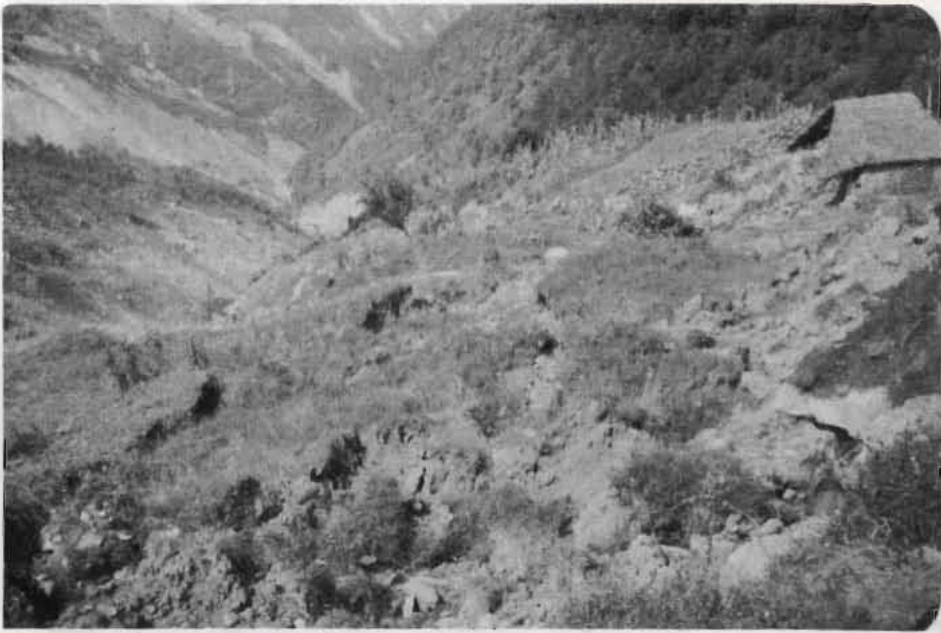
Plate 37: Several rock and soil slides around Chaubas, the Agra *Khola*. View towards the north-west

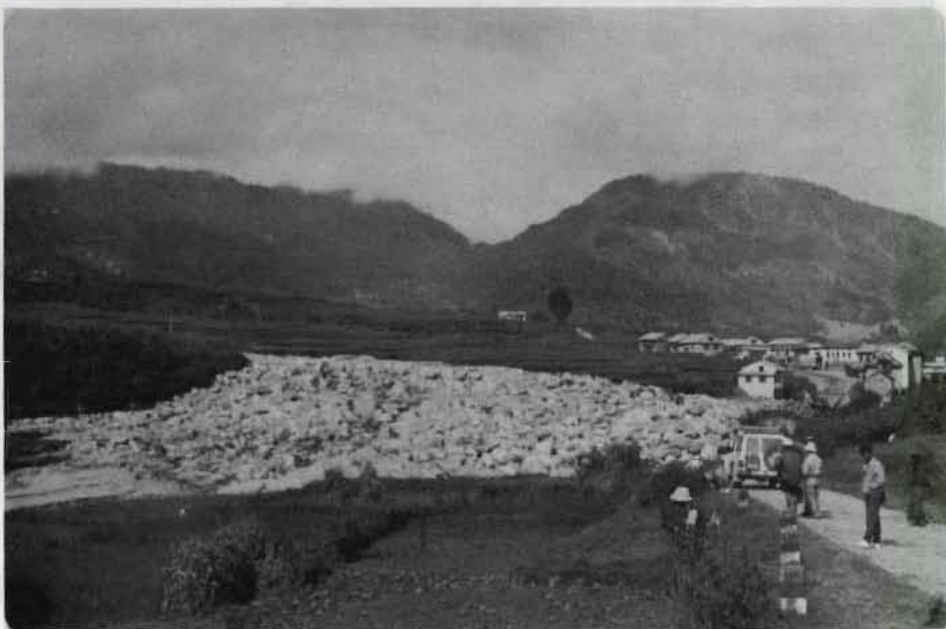
Plate 38: The Kitni *Khola* alluvial fan at Thana Bazaar, the confluence with the Sankhamul *Khola*. All the white boulders are of granite. View towards the north-west

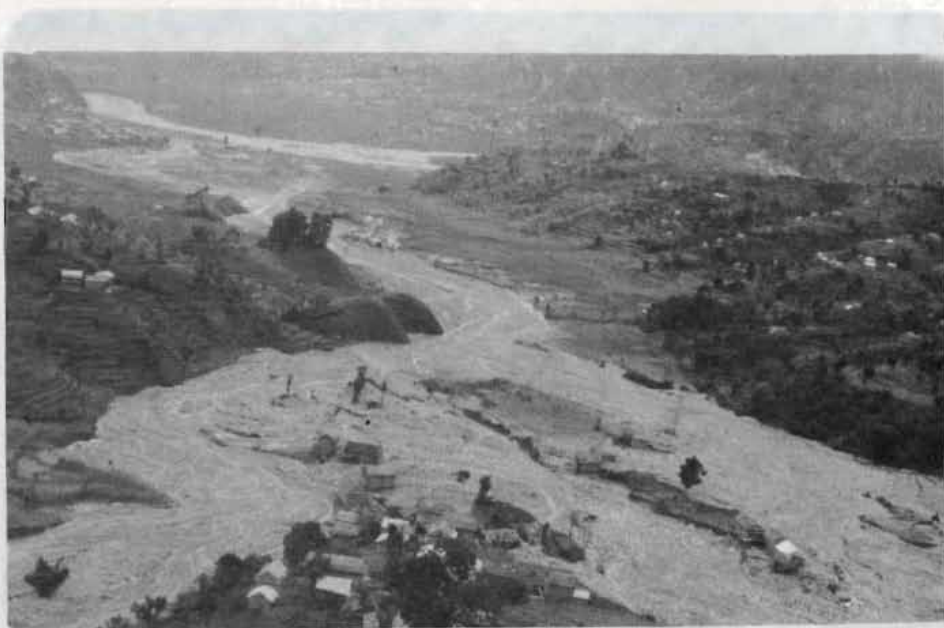
Plate 39: Phedigaun and the debris fans around it. Notice that the middle channel is passing just through the village. View towards the east

Phedigaun (Fig. 2.2, Plate 39) is located at an elevation of about 1,830 masl. It is one of the most severely damaged areas where 52 houses were destroyed (Plates 40, 41, 42) and 62 persons were killed.

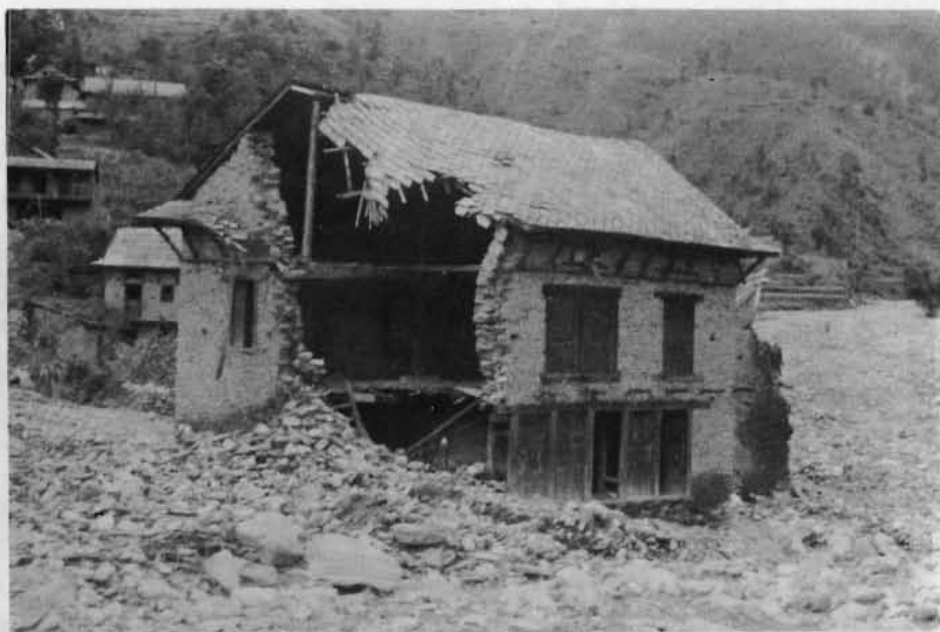
Plate 40: A damaged house at Phedigaun. View towards the west

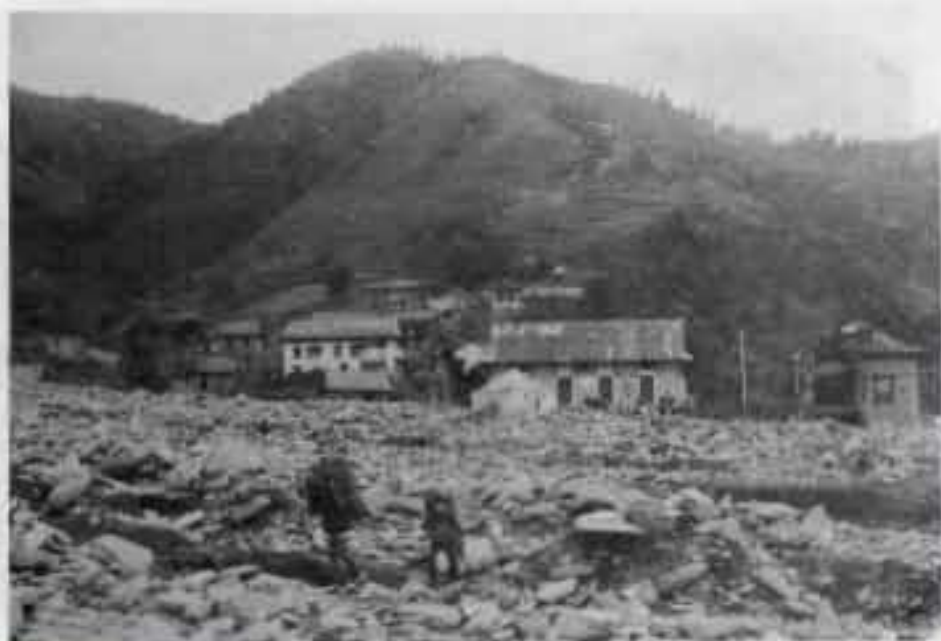
Plate 41: The debris fan at Phedigaun. Notice the green strip of cultivated land to the right. View towards the north-west.

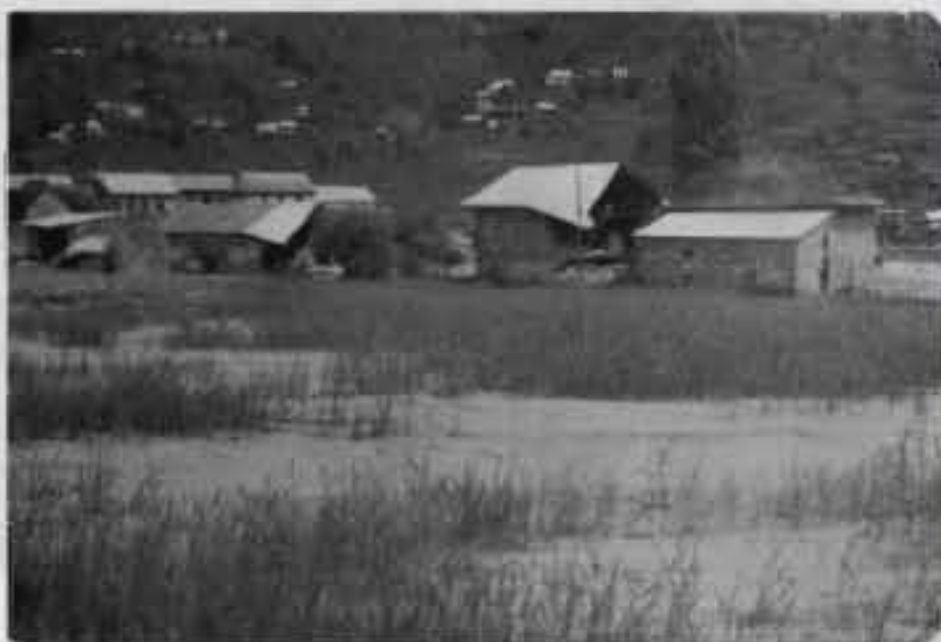
Plate 42: The paddy field in Palung filled up with 0.5 m thick sand. Notice also the damaged houses. View towards the north.

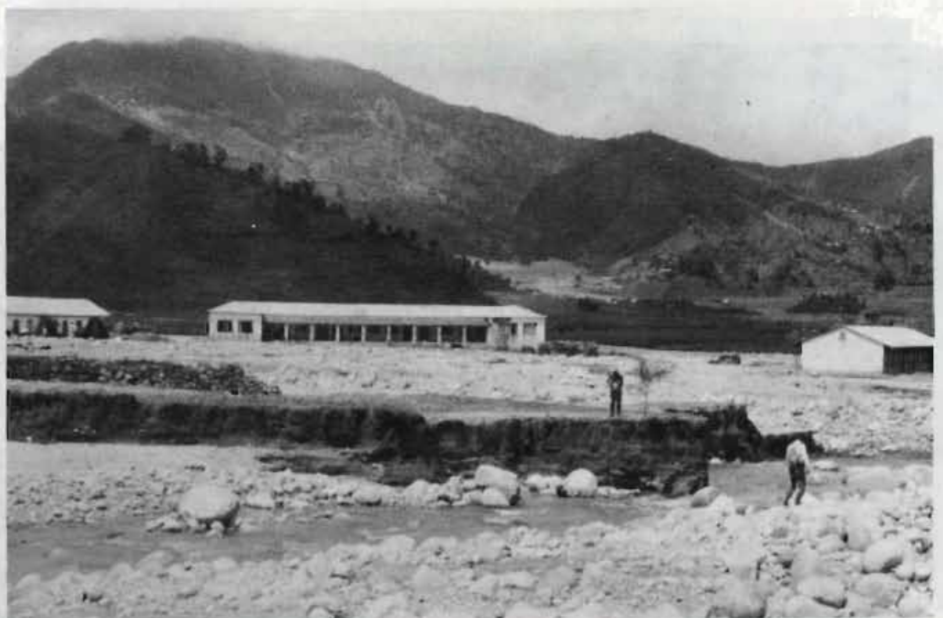
Plate 43: The area around the school filled with boulders and wood debris. The present river channel of the Gairi Khola is 2.6 m below the inundated cultivated land. View towards the north-west

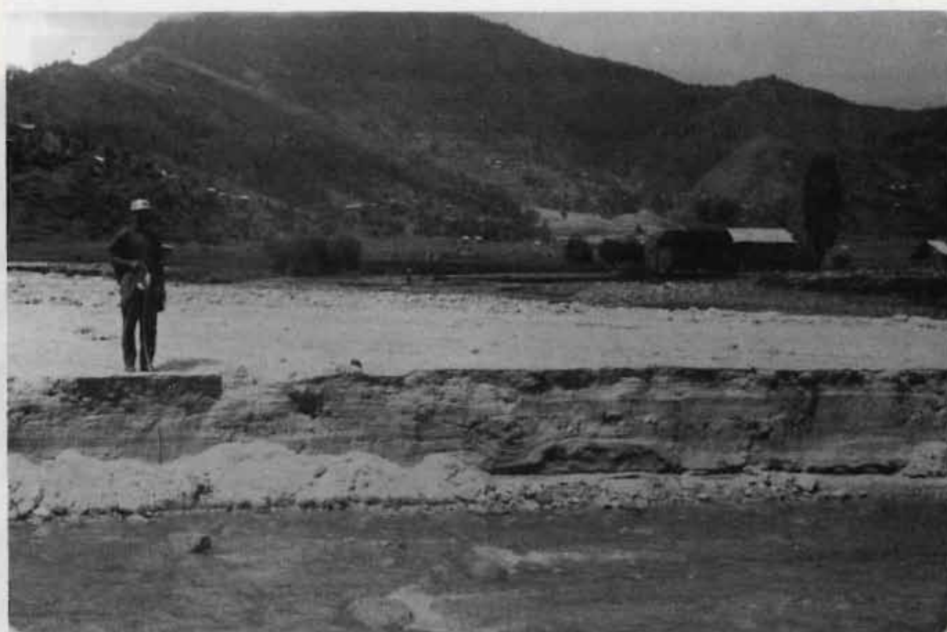
Plate 44: The left bank of the Gharti Khola, about 100m north of the school. Notice the one metre thick gravel bed with cross-bedding and scour marks. View towards the west

The Janakalyan High School is situated on the left bank of the Gharti *Khola*, a tributary to the Palung (Sankhamul) *Khola*. The debris flow in the stream filled up the school campus with boulders and wood debris (Plate 43). At the same time, the river scoured a deeper channel and changed its previous course (Plates 43 and 44).

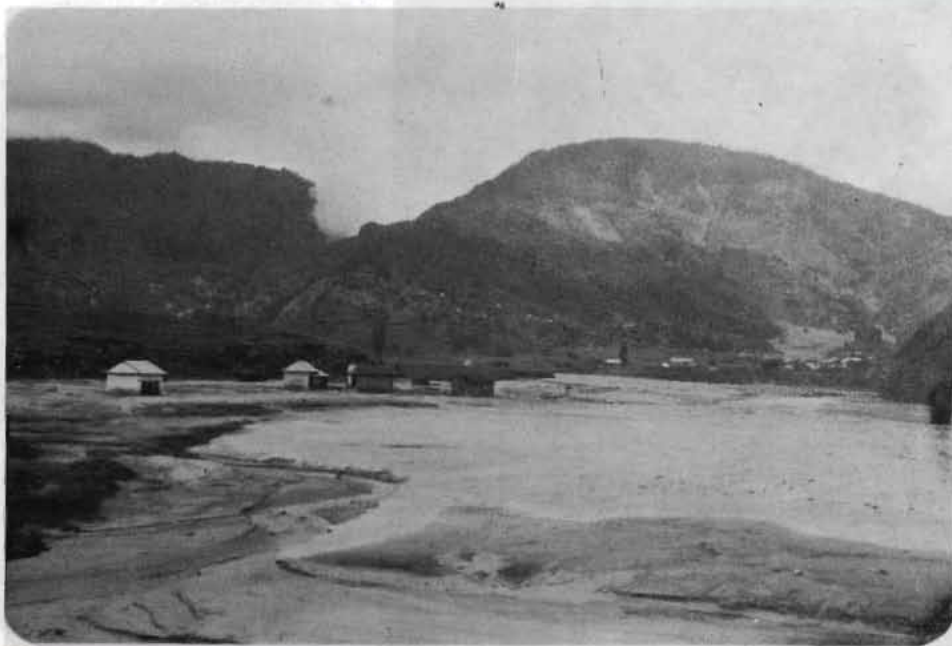
Plate 45: The cultivated land filled up with sand at the temple of Indrenithan on the right bank of the Palung (Sankhamul) *Khola*. Notice the flood level mark on the houses about 70 cm above the sandbar. View towards the west

Further downstream, the Palung (Sankhamul) *Khola* deposited a huge amount of sand and gravel on the cultivated land on its right bank, and the flood marks were noticed on the houses about 70 cm above the sand bar (Plate 45). The temples at Indrenithan situated in the middle of the terrace were filled up by sand and silt for 0.7 m above the ground level (Plate 46).

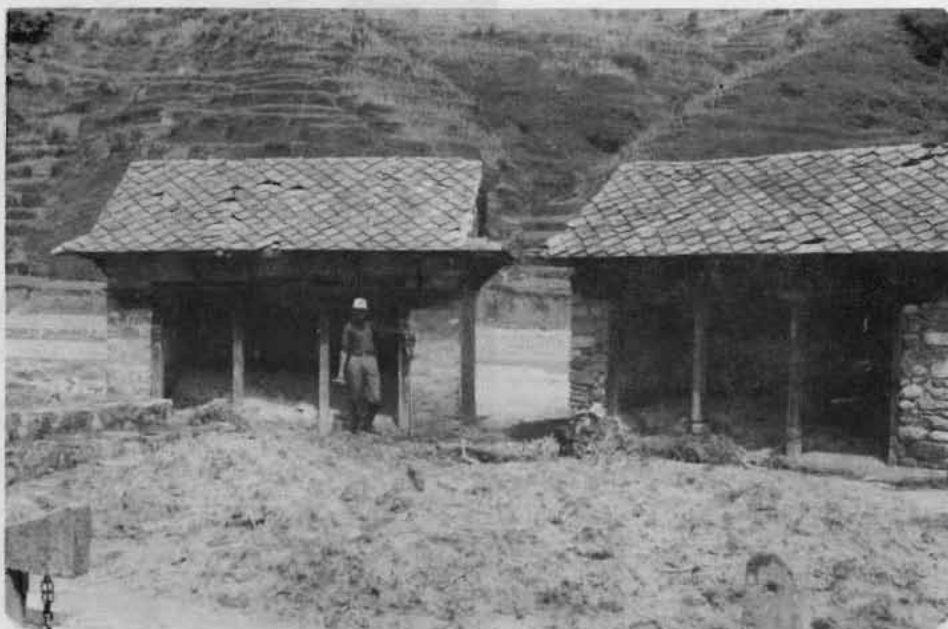
Plate 46: The sand and silt deposits in the temples at Indrenithan, about 70 cm above ground level. View towards the west

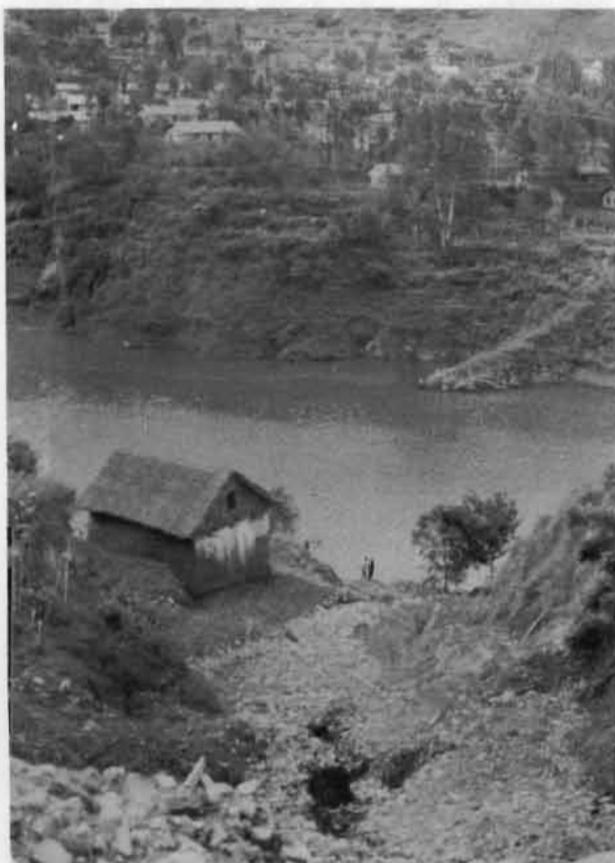
◀ Plate 47: Debris flow in the gully at Dalsing Pakha destroyed two houses and carried down these two children for 75 m (where the two children are standing). View towards Markhu

The material brought into the Kulekhani Reservoir (Plate 10) can be grouped into four types: the suspended wood debris (Plate 15), the suspended sediment load, the bed load, and material from the landslides and gullies surrounding the reservoir (Plates 47 and 48). The debris flow in the gully at Daksing Pakha (Plate 47) destroyed two houses and carried away two children to a spot about 75 metres downstream. The bed load and suspended load were brought into the reservoir by the Palung *Khola*, the Chitlang *Khola*, and the other streams (Fig. 2.2).

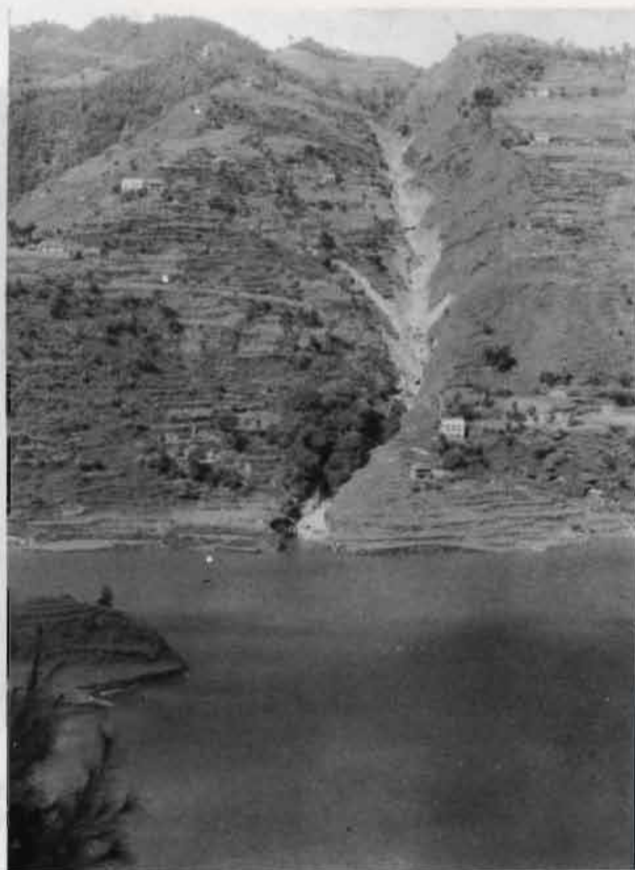
Plate 48: Gully erosion and debris flow on the southern slope of the Kulekhani Reservoir near Markhu. View towards the south-west ▶

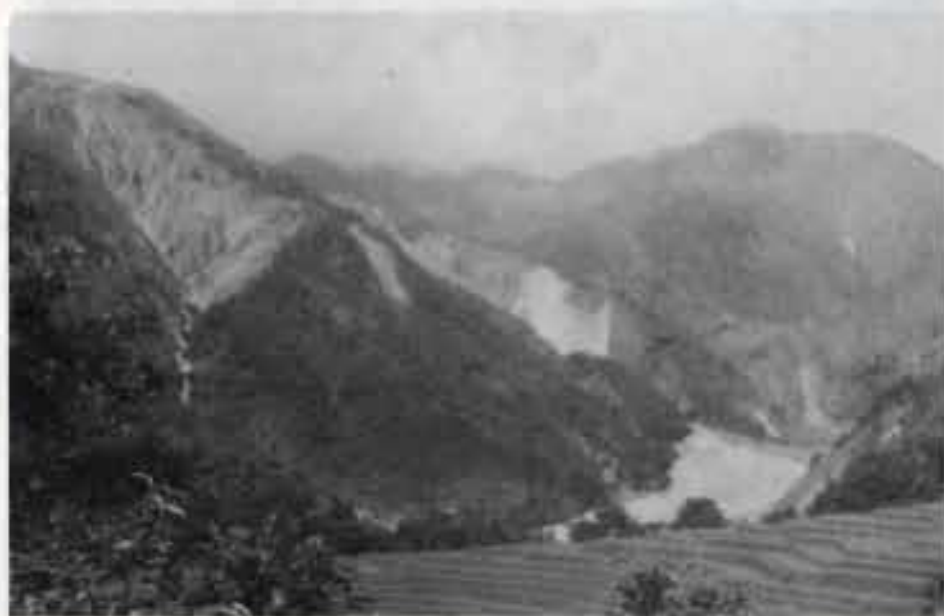
Plate 49: Large rockslide at the contact between granite (white) and slate (grey) on the right bank of the Ipa Khola. There is a wide debris fan below the slide. View towards the west

confluence with the Khani Khola), on the Kanti Rajpath, it can be inferred that there was a past landslide dam. A huge landslide zone is seen at the Ipa Khola (Plate 49) with a large debris fan below. It is the Mahabharat Thrust zone (Fig. 2.2). Landslides and debris flows were also observed at the Deuta Khola and the Neureni Khola.

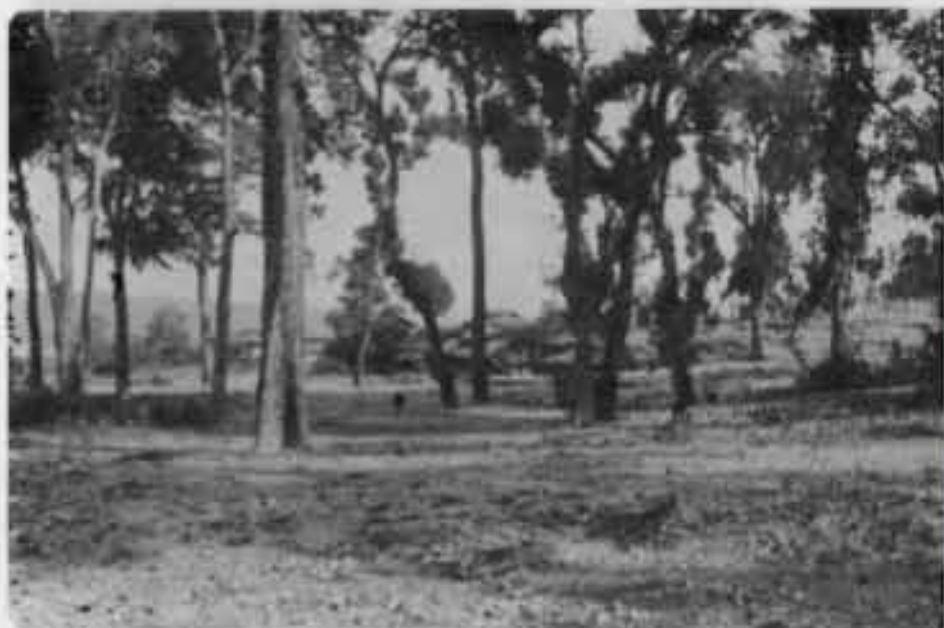
Plate 50: Sheet flooding and debris flow in Karsonje. Most of the pebbles are derived from the Upper Siwaliks. Notice buried and destroyed houses. View towards the south

The village of Karaonje (Fig. 2.2) is situated on the right bank of the Bagmati River on the alluvial fans (Plates 50 and 51). Most of the material was derived from the Upper Siwalik conglomerates. The gullies reworked and transported the pebbles downstream. During the period of intense rainfall, the channel could not contain the water within its very low banks and the sheet flood spilled over the entire alluvial fan. As a result, the houses were buried or destroyed by the debris.

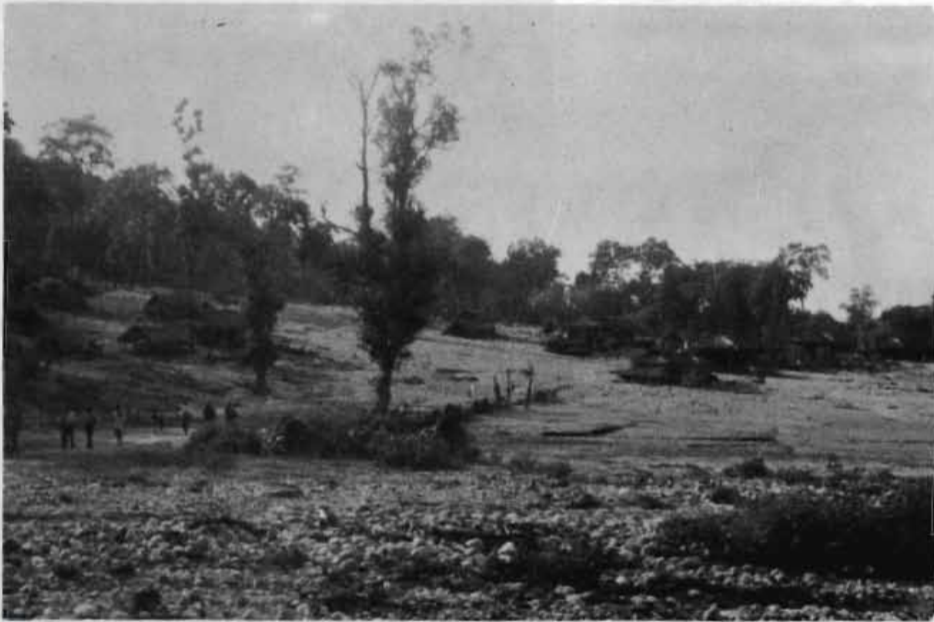
Plate 51: Sheet flooding and debris flow in the southern part of Karaonje. Notice that the damaged village is in the middle of the fan. View towards the north

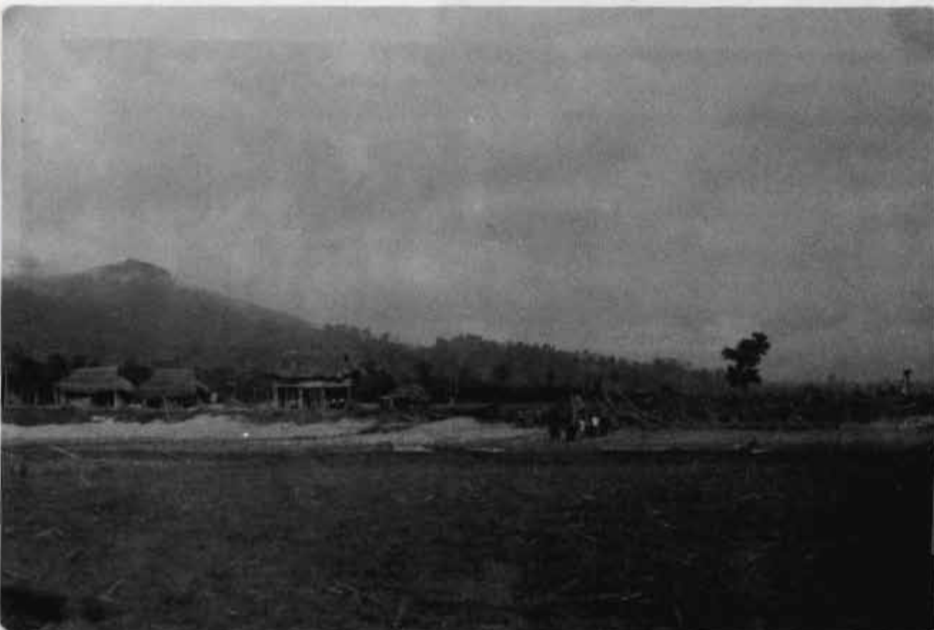
Plate 52: Rai Gaun inundated by flood. The flow direction is marked by the inclined fence to the right. The high flood level was at the ceiling of the ground floor of the hut. View towards the west

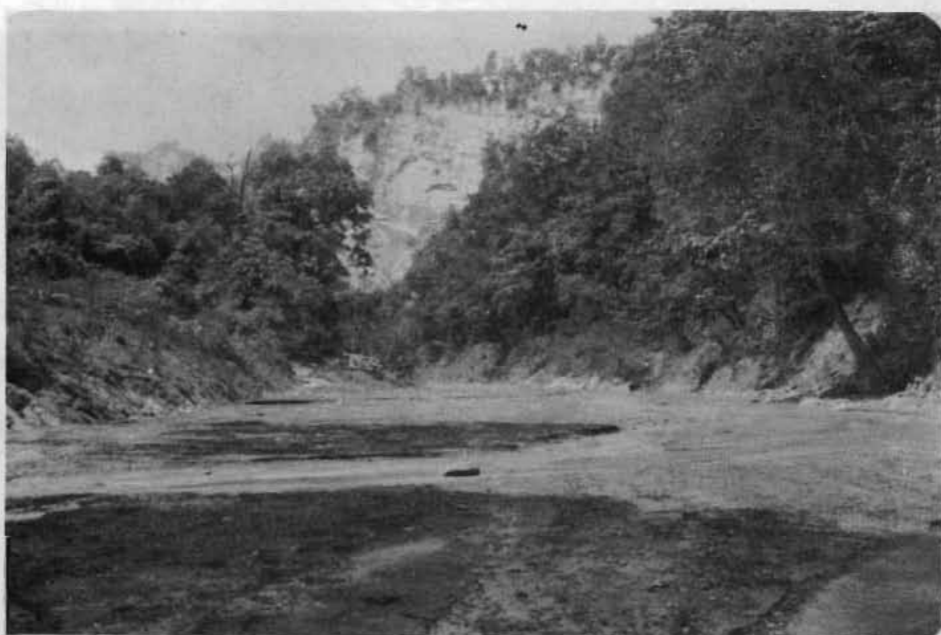
Plate 53: Back water flow marked by an even bed of sand in the Sangle Khola. Notice the landslide on the Middle Siwaliks and the high flood level marked by the colour difference in grass. View towards the west

the Bagmati River was seen in the Sangle *Khola* (Plate 53) situated to the south of Raigaun (Fig. 2.2), where the high flood level was from 1.5 to two metres above the present stream level. The channel was evenly filled up by medium to fine sand, making the bed almost horizontal (Plate 53).

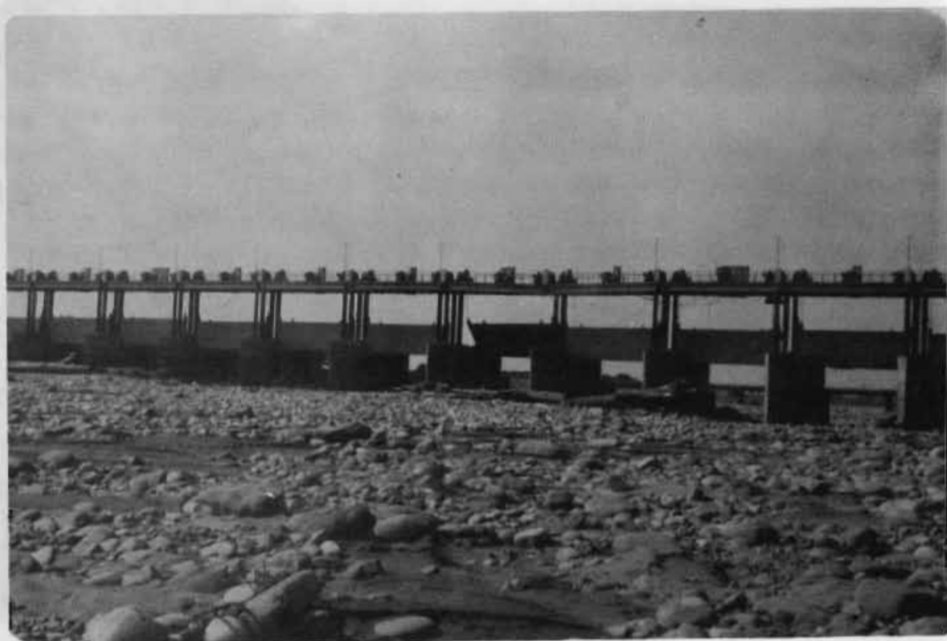
Plate 55: Downstream view of the Bagmati Barrage and the mid-channel bar. Notice a damaged gate (in the centre) and a 33 m long tree trunk. The Bagmati Bridge is seen in the background. View towards the south

Although all 36 gates (9m wide) of the dam were open at the time of the peak flood, these gates were blocked by many large and small logs (with diameters of about 1.9m and heights of up to 30m) and bed load materials. As a result, the water level rose from 125m (at the base level of the dam) to 140.7m (wave height) with a net rise of 15.7m. Water was dammed up to 12 km upstream from the barrage (Graph 1.1). During the field visit, deposition of fine sediments was observed in Sangle *Khola* 12 km upstream, supporting the argument that water was dammed by the barrage. No sign of any damming of the Bagmati or Kulekhani rivers was found in their upstream reaches. It was reported by the local people that generally, in normal flow, it takes two to three hours for water from Raigaun to reach the Bagmati barrage.

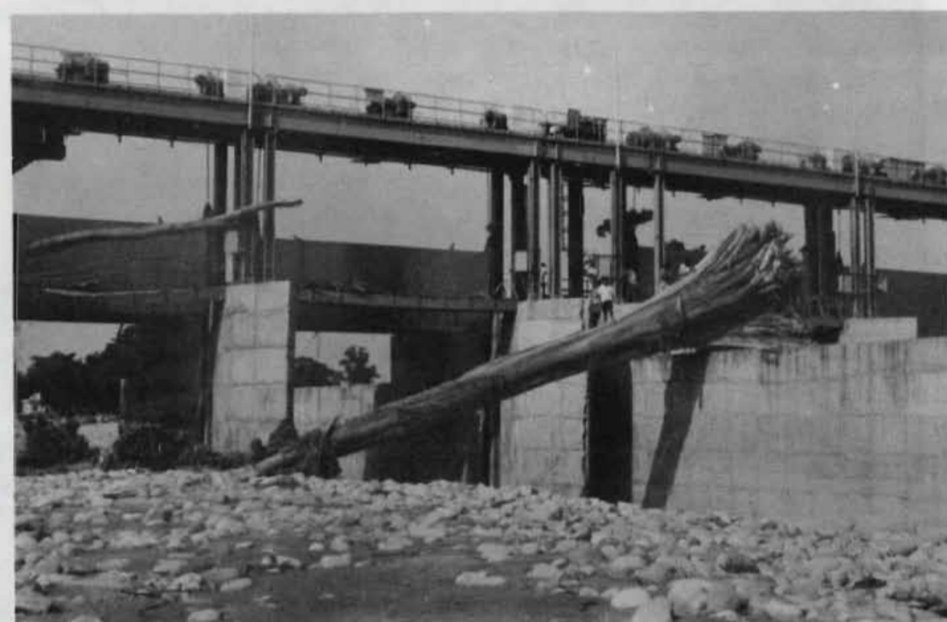
Plate 56: A large tree trunk resting over the dividing wall of the western canal. Notice also another log entrapped in the raised gates. View towards the south

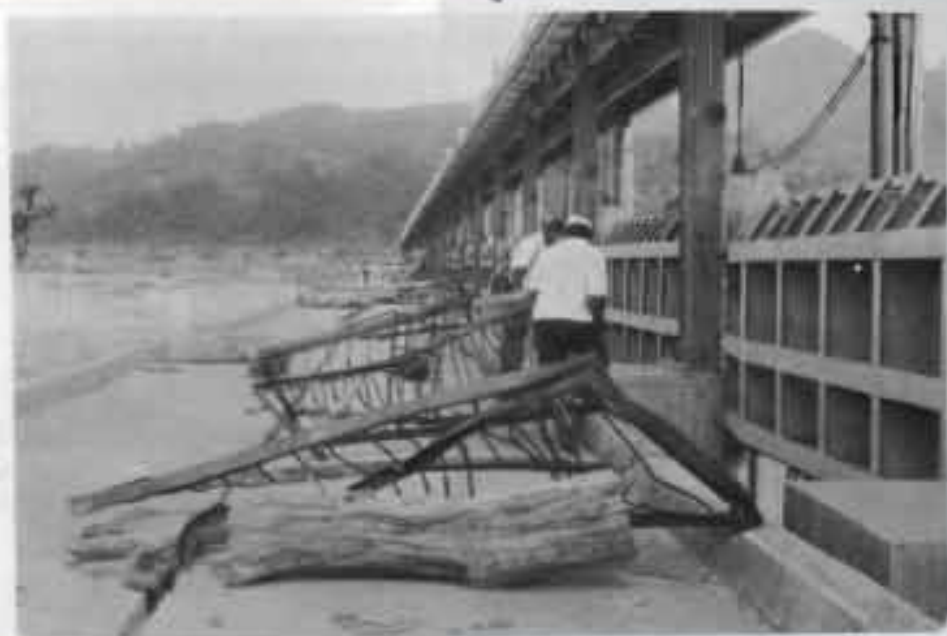
Plate 57:

Twisted and torn apart railings of the Barrage road. Notice several logs blocking the road. Most of the wood debris was already removed. View towards the west

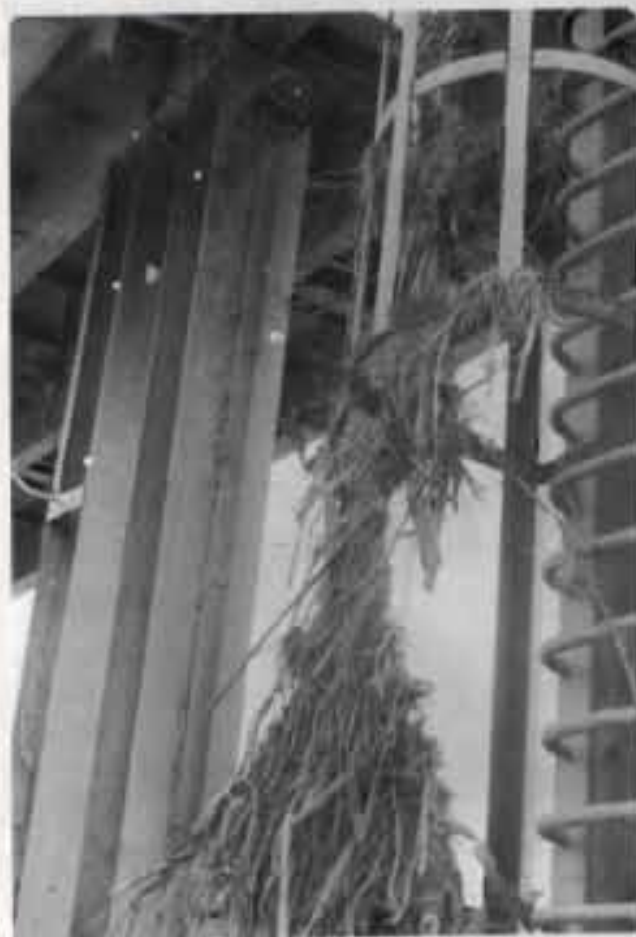
- The tangled straw and roots around the gate-raising wires. Notice that straw can be seen up to the ceiling. View towards the north-west

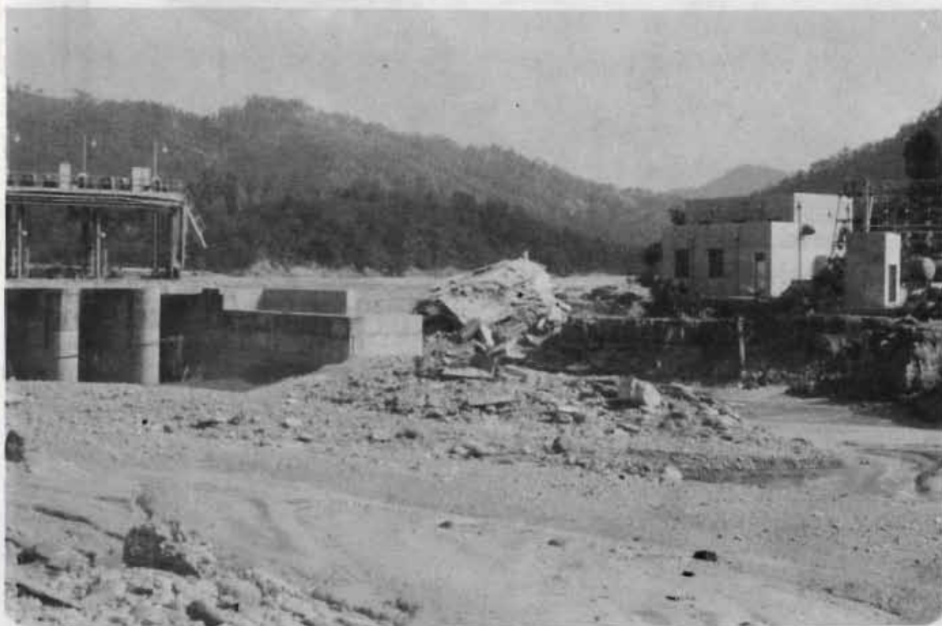
Plate 59: The washed-out control tower on the left bank of the barrage. Notice also that the sediment undersluices and the eastern canal are filled up with gravel. View towards the north

Large trees (more than 30 m long) and wood debris (Plates 55, 56, 57) were some of the underestimated loads. The large tree trunks blocked the barrage as the gates were too narrow to let the wood debris pass through them. As a result, the entire barrage became clogged by the sediment and wood debris. It acted as a large dam and the flood started overflowing the raised gates (Plates 57 and 58). In this process, the eastern and western guide bunds were washed away. The flood and debris destroyed the control tower on the eastern bank at 5:30 a.m. (Plate 59) and washed away the settlements and cultivated land downstream (Plate 60).

The sediment sluices were buried by the sediment, being unable to carry away the bed load. As there were no sediment ejectors, a lot of sand and gravel was deposited in the canals (Plate 59). Neither were there any log-catching structures upstream. The western sediment sluice contained less sediment than the eastern one, indicating uneven flow of the bed load.

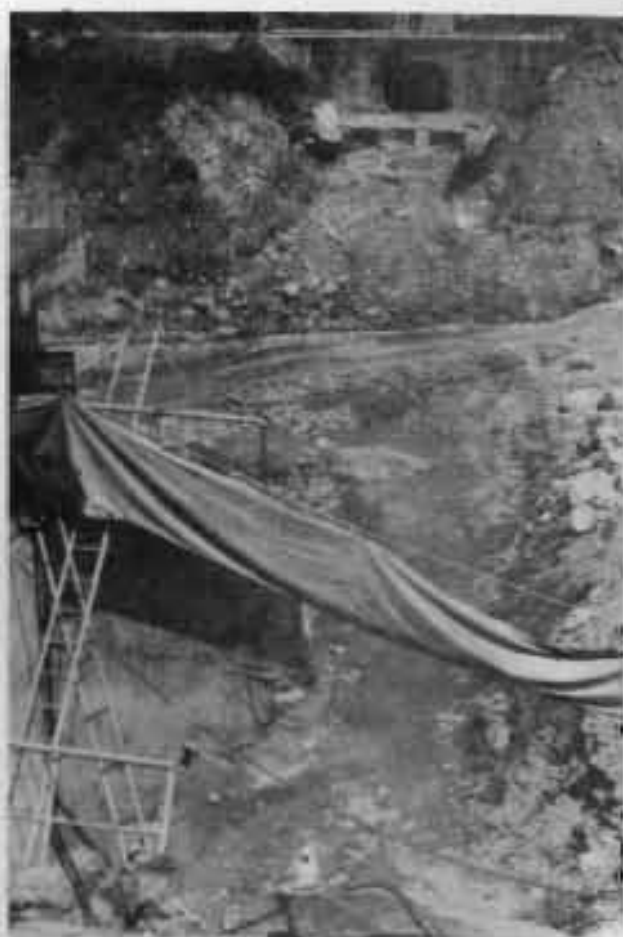
Plate 62: The outlet portal of the Kulekhari I tailrace tunnel damaged by the debris flow from the Mandu Khola. Notice also the damaged intake canal of Kulekhari II. View towards the north

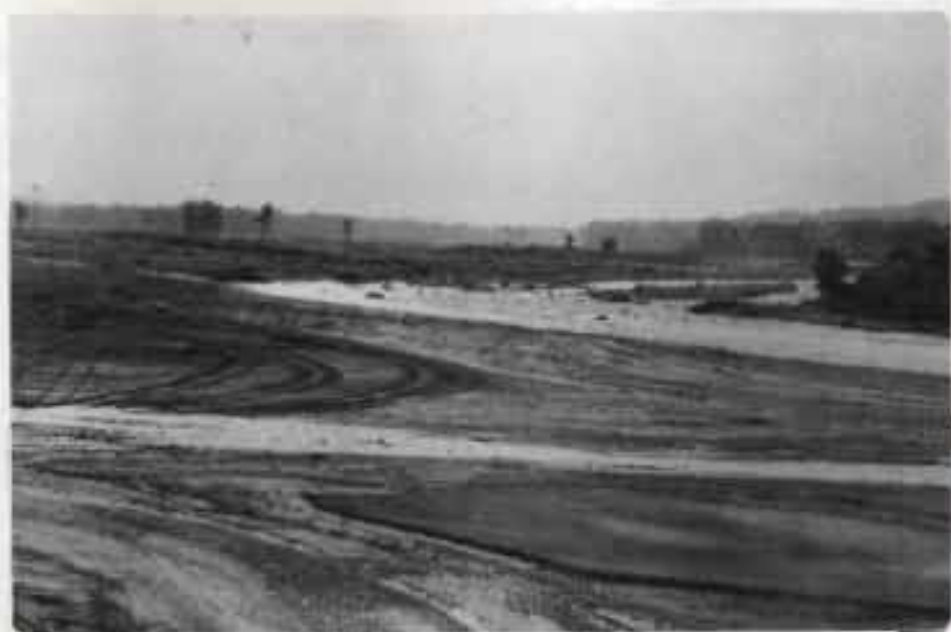
Plate 65: The breached dykes on the right bank of the Manohari Khola. The river shifted to the west and destroyed the cultivated land of the Chitwan Valley
