Landslide Hazard Mitigation

in the Hindu Kush-Himalayas

Editors

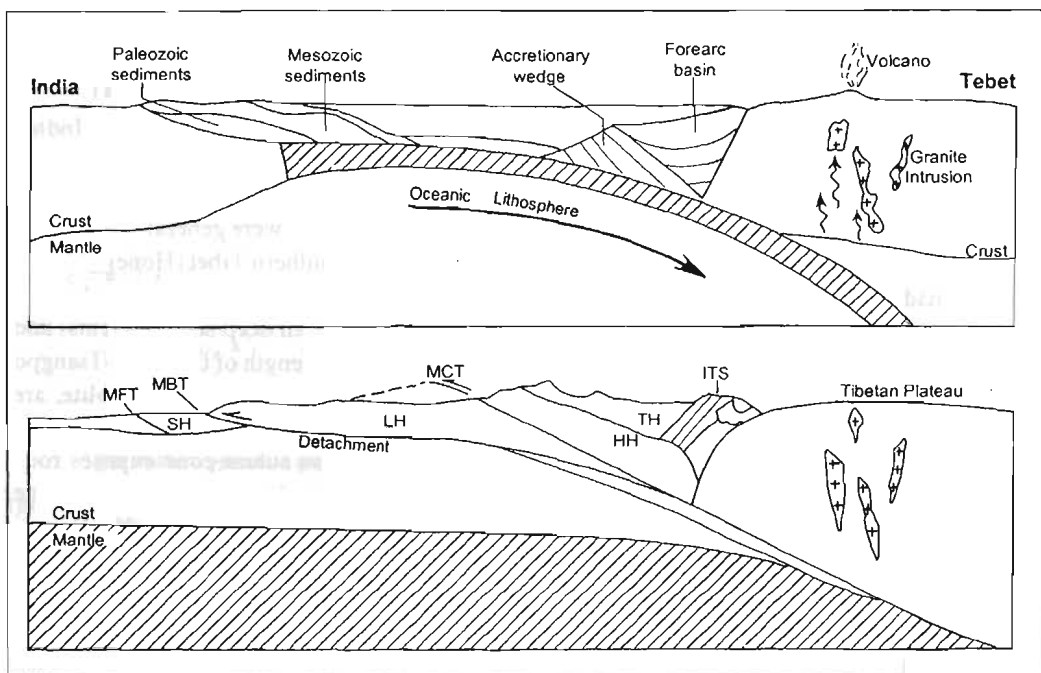
Figure 1.5: Upper figure: closing of Tethys ocean by subduction of oceanic lithosphere of Indian plate under Tibet (Asia), producing island arc volcanoes, granite intrusions, accretionary wedge and fore-arc basin, some 80 million year ago. Lower figure: continent-continent collision between Indian crust and Tibetan crust at 50 million years ago. Slicing of Indian margin crust along MCT, MBT and MFT and stacking of crustal slabs (after Molnar 1986, Valdiya 1988)

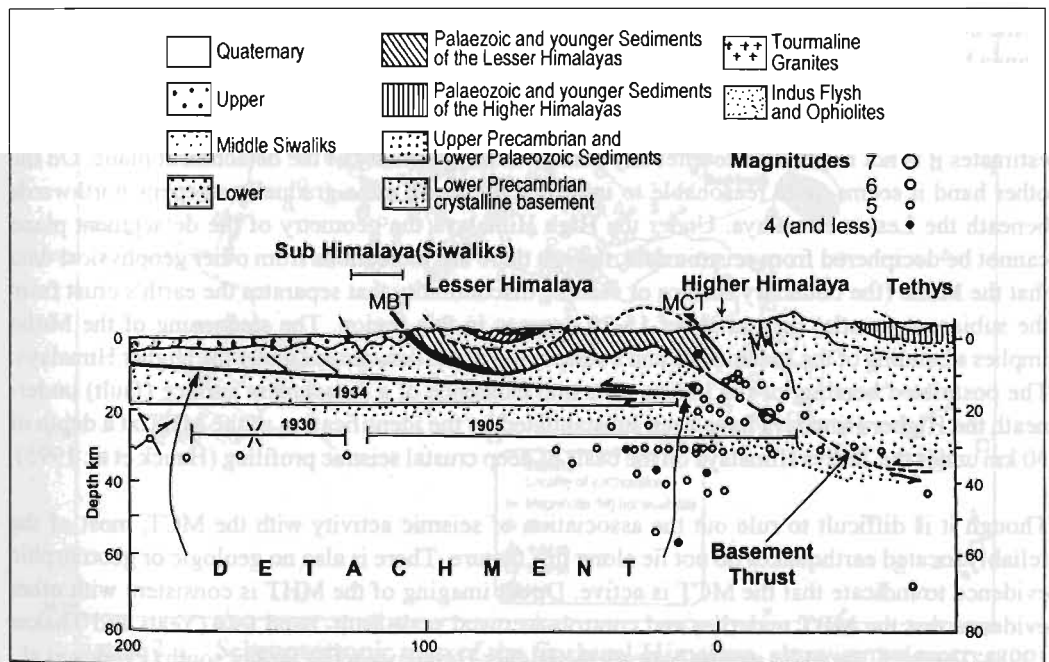
Figure 2.3: Seismotectonic model of the Himalaya showing rupture zone of the great earthquake of 1905, 1930 and 1934, which were associated with slip along the detachment (modified after Seeber et al. 1981)

Seeber et al. (1981) postulated that there was a detachment surface (fault) underlying the entire Himalaya and representing the upper surface of the underthrusting Indian plate (Figure 2.3). This fault was thought to be a decollement, an area with folding or faulting of sedimentary beds as a result of sliding over underlying rock. The fault was thought to dip north at a shallow angle below the Sub-Himalaya (Siwalik zone) at a depth of 2 to 7 km, and then continue into a steeper dipping Basement Thrust (BT) under the Higher Himalaya and Tethys Himalaya. The Himalayan rock formations appear in the form of thrust wedges overlying the detachment; as the Indian plate moves northward (at a rate of 1.5 to 5 cm per year depending on the location), the thrust wedges are pushed southward relative to the northward movement like a pack of cards.

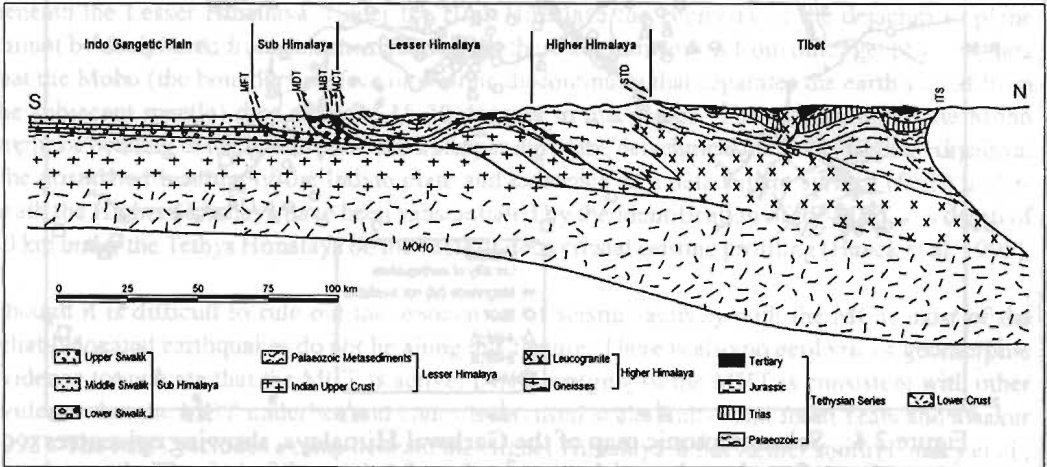
Figure 2.5: Seismotectonic model of the Central Nepal Himalaya, showing detachment and ramp structures (modified after Pandey et al. 1995)

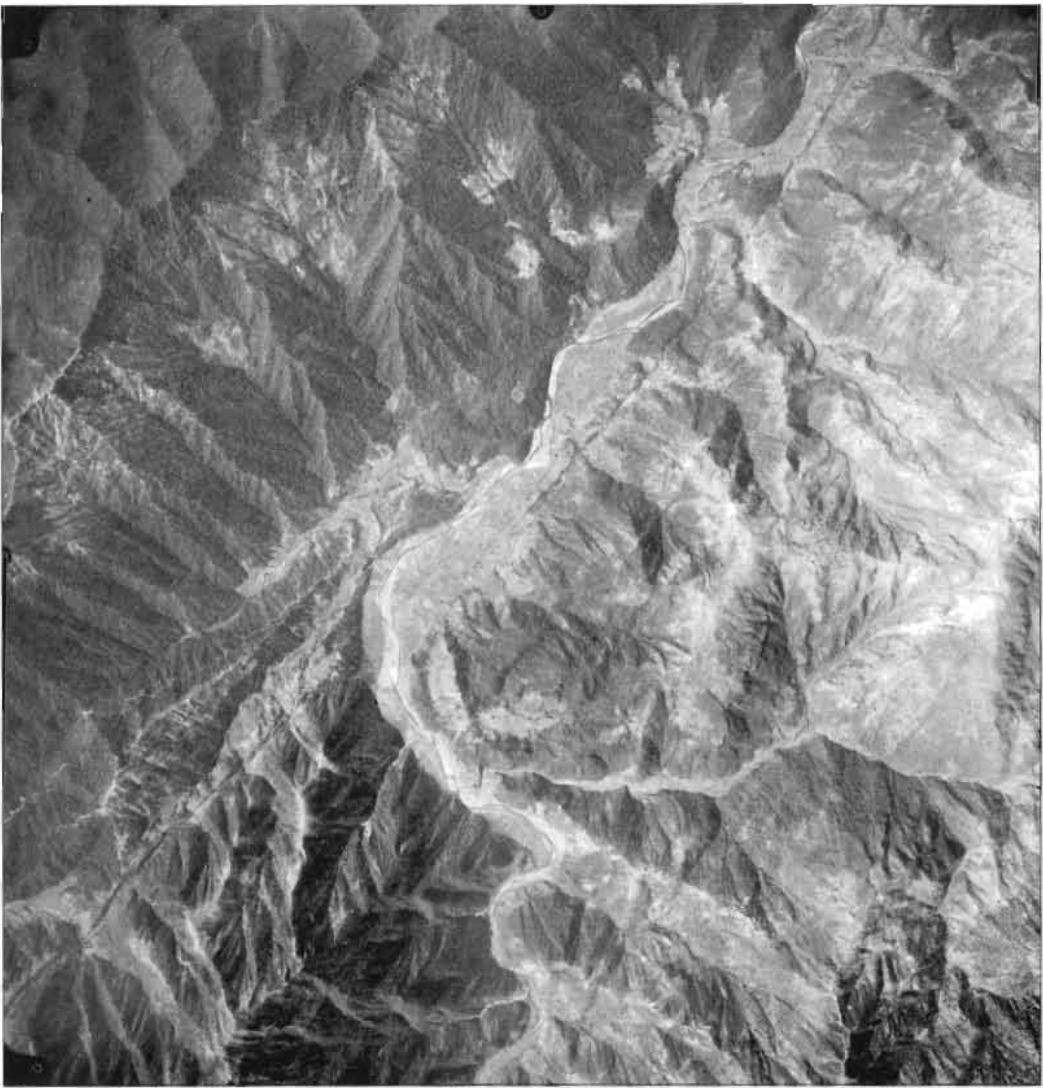
Figure 3.11: Aerial view of the trace of the Main Boundary Thrust (MBT), 25 km north-west of Tulsipur, Dang Valley (along the Sarda Khola) in mid-western Nepal

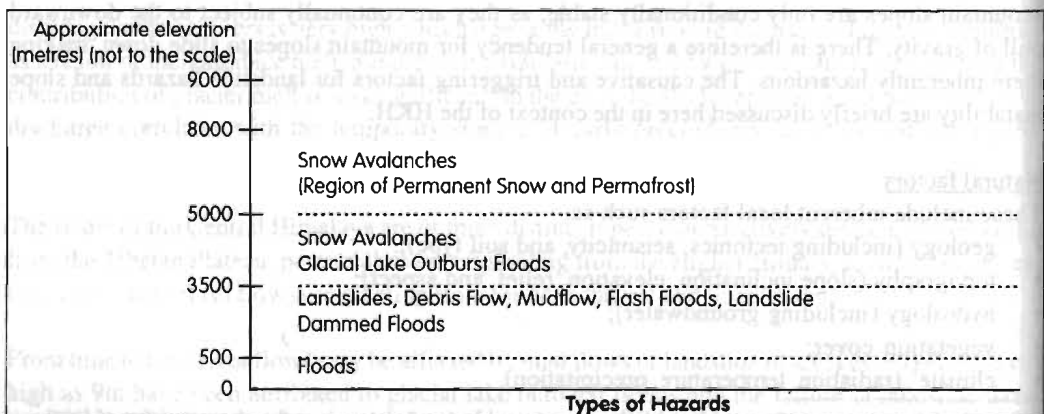
Figure 4.3: Types of natural hazard in different elevation zones of the HKH

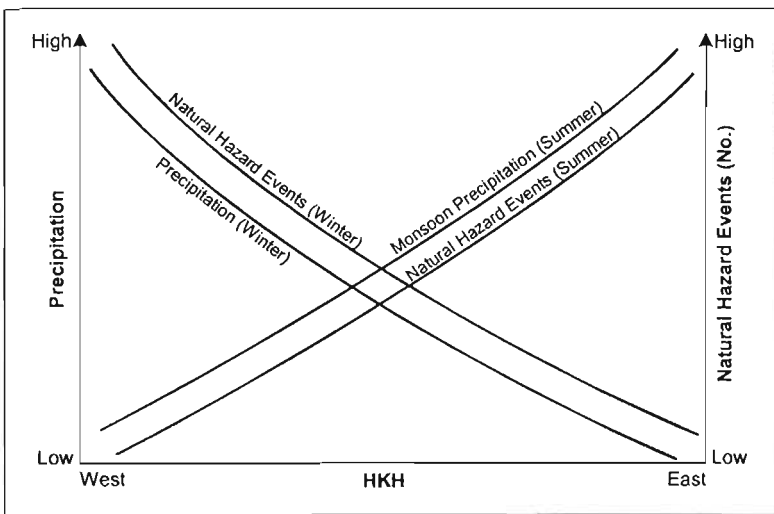
Figure 4.4: Generalised view of the relationship between precipitation, natural hazards, and seasonality across the HKH

The HKH is tectonically very active and hence inherently vulnerable to hazards. In addition, these mountains – particularly in their eastern parts – are exposed to intense seasonal precipitation during the summer monsoon. This acts as a trigger for various types of natural hazards in different elevation zones. Snow avalanches and glacial lake outburst floods predominate at high elevations (above 3,500m), while landslides, debris flows, and flash floods are common in the middle elevations (500-3,500m). Floods are the principal hazard in the lower valleys and plains. Figure 4.3 shows a generalised view of natural hazards at different altitudes; the relative seasonal susceptibility to hazards from west to east is schematically represented in Figure 4.4.

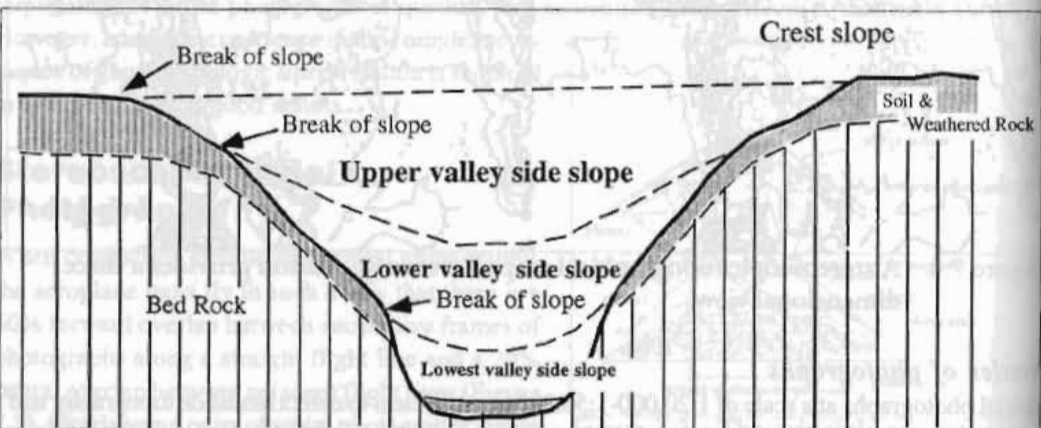
Figure 7.6: A schematic section of valley side slopes, divided by breaks of slope

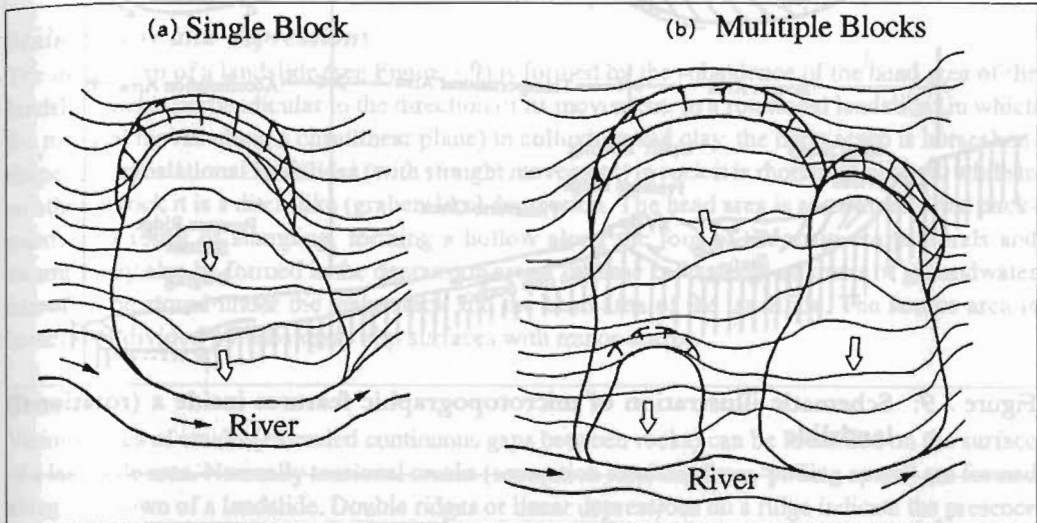
Figure 7.7: Example of block division of a landslide

A landslide area may consist of several blocks, each showing separate movement. Some of these are usually active (Figure 7.7). Prevention work on an active block may be sufficient to restrain the movement of a landslide area as a whole. Active blocks are characterised by microtopography with cracks, pressure ridges, breaks of slopes, and scarplets.

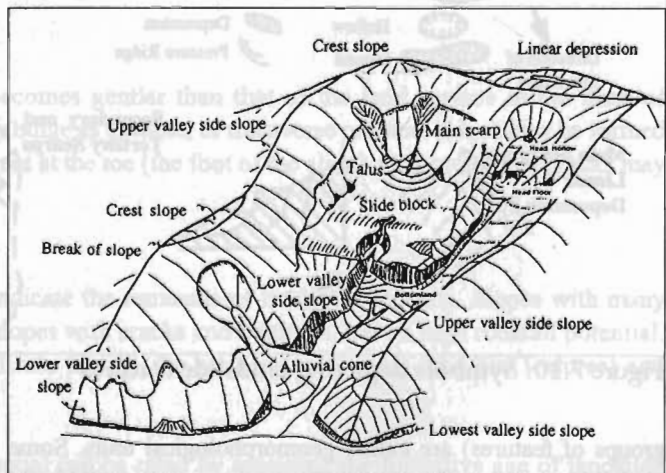
Figure 7.8: Typical topographic features of a rock slide

Some of the typical topographic features of a landslide are illustrated in Figures 7.8 and 7.9. These features are generally depicted on topographic maps using the symbols shown in Figure 7.10. Slope deformations related to landslides like scarps, hollows, linear depressions, cracks, bulges, and pressure ridges are detected through aerial photography and can be used to gain an understanding of past and future mass slope movement. Microtopography, i.e., ruptures or deformation of slope surfaces with dimensions of a few centimetres to a metre or more, can be examined from aerial photographs at larger scale. These micro-topographic features are convincing signs for identifying moving blocks, their direction of movement and precursors of landsliding (Figure 7.9). The larger geographical features (or homogeneous

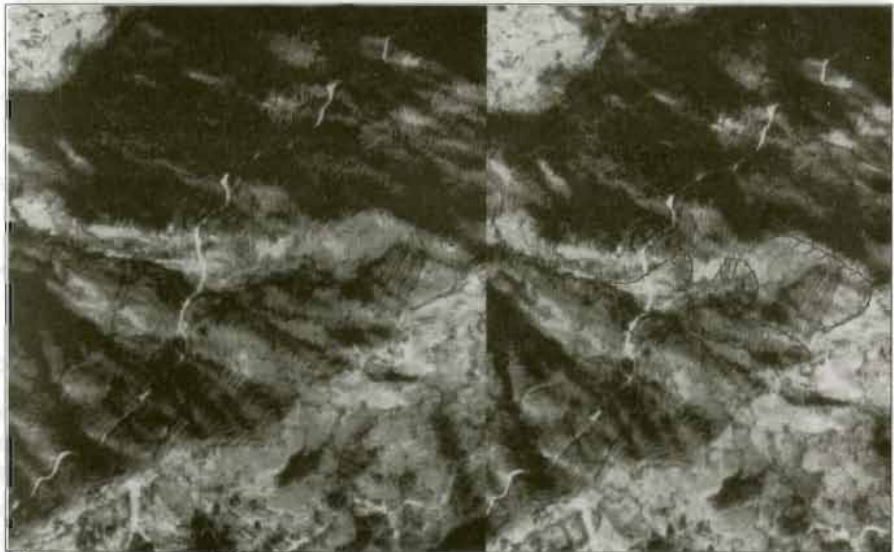
Figure 7.A4: Landslide in a fractured schistose zone (Kathmandu-Trisuli Road, 19-km, central Nepal)

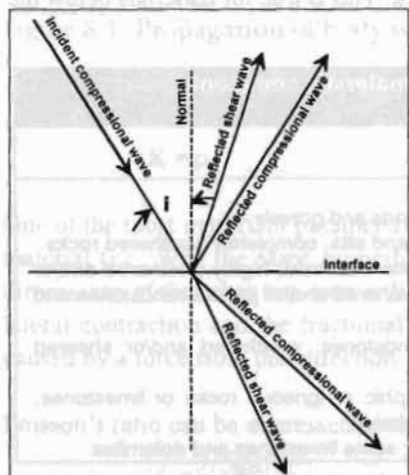
Figure 8.3: Partition of energy of an incident compressional wave at an interface

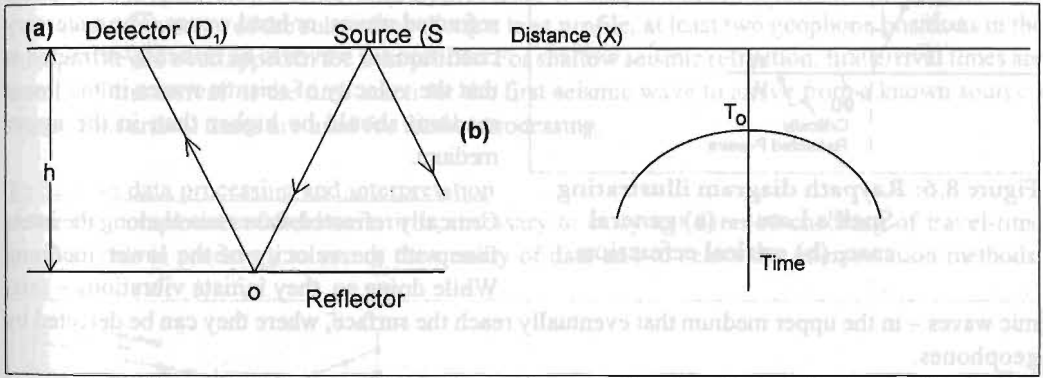
Figure 8.4: Raypath diagram illustrating seismic reflection (a) and its time-distance graph (b)

As the distance between the source and detector (x) is increased, the wave's two-way travel time (t) increases at twice the rate: thus the plot of t against x is a hyperbola (Figure 8.4b). Several hyperbolic forms of waves reflected from different interfaces can be observed on a seismogram.

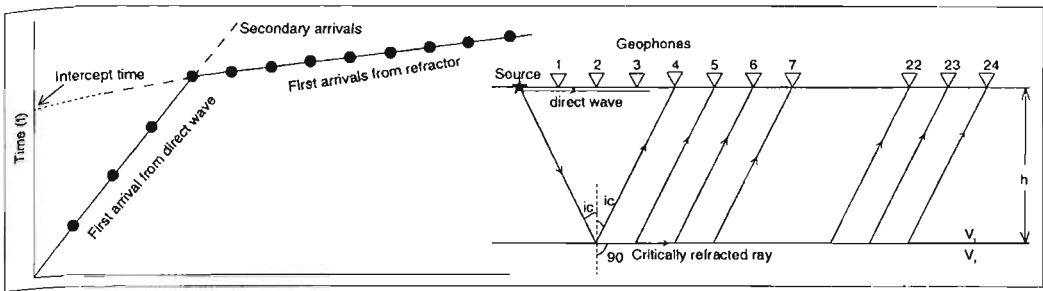
Figure 8.7: Time-distance graph and direct and critically refracted waves in an ideal two-layer case

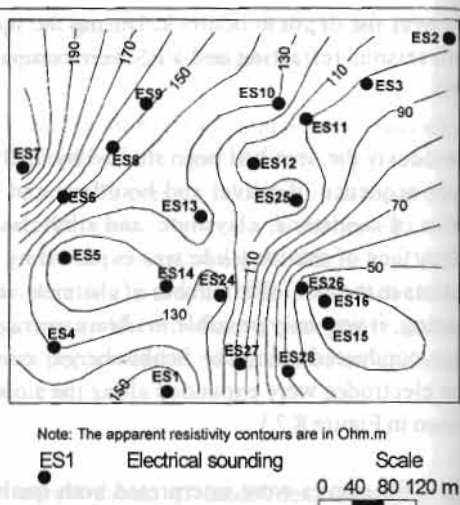
Figure 8.25: Apparent resistivity map at electrode spacing (AB/2) of 8 m, Xiakou Landslide, Sichuan, China

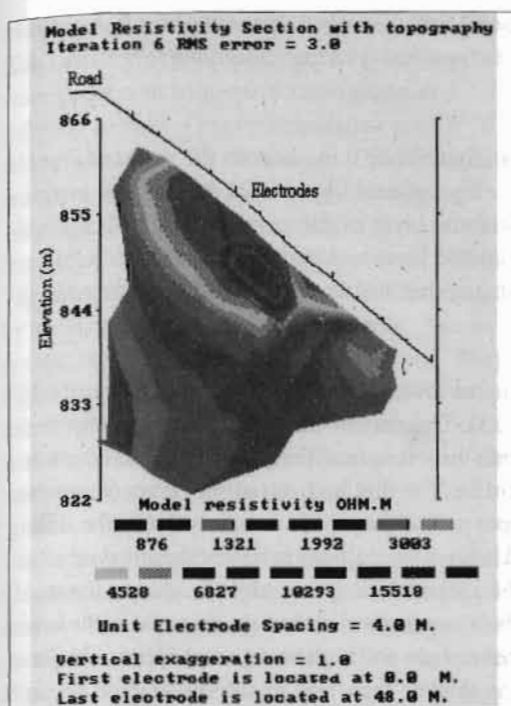
Figure 8.31: Tomogram of landslide at km 85+280, Arniko Highway, Nepal

The sliding area at km 85+280 seems to be a part of a larger unstable area. Figure 8.31 shows the 2-D profile along the downslope (below road level) at an angle of 32 degrees. The very high electrical resistivity (more than 5000 Ω m) in the model section indicates a dry, loose, and displaced mass. The maximum thickness of the image (high resistivity zone) is 10-12m. This zone is prone to sliding

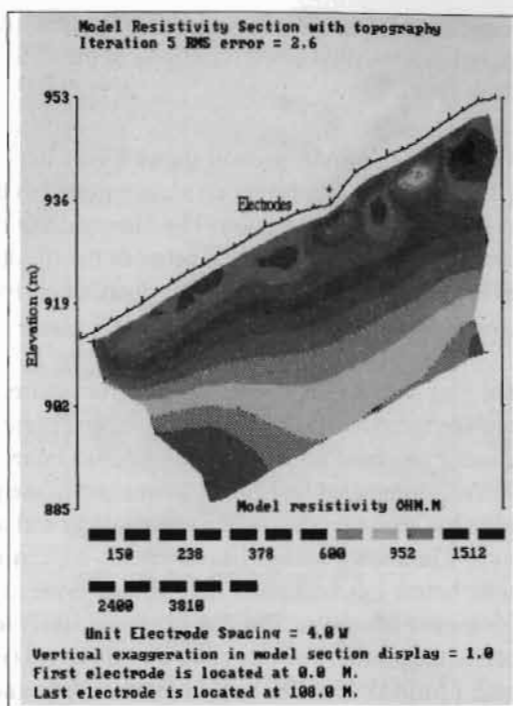
Figure 8.32: Tomogram of landslide at Sandhi Kholsa, Profile One, Arniko Highway, Nepal

The 2-D profiles shown for the Sandhi Kholsa (km 87+700) were made at an angle of 45° to each other and in a slope of 20° . The first profile (Figure 8.32) trends north-east to south-west, and the second (Figure 8.33) south-east to north-west; they cross each other at the point denoted by the asterisk. The unit electrode spacings for the first and second profiles were 4 and 5m respectively. Micro-VES measurements using a pole-pole configuration showed the ratio of the resistivity of the slide to the resistivity of the underlying layer to be 3:10. This was interpreted as reflecting differences in rock (lithological) characteristics between the sliding material and the underlying material that serves as the slip surface. The lower part of the slide (silt-domi-

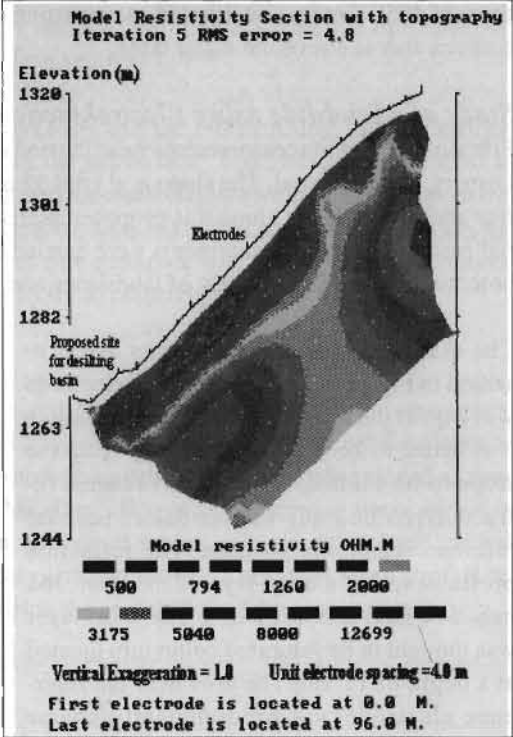
Figure 8.35: Tomogram of critical slopes for profile C-C' near the Khimti I hydropower project, eastern Nepal

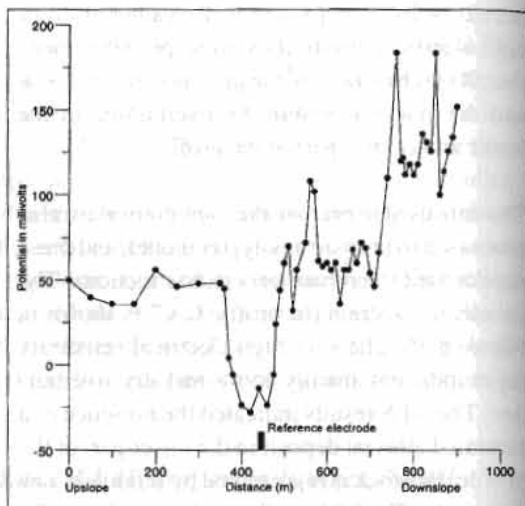
Figure 8.37: Filtration potential observed on the Ashine slope, Okhaldhunga, eastern Nepal

The Ashine slope measurements are presented in Figure 8.37. The reference electrode was kept at the middle of the profile, although it is better to keep electrodes away from the slope to be studied. A very short seismic refraction profile study was conducted near the reference electrode position. The refraction profile revealed a three-layered medium: 365 m/s, 674 m/s, and 1561 m/s. The third layer was thought to be saturated colluvium located at a depth of 11.5m. The area near the reference electrode was predominantly coarse grained and served as a recharge (permeable zone). The upper and lower parts of the slope had several permeable and impermeable beds indicated in the figure as local lows and highs. If these local minima and maxima are ignored, a trend can be seen towards increased potential values downslope. This is mainly related to groundwater movement; there is a large amount of discharge at the lower end of the profile. The results show that if the measurements are taken with care, even low filtration potential values can be useful for mapping the surface and near-subsurface distribution of materials in a slope.

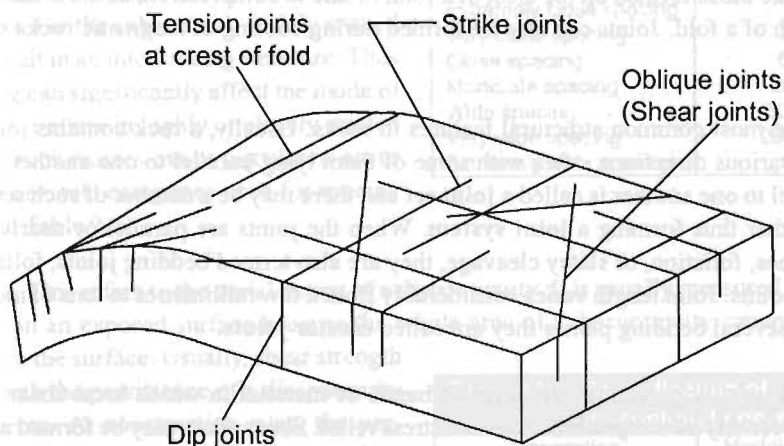
Figure 9.1: Joints in a folded stratum (after Blyth and Freitas 1974)

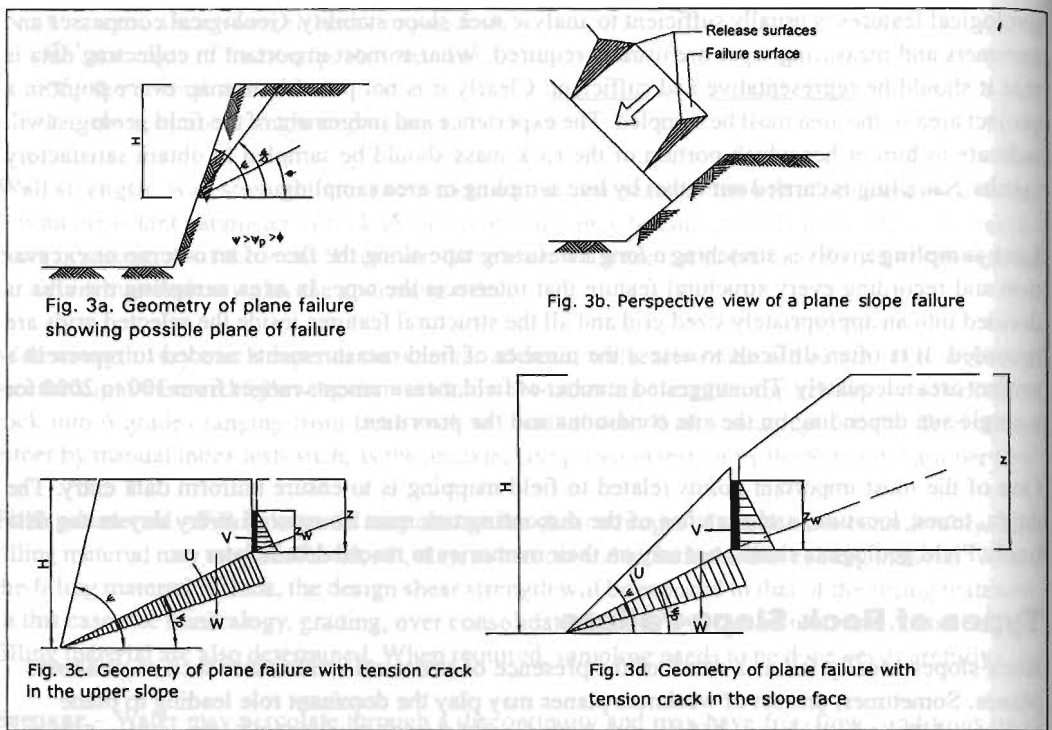
Figure 9.3: Geometry of plane failure (after Hoek and Bray 1981)

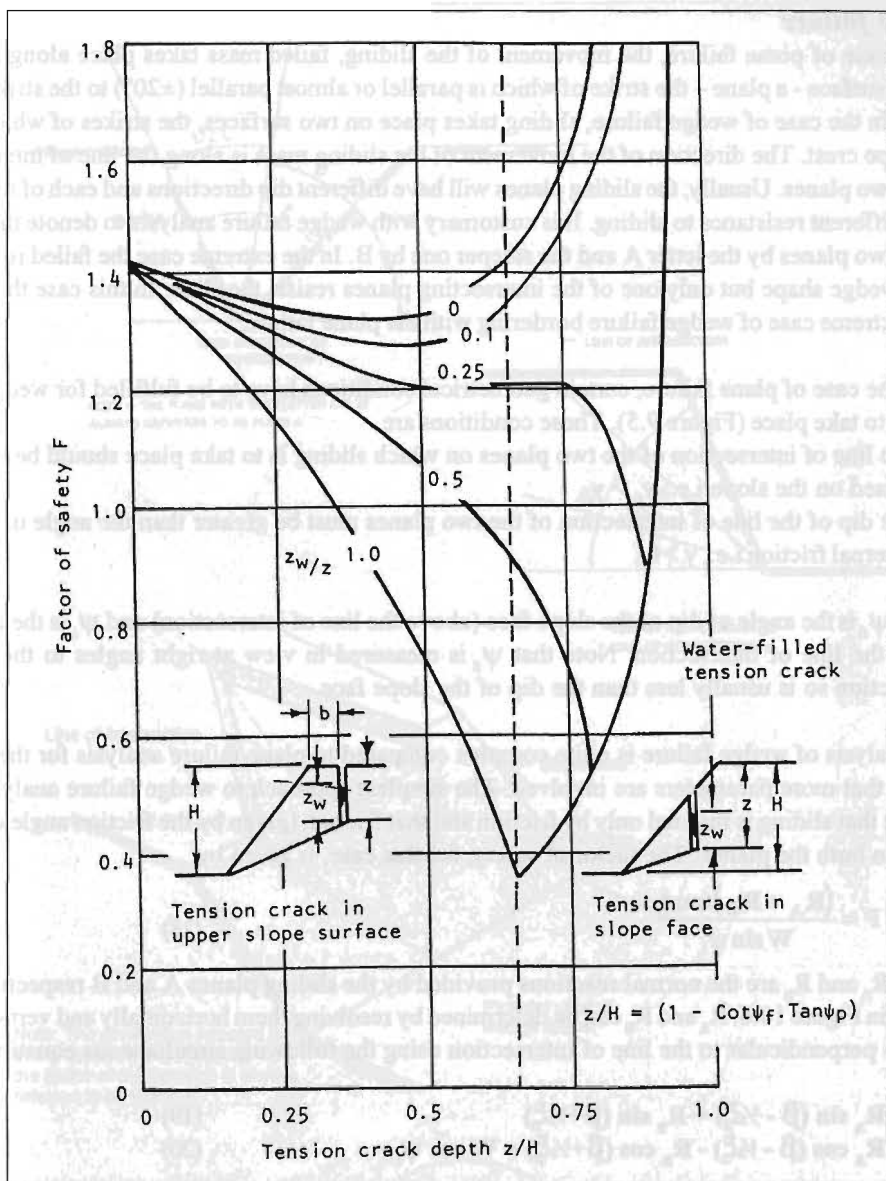
Figure 9.4: Influence of tension crack depth and depth of water in the tension crack upon the safety factor of a typical slope (Hoek and Bray 1981)

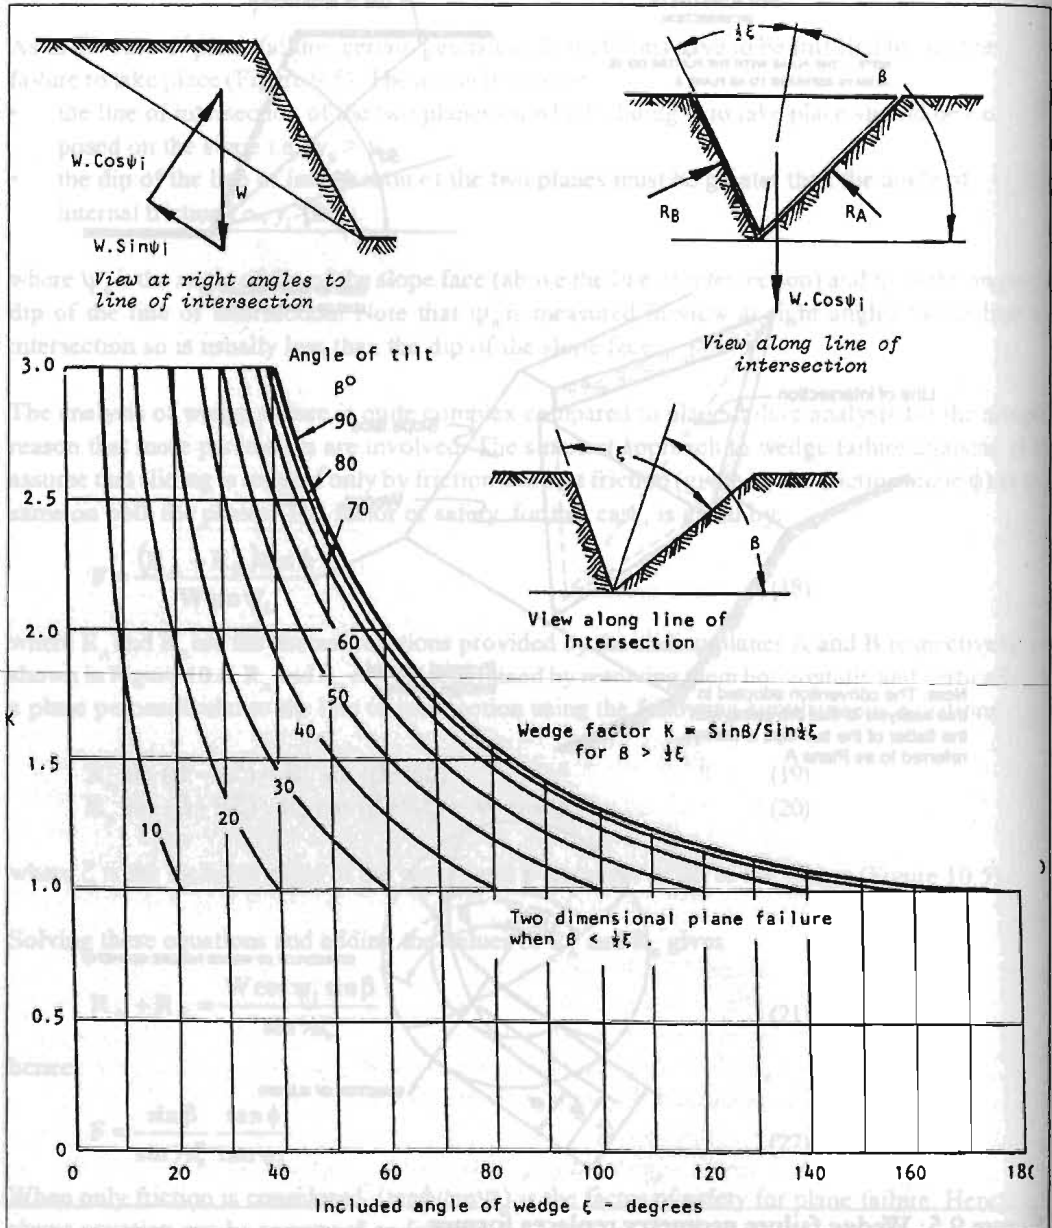
Figure 9.6: Wedge factor K as a function of wedge geometry (Hoek and Bray 1981)

where F_w is the factor of safety of a wedge supported by friction only, and F_p is the factor of safety of a plane failure in which the slope face is inclined at ψ_n and the failure plane is inclined at ψ_i . Since $K = (\sin \beta / \sin 0.5\xi) > 1$, resistance to sliding will be greater in the case of wedge failure than that in the case of plane failure. The wedge factor K depends on the included angle of the wedge ξ and the angle of tilt of the wedge β . The values of K can be plotted for various values of ξ and β and be readily used for wedge failure analysis. Further details are shown in Figure 9.6.

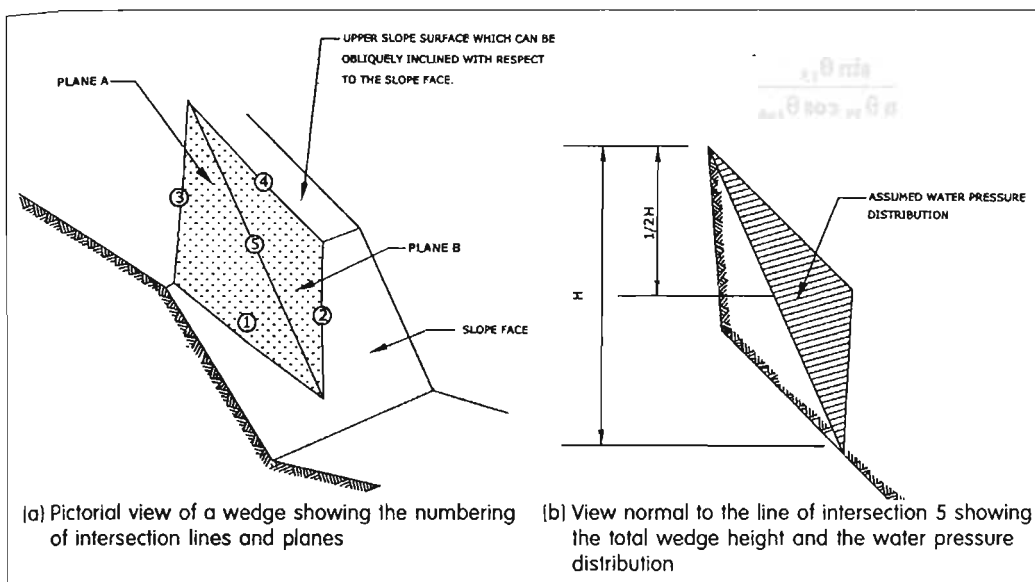
Figure 9.7: **Geometry of wedge used for a stability analysis that includes the influence of cohesion and water pressure on the failure surfaces** (after Hoek and Bray 1981)

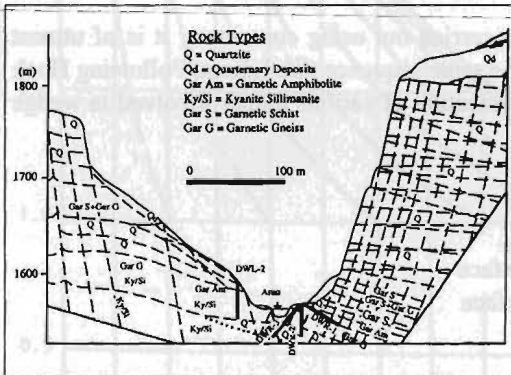
Figure 9.8: Geological cross-section 300m downstream of proposed Upper Arun dam site

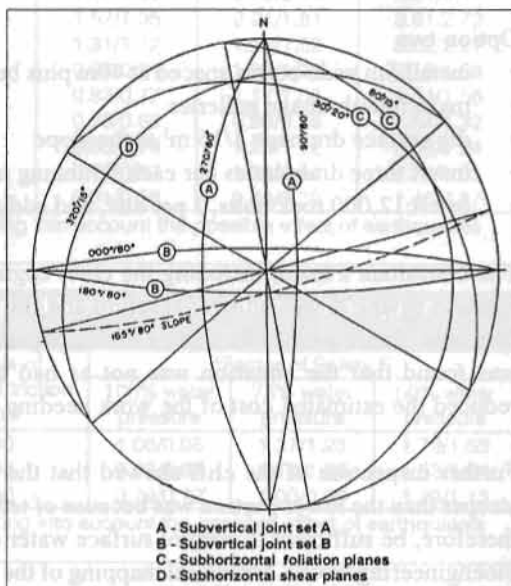
Figure 9.9: Stereographic plot of various discontinuities at the proposed Upper Arun dam site area

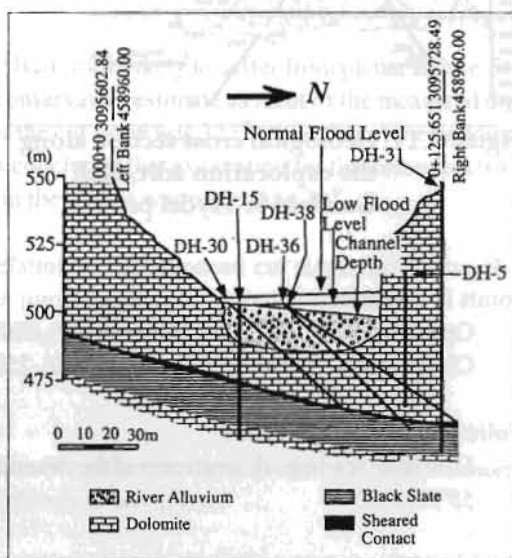
Figure 9.10: Geological cross-section along the dam axis of the Kali Gandaki 'A' hydel project (Kafle 1996)

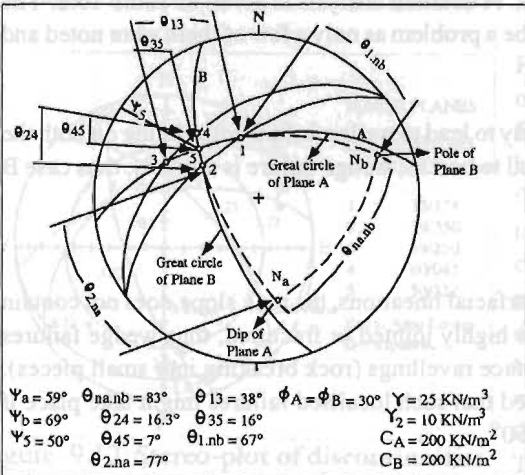
Figure 9.13: Stereo plot of wedge forming joints, Kali Gandaki 'A' Hydel project

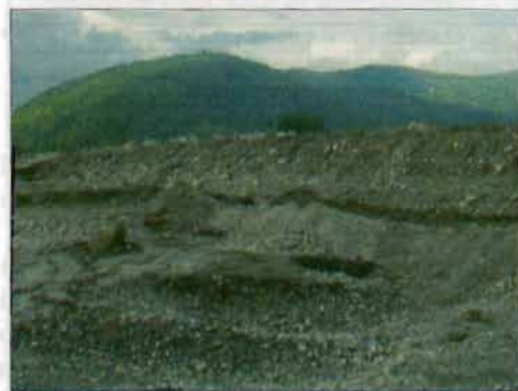
Plate 10.5: The Manohari River (central Nepal) embankment in May 1994, during construction

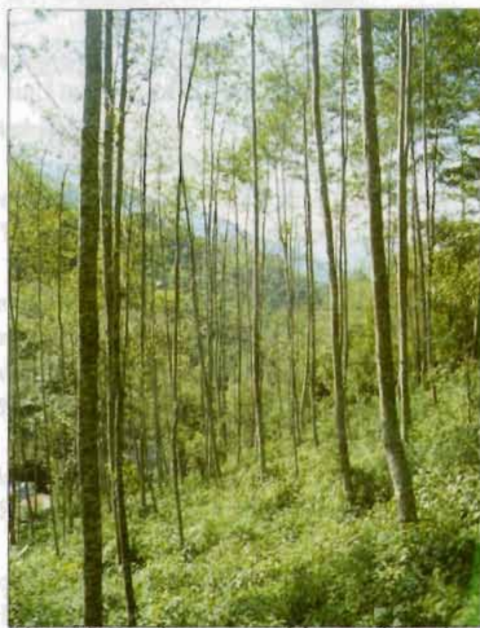
Plate 10.7: A mature bio-engineering site: *utis* (*Alnus nepalensis*) forest on the Lamosangu-Jiri road (central Nepal)

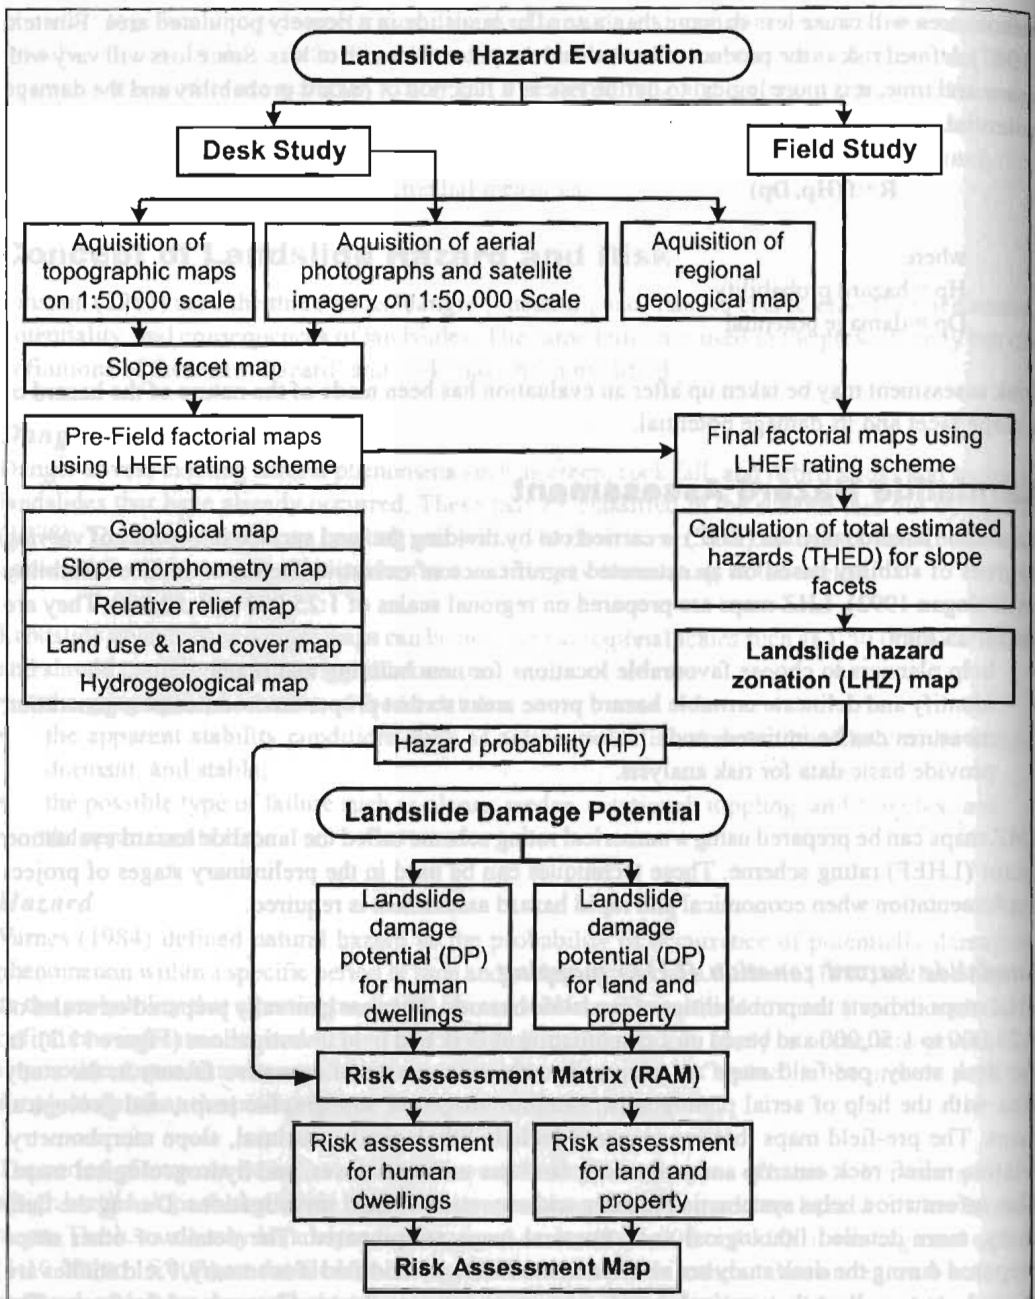
Figure 11.2: Procedure for landslide hazard mapping

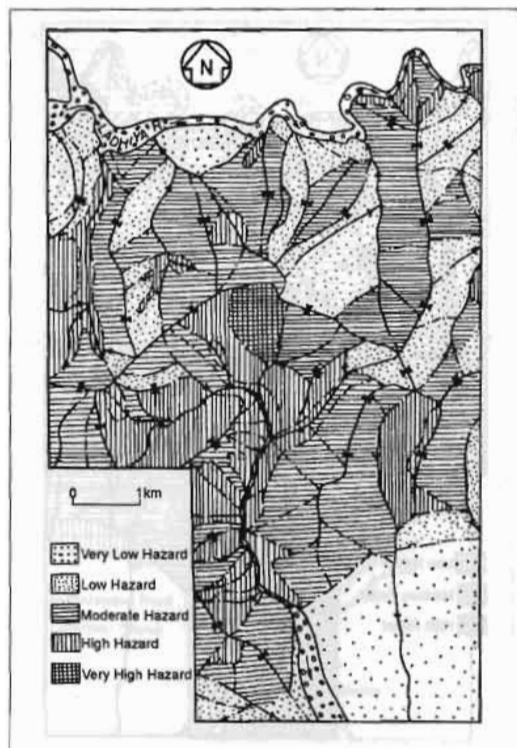
Figure 11.11: Landslide hazard zonation map of Sukhidang area

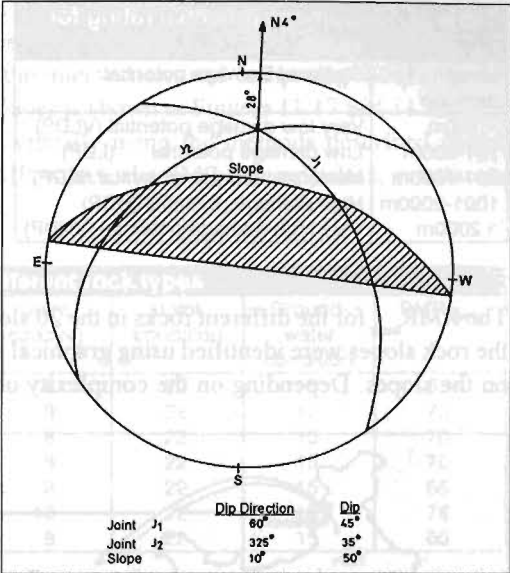
Figure 11.14: Stereo-plot for wedge analysis

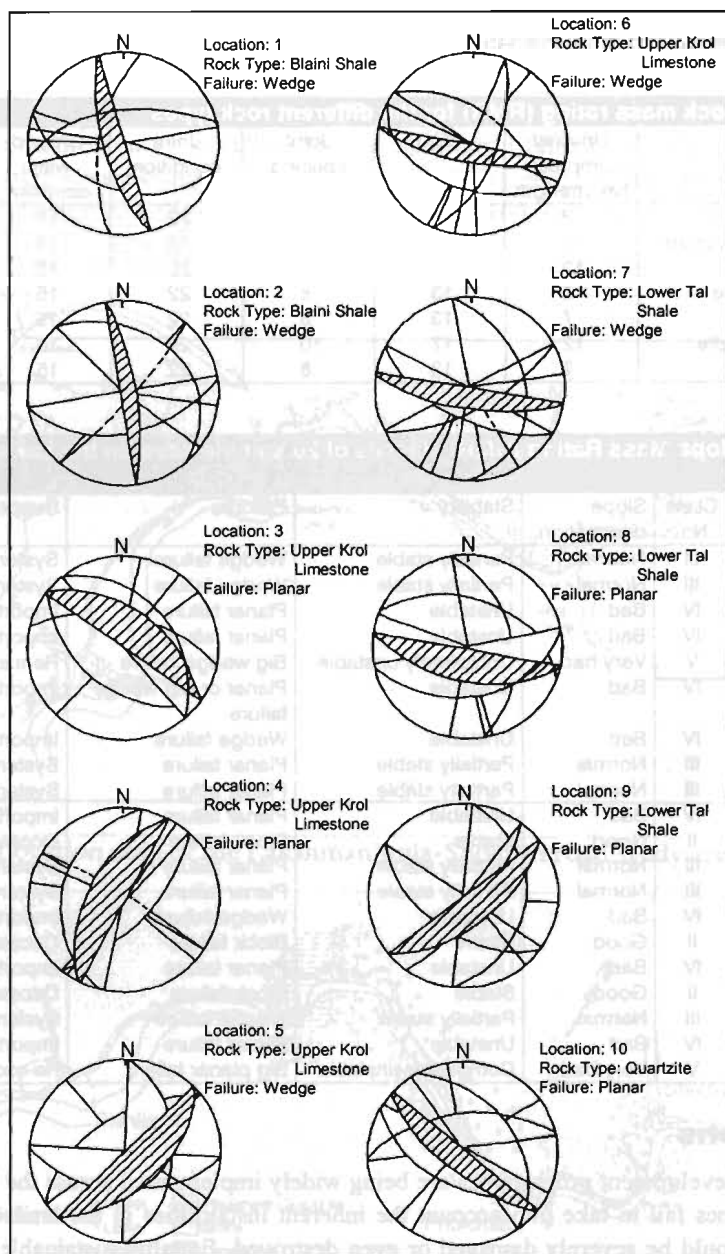
Figure 11.17: Stereo-plots of stability analysis for locations 1-10 (Anbalagan et al. 1992) on the Lakshmanjhula-Shivpuri road

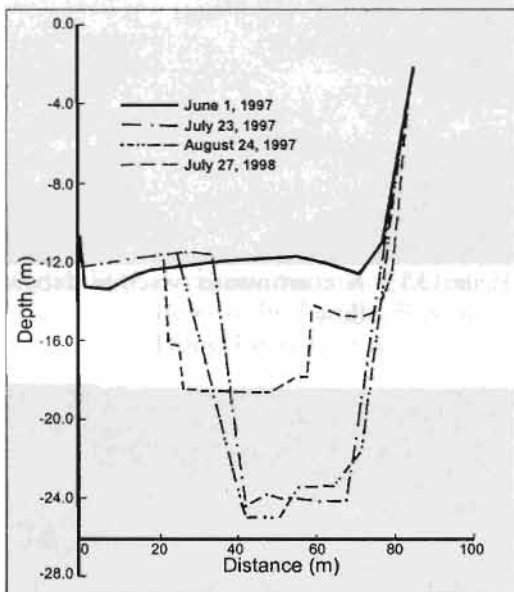
Figure 13.19: A cross section of the Jiangjia Ravine showing topographical changes caused by debris flows on four occasions between June 1997 and July 1998

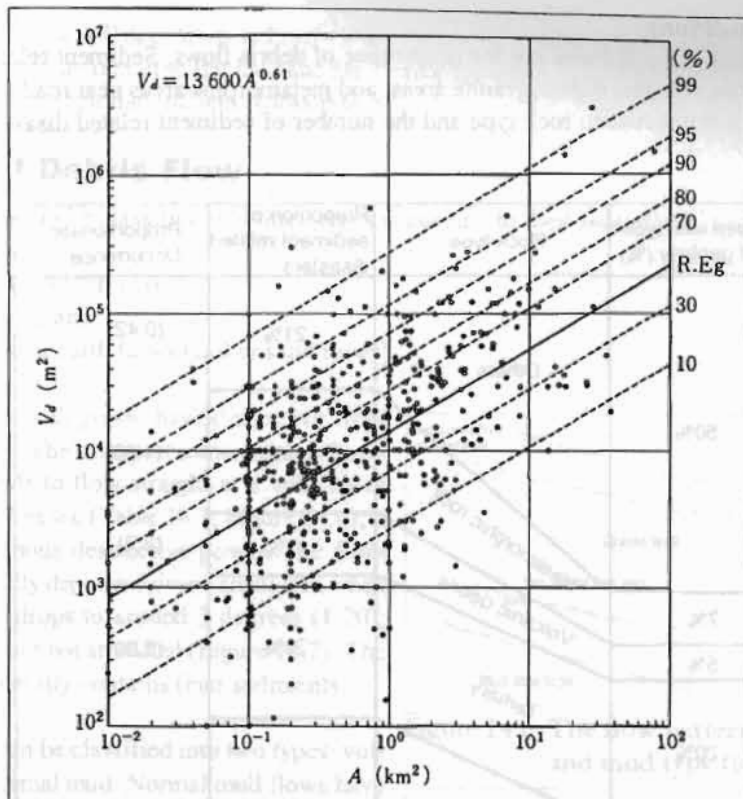
Figure 14.3: Relationship between catchment area and the sediment volume of debris flows

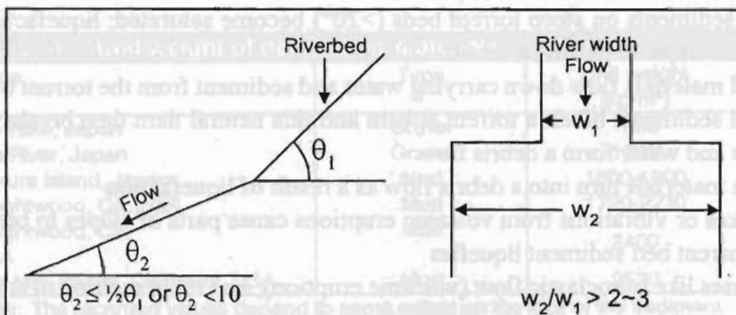
Figure 14.5: Stop conditions for debris flows (Ikeya 1980)

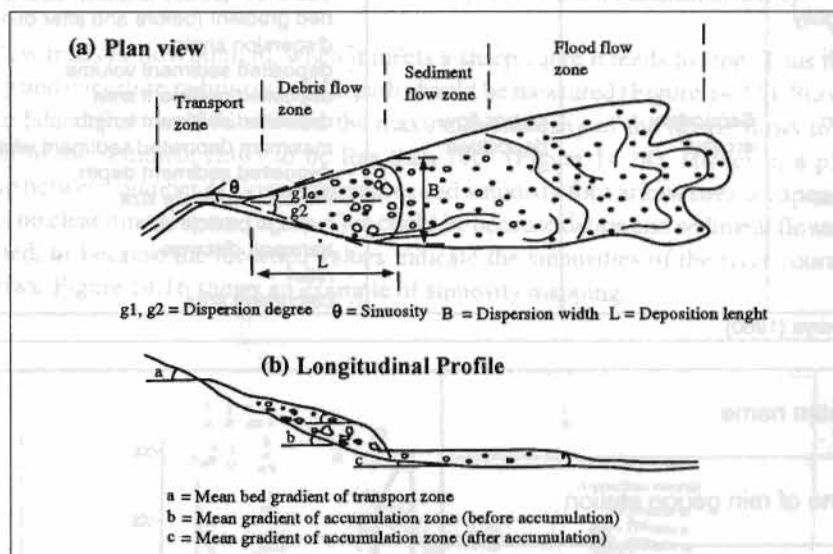
Figure 14.10: The sediment characteristics in the front and rear parts of a typical debris flow (a) plan view (b) longitudinal profile

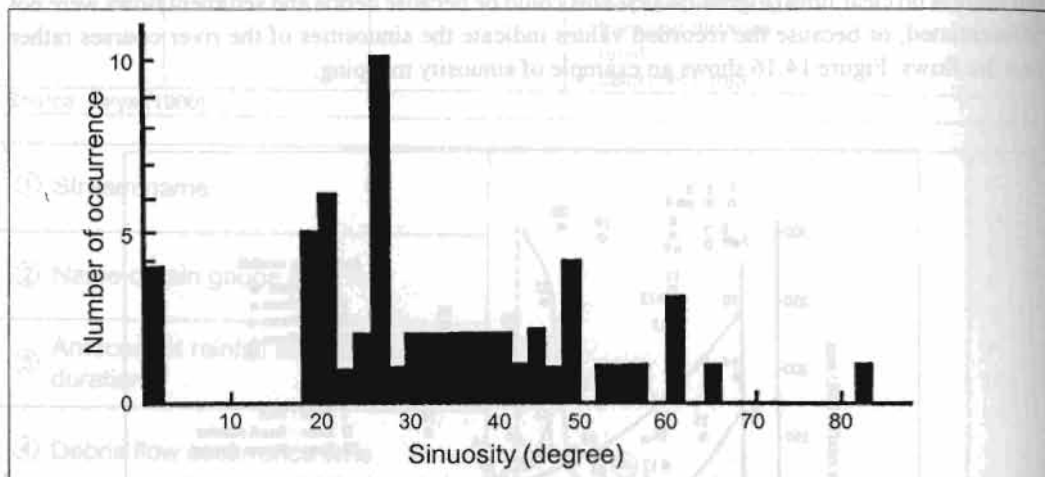
Figure 14.16: Relative occurrence of different degrees of sinuosity in debris flows in Japan

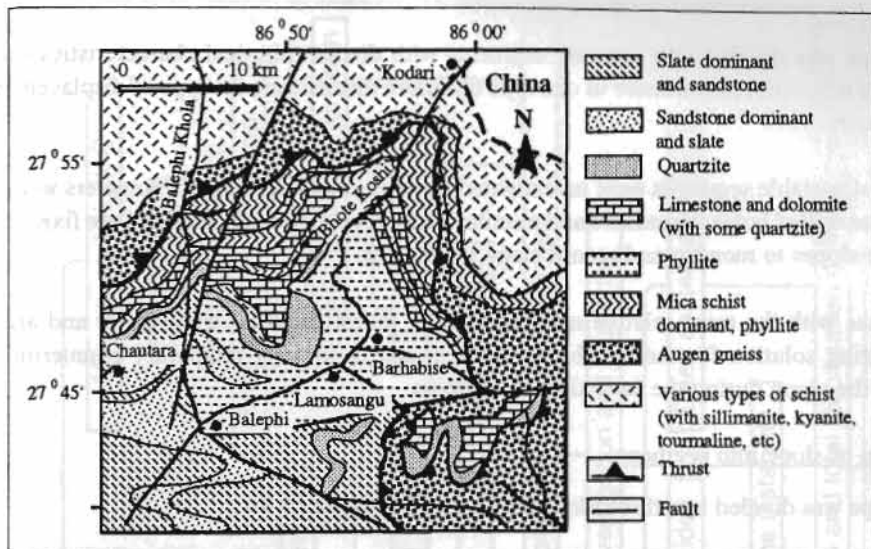
Figure 15.8: Geological map of Sunkoshi area (Maruo et al. 1973)

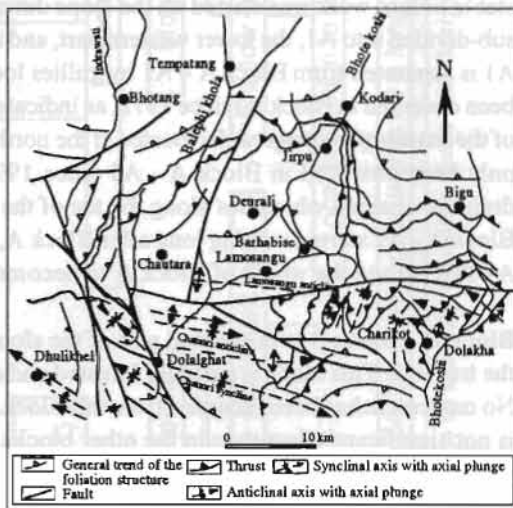
Figure 15.9: Structural map of the Sunkoshi area (JICA 1985)

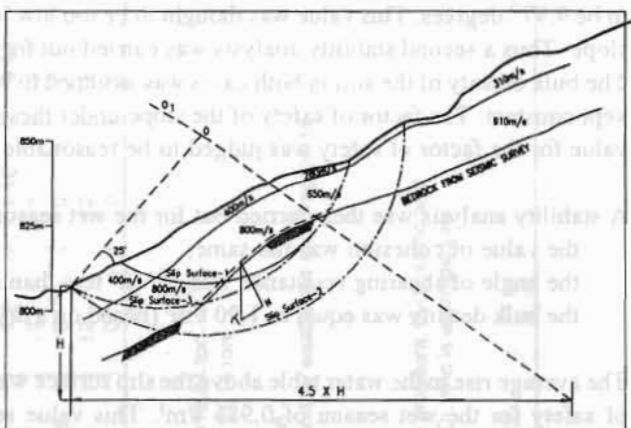
Figure 15.12: Stability analysis based on the seismic depth profile

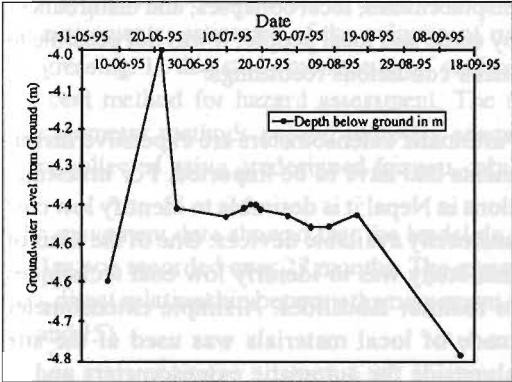
Figure 16.5: Variation of groundwater level in the landslide area as shown by piezometer readings

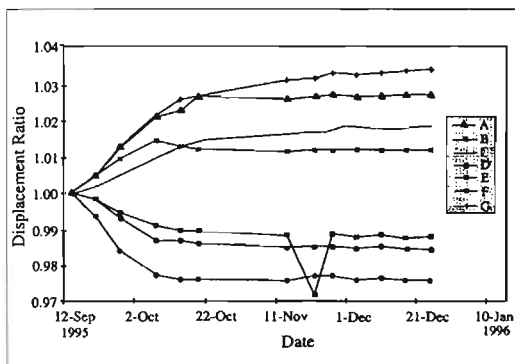
Figure 16.12: Displacement data obtained by the simple extensometers
