Landslide Hazard Mitigation

in the Hindu Kush-Himalayas

Editors

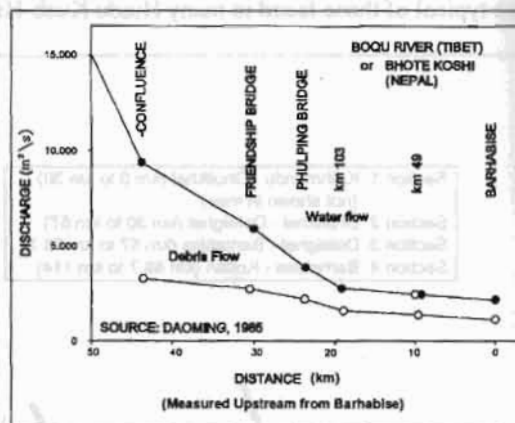
Figure 17.3: Glacial lake outburst flood (GLOF) discharge attenuation along the Bhotekoshi River (1981)

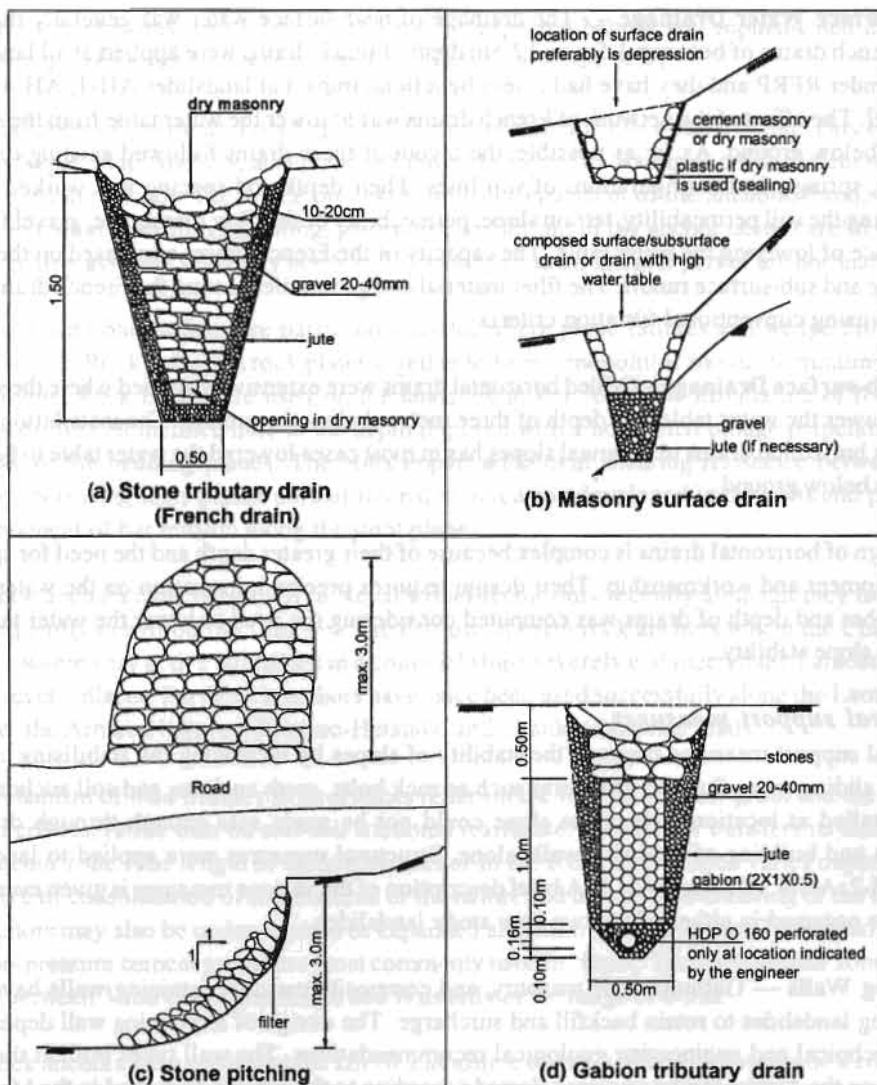
Figure 17.21: Typical drainage measures

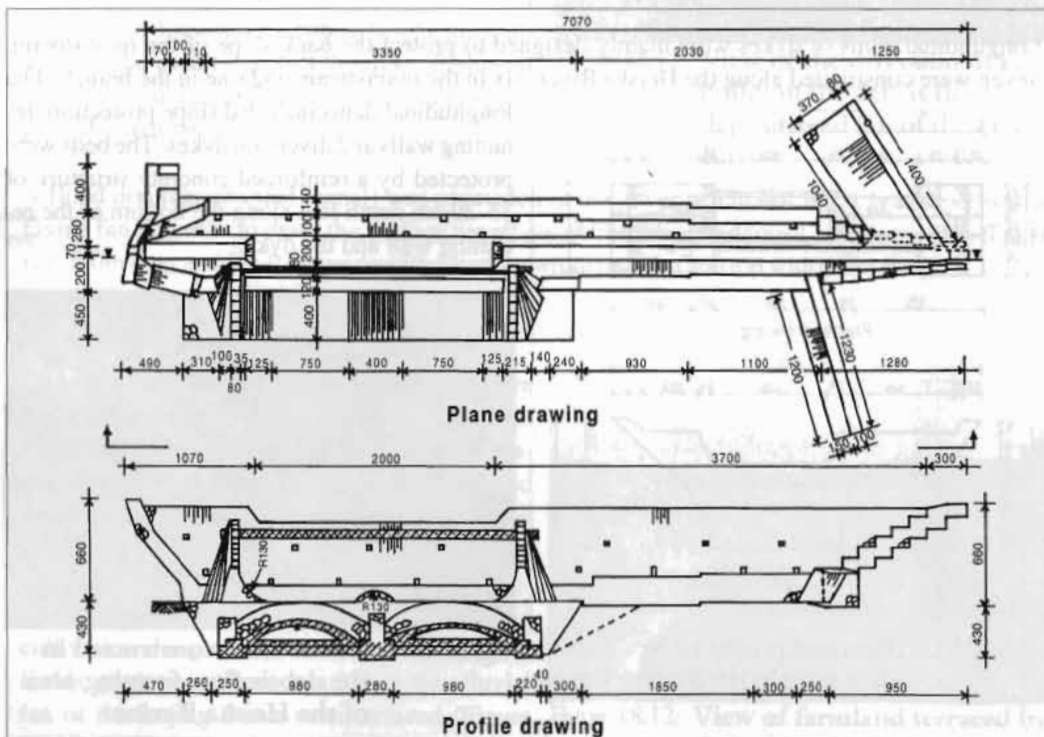
Figure 18.5: Plan and profile of sediment trapping dam No. 5 with double arch foundation

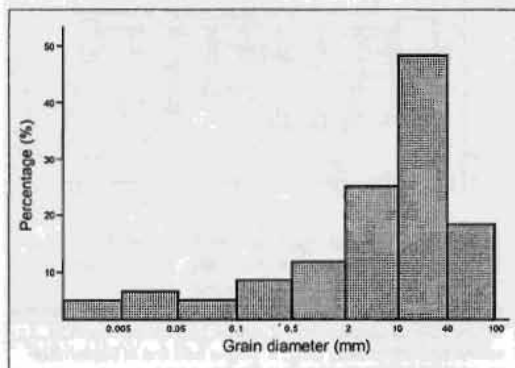
Figure 18.15: Grain diameter of solid material deposited by a low viscosity debris flow in 1989

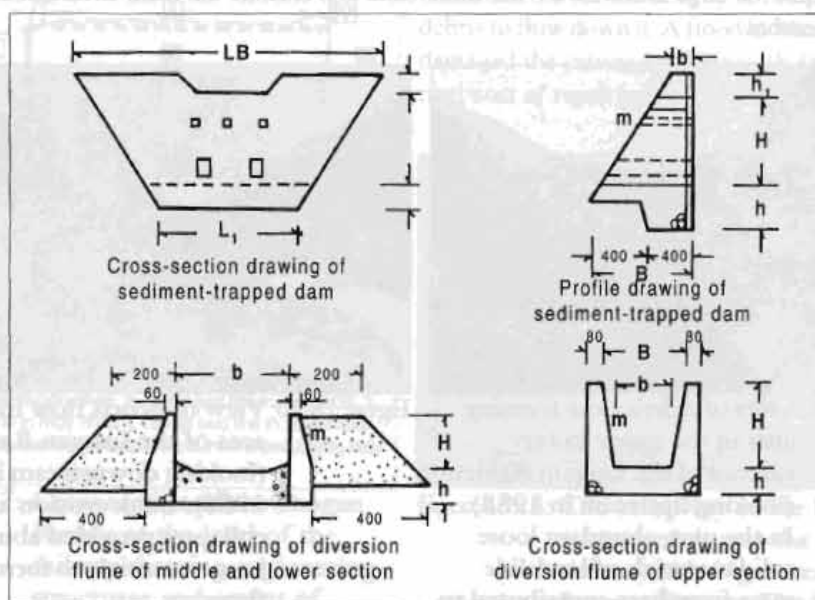
Figure 18.22: Plan of the sediment-trapping dam and diversion flume (for actual values see Table 18.6)
