Landslide Studies and Management in Nepal

B.N. Upreti
and
M.R. Dhital

International Centre for Integrated Mountain Development
Kathmandu, Nepal
1996

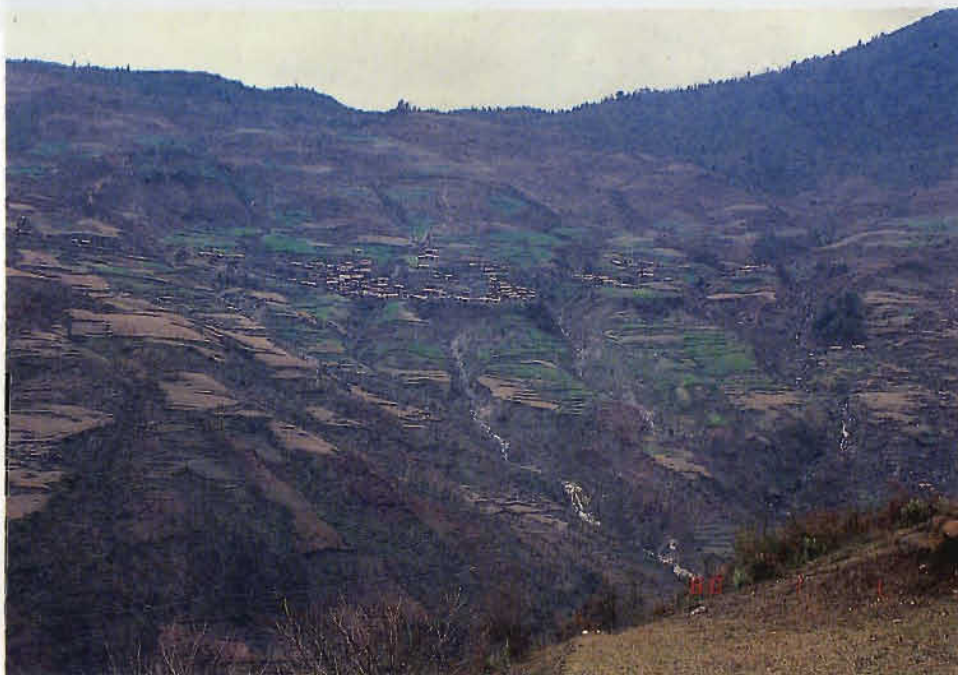
Plate 1: Strongly developed gully erosion in Hungung Village, Arun Valley, eastern Nepal, gradually destroying the agricultural land and threatening the stability of the village.

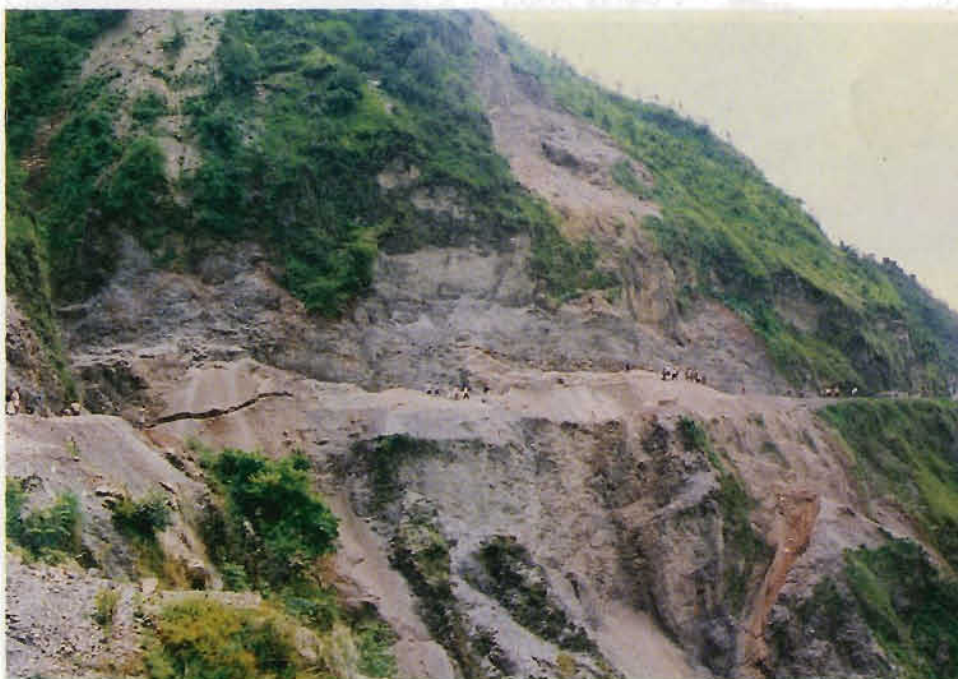
Plate 2: Rockslide in the highly crushed zone near Jhakri Danda, Kanti Rajpath, Central Nepal.

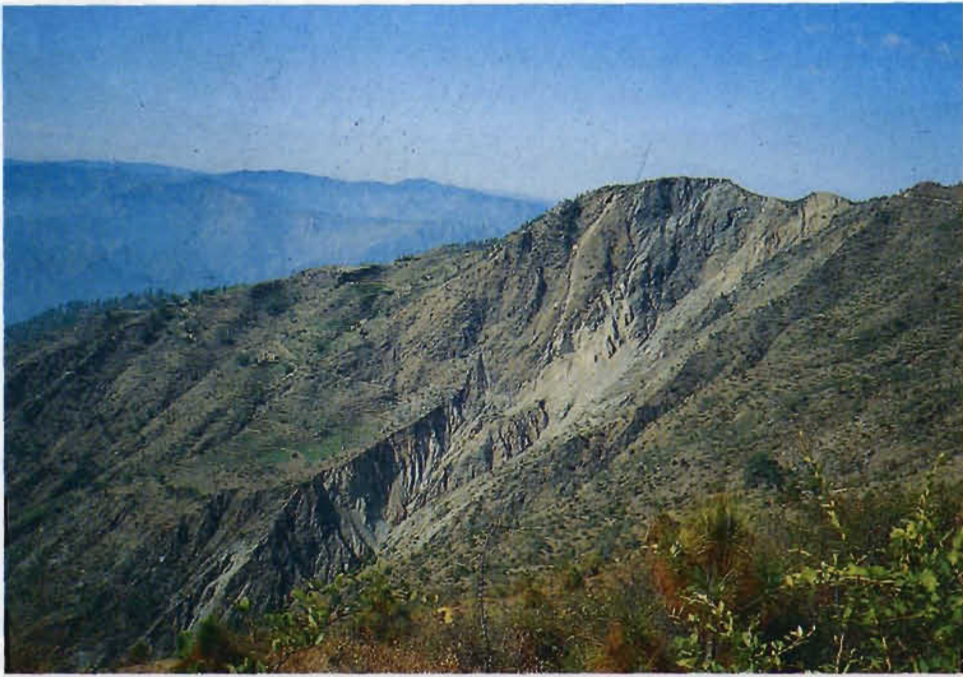
Plate 3: A large landslide formed by wedge failure in quartzites and phyllites (location: Far-western Nepal).

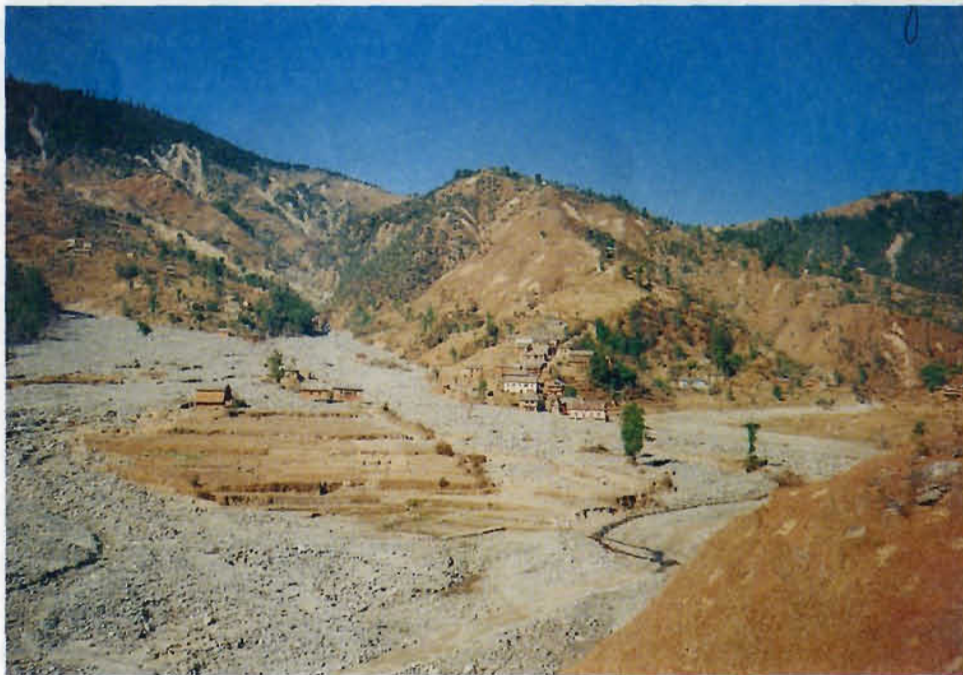
Plate 4: Phedigaun devastated by the disaster of July 19-21, 1993. Notice an island in the middle of the fan with a few houses. The previous river channel was confined to the west of the island, but, during the disaster, it shifted to the right (north) and swept away many houses - view towards the west.

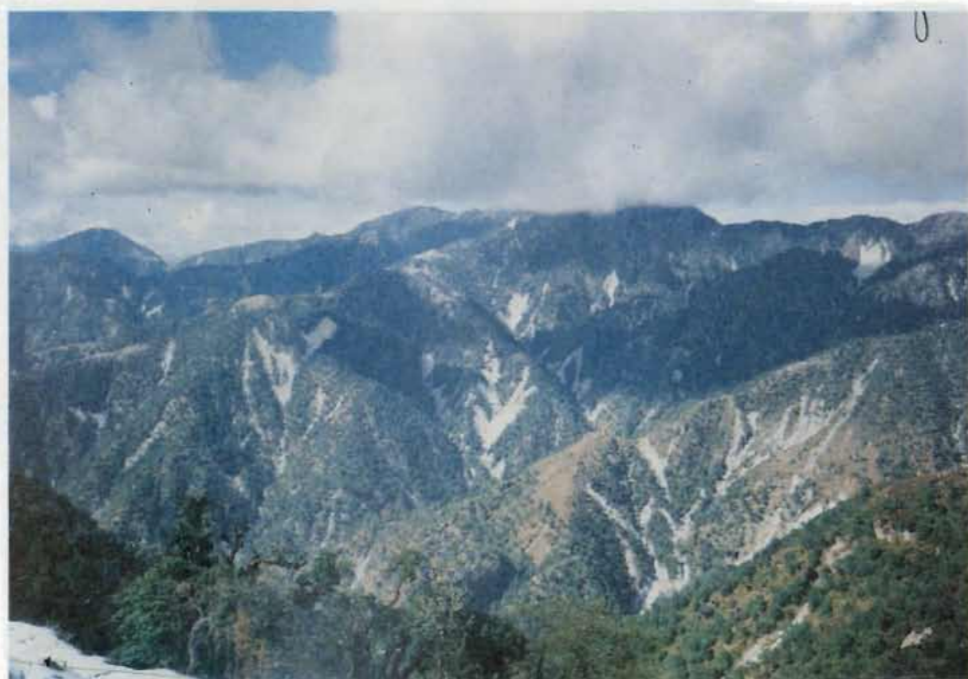
Plate 6: Landslides in the Agra Khola Watershed (Central Nepal) triggered by the cloudburst of July 19-21, 1993 - view towards the southwest.

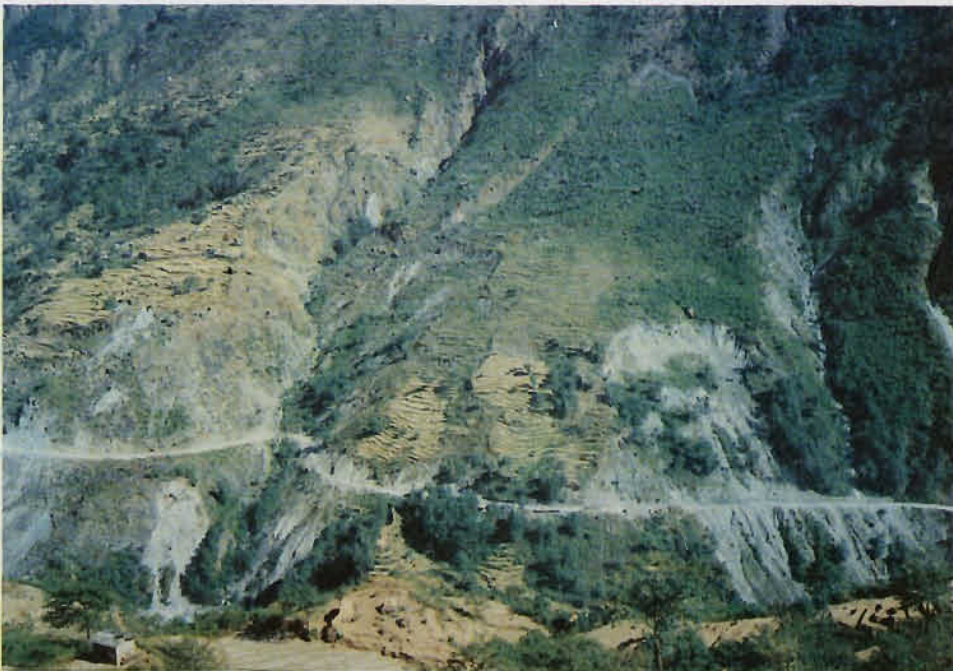
Plate 8: Soil slides at Daklang (about 2km north of Chaku Khola) along the Arniko Highway).

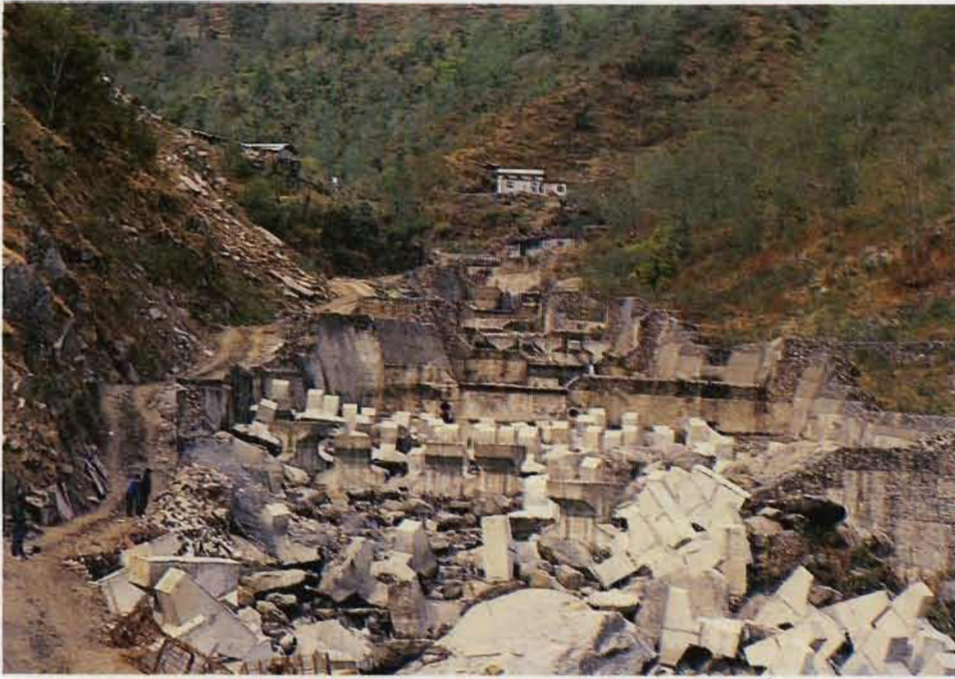
Plate 9: Gully erosion protection work in the Charnawati Valley using concrete lining on the stream floor, to make cascades, concrete retaining structures along the banks, and large tetrapods along the streambed and the banks

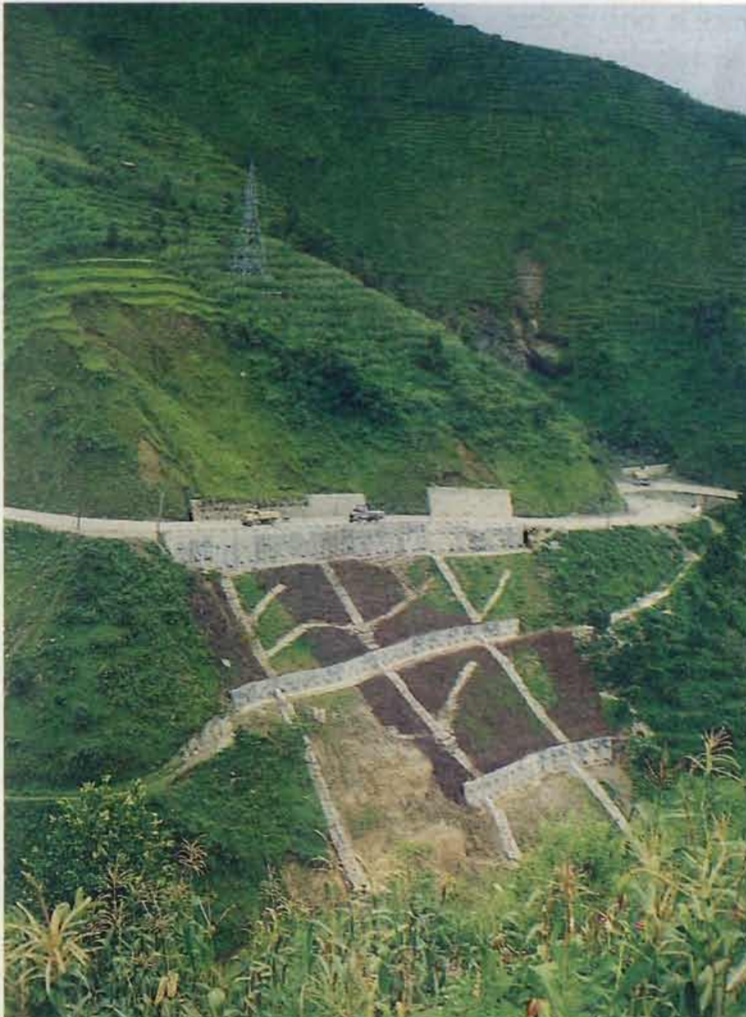
Plate 10: Landslide stabilisation measures (retaining walls, rock anchoring, surface and subsurface drains, and bioengineering works) applied at the Khatripauwa Landslide along the Thankot-Naubise road, Central Nepal - view towards the southwest.
