Landslide Hazard Management and Control in India

V.C. Thakur

International Centre for Integrated Mountain Development

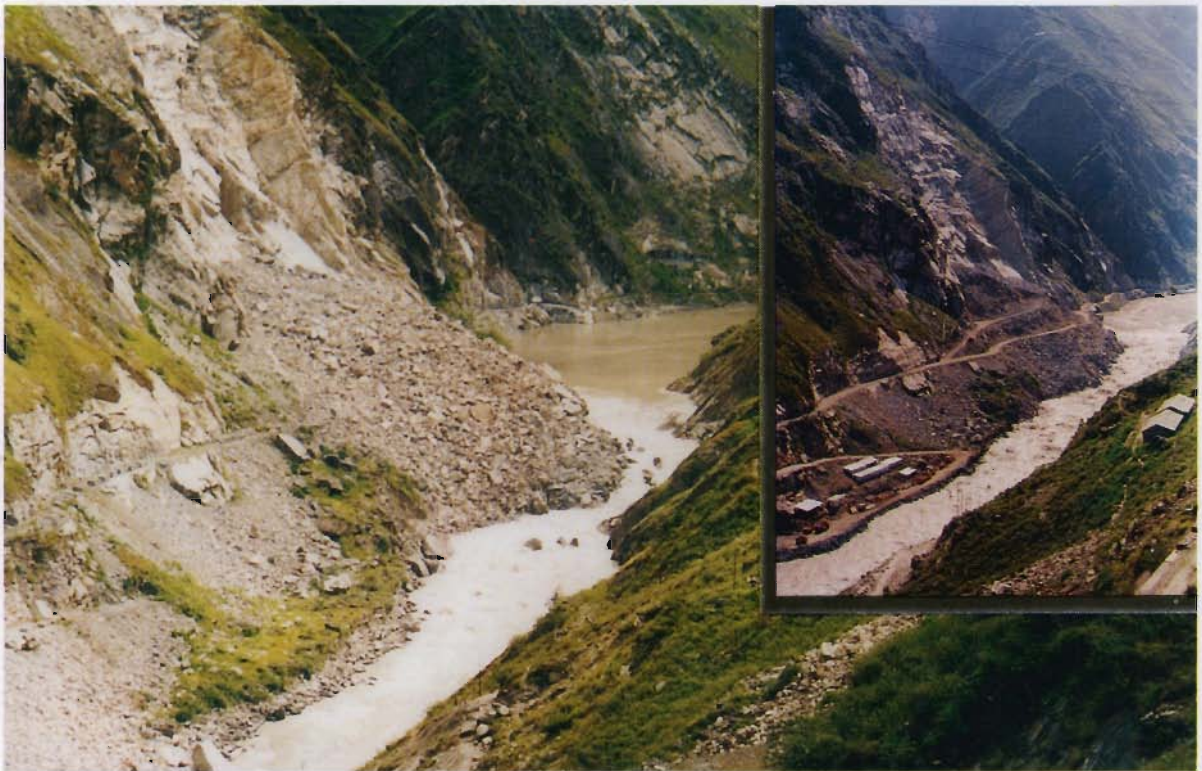
Cover Photograph: Two perspectives of the area near Nathpa village, NW Himalayas — rockfall cum debris slide blocking the Sutlej River (background) and translational debris slide on the same site, the imminent hazard to construction activities (inset)

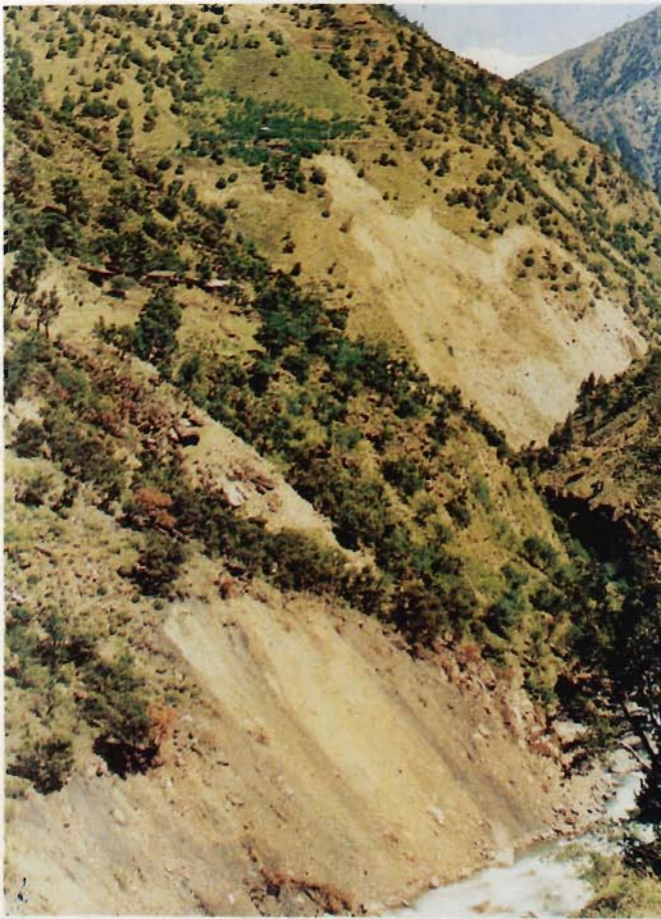
Plate 1: Sapni Slide:
Combination of rotational debris slump and translational slide in the Quaternary overburden with graphitic horizons in the lower and middle valley slope of the Baspa River near the Baspa-Sutlej confluence, NW Himalayas

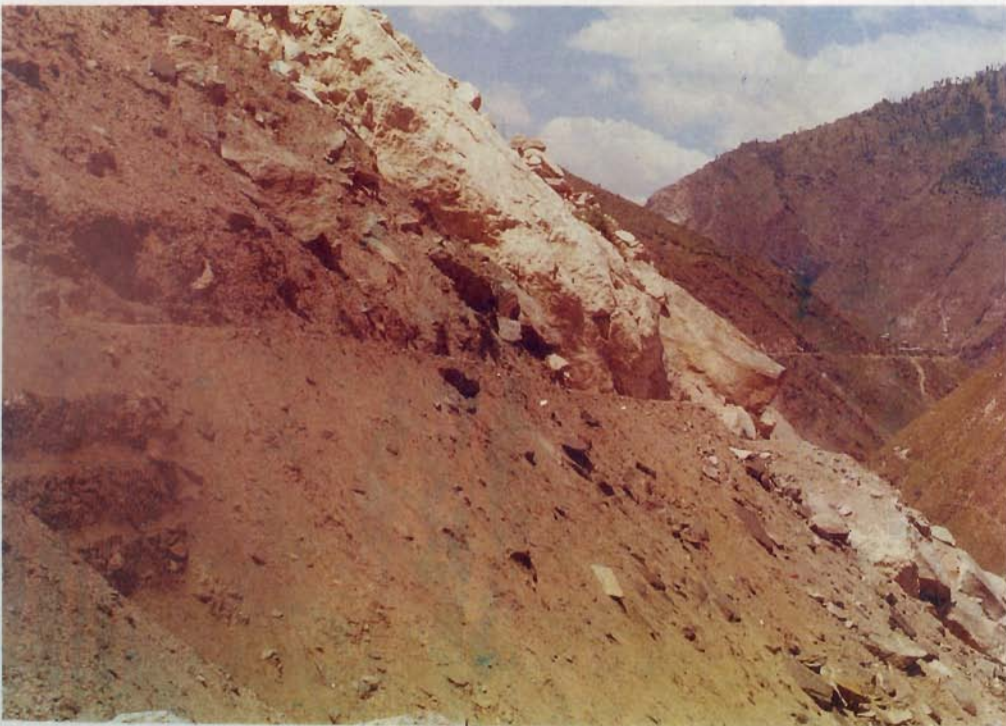
Plate 2: Rockfall : Wedge failure cum debris slide between Wangtu and Nathpa villages near Kandru Khad, NW Himalayas

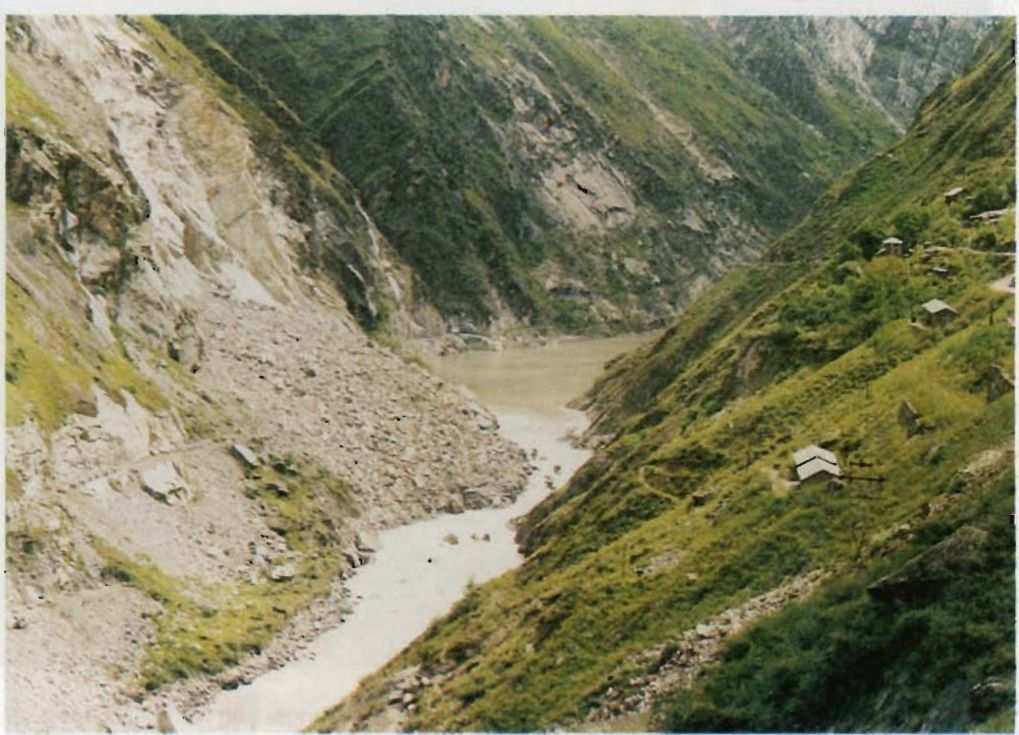
Plate 4: Rockfall cum debris slide: near Nathpa village. This slide has blocked the Sutlej River creating a lake more than one kilometre long, NW Himalayas

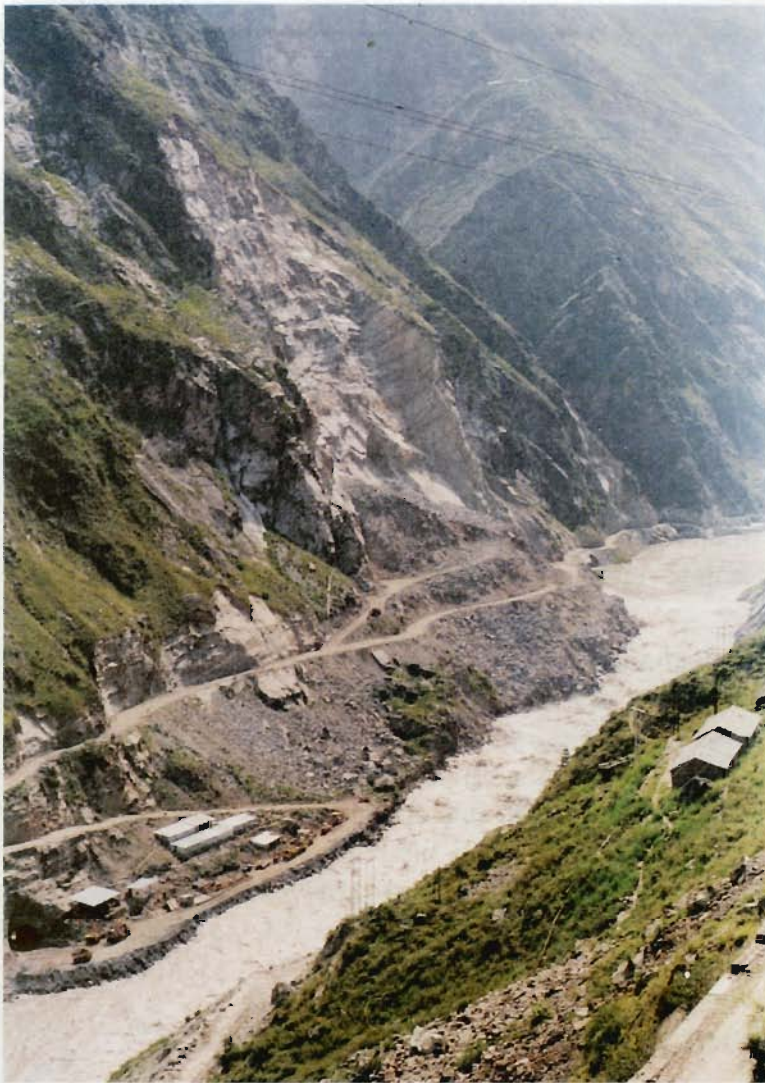
Plate 5:
Translational
debris slide:
near Nathpa
village, NW
Himalayas
