Executive summary on Attabad landslide survey in Hunza 7-17 April 2010

Short introduction

Attabad Landslide 4 January, 2010

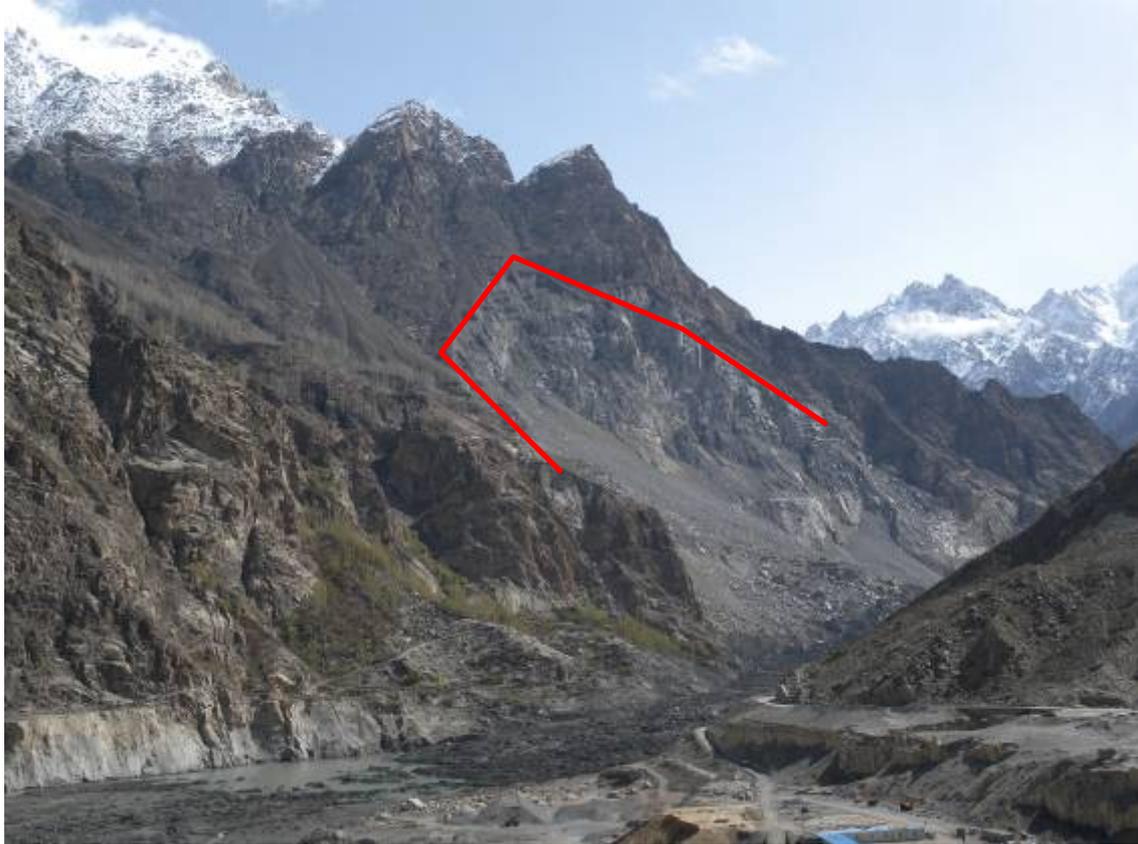
Figure 3: View of the landslide from the southern side; in red the main scarp.

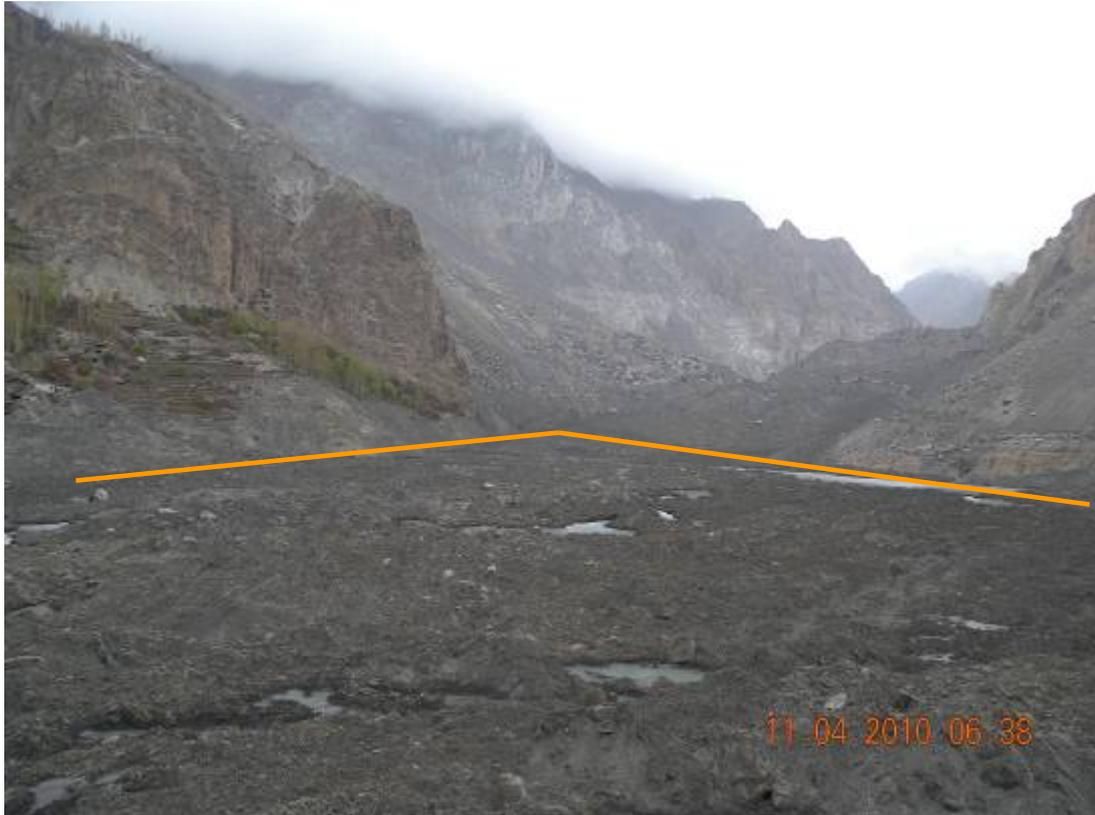
1. Rock fall of large boulders from the right hydrographic side which occluded part of the riverbed, squeezing the clay deposits derived from the lake created downstream by the event of 1858.
2. The squeezed materials invested the opposite banks reaching an elevation of 2,460 m and collapsed over the previously deposited rocky material, covering it all.
3. Another rock fall, again from the right side, submerged the previous one, running through it and giving the actual shape to the deposit (Figure 1).
4. The material squeezed through a mud flow reached 0.8 km upstream and 1.2 km downstream to the dam that had been created. The colossal amount of clay deposit is due to sedimentation caused by the blockage of the Hunza river by the ancient landslide. When the dam formed, a new lake was created.

Figure 4: Clay deposits squeezed in a mud flow due to the rocky landslide.

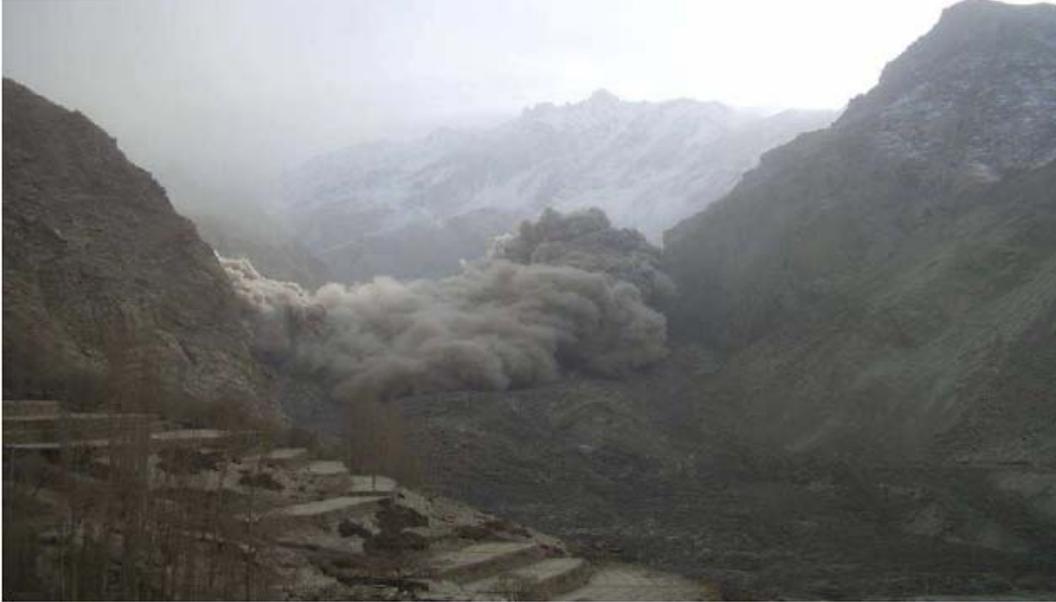
Figure 8: 4 January 2010 - Landslide along the main scarp downslope at Attabad (web source).

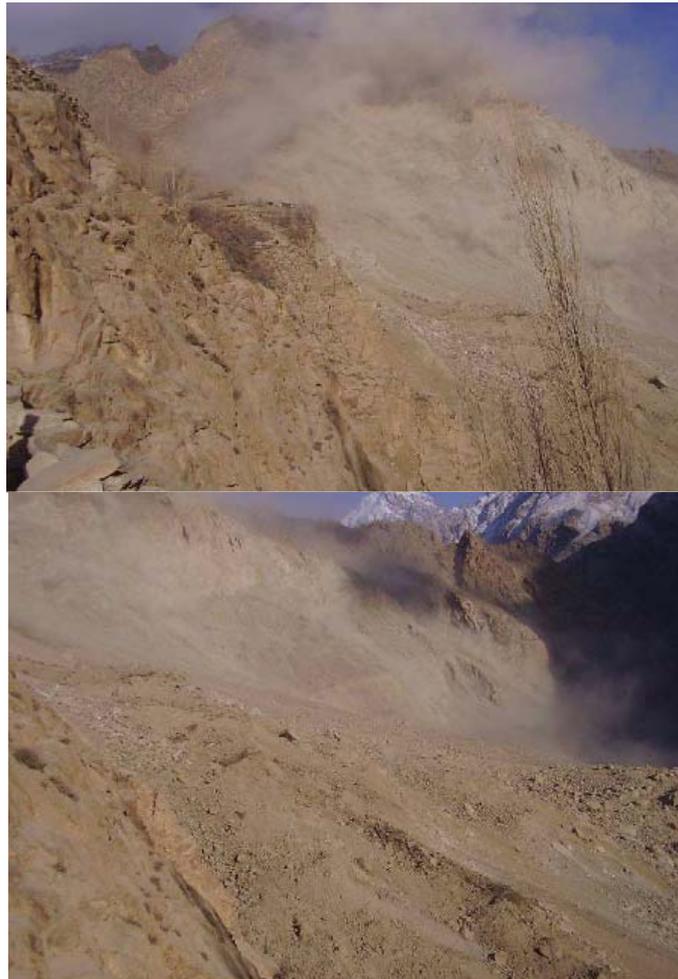
Figure 9: Debris along downward slope in the Hunza river channel on 4 January 2010 (FOCUS Humanitarian Assistance, 2010).

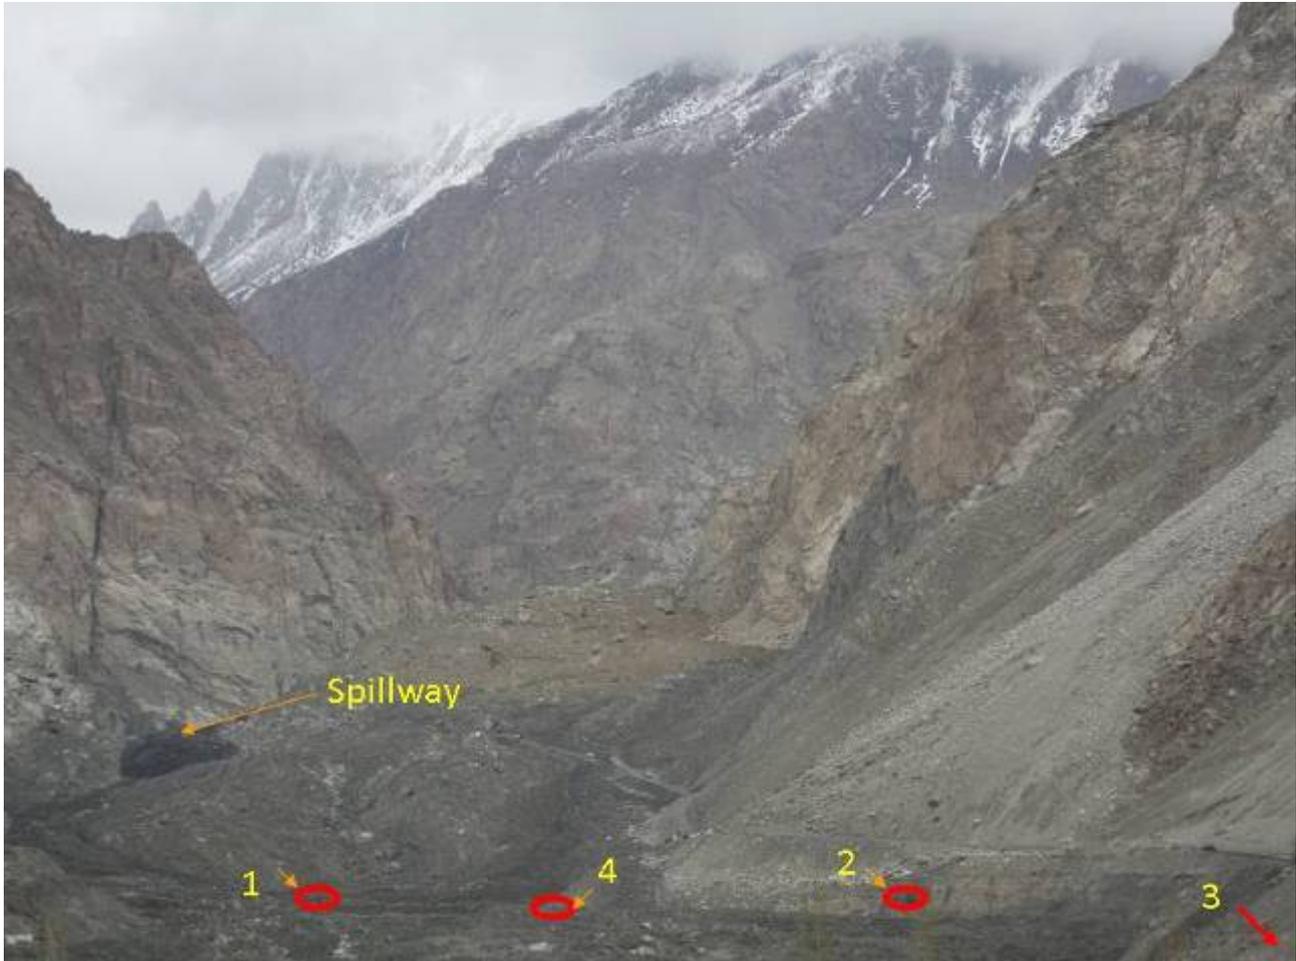
The four steps that define the event of 4 January 2010 created a particular sedimentary sequence that is compatible with the behaviour and positioning of the actual seepage points. It means that the water found a channel at a higher permeability compared to the clay matrix widely present in the middle part of the neof ormation dam. Large boulders of granite and granodiorite compressed the

lacustrine deposits and were covered by them, so the permeability of the dam is not completely compromised. This allowed multiple seepage in 4 different positions (Figure 9).

Figure 11: Seepage points at the toe of the dam (web source).

- The most important thing is to check the colour of the water coming out from the seepage points and its discharge. Every change in colour or quantity means that there is an evolution in the phenomena.

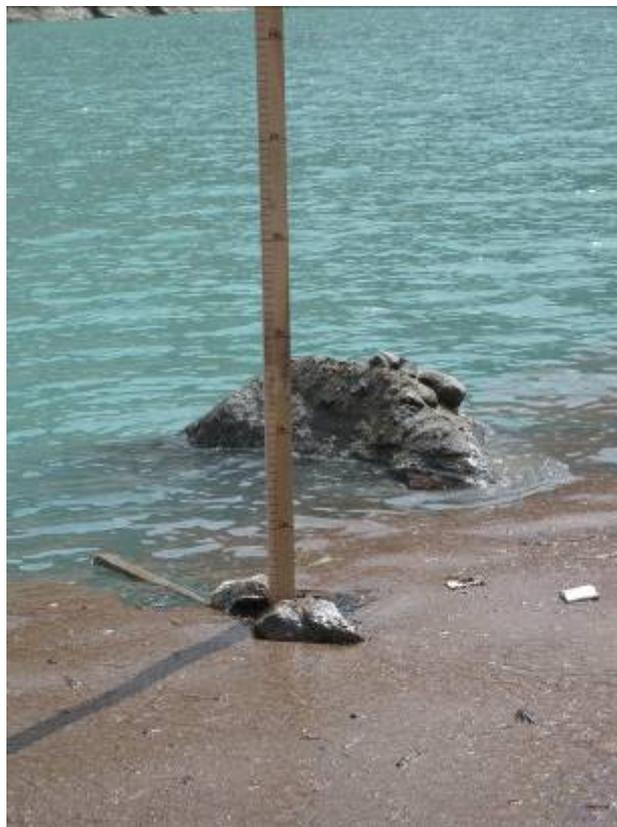
Figure 4 shows the hydrometric pole used to monitor the increasing water level. From the measurements already done, the level is increasing at a rate of 25-30 cm/day.

Figure 13: Hydrometric pole.

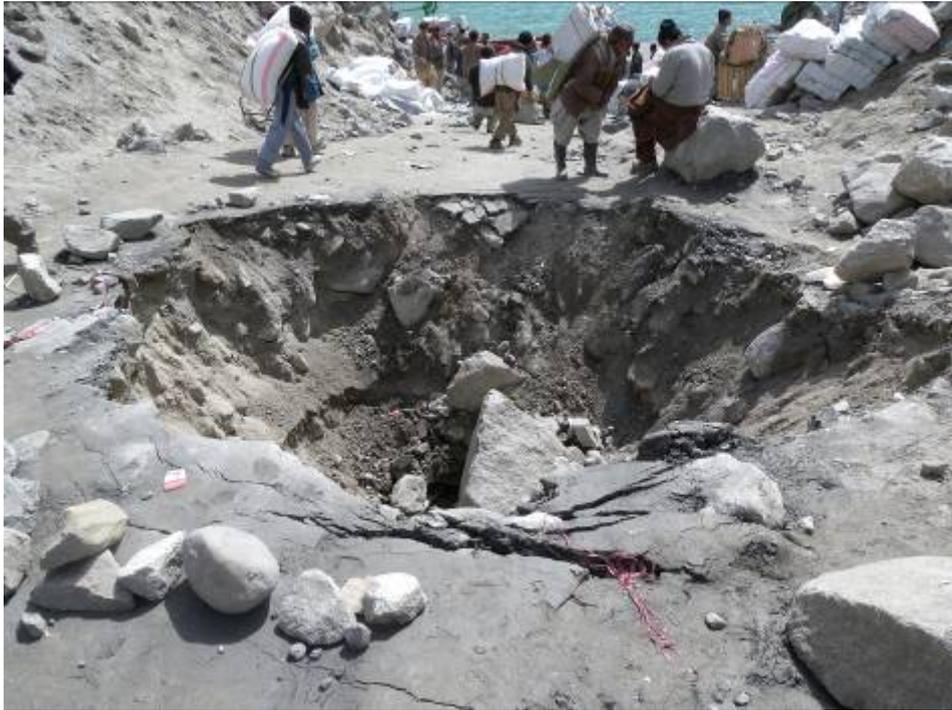
- The presence of 2 sinkholes (Figure 12) formed on 14 April means that the water is flowing under the dam structure with an intense erosive power.
- The lining of the base of the channel and its banks with large boulders will be very important to prevent - as much as possible - erosion of the fine material (clay and colluvium) when the water will begin to flow.

Figure 14: Sinkhole formed on 14 April 2010 on the dam, from the lake side.

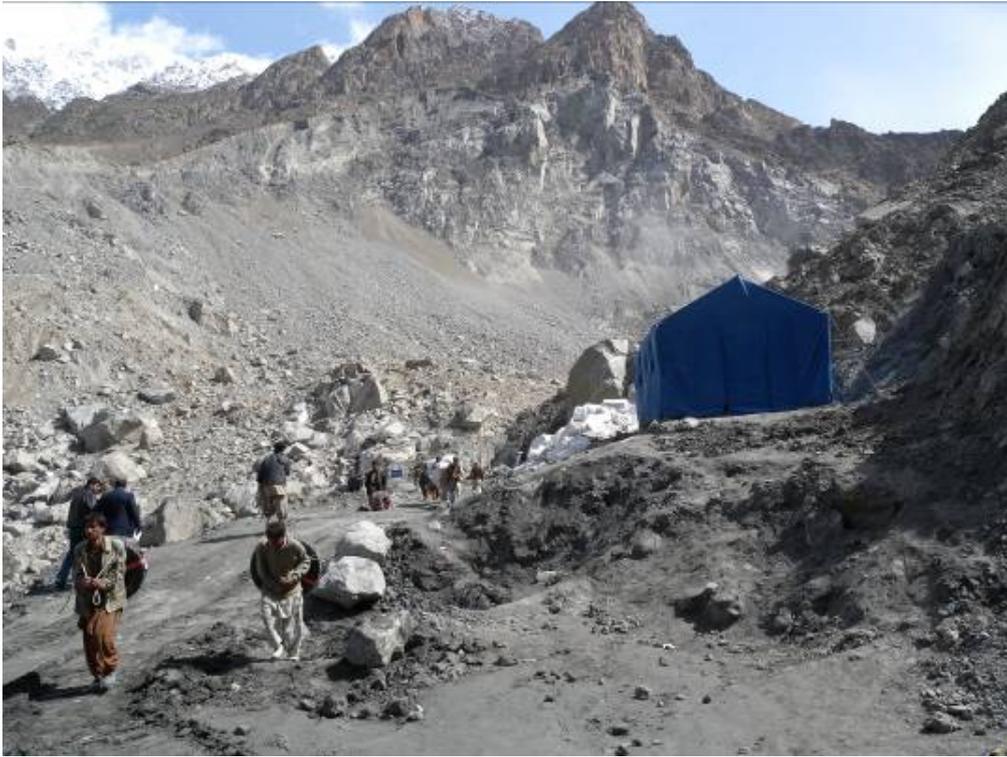
- From the steep slopes upstream of the dam, very dangerous boulders are still falling, creating a high risk area in correspondence of the spillway and the way created and being used by the merchants attempting to carry out their business.

Figure 15: Residual hazards still present in the dam area: porters, technicians and workers in rock fall danger.

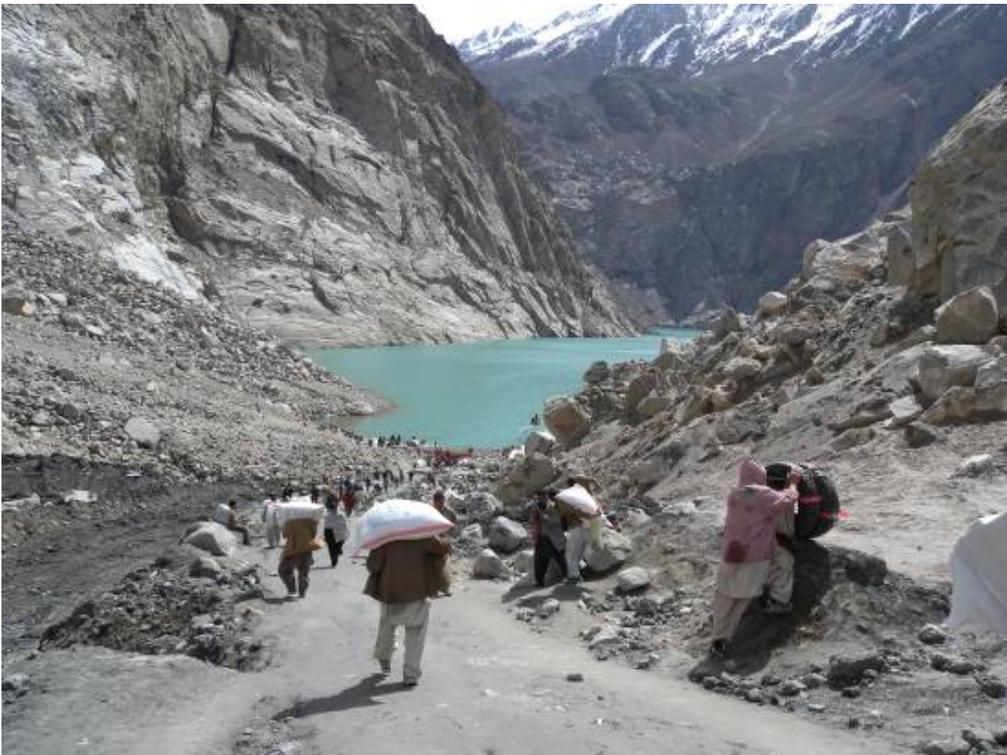
Figure 16: View of the lake from the upper side of the blocking dam (porters working in a dangerous area).
