Chapter 4

VISUAL EVIDENCE

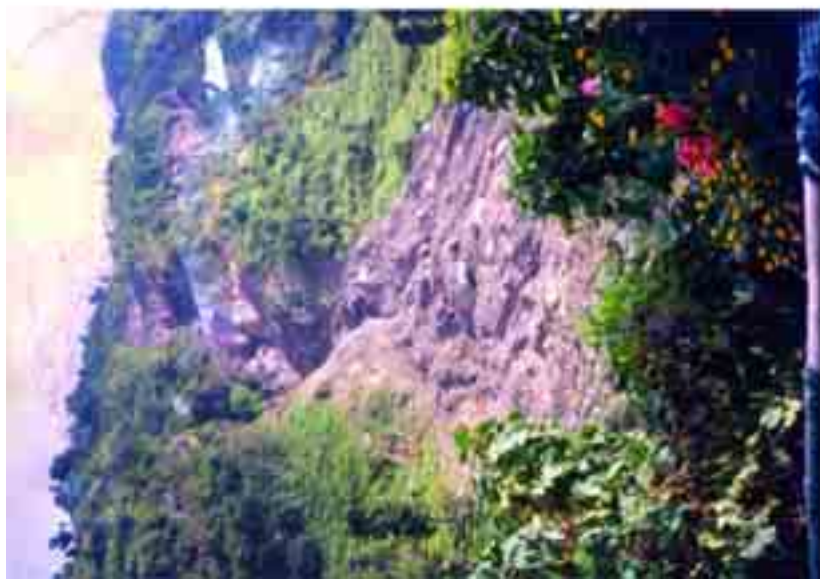
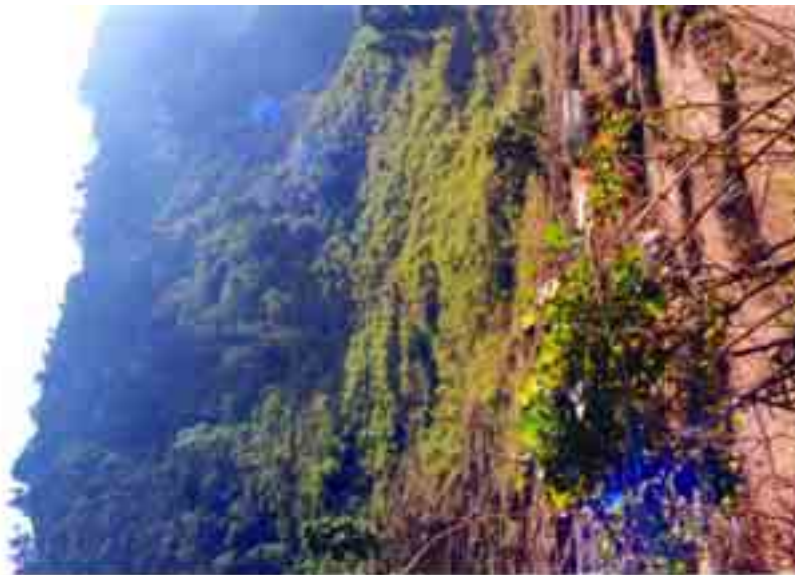
Figure 27: Chiyabari landslide: This slope east of Tanklichok, known as Chiyabari because of the *Osyris arboreal* bushes used for tea, collapsed on 24 August 1988 and killed five persons. The photo (Figure 27A), taken three months later, shows the source of slope failure and boulder-strewn rubble. The place is now overgrown with secondary vegetation while the lower section has been reclaimed for paddy cultivation (Figure 27B).

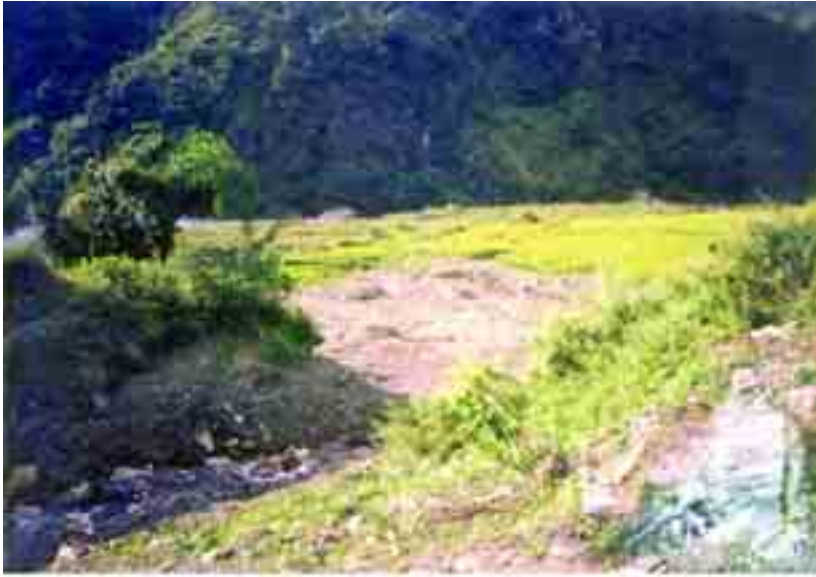
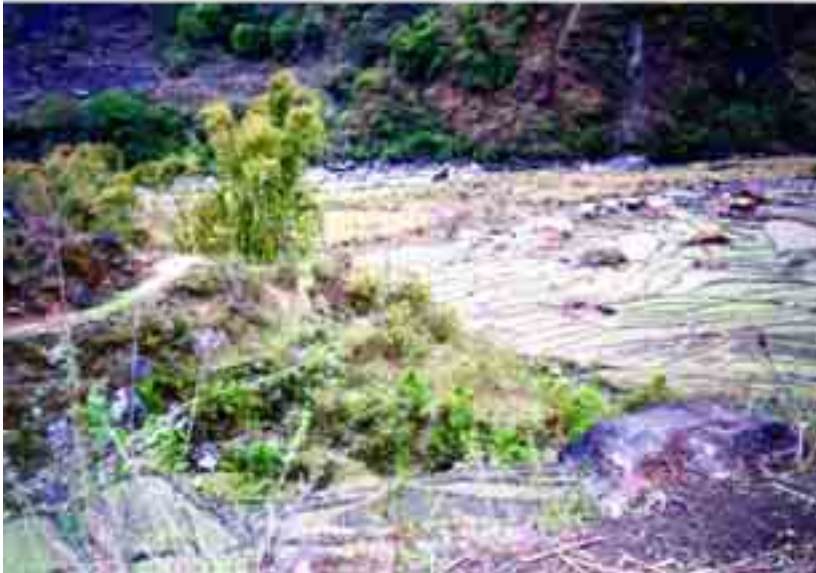
Figure 28: Bimire: The Chiyabari landslide flooded the paddy fields of Bimire with sand, pebble, stone, and boulders (Figure 28A). Fourteen years later, the damage is not apparent after reclamation (Figure 28B). Instead, the new encroachment on cultivated land is for construction of tourist lodges. These are at the southern end of Ngadi Bazaar (Figure 25B), a staging-point for mule caravans and trekkers to Manang since the late 1970s.

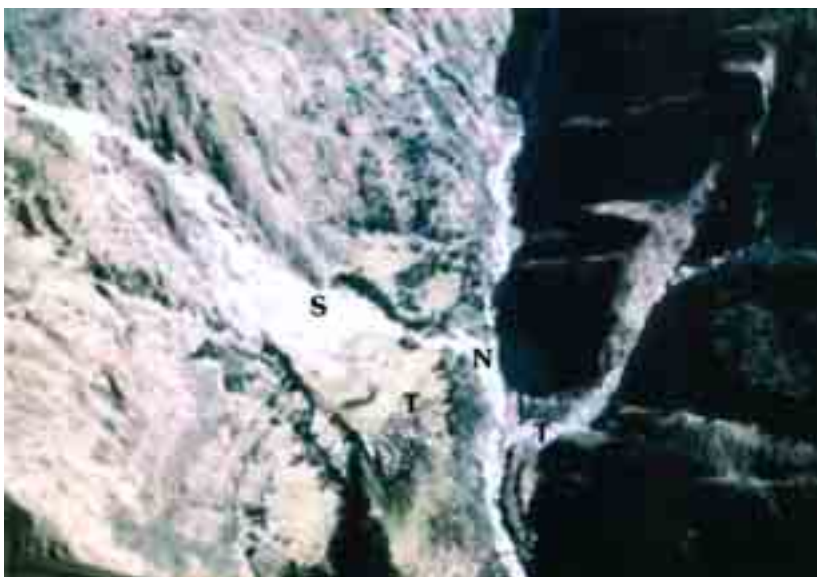
October 1989

Figure 29: Naiche from the air: The village (1,300m) sited on the ridge slope west of the confluence of the Ngadi and Tonjo Khola. The landslide (S) that started on the 1st September 1989 and recurred in July 2001 damaged some fields. There are shady slopes east of the Ngadi with dense forest cover. (see figures 45 and 46 for a terrestrial view of the village from the West).

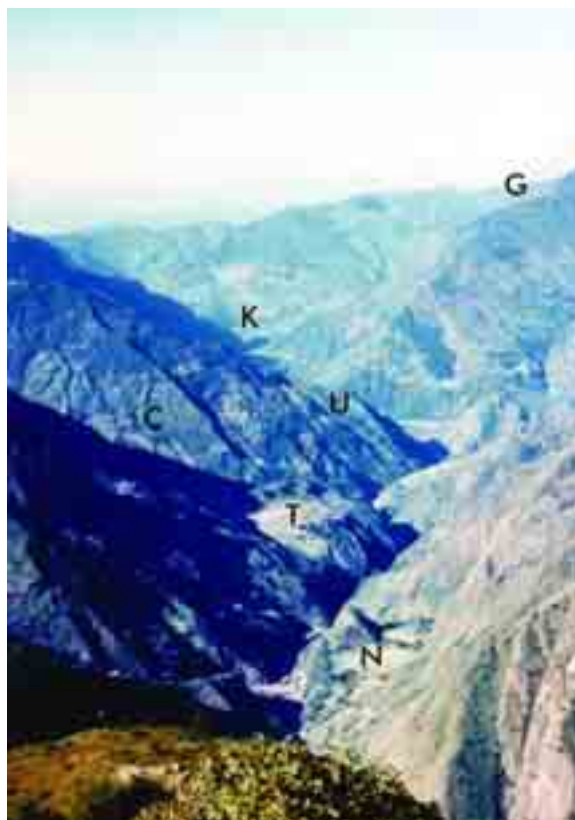
October 1962

Figure 30: Ngadi Valley from the north: A panoramic view taken from Prepron (c. 2,400m). Naiche (N) and Tarachok (T) fields are on high river terraces while Usta (U) is on a ridge. Usta and Chimkhola (C) fields are on a north-facing dip slope. Naiche is inhabited by Gurung, Tarachok by Chhetri, Usta by Ghale, and Chimkhola by Tamang. Ghanapokhara (G) at 2,192 m has now been abandoned with its inhabitants settled in the Khudi (K) area.
