## C. MASS WASTING

### 1. Factors Contributing To Mass Wasting

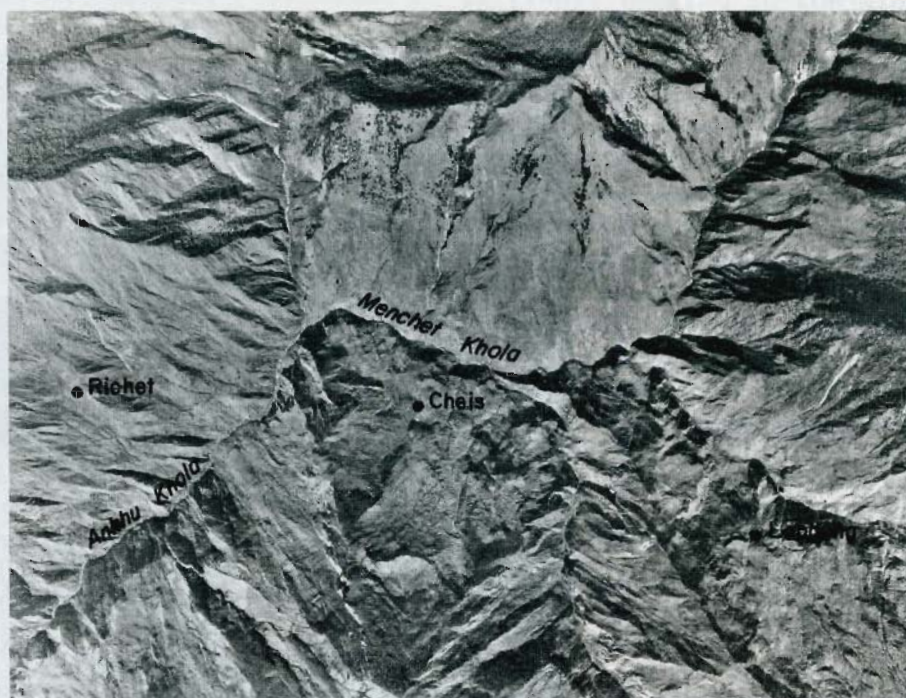
## AERIAL PHOTOGRAPH OF UPPER ANKHU KHOLA

The interpretation of the above features requires a trained eye.

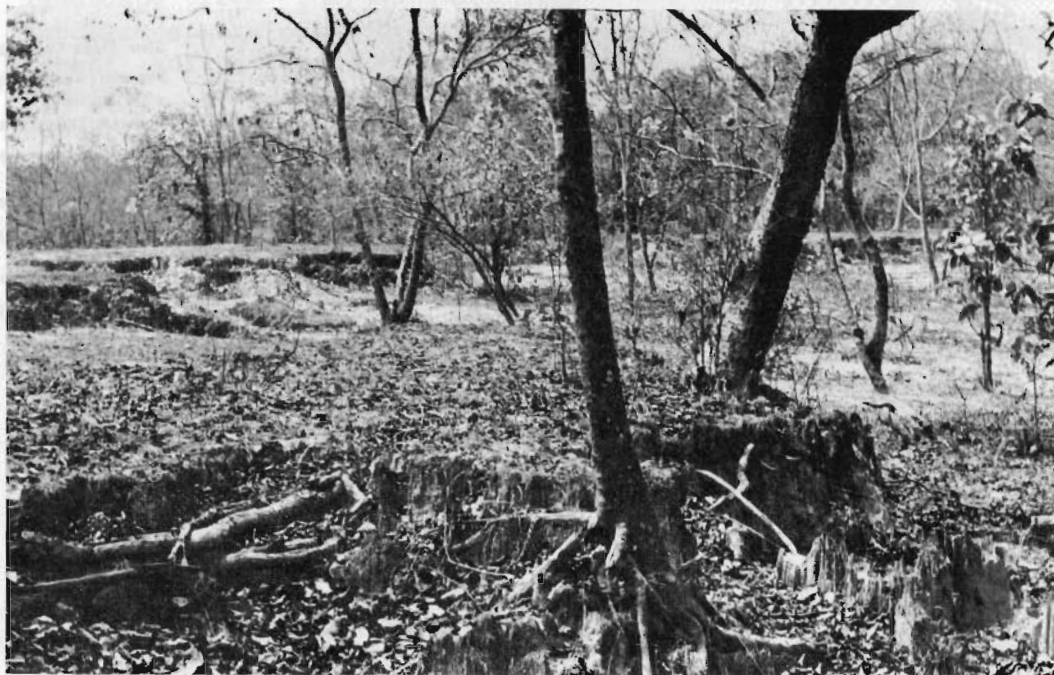
Photo I. - North of Nepalgunj, Banke District, dissected alluvial upland. High intensity rainfall combined with repeated burning and overgrazing results in an extremely high rate of surface erosion.

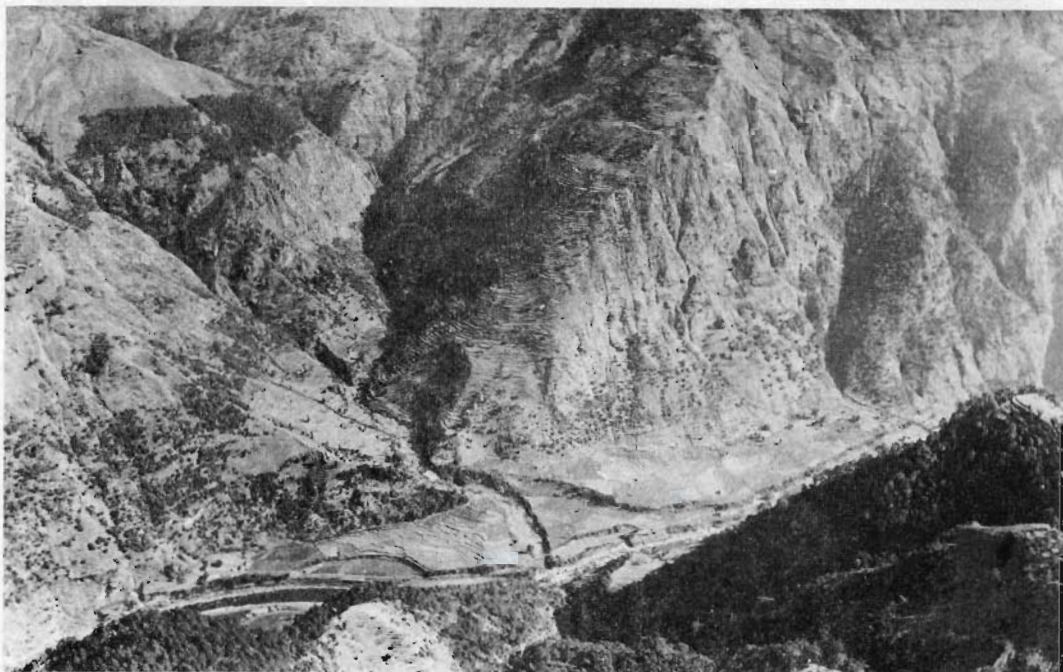
Figure 2

# Geomorphic Damage, Kakani Area (after Kienholz et al 1981)

Phyllitic landscape similar to the Kakani area. Note the wide variety of erosion processes and their significance to landscape formation. Gullies, slumps, slides and debris torrents are common.

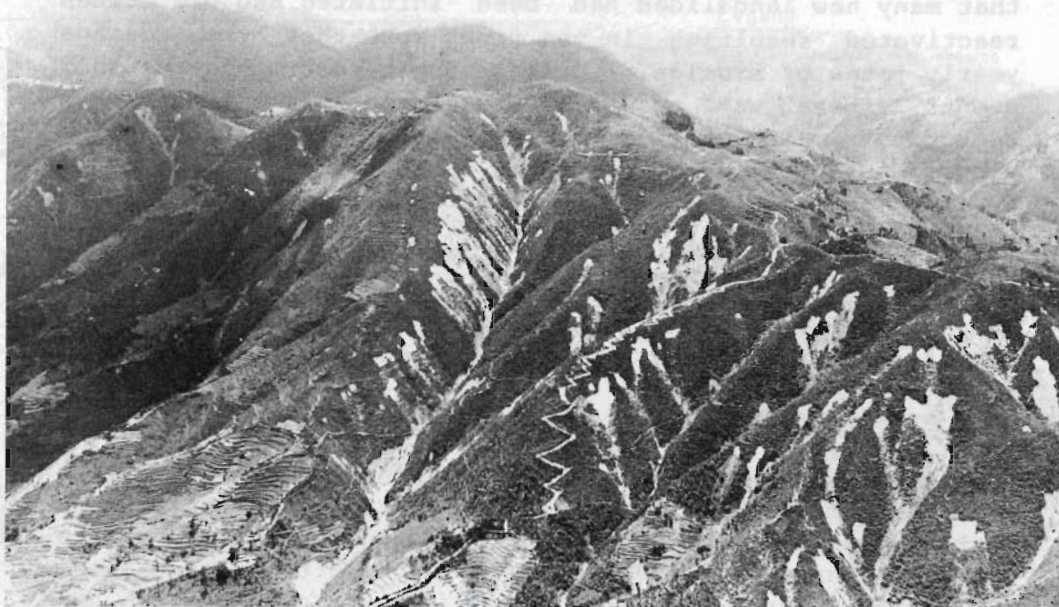
Photo III Near Lele, Lalitpur District. After a prolonged rainfall in Sept. 1981, this slope failed en masse in spite of thick shrub cover. Such catastrophic events are common on certain landforms within the Nepal Himalayas but are difficult to predict.

Many Himalayan landscapes appear to have a period of relative stability of slopes when mass wasting is not a dominant process, followed by a spell of instability during which a large number of landslides occur almost simultaneously on an otherwise undisturbed slope. (See Photo III.) Villagers often tell stories about extreme precipitation events, occasionally concurrent with earthquakes, that trigger large scale slope failures. In one area south-west of Banepa the villagers acknowledged that the landslides still visible had all occurred during two heavy rainfall events, one in 1934 and the other in 1971. In spite of heavy, more recent rains, no major sliding had occurred since the 1971 monsoon. Such processes tend to be similar throughout much of the Middle Mountains of Nepal.

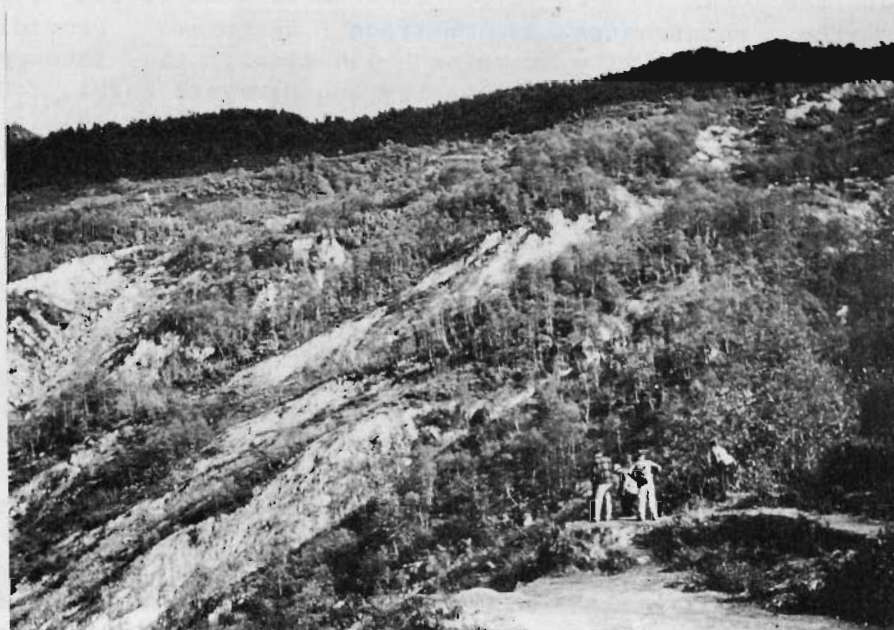
PHOTO IV. - Large landslide north of Taplejung, measuring over one km wide, three km long and over 20 meters deep. In the past fifty years over one hundred million tons of soil material has washed into the Tamur River from this slide. The progressive destruction of the hillside is difficult to blame on man's activities, as the land is generally well managed.

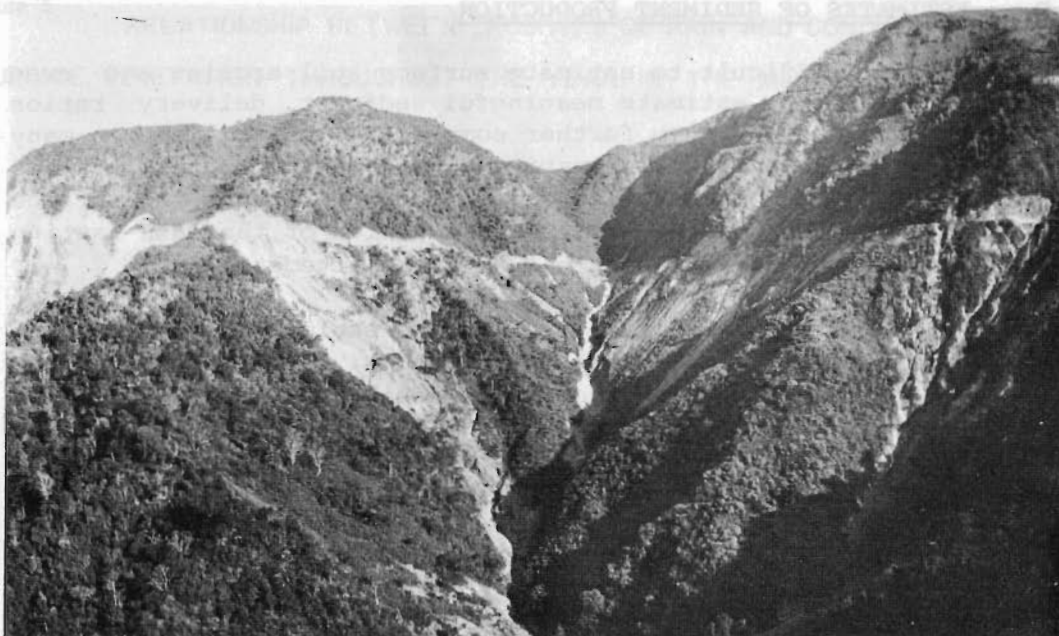
PHOTO V. - Feeder road construction northeast of Dharan. Severe erosion has been initiated by the poor layout, design and construction technique of this road. This alignment has since been abandoned as too costly to construct and maintain.

Disturbance of slopes by man's activities, particularly slope cutting and changing drainage patterns introduces serious mass wasting onto otherwise "stable" slopes. Road construction in particular is responsible for the initiation of many landslides. (See Photo V.) Deep side hill cuts and side-cast material result in initiation of cycles of instability. Proper location of roadways, by avoiding potential slide areas, appropriate drainage works, avoiding or at least minimizing cuts when unstable slopes are encountered and prohibiting side casting of cut bank material can all greatly reduce the destabilizing effect of road construction.

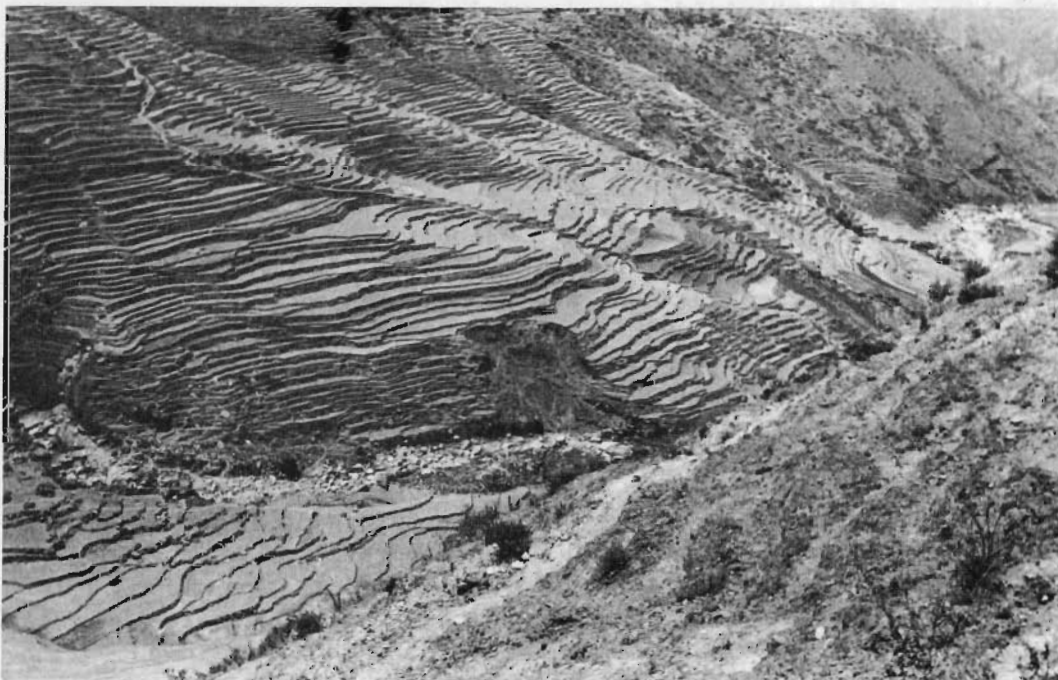
PHOTO VI. - Irrigated rice terraces in Accham. Irrigated lands are generally worth at least twice the value of nonirrigated lands. Small slope failures such as seen in this photo are quickly reclaimed as long as soils remain productive.

Irrigation of hillslopes is also a source of accelerated mass wasting. Generally, bunded rice terraces represent a stable land use in which one can often measure net additions to the soil surface by sediment laden irrigation water. However, in certain cases the extra weighting of slopes and increased pore pressure, caused by irrigation water within slopes can cause slopes to fail, especially when coinciding with earth tremors. The introduction of new water sources onto slopes rarely occurs because all easily irrigable areas have been irrigated. Those areas that were likely to fail have often already done so. Obviously, newly planned irrigation on presently unirrigated sloping land must take into account the increased likelihood of major slope failures. Smaller slumps and terrace riser failures frequently occur in rice terraces but are quickly repaired by the farmer. (See Photo VI.) Without constant attention, terrace, and eventually slope degradation proceeds rapidly.
