4. Erosion Processes And Their Effect On The Landscape

E. SEDIMENT MANAGEMENT IN PROJECT DESIGN

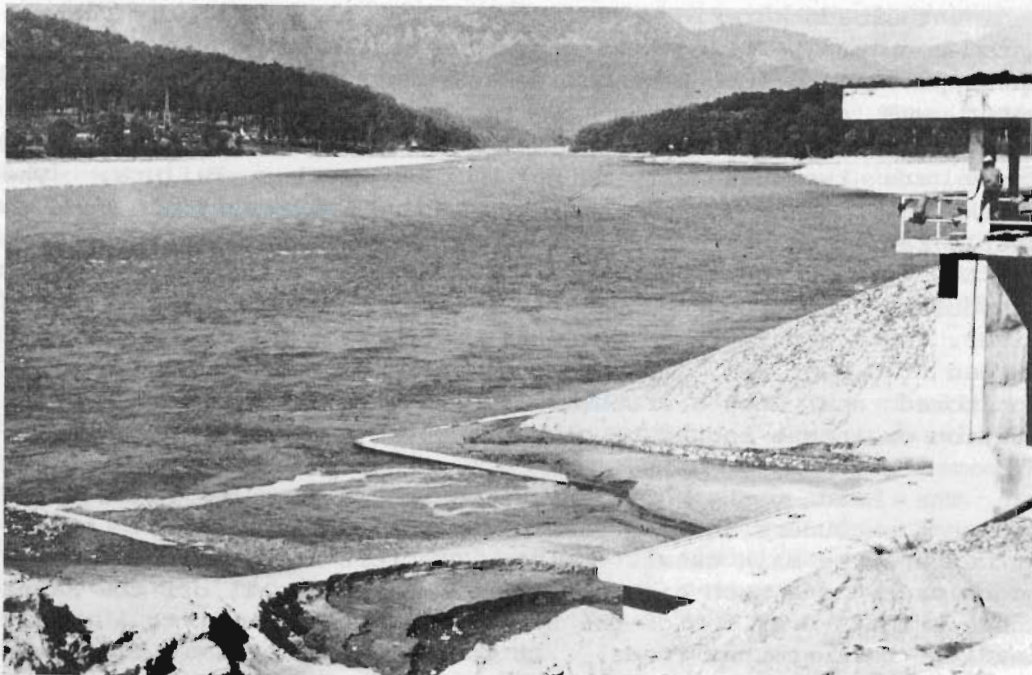
Photo XIV - Narayanghat, Chitwan District - Irrigation intake on Narayani River completely choked with sediment. A better design could have significantly reduced this sedimentation.

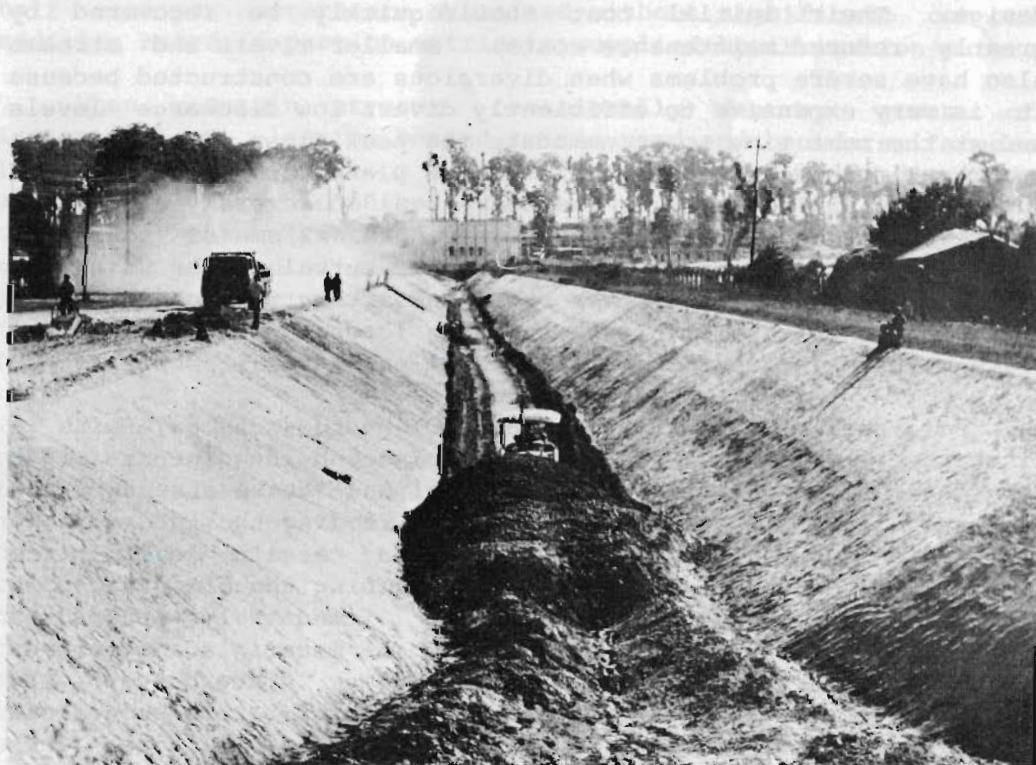
Photo XV Narayanghat, Chitwan District - Sediment removal from the main canal, Chitwan Irrigation Project. Over 2.5 meters of fine sand were deposited in this canal during the 1984 monsoon, completely blocking irrigation water flow. Better use of available data could have warned designers of such a hazard.

sediment loads entering the irrigation system. The main canals were completely filled with fine sand after only three months of such operation. (See Photo XV.) Damage was so extensive that no water was supplied to farmers for the 1985 winter irrigation season, only 8 months after the pumping station was opened. There are two lessons to be gained from such a failure. The intake was positioned in a backwater where sediment would tend to settle rather than be carried away by the river and the operators of the pumping station were maintaining inflexible pumping schedules, oblivious of the fluctuating sediment loads in the river. In a country such as Nepal, where sediment loads commonly exceed 10,000 ppm, river sediment concentrations must be monitored and when a critical level is exceeded, the pumping station or intake should be closed down.

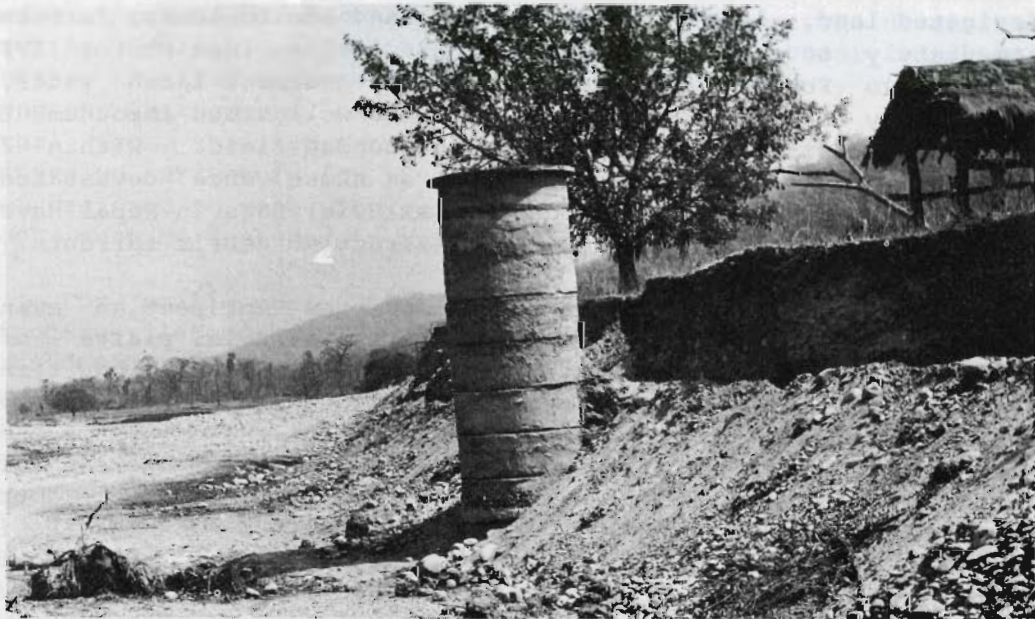
PHOTO XVII - Near Waebater Village, Marin Khola, Sindhuli District. River scouring has exposed 6 rings of this concrete lined well, leaving behind a monument to the fury of the Marin Khola in flood. Throughout the watershed, many river banks were eroded destroying many hectares of farmland.

When mountain streams occasionally destroy areas of irrigated land, leaving behind coarse sand and boulders, farmers immediately set about to reclaim their fields (see Photos XVI and XVII.) For this they require heavily sediment laden water, which they channel onto their land. One well timed impoundment can drop 2 or 3 mm of sediment onto the bunded field. Within 2 monsoon seasons, rice can be grown on those once devastated fields. Many of the most productive alluvial fans in Nepal have been at least partly reclaimed from destructive debris torrents.
