Chapter 9

Glacial Lake Outburst Floods and Damage in the Country

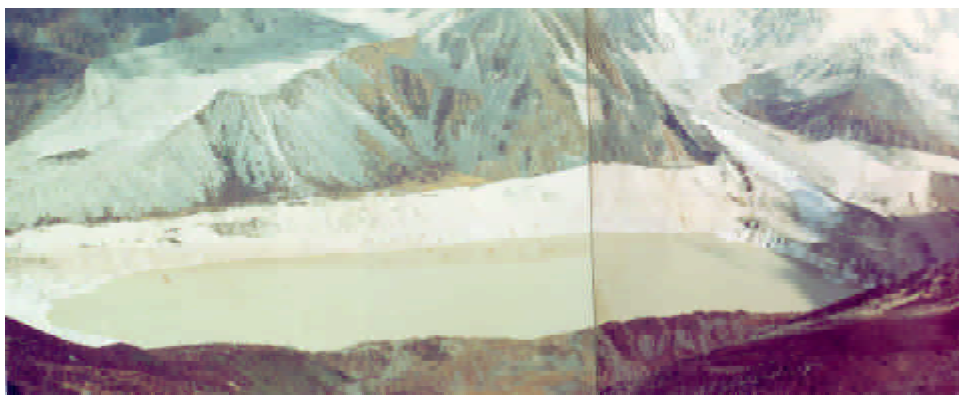
Plate 9.1: Lugge Tsho Glacial Lake two weeks after the GLOF of 7 October 1994
(Yeshe Dorji)

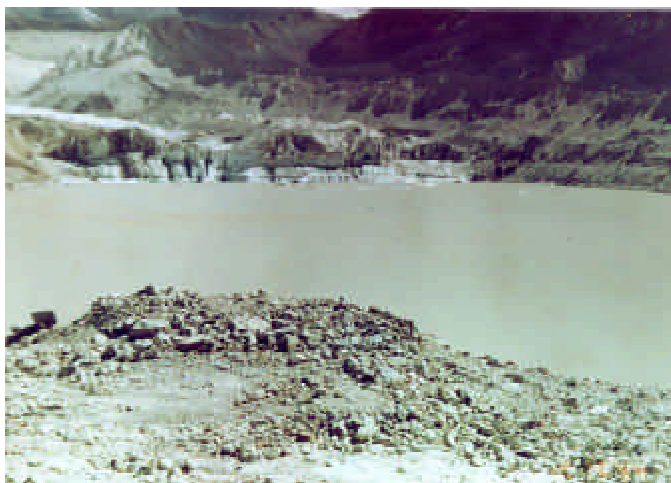
Plate 9.2: Lugge Tsho Glacial Lake in contact with the tongue of Lugge Glacier. The photograph was taken two weeks after the GLOF of 7 October 1994. The tonal difference indicates the fresh surfaces on the slope after the first (7 October) and the second (17 October) events.
(Yeshe Dorji)

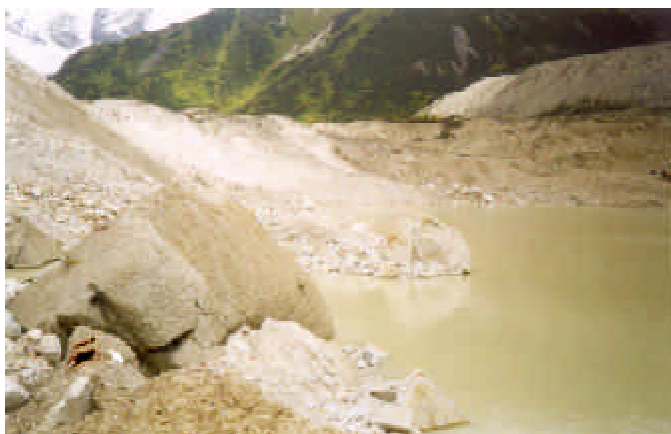
Plate 9.3: The occurrence of dead ice within the moraine of Lugge Tsho
(D.R. Gurung 1999)

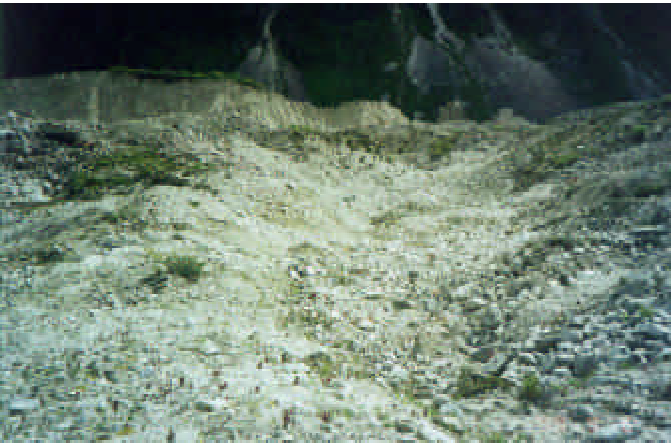
Plate 9.4: The end moraine of Lugge Glacier slumps and fine sand indicating that it is underlain by dead ice.
(D.R. Gurung 1999)

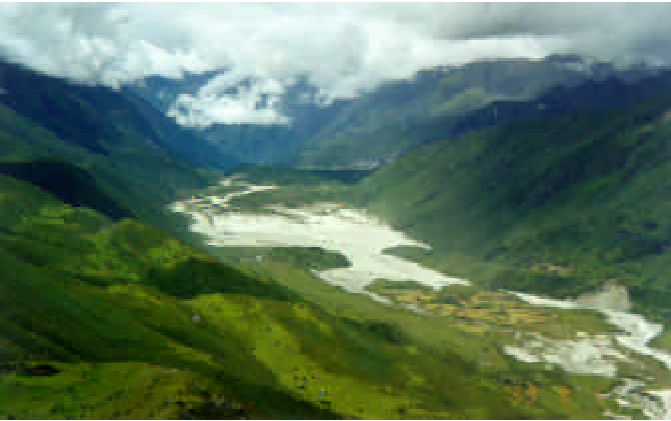
Plate 9.5: The U-shaped valley looking downstream and Tenchey, Dota, and Tshoju Villages The sand deposited by the flood of 1994 is still seen in between Dota and Tshoju where only a little grass has grown.
(Yeshe Dorji)

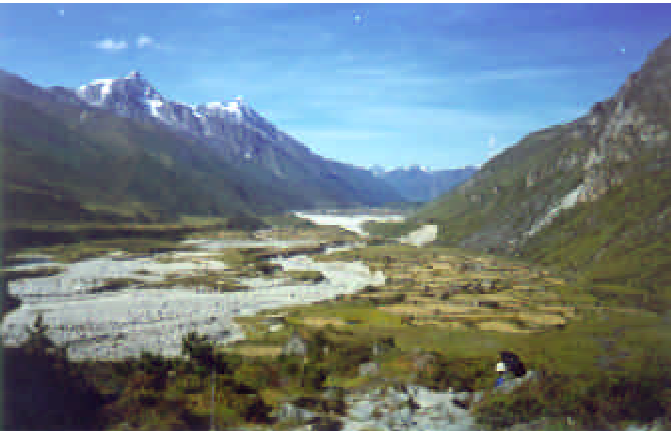
Plate 9.6: Thanza Village and erosion downstream caused by the flood of 1994.
(Tshering Tashi, NEC)

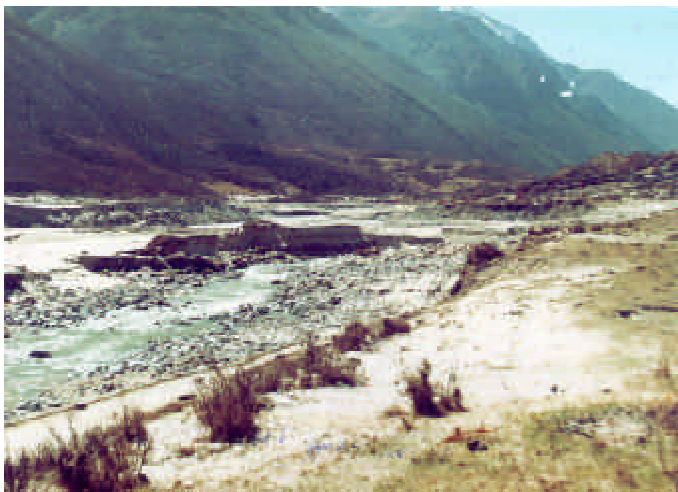
Plate 9.7: Tshoju Village is just behind, the photograph was taken facing southeast. It shows the lacustrine deposit and sand deposited by the flood of 1994.
(Yeshe Dorji)

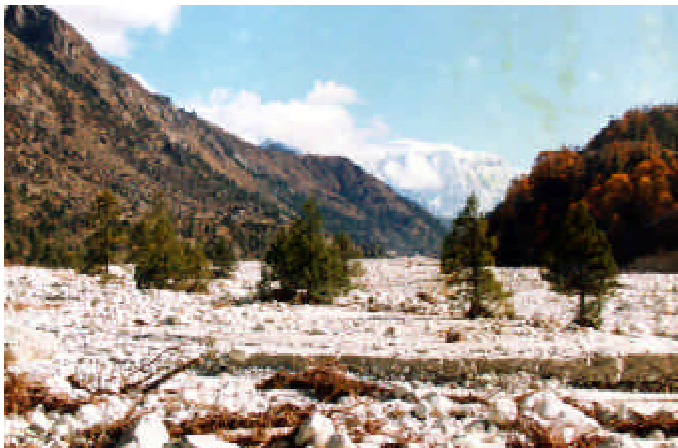
Plate 9.8: The debris brought down by the flood and deposited in the riverbed below Lhedi Village which destroyed the pasture land of Lunaps; a few trees were seen in the riverbed.
(Yeshe Dorji 1994)

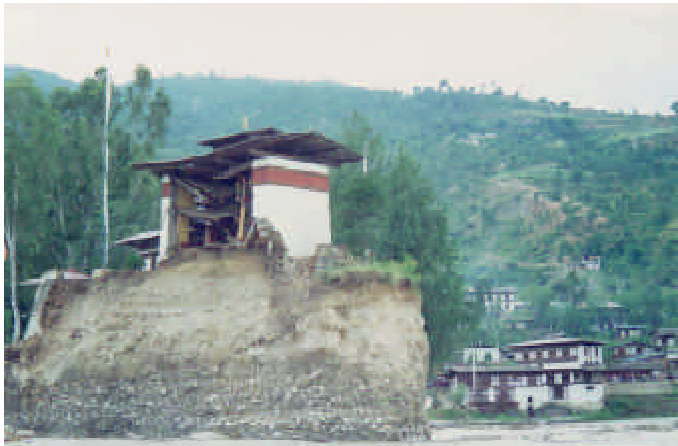
Plate 9.9: Damage caused by the flood of 1994 to one of the oldest and most sacred temples in Punankha.
(Helvetas)

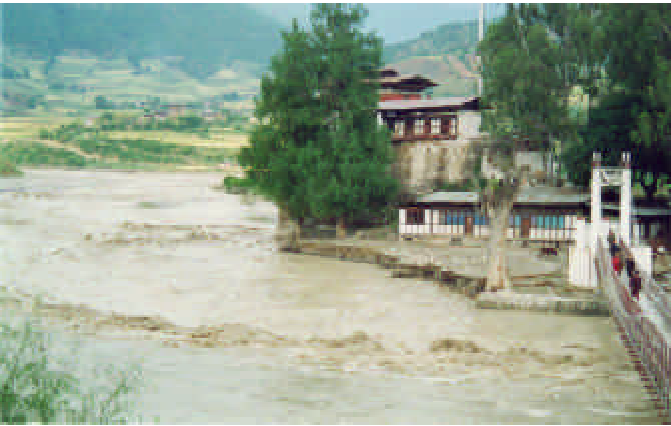
Plate 9.10: Erosion caused by the flood on the right bank of the Mochu above Punakha Dzong.
(Helvetas 1994)

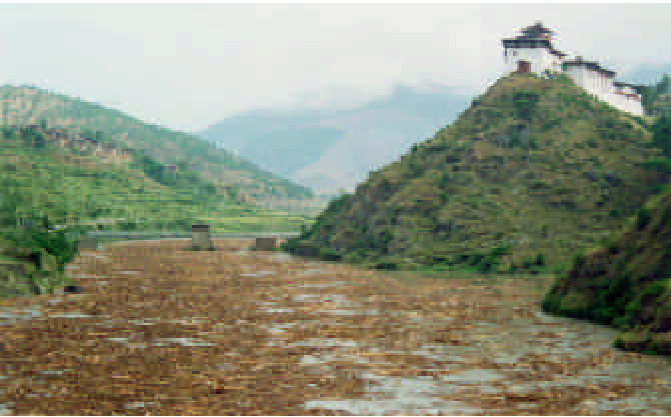
Plate 9.11: A log being brought down by the flood of 1994 and the scene below Wangdue Phodrang Bridge.
(Helvetas 1994)

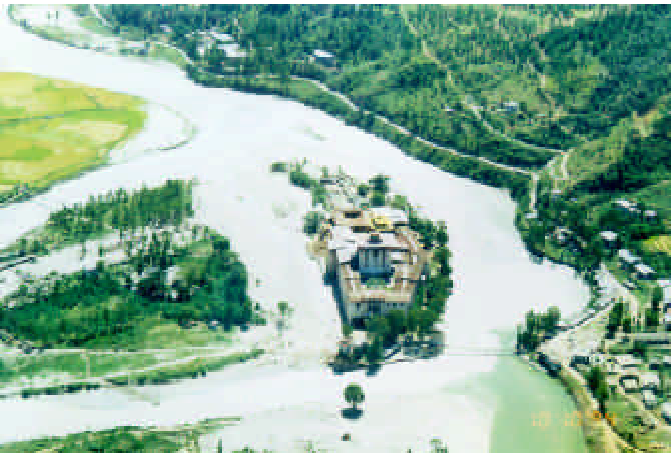
Plate 9.12: Punakha Dzong three days after the disaster of 1994. Also shown is the confluence of the Phochu and the Mochu below the Dzong and scars of the back flow water after it had joined the Mochu and dammed the flow above the Dzong.
(Phuntso Norbu 1994)

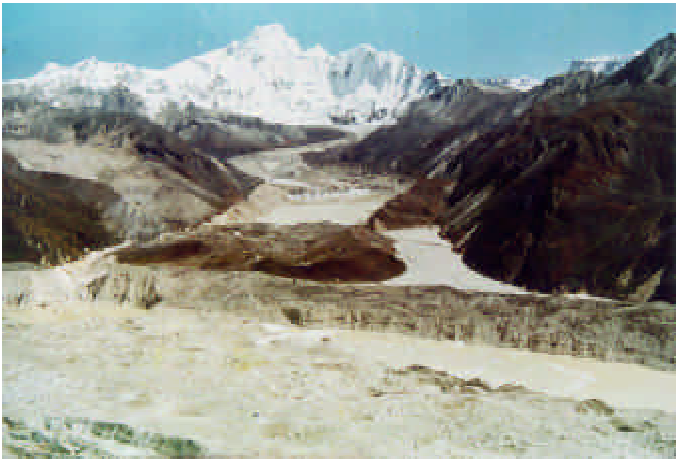
Plate 9.13: Thorthormi Glacier, Lugge Glacier, Lugge Hanging Glacier just above the right lateral moraine of Lugge and Druckchung Glaciers, Lugge Tsho, and Thorthormi Tsho. Also showing is the trench formed by water flowing from Lugge Hanging Glacier into Thorthormi Lake. The breach point of Lugge is also seen on the left lateral moraine of Lugge.

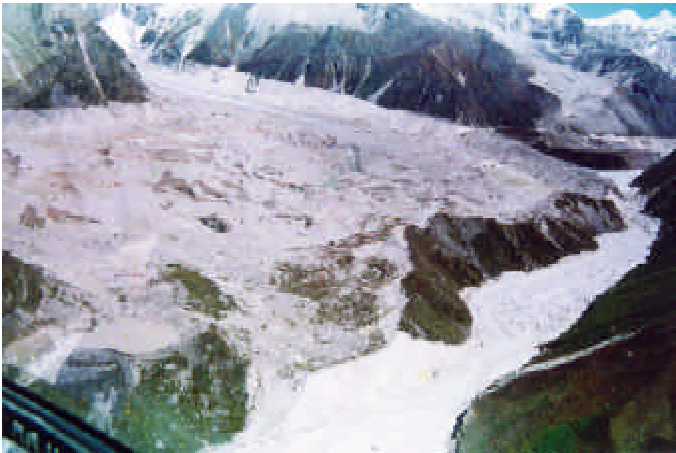
Plate 9.14: Supraglacial lakes being formed in Thorthormi Lake and erosion caused by the 1994 flood on the left lateral moraine.

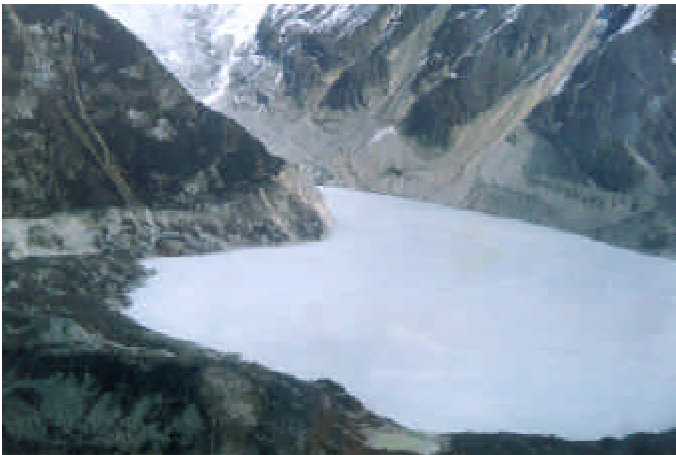
Plate 9.15: Raphstreng Lake with a frozen surface. Also shows first subsidiary lake. This was taken from a chopper before the mitigation measures for Raphstreng were undertaken.

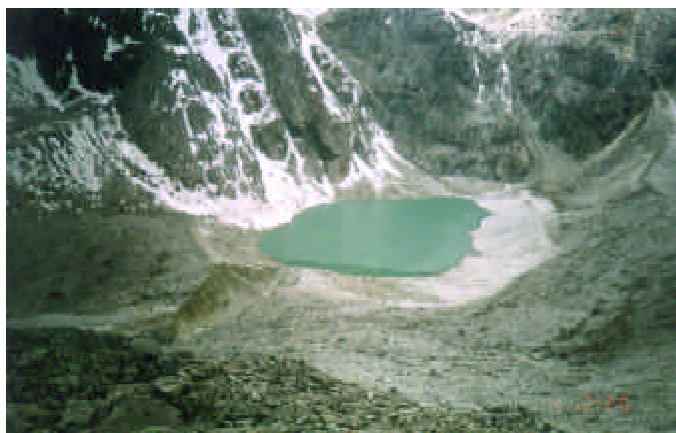
Plate 9.17: Gangri Tsho and deep V-shaped cut at the outlet indicating that the lake had breached earlier.
