Chapter 9

Glacial Lake Outburst Floods and Damage in the Country

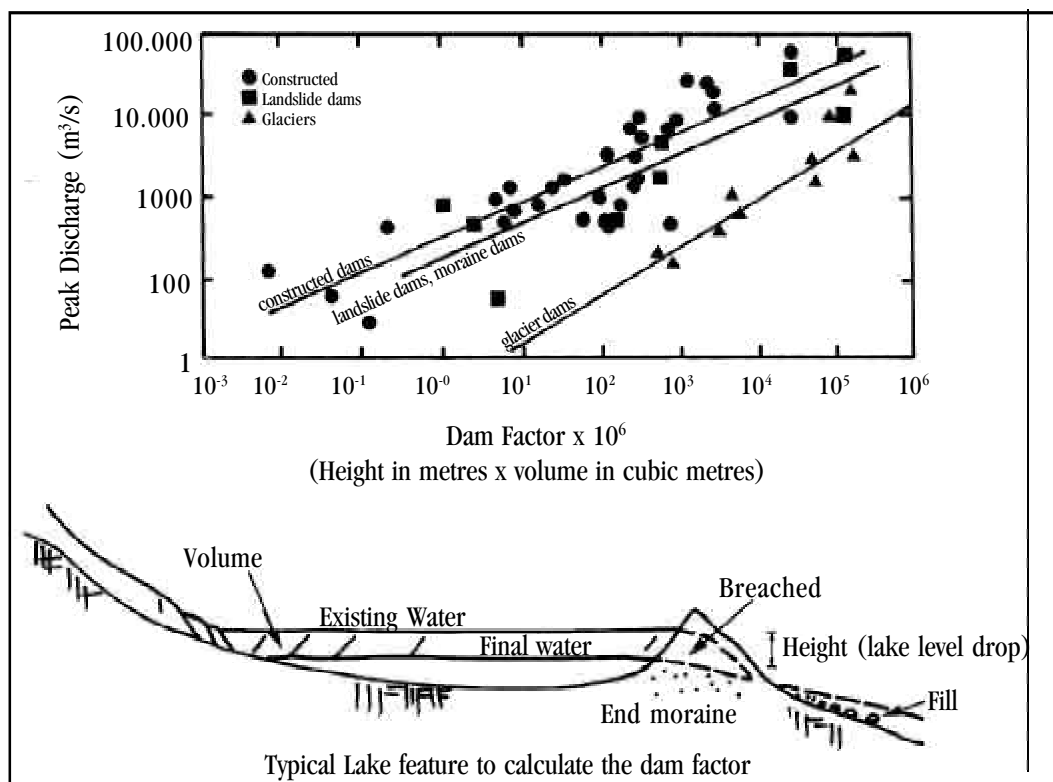
Figure 9.1: Peak discharge from breached moraine-dammed lakes can be estimated from an empirical relationship developed by Costa (1985)

Moraine-dammed lakes are generally drained by rapid incision of the sediment barrier by outpouring waters. Once incision begins, the hustling water flowing through the outlet can accelerate erosion and enlargement of the outlet, setting off a catastrophic positive feedback process resulting in the rapid release of huge amounts of sediment-laden water (Figure 9.1). The onset of rapid incision of the barrier can be triggered by waves generated by glacier calving or ice avalanching, or by an increase in water level associated with glacial advance (examples include an ice avalanche from Langmoche Glacier on 4 August 1985 and another on 3 September 1998 from Sabai Glacier).

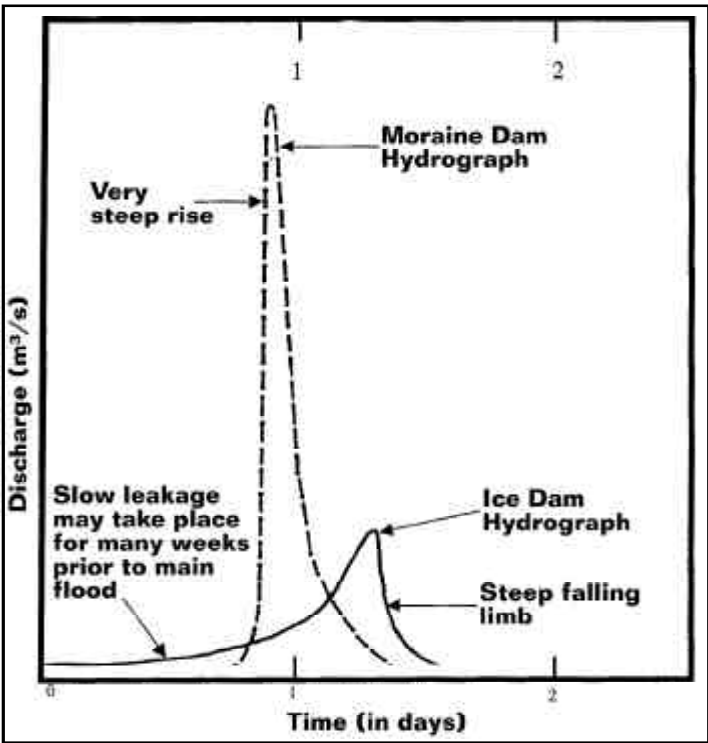
Figure 9.2: Difference in release hydrograph between moraine- and ice-dammed lakes (WECS 1987A)

As GLOFs pose severe threats to humans and man-made structures, it is important to make accurate estimates of the likely magnitude of future floods. Several methods have been devised to predict peak discharges, which are the most erosive and destructive phases of floods. The surge propagation hydrograph depends upon the type of GLOF event, i.e. from moraine-dammed lake or from ice-dammed lake (Figure 9.2). The duration of a surge wave from an ice-dammed lake may last for days to even weeks, while from a moraine-dammed lake the duration is shorter, minutes to hours. The peak discharge from the moraine-dammed lake is usually higher than from ice-dammed lakes.

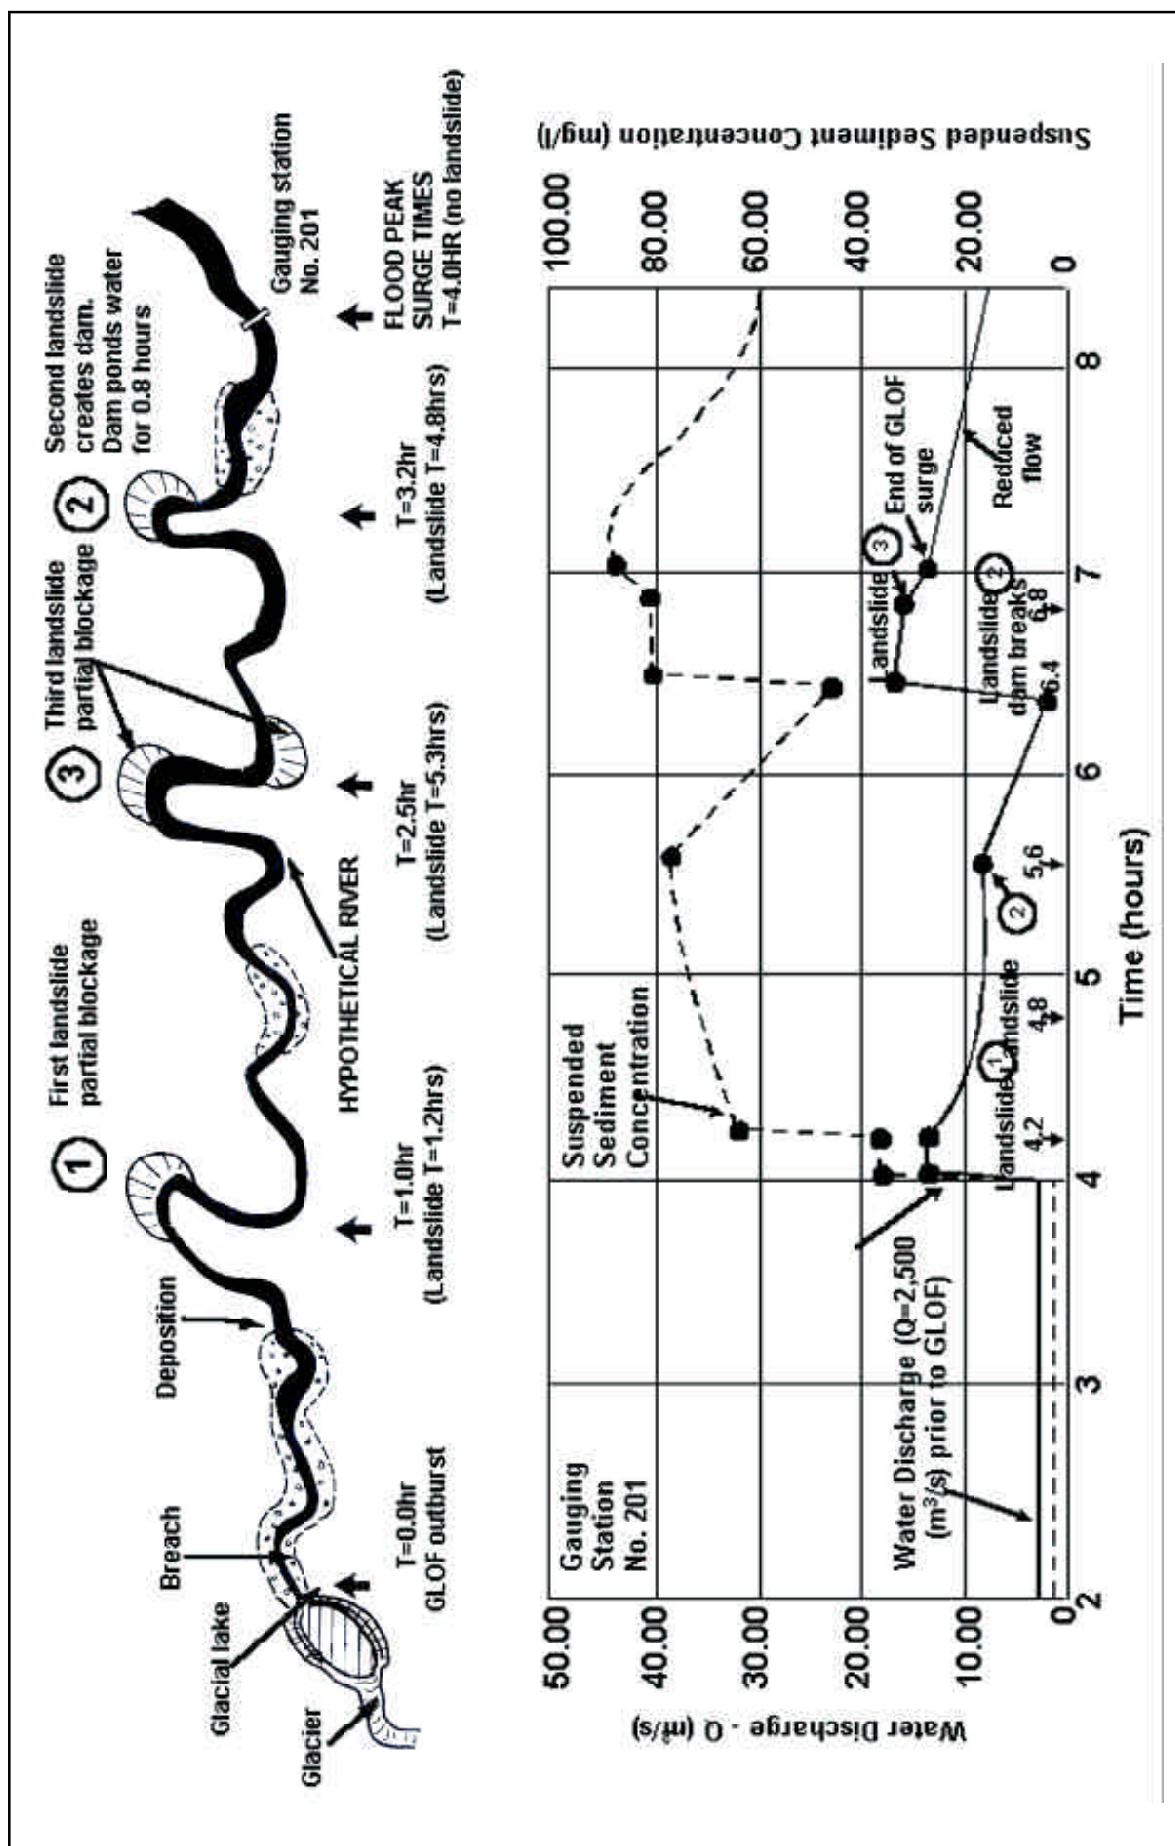
Figure 9.3: Hypothetical illustration of GLOF showing discharge and variation in sediment concentration (WECs 1987a)

During a GLOF, the flow velocity and discharge are exceptionally high and it becomes practically impossible to carry out any measurement. Field observations after a GLOF event have shown a much higher sediment concentration of rivers than before the GLOF event (Electrowatt Engineering Service Ltd 1982; WECS 1995a). WECS (1995a) calculated the volume of scoured sediment as $22.5 \times 10^4 \text{ m}^3$ after the Chubung GLOF in 1991. A high concentration of $350,000 \text{ mg}^{-1}$ during a GLOF in the Indus River at Darband in 1962 is reported by Hewitt (1985). Hypothetical illustrations showing discharge and variation in sediment concentration (WECS 1987a) are shown in Figure 9.3.

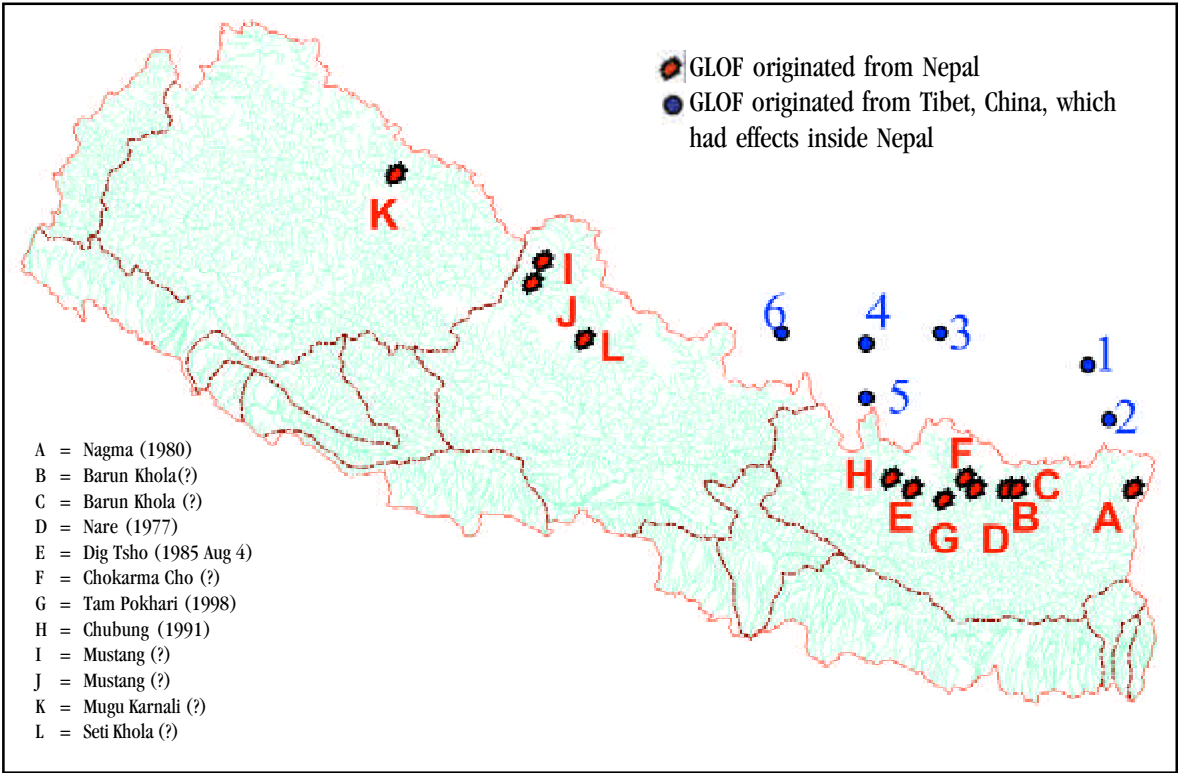
Figure 9.4: Glacial lake outburst events in the Himalayan region affecting Nepal

GLOF events have been reported most frequently within the last three decades. The reported GLOF events are given in Table 9.1 and shown in Figure 9.4. Some of the events have been disastrous for Tibet (China) as well as for Nepal. The GLOF event of the Barun Khola is not known, but the accumulation of the debris along the river valley is the indication of the GLOF event along the Barun Khola. The damage caused by the GLOF event of Jinco and Tara-Cho is not well known. The first GLOF event was experienced on 25 August 1964, when the Longda GLOF took place in the headwaters of the Trishuli River in Chinese territory. Most of the damage occurred in Chinese territory and a large debris flow was experienced in Nepal. In the same year, another Gelhaipuco GLOF was experienced along the Arun Valley. Severe damage and heavy economic losses occurred in Chinese Territory. The Zhangzangbo-Cho GLOF event at the headwaters of the Sun Koshi River on 11 July 1981 destroyed the Friendship Bridge of the China–Nepal Highway and the diversion weir at the Sun Koshi hydropower plant in Nepal, causing serious economic losses for Nepal. Dig Tsho GLOF, on 4 August 1985, destroyed the nearly completed Namche hydropower plant, cultivated land, and other infrastructures and caused the loss of many lives. Similar events have been reported from time to time. The most recent GLOF event is that of Tam Pokhari (Sabai-Tsho) on 3 September 1998 at the headwaters of the Inkhu Khola, one of the tributaries of the Dudh Koshi River.

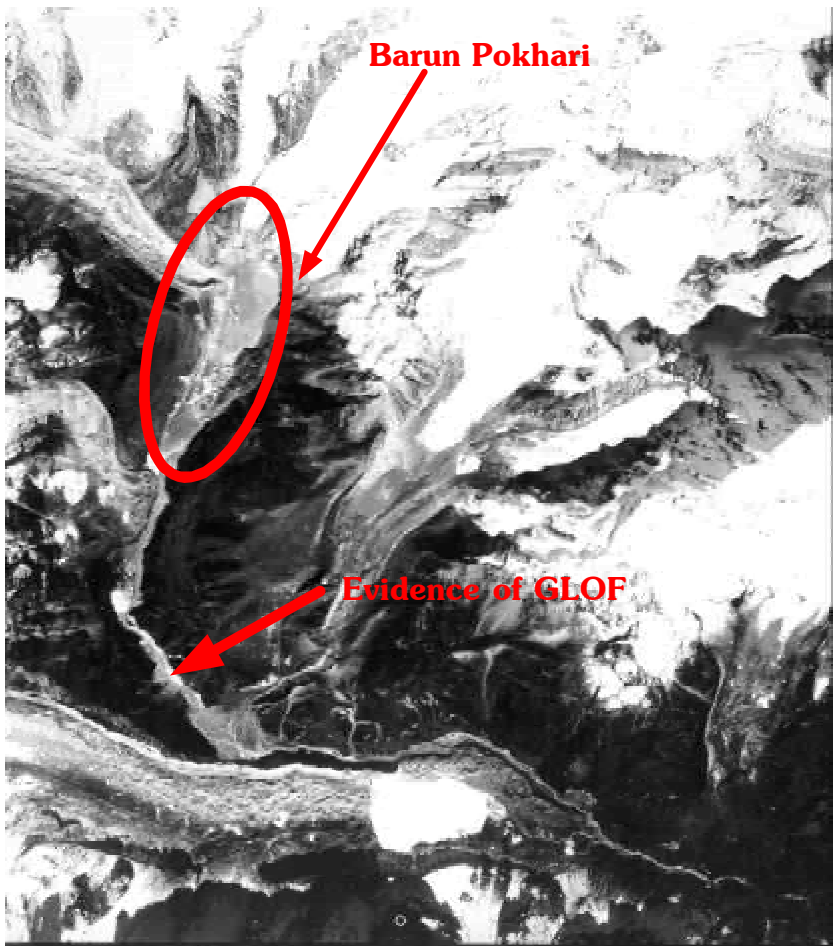
Figure 9.5: Part of an aerial photograph of 1992 acquired by the Survey Department of His Majesty’s Government of Nepal (HMGN) showing the Barun Pokhari and evidence of a GLOF from the Barun Pokhari (Aerial Photo 53-35)

There is evidence of a GLOF in the Barun Khola Valley as shown in Figure 9.5, and this is indicated by the debris along the Barun Khola. The source of the GLOF is the Barun Pokhari. The dates and other details are not available.

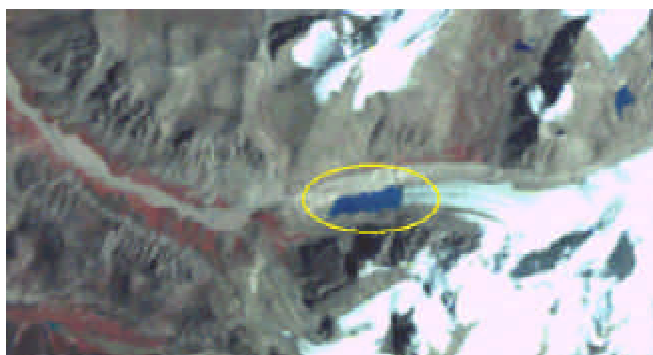
Figure 9.6: LANDSAT TM of 22 September 1988 (the Gelhaipuco Glacial Lake area is shown in the circle)

The LANDSAT TM and field photographs of Gelhaipuco Lake are given in Figures 9.6, 9.7, and 9.8 respectively.

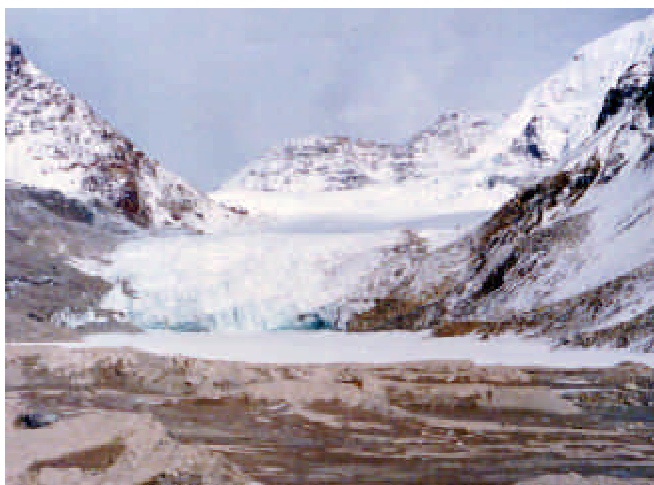
Figure 9.7: The field photograph (1987) of Gelhaipuco Glacial Lake shows the lake in contact with the hanging glacier

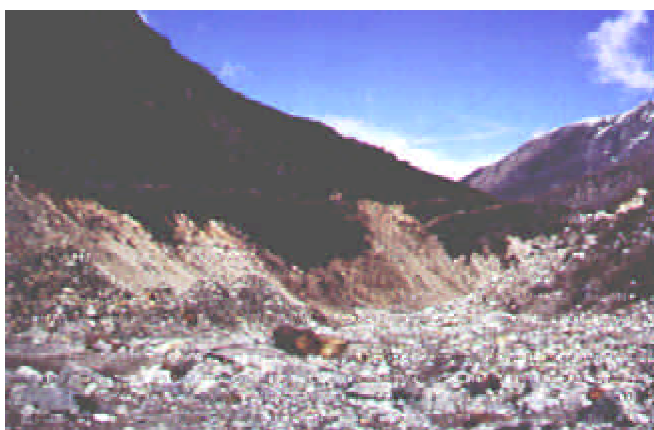
Figure 9.8: The eroded banks of the Natangchu (tributary of the Arun River in Tibet [China]) after the Gelhaipuco GLOF in 1964 (photograph 1987)

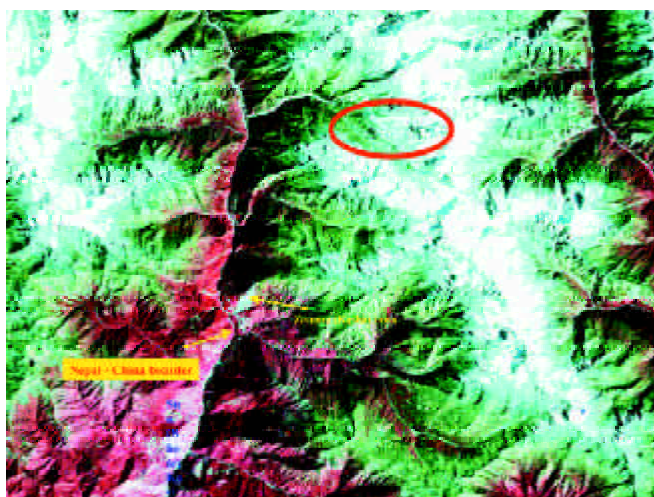
Figure 9.9: LANDSAT TM of October 1988 of Bhote (Sun) Koshi (Poiqu in Tibet [China]) showing Zhangzangbo-Cho

from that in 1981. The burst discharge and the damage caused were smaller. There is a cirque hanging glacier in the Zhangzangbo Gully (Figure 9.9), whose area is 2.47 sq.km, length is 2.2 km, and it ends at the bank of the lake. From 5 to 10 July 1981, there was continuous hot weather. The increased glacier ablation produced a large amount of water seeping into the crevasse of the glacier tongue, which brought the glacier into a critical state and caused part of the glacier to slide. Huge amounts of ice collapsed into the lake, which generated the shock wave that caused the dam burst.

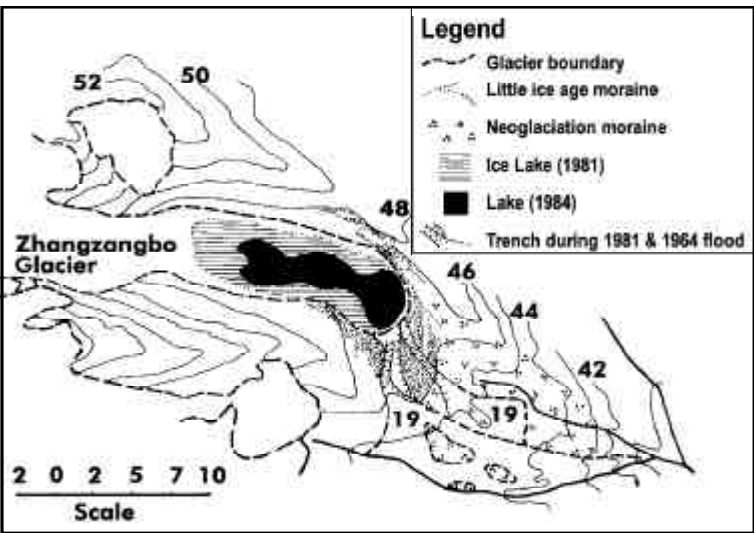
Figure 9.10: Geomorphological map of Zhangzangbo Glacial Lake area, Tibet (China) (XuDaoming 1985)

The geomorphological map around Zhangzangbo Glacial Lake (XuDaoming 1985) is shown in Figure 9.10.

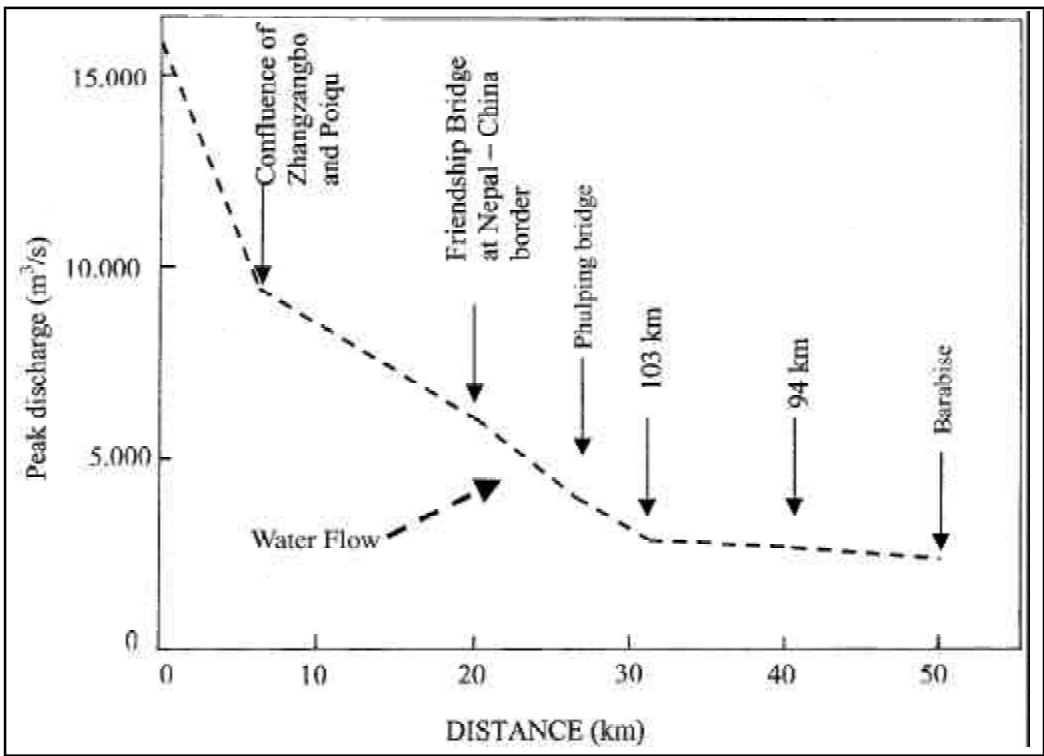
Figure 9.11: Peak discharge attenuation downstream due to the GLOF from the Zhangzangbo Glacial Lake, Poiqu River, Tibet (China) or the Bhote (Sun) Koshi (Nepal) (Xu Daoming 1985)

Attenuation of a peak discharge of $15,000\text{--}20,000 \text{ m}^3 \text{ s}^{-1}$ has been reported for the Sun Koshi River in Tibet within a distance of 50 km (XuDaoming 1985) (Figure 9.11). The propagation of surge waves can be numerically modelled using the dam-break flood-forecasting model.

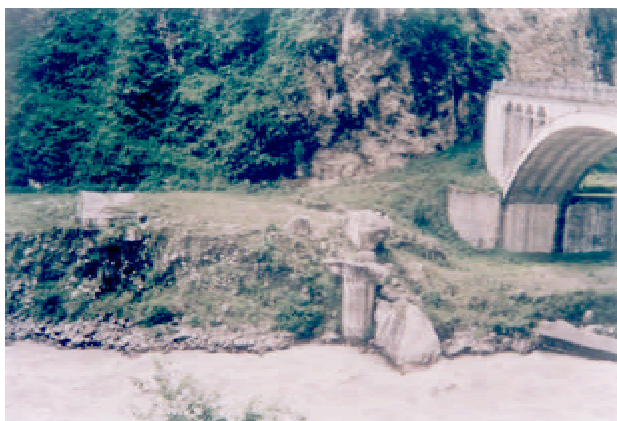
Figure 9.12: Remnant pier of the old bridge damaged by the 1981 GLOF and the new bridge at Phulping along the Nepal–China Highway

This debris flow damaged the highway sections between the outlet of Zhangzangbo Gully and the Sun Koshi Power Station in Nepal. It destroyed the Friendship Bridge of the China–Nepal Highway and the diversion weir at the Sun Koshi hydropower plant in Nepal, causing serious economic losses to Nepal. It also destroyed two bridges and tore out extensive road sections of the Amiko Highway of Nepal amounting to losses of US \$3 million. The peak discharge attenuation downstream due to the GLOF is shown in Figure 9.11, the remnant pier of the old bridge damaged by the 1981 GLOF and new bridge at Phulping is shown in Figure 9.12, and the washed out portion of the Kodari Highway is shown in Figure 9.13.

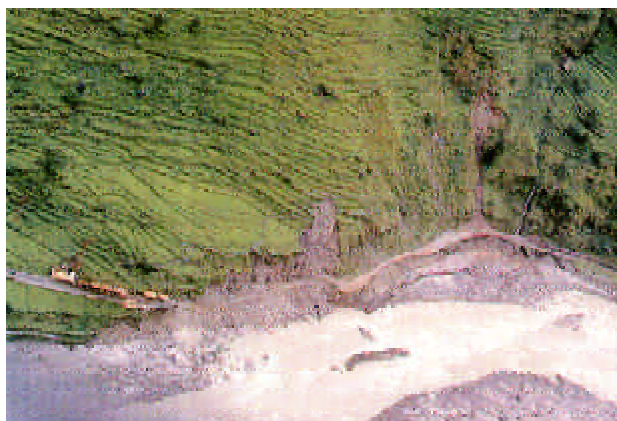
Figure 9.13: The washed out portion of the Kodari Highway (Nepal–China Highway) by the 1981 GLOF

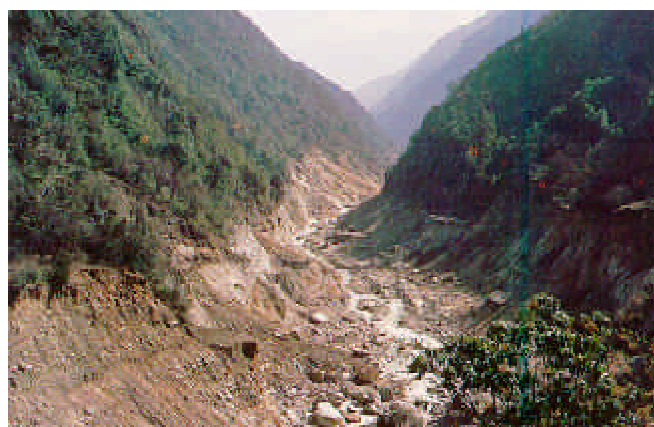
Figure 9.14: The eroded banks of the Tamor River after the Nagma GLOF of 1980 (Carson 1985)

Nagma (Punchan) is situated at the Tamor watershed. Due to the GLOF event of 23 June 1980, one village was completely destroyed and the villagers had to migrate to other places. The eroded banks of the Tamor River after the Nagma GLOF of 1980 is shown in Figure 9.14, while the 1992 aerial photographs of Nagma Glacial Lake and Chhechen Pokhari formed after the Nagma GLOF are shown in Figure 9.15 and 9.16 respectively.

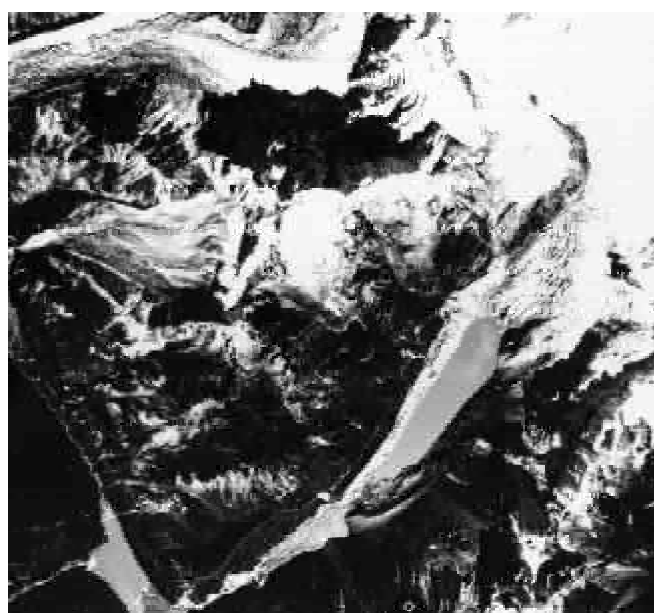
Figure 9.15: Part of the 1992 aerial photograph acquired by the Survey Department of HMGN showing the Nagma (Phuchan) Glacial Lake after the GLOF of 1980 (Aerial Photo 53-56).

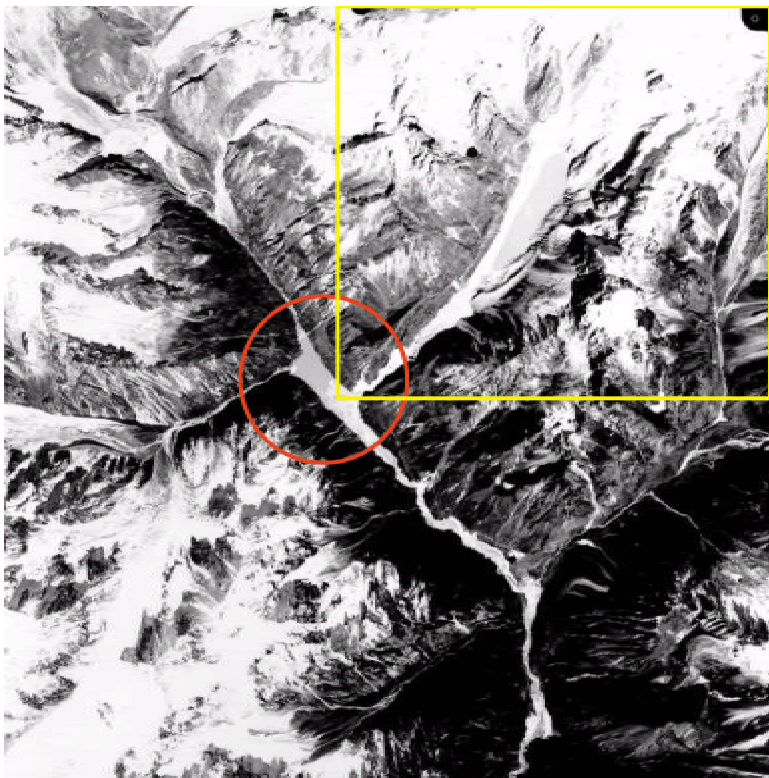
Figure 9.16: Part of the 1992 aerial photograph acquired by the Survey Department of HMGN showing the debris deposited along the gully which blocked the Chhechen Khola to form the Chhechen Pokhari after the Nagma (Phuchan) GLOF of 1980 (Aerial Photo 52-15)

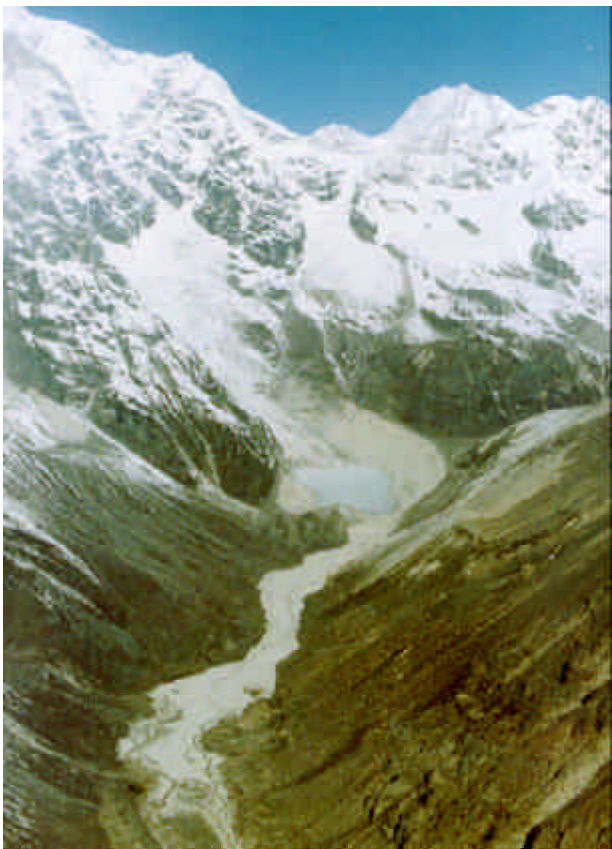
Figure 9.17: Birds-eye view showing the remnants of Dig Tsho Glacial Lake, Langmoche Glacier at the slope and the debris along the gully after the GLOF of 1985 (WECS 1991)

Dig Tsho (Langmoche) Glacial Lake is in contact with the Langmoche hanging glacier in the Dudh Koshi Basin. It burst on 4 August 1985. The GLOF destroyed the nearly completed Namche Hydropower Plant (estimated loss of US \$1.5 million), 14 bridges, trails, cultivated land, etc and caused the loss of many lives. The details of the Dig Tsho Glacial Lake are given in Chapter 10. A photograph taken after the GLOF of 1985, showing the remnants of Dig Tsho Glacial Lake and Langmoche Glacier, constitutes Figure 9.17.

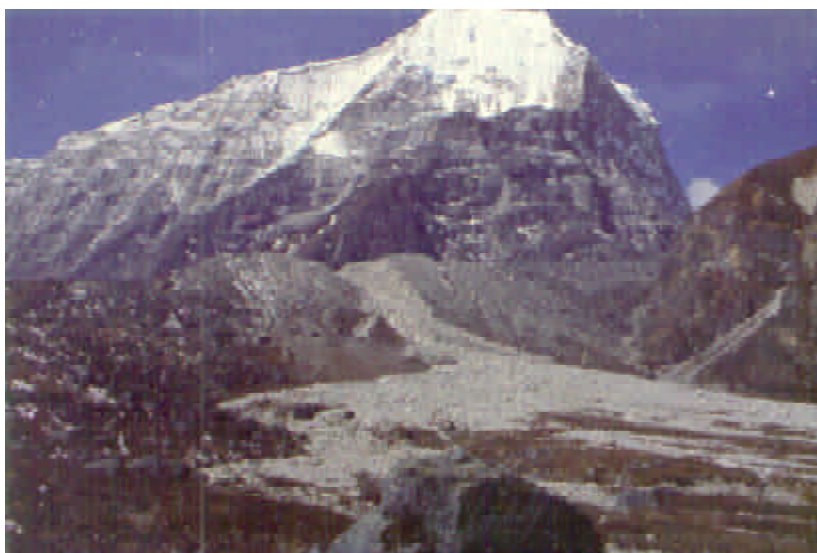
Figure 9.18: The breaching of the moraine dam and fan deposited after the Chubung GLOF of 12 July 1991 in the Rolwaling Valley, Nepal (photograph 1993)

Chubung is situated in the Tama Koshi Basin at the end of the Ripimo Shar Glacier in the Rolwaling Valley. It is a moraine dam type of glacier, which burst on 12 July 1991 and damaged many houses and much farmland in the upper part of the Rolwaling Valley. Figure 9.18 shows the photograph of the breaching of the moraine dam and fan deposited after the Chubung GLOF of July 1991.
