# Chapter 12

## Glacial Lake Outburst Flood Mitigation Measures, Monitoring and Early Warning Systems

### *Mitigation measures at Tsho Rolpa Lake*

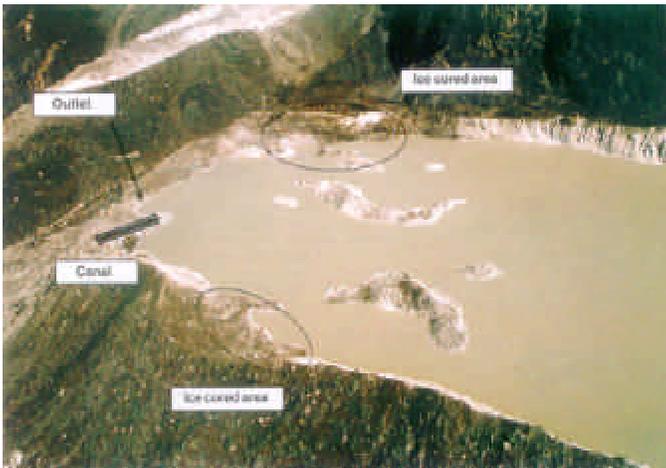
Figure 12.1: Aerial view of end moraine area of Tsho Rolpa Glacial Lake showing the mitigation project construction site (photograph source: DHM 2000)

- The channel will pass through a depression in the moraine commonly referred to as the Horseshoe Lake (Figures 12.1 and 12.2).

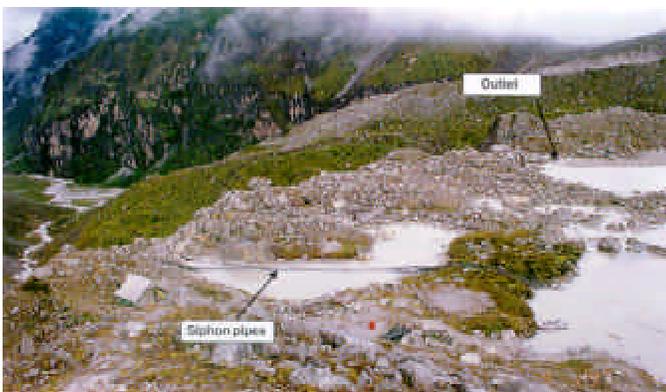
Figure 12.2: Closer view of Tsho Rolpa Glacial Lake mitigation construction site (photograph source DHM 2000)

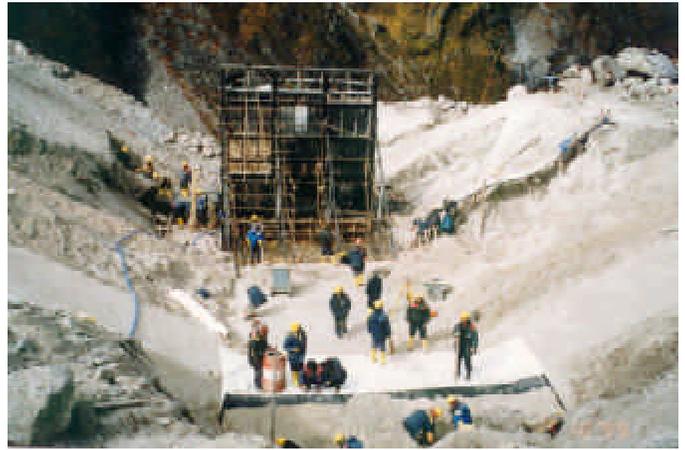
Figure 12.3: Gate structure with partially erected gates. In the foreground geomembrane and geotextile are being laid (photo credit: Shrestha 2000)

- The channel will be 6.4m wide at the bottom.
- The bottom elevation of the channel at the gate structure will be 4.2 below datum.
- The channel bottom will be flat upstream of the gate structure and will have a gradation of 0.3% downstream of the gate.
- The channel sides will be sloped at 2H:1V.
- A gate structure will be located in the channel (Figure 12.3).
- There will be three gates, each 2m wide and capable of being opened 1.5m above the channel bottom.
- The 20m of the channel upstream of the gates will be lined with gabion mattresses extending 1m above datum. The gabion mattresses will be underlain by (in turn) a geotextile, 100 mm of sand, a geomembrane, a geotextile, and a further 100 mm of sand (Figure 12.3).
- The channel is designed to convey the design flood flow of  $14.6 \text{ m}^3 \text{ s}^{-1}$  and the extreme flood flow of  $30 \text{ m}^3 \text{ s}^{-1}$ .

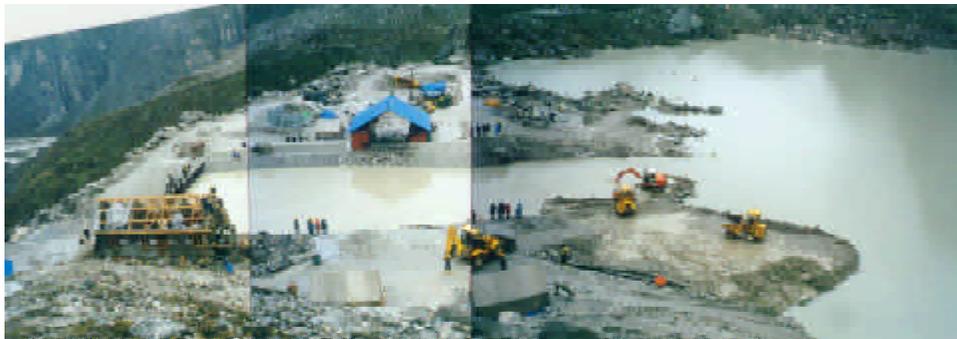
Figure 12.4: Synoptic view of mitigation construction activity at the end moraine of Tsho Rolpa Glacial Lake to reduce the lake water level (photo credit: Shrestha 2000)

- After 6 June the filling of the canal upstream with water began and continued until June 8 (Figure 12.4).
- The official beginning of drawdown was at 11 am on 8 June. The daily drawdown rate was maintained well below the allowed 25 cm. By late June a drawdown of 3m was achieved (Figure 12.5).
- After drawdown the unlined portion of the canal was given the specified configuration.
- The downstream part of the moraine, where the new flow took place, was closely monitored for the possibility of erosion. No erosion occurred on the slope. Some toe erosion of talus slopes opposite the moraine occurred.

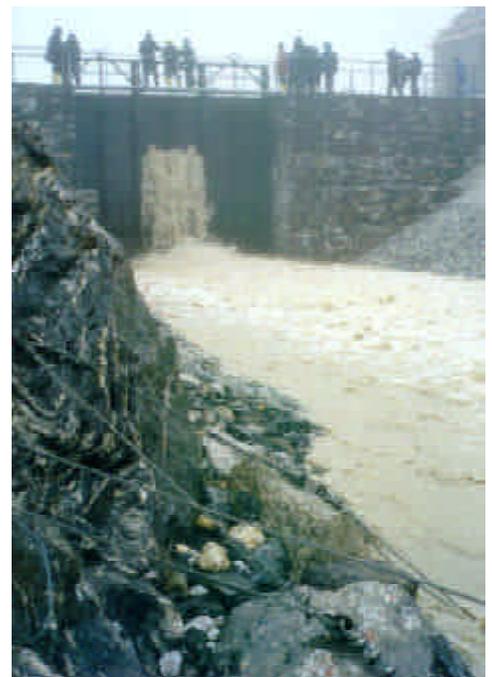
Figure 12.5: Downstream view of outlet canal and gate structure (photo credit: Shrestha 2000)
