## Chapter 5

# Terrain Classification, Hazard and Vulnerability Assessment of the Imja and Dudh Koshi Valleys in Nepal<sup>1</sup>

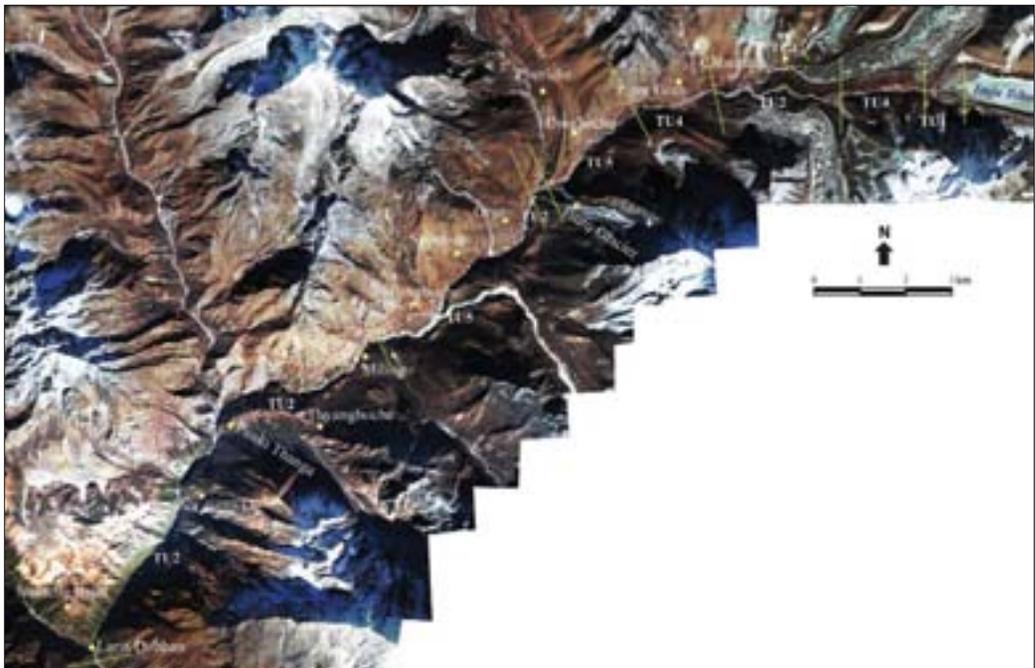
**Figure 5.3:** Terrain units (see Table 5.2) from Lake Imja Tsho to Namche Bazar (Larja Dobhan)

Chhukung village (Figures 5.3 and 5.31) is located on the end moraines of the Lhotse Nup and Nuptse glaciers. This area is separated from the median moraine of the Lhotse and Imjatse glaciers by the Lhotse Khola (Figure 5.32) originating from the Lhotse glacier. The median moraine which separates the village from the Imja Khola is about 300m wide, 3 km long, and less than 40m high (Figures 5.3 and 5.32b). The hydrodynamic modelling showed inundation of Chhukung, but the field verification revealed less chance of such inundation. However, about 1 km downstream from the village, the valley narrows at the Pipe confluence. If this is blocked, the backwater can extend up to Chhukung.

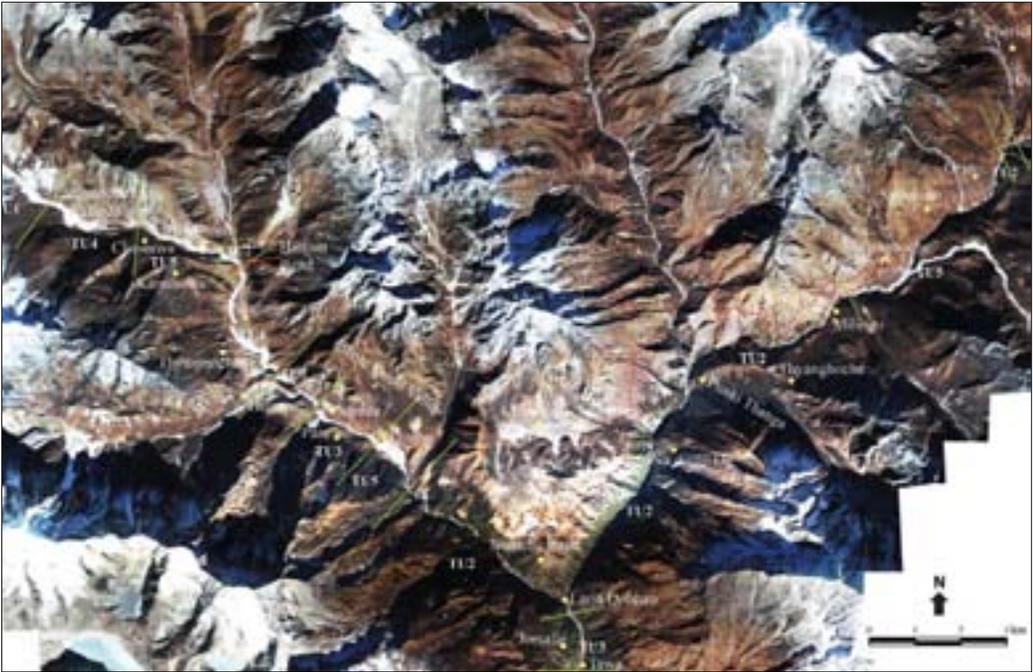
**Figure 5.4:** Terrain units (see Table 5.2) along the Langmoche valley and Bhote Koshi valley from Lake Dig Tsho to Namche Bazar (Larja Dobhan)

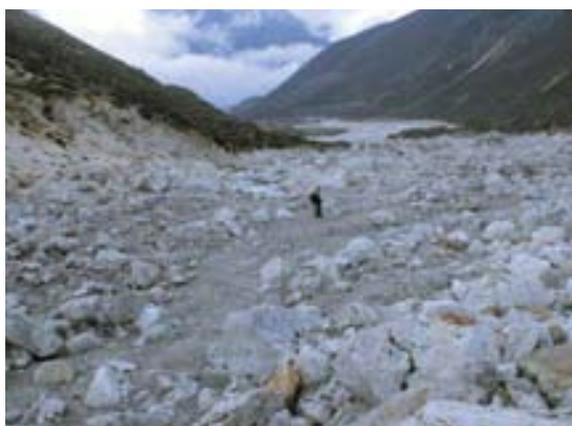
**Figure 5.7:** Sediments deposited downstream of Dig Tsho

The Dig Tsho GLOF of 1985 deposited a large amount of sediment, ranging in size from big boulders to silt, on the immediate downstream valley (Figure 5.6). The sediment gradually diminishes in size the further it is from the lake outlet. The valley is characterised by a large amount of sediment and many huge boulders. The wide valley, with the debris fan resulting from the GLOF, is shown in Figure 5.7.

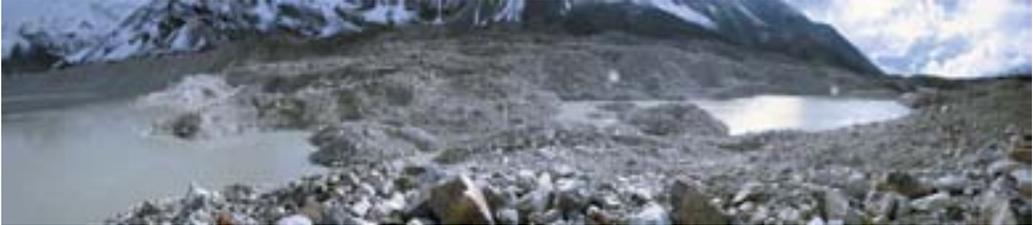
**Figure 5.8:** Supraglacial lakes and hummocky terrain around Lake Imja Tsho

Lake Imja Tsho is dammed by a thick, large area of end moraine and exhibits hummocky terrain near the outlet; these are indications that an Imja GLOF may carry with it a very large amount of debris, predictably more so than any other previously recorded GLOF in Nepal (Figure 5.8).

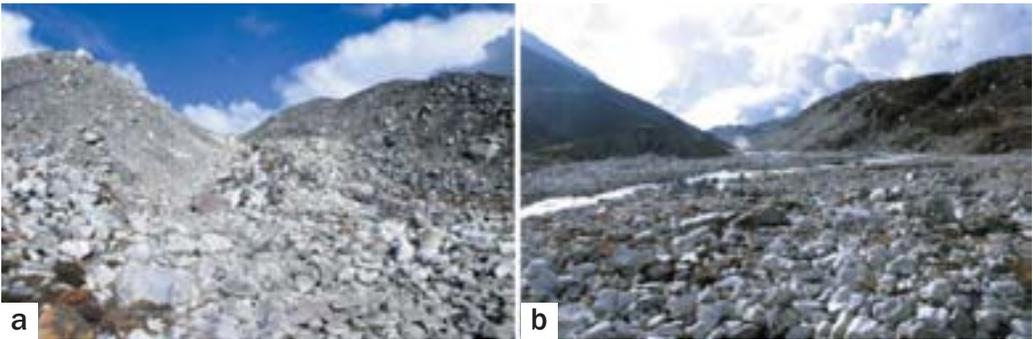
**Figure 5.9:** Cobble-size sediments deposited at the Lake Imja Tsho outlet (a) and downstream (b)

The outlet of Lake Imja Tsho drains through a sloping moraine that opens up into a wide valley immediately after the moraine dam (Figure 5.9). In the case of a GLOF, the wide valley below will experience extensive bed and bank erosion and large amounts of debris will be deposited.

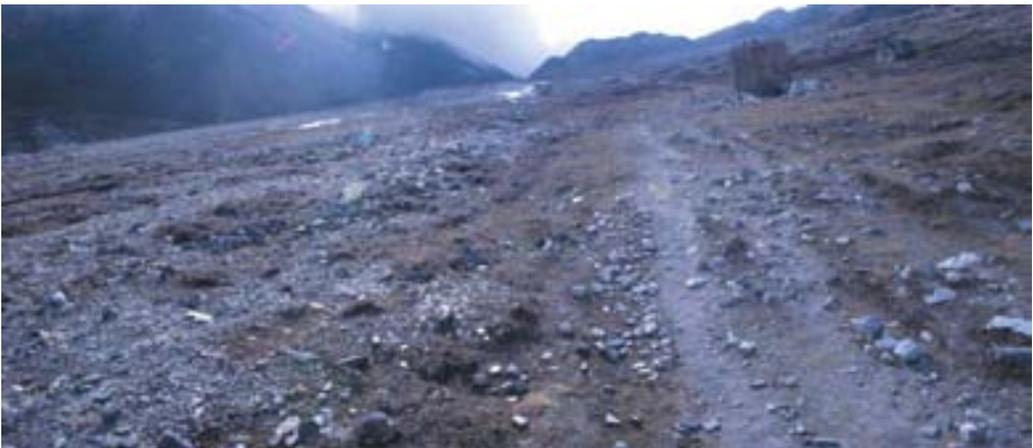
**Figure 5.10:** The downstream view of the wide Imja valley before reaching the constriction near Pipe Goth

Before the GLOF enters the narrow valley constriction near Pipe Goth, it first traverses a very wide valley where the sediments will most probably be sorted. The bigger size boulders are expected to be deposited nearer the outlet while finer ones will accumulate further downstream. By the time the flow reaches the constriction (4.5 km downstream) the sediment is expected to be quite small (Figure 5.10).

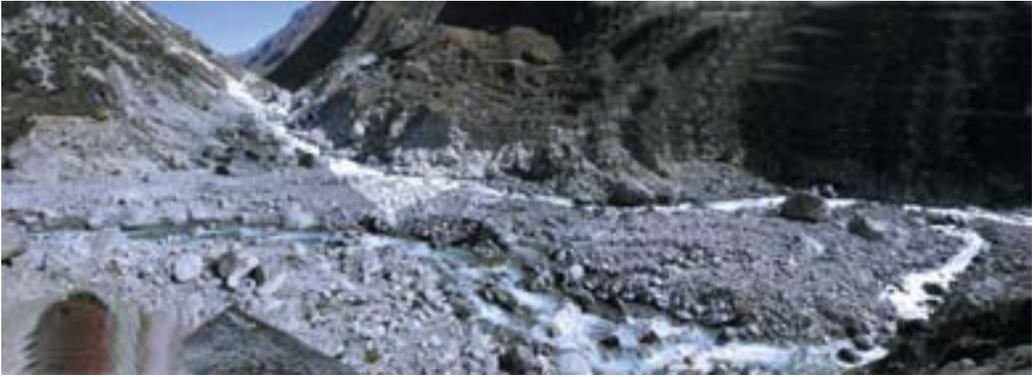
**Figure 5.12:** Erosion and sedimentation at the Langmoche (background) and Bhote Koshi (right and foreground) confluence. View upstream

Both the Langmoche Khola and Bhote Koshi rivers have sharp bends upstream of the confluence. Lateral erosion has occurred at the bends of both rivers. The sediment scoured from these sections is deposited at the confluence (Figures 5.12 to 5.14). Erosion of the

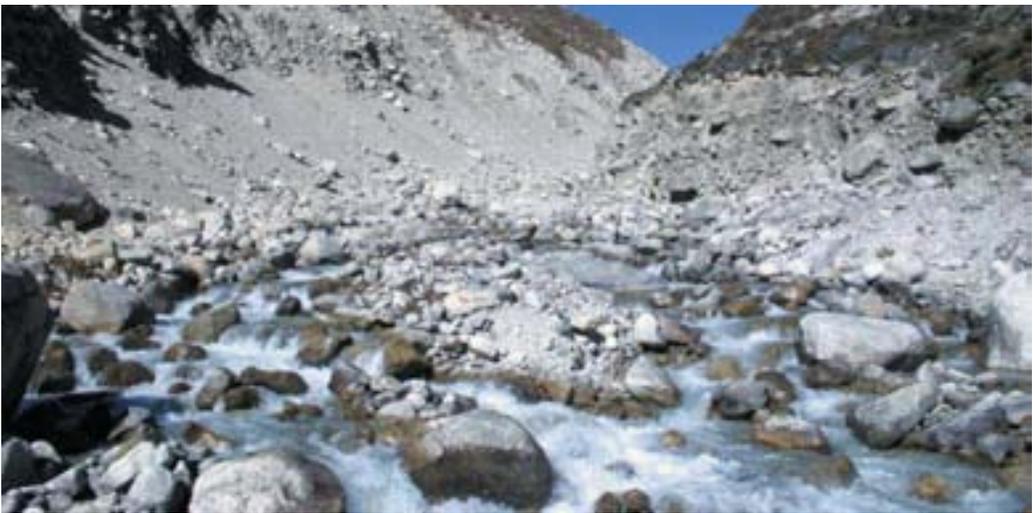
**Figure 5.13:** Erosion and sedimentation observed at the confluence of the Langmoche Khola and Bhote Koshi. View upstream

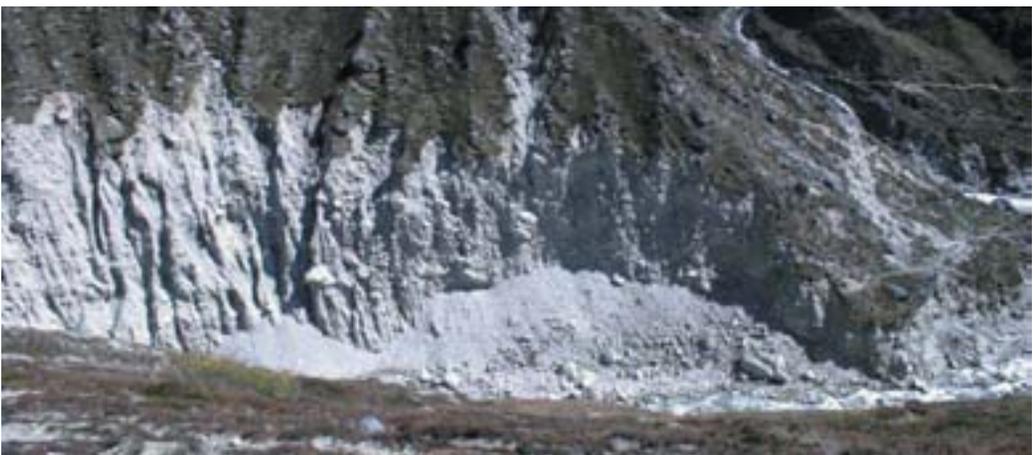
**Figure 5.14:** Bank erosion at the Bhote Koshi–Langmoche confluence

bedrock on the left bank and the palaeo-moraine on right bank is observed. The erosion on the palaeo-moraine extends from the riverbank to the upper river terraces. Similarly, both banks of the Langmoche Khola, which consist of old moraine sediments, have experienced extensive lateral erosion. The lateral erosion extends from the valley floor to the upper terraces.

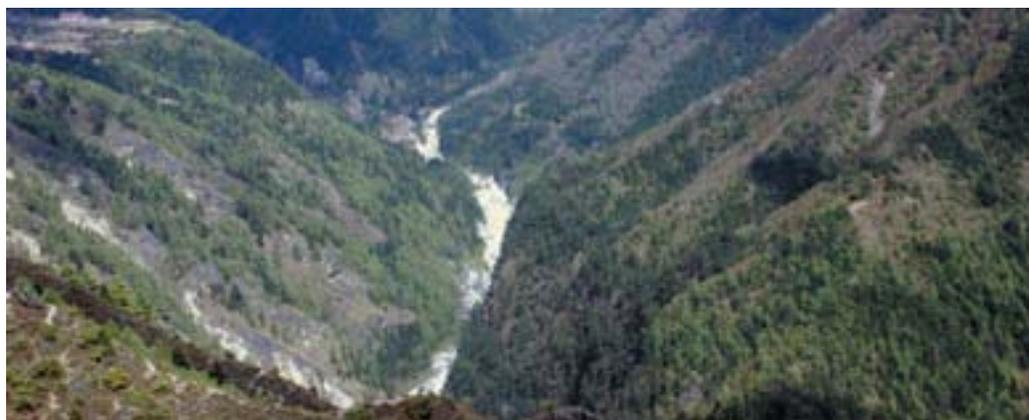
**Figure 5.15:** Narrows at Phunki Thanga. View downstream

The river section between Thamu and Larja Dovan passes through a narrow valley. This river section is incised in the bedrock and vegetation cover on both valley slopes (Figures 5.15 to 5.17). The tributaries to this section are also steep, with highly dissected valleys, and can transport larger boulders to the Bhote Koshi. These local streams deposit large boulders and sediment. This type of sediment deposit can be observed in the Larja Dovan, Jorsalle, Tawa, Benkar, and Ghat villages. The lower valley sections are steeper and are covered by thick forest. Settlements are situated only on the upper terraces where the GLOF should have no effect at all.

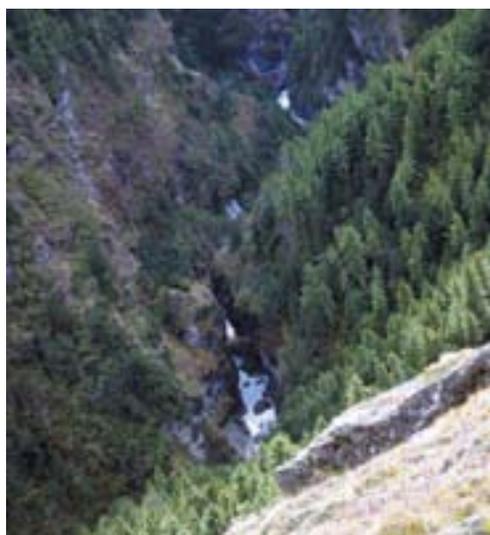
**Figure 5.16:** A boulder caught in the narrows between Latho Goth and Larja Dovan. View downstream

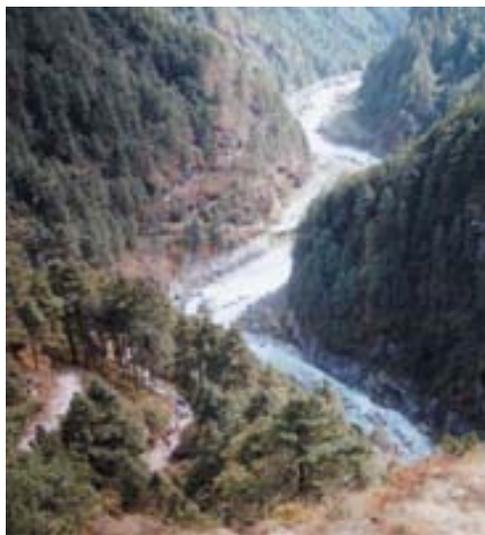
**Figure 5.17:** The deep valley of Lower Dudh Koshi near Larja Dovan. View downstream

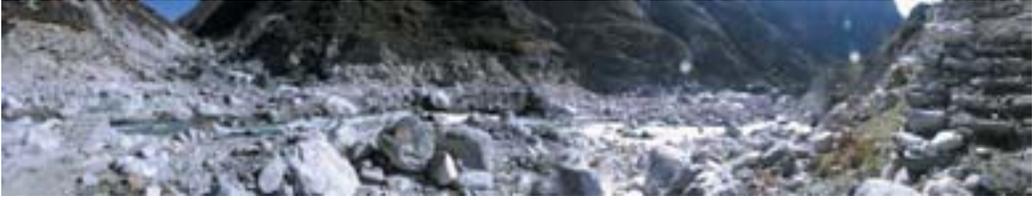
**Figure 5.18:** Erosion and sedimentation at the confluence of the Dudh Koshi (foreground) and Bhote Koshi coming from the left (background) looking upstream of the Bhote Koshi

Both the Bhote Koshi and Dudh Koshi flow through a narrow valley composed of bedrock near the confluence. The concave bend of the Dudh Koshi records bank erosion while the convex side contains many big boulders (larger than 50 cm) presumably deposited during the Dig Tsho GLOF (Figure 5.18). Due to the deposits of boulders, the level of the right bank is higher than the left bank (Figures 5.19 and 5.20).

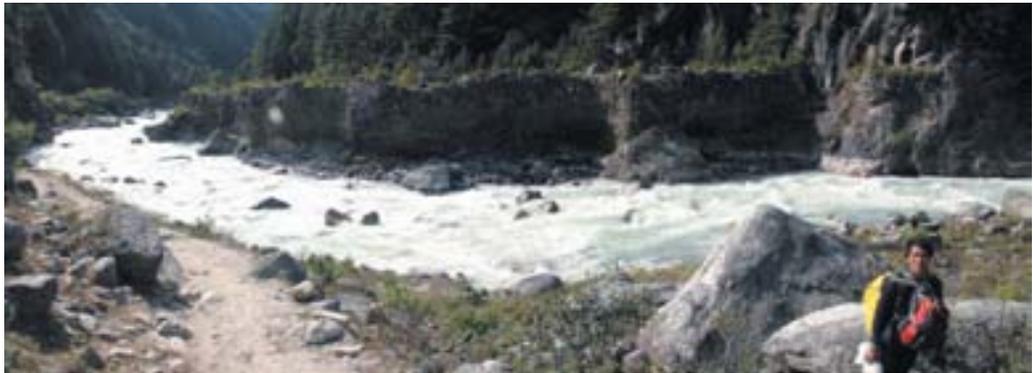
**Figure 5.19:** Downstream view of the Dudh Koshi River from Larja Dovan

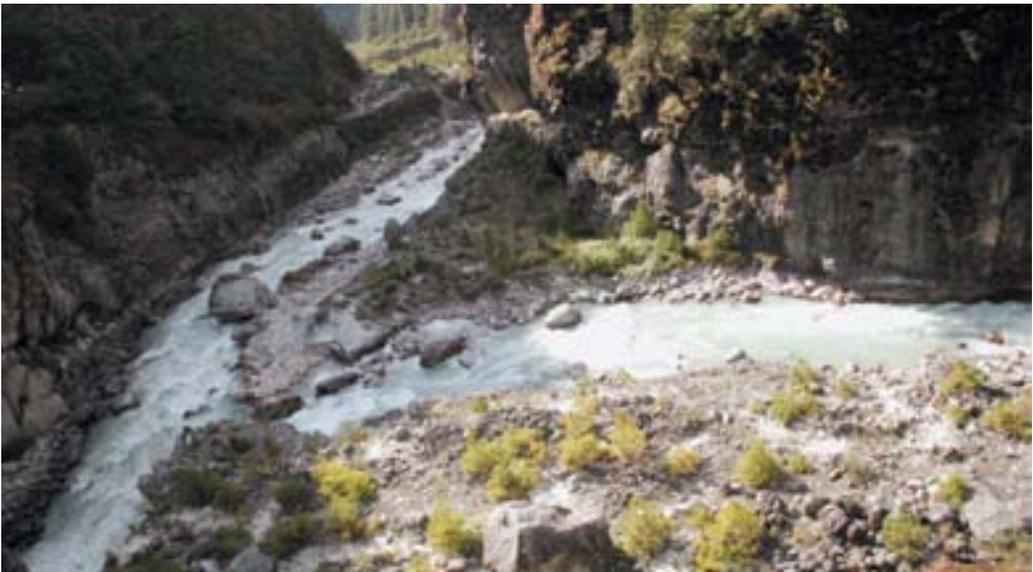
**Figure 5.20:** The Bhote Koshi (right) and Dudh Koshi (left) at Larja Dovan looking downstream

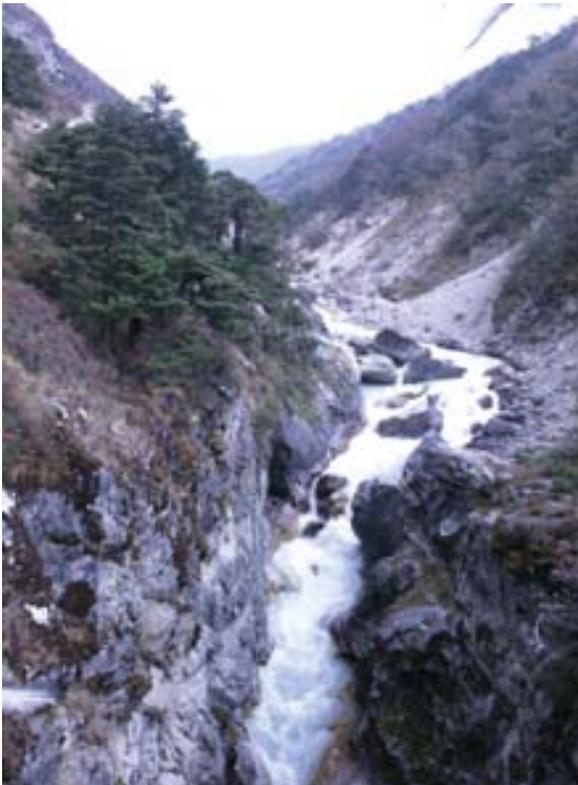
**Figure 5.21:** Landslides on the narrows of Milingo, view upstream

The section upstream of the Milingo Bridge is characterised by narrow sections passing through bedrock and by a series of falls similar to the Thame Gorge. The sections both upstream and downstream of the Milingo Gorge have severe bank erosion. The trekking trail on the left bank is affected by river scouring resulting in active landslides (Figure 5.21).

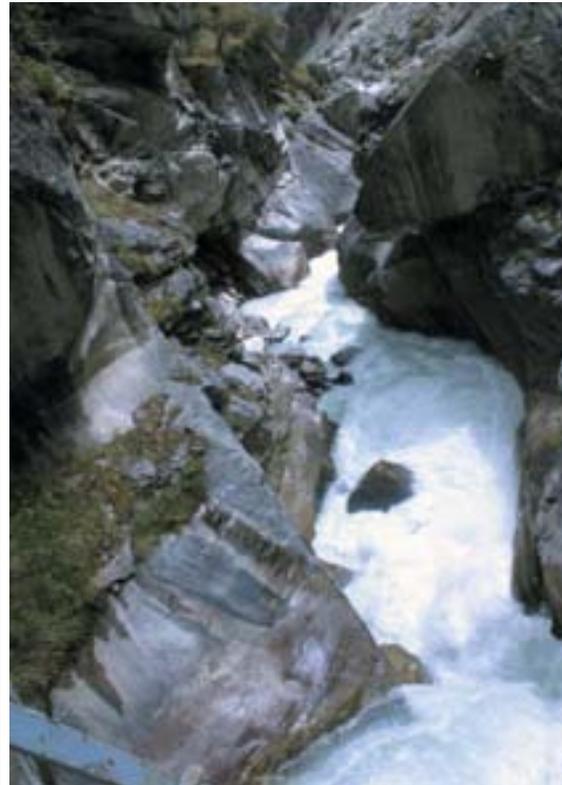
**Figure 5.22:** Downstream view of the narrows of Thame with landslides on the right bank

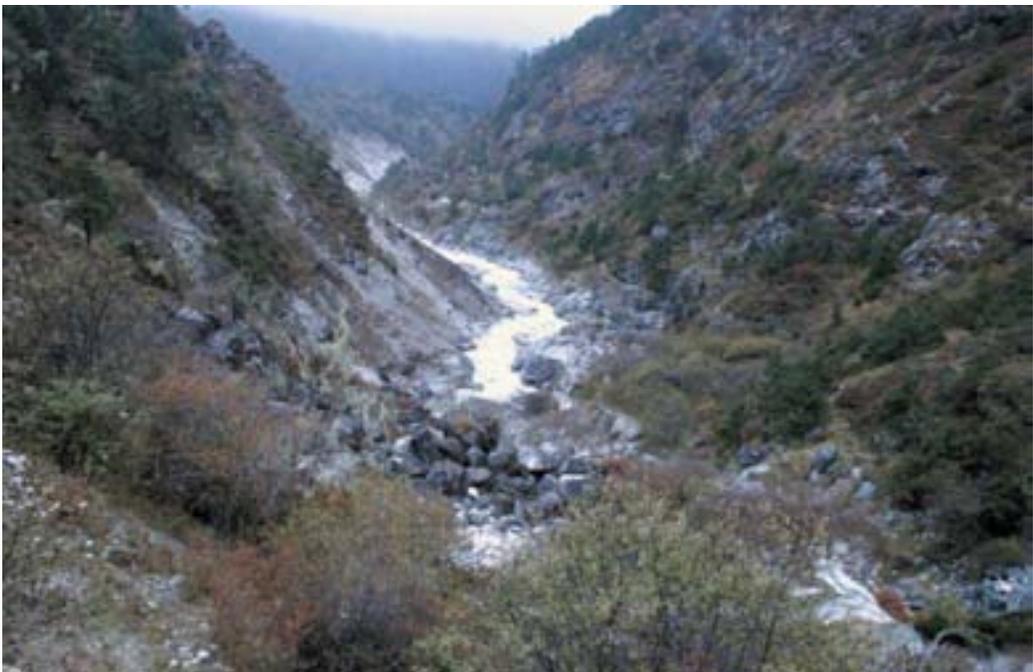
**Figure 5.23:** The downstream view of the Dudh Koshi River from the Milingo bridge, showing extensive erosion

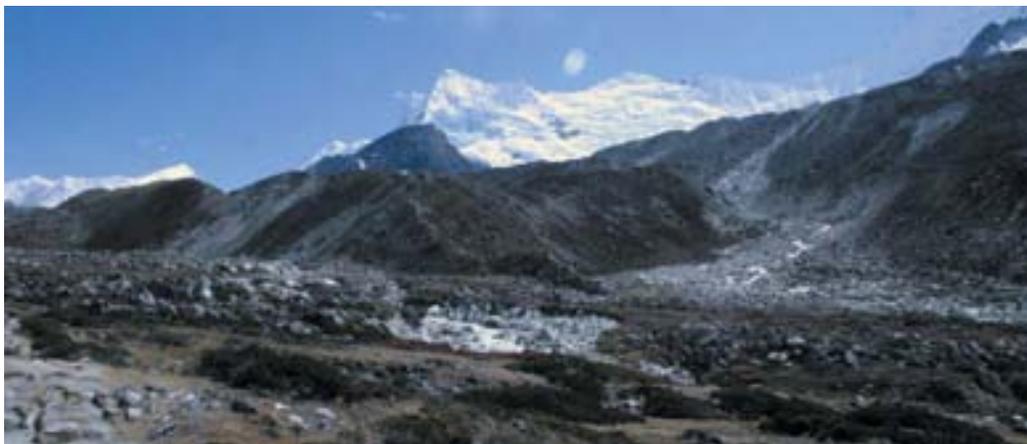
**Figure 5.24:** A wide valley upstream of the Tsuru confluence. The debris on the left bank derives from the 1977 Nare GLOF

In the areas upstream of the Tsuru confluence is a wide valley. The debris seen on the left bank derive mainly from the Nare GLOF (Figure 5.24). Before reaching the confluence, the Imja River passes through a narrow valley made up of the Tsuru glacial deposits. The area at the confluence of the rivers from the Khumbu Glacier and the Imja River (near Pheriche village) is a wide valley but the river narrows near the Tsuru confluence (Figures 5.25 and 5.26). Upstream of the confluence (towards the Imja River) are several bends where extensive erosion is possible; this area consists of the palaeo-moraine of the Tsuru glacier. These sediments might be transported long distances, possibly even beyond Orsho. Such a process is seen at the Langmoche–Bhote Koshi confluence and the Bhote Koshi–Dudh Koshi confluence (which experienced the Dig Tsho GLOF).

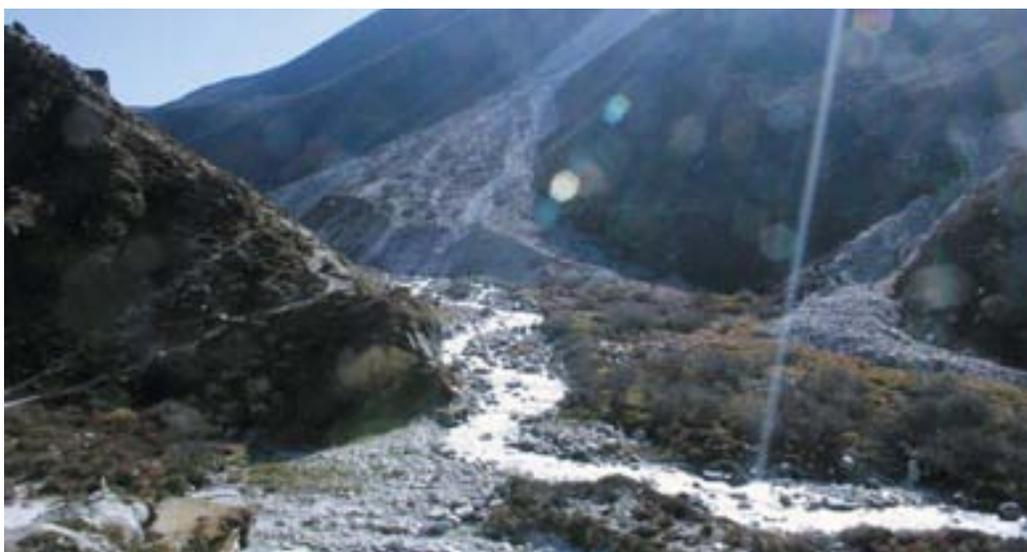
**Figure 5.25:** Upstream view of the Imja valley from the Tsuru confluence

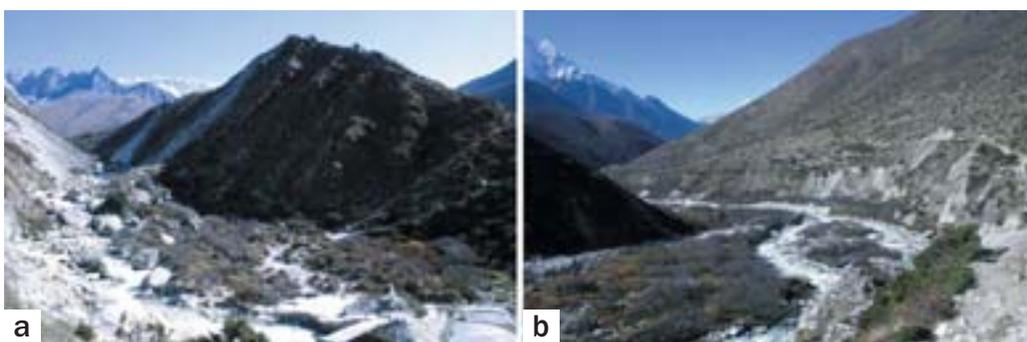
**Figure 5.26:** Situation near the Tsuru confluence: a) Upstream view to Pheriche, b) downstream view to the Imja valley

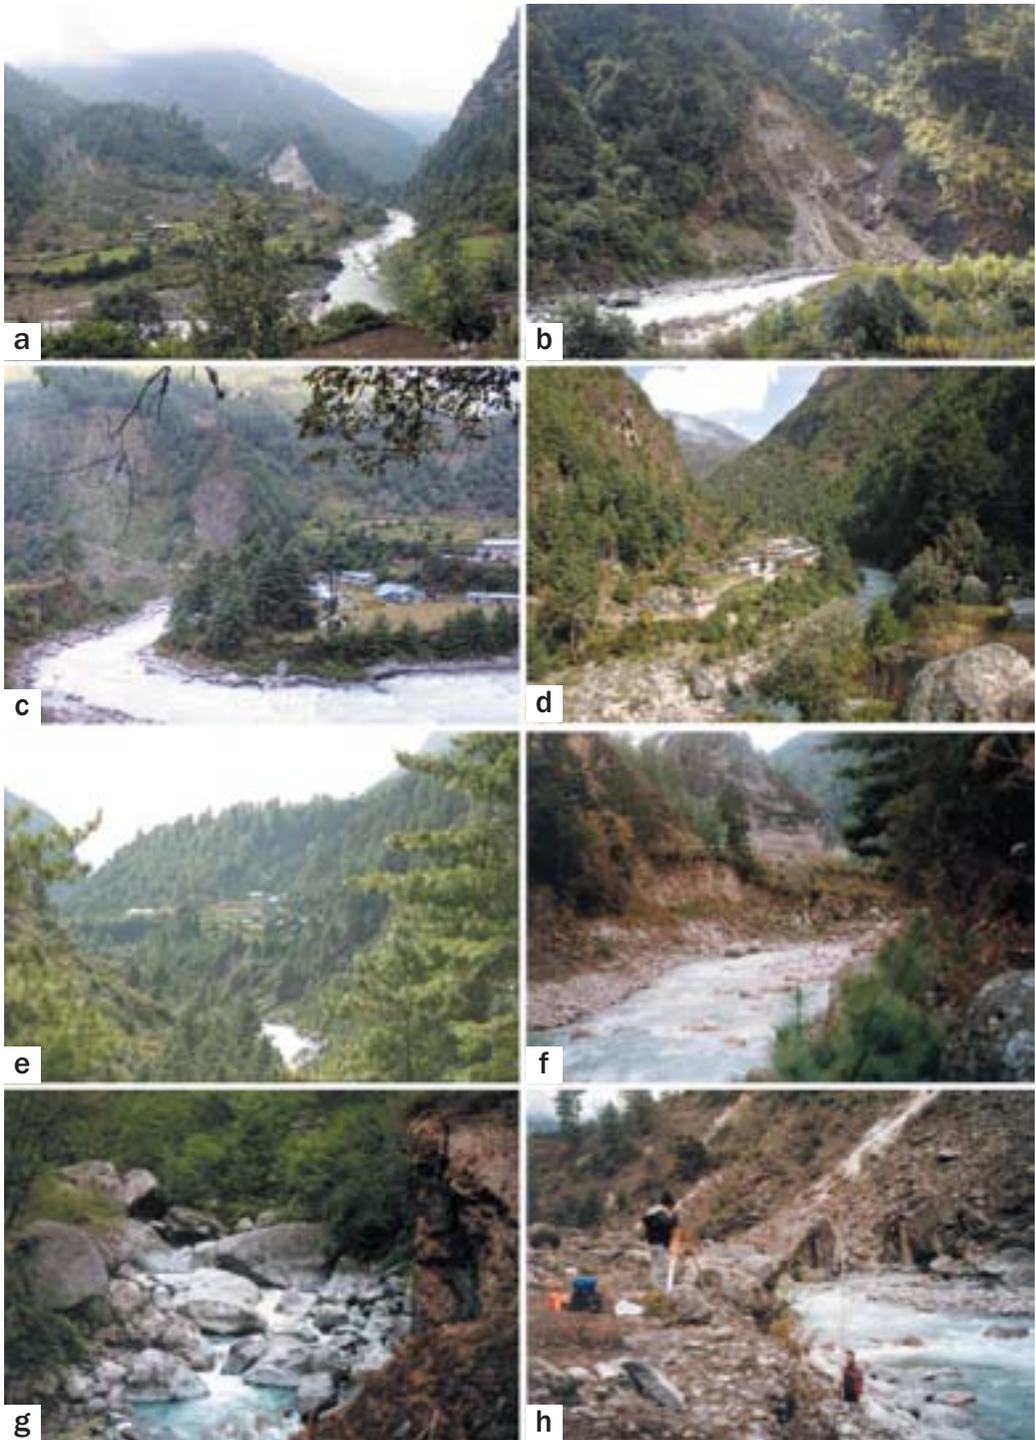
**Figure 5.27:** Vulnerable river sections near main villages (between Larja dovan and Ghat) in the Dudh Koshi valley: a) Chutawa village and surroundings; b) Lateral erosion at Benkar village; c) Phakding village on the lower terrace near a river bend; d) Jorsalle village on the lower terrace looking upstream; e) River section at Tok Tok village; f) Status of bank erosion downstream of Jorsalle in 1996; g) Situation of river section downstream of Nakchun in 1996; h) The unstable riverbank downstream of Ghat in 1996

Most of the bridges, agricultural land, and settlements of Ghat, Nurnin, Chutawa, Chermadin, Dukdinma, Phakding, and Benkar lie on lower terraces that could be overtopped by debris and flood from a GLOF at Lake Imja Tsho (Figure 5.27). The cultivated land and settlements of Chuthawa, Chermading, Phakding, and Benkar are directly at high risk from a GLOF event and could also suffer damage from secondary events such as landslides on medium to upper terraces. Since these areas were previously affected by the Dig Tsho GLOF, the likelihood of their being affected by a GLOF event at Lake Imja Tsho is high.

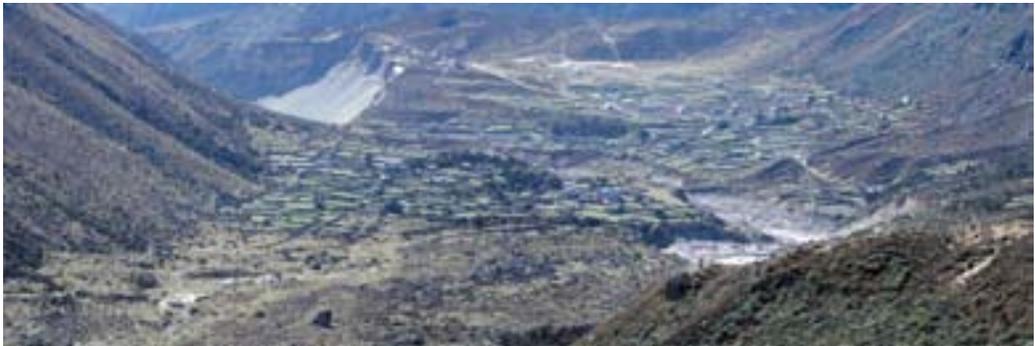
**Figure 5.29:** Hilajun (foreground) and Thamo Teng (background). View downstream of Dig Tsho

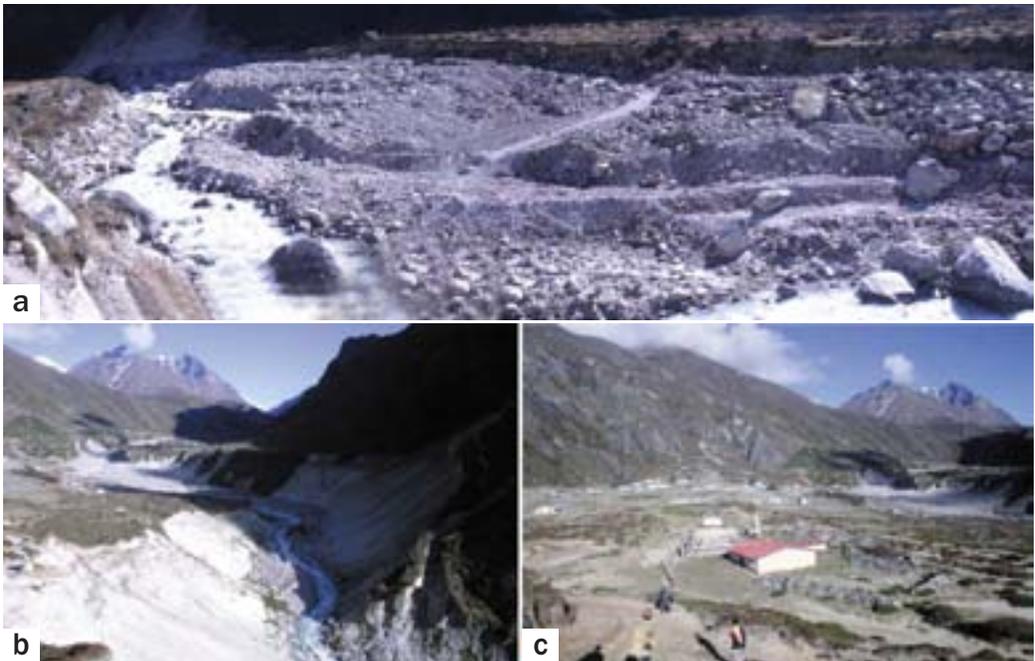
**Figure 5.30:** Erosion and deposition along the Bhote Koshi River: a) Sediment deposition and erosion at a river bend; b) Extensive bank erosion and landslides observed upstream of Thame George; c) Thamo Teng village situated on middle terrace

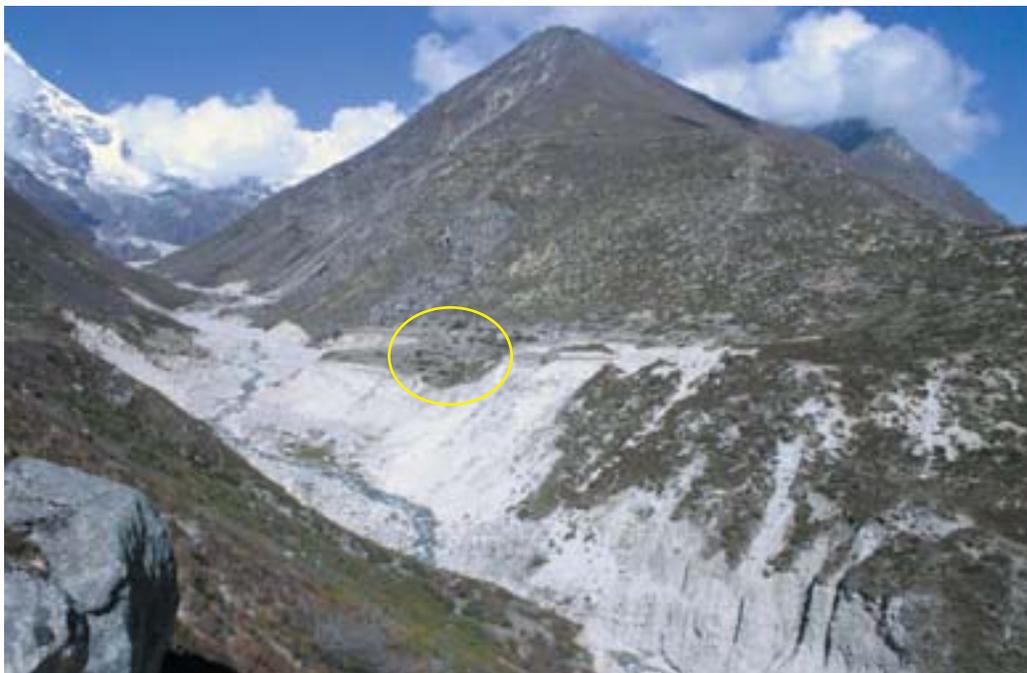
**Figure 5.33:** Precarious position of Mingmo located on the left bank of the Langmoche River with extensive bank erosion. View upstream

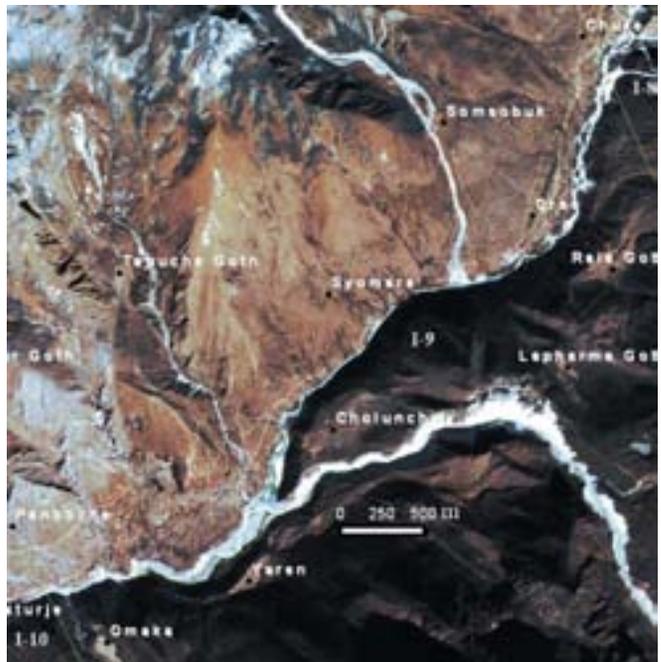
**Figure 5.35:** Concave bend of the Imja Khola at Syomare where bank scouring is expected in the case of a GLOF

Syomare village is a typical example of a high hazard area. This village is situated on a fossil landslide but lies above the high flood level. Any slight lateral erosion at the toe will reactivate the landslide. This village also sits on a concave bend of the Imja Khola; in the case of a GLOF, the flow will reactivate the landslide by scouring its toe and will create a high risk to the village (Figure 5.35). The infrastructure that is at high risk consists of 3 small one-storey wooden house, 11 medium-sized chiselled cement-mortared houses, and 3 large chiselled cement mortared houses (Table 5.3).

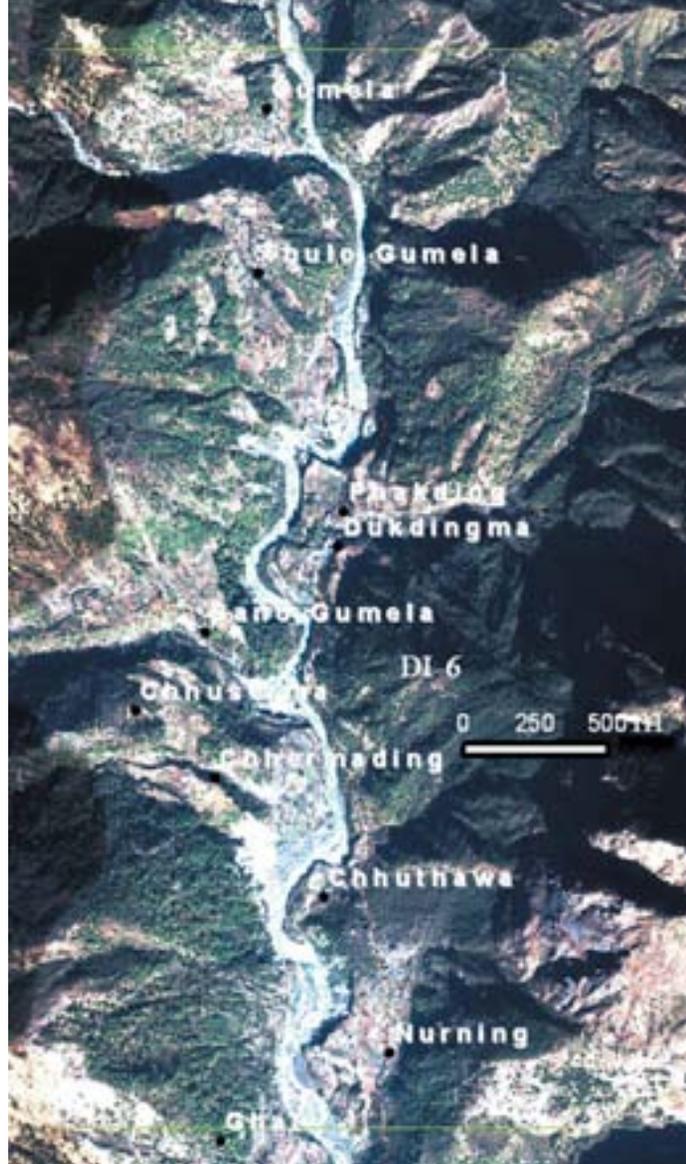
**Figure 5.36:** Phaking and Chermading villages lying on the lower terrace of the Dudh Koshi River

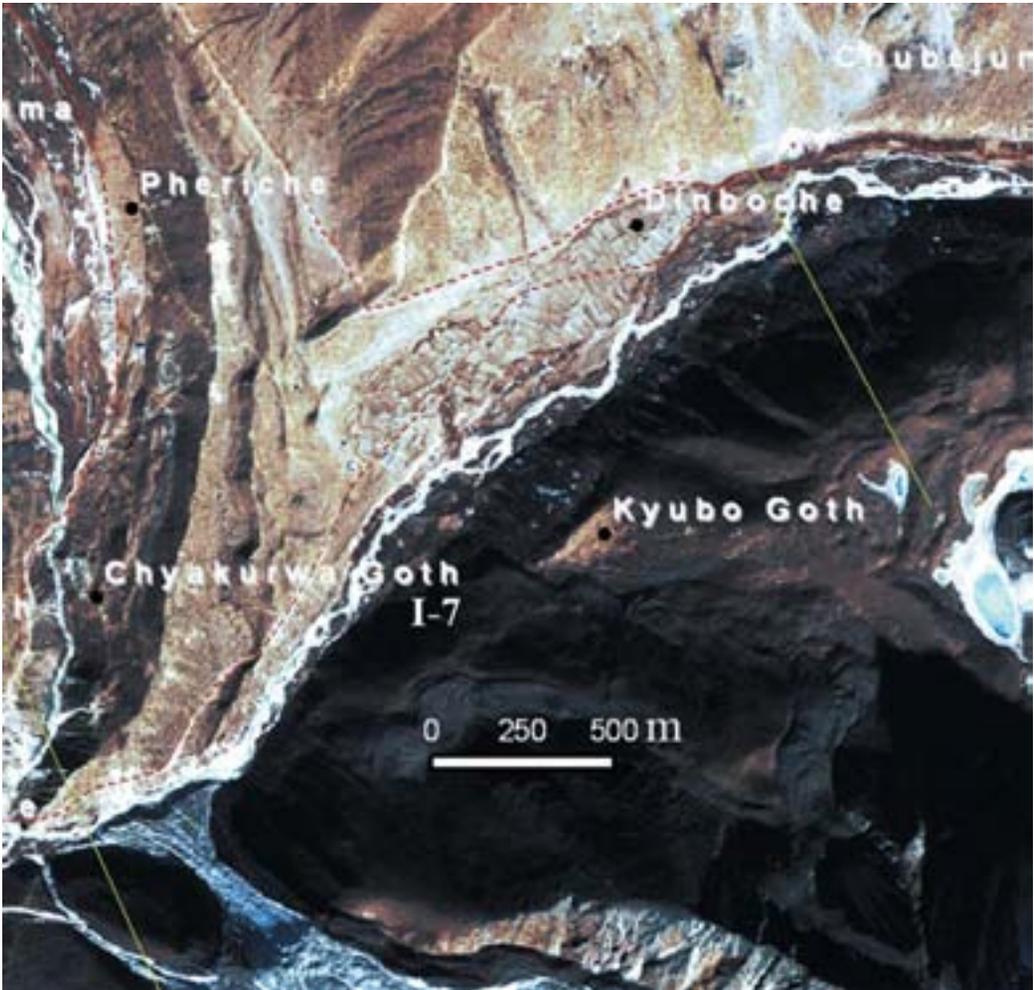
**Figure 5.37:** Dingboche village on the upper terrace in a wide valley of the Imja Khola
