# Chapter 6

## Early Warning Systems and Mitigation Measures

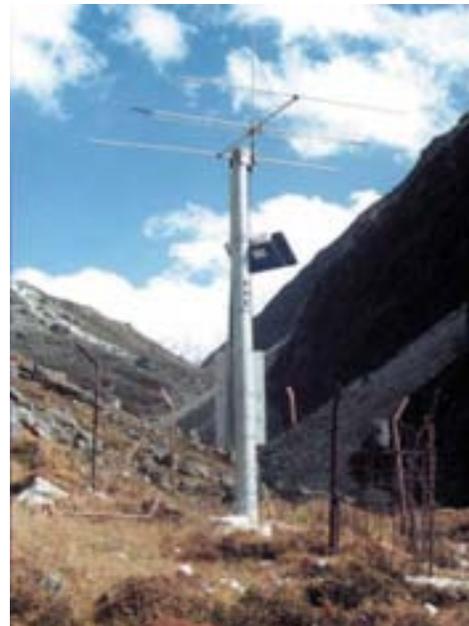
**Figure 6.1:** The transmitter station of Sangma Kharka outside Lake Tsho Rolpa receives signals from sensors and transmits to other remote warning stations.

The sensing system detects the occurrence of a GLOF and transmits relevant information to the transmitter station to initiate the warning process. Six water level sensors are installed at the river channel (immediately downstream of the lake outlet) at Sangma Kharka to detect the onset of a breach. The sensors are connected by armoured and shielded cables to a transmitter station (Figure 6.1) located at a higher elevation within a distance of 80m from the sensors. In the event of a GLOF, the system detects and immediately relays the information. The information is received by all warning stations located downstream within two minutes of initiation of the flood. The warning system is fully automated, redundant and requires no human intervention.

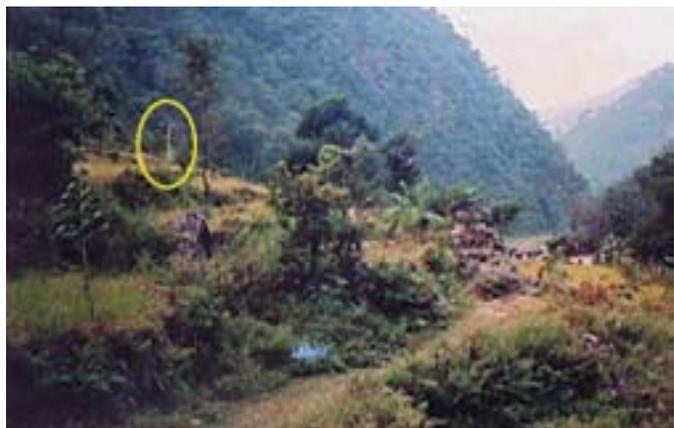
**Figure 6.3:** The early warning system installed at Borle village

A series of 19 GLOF warning stations and relay stations are installed at the 17 villages in the Rolwaling and Tama Koshi valleys (Naa, Bedding, Jyablu, Gongar, Jagat, Totalabari, Borle, Singati, Pikhuti, Nagdaha, Nayapul, Sitali, Kirne, Khimtibesi, Haldibesi, Manthali and Rajagaon) (Figures 6.2, 6.3, and 6.4). In addition, a meteor-burst master station has been installed in the city of Dhanagadhi in western Nepal. The master station provides a communication link between remote stations located in the Rowaling and Tama Koshi valleys and the system monitoring station located in Kathmandu.

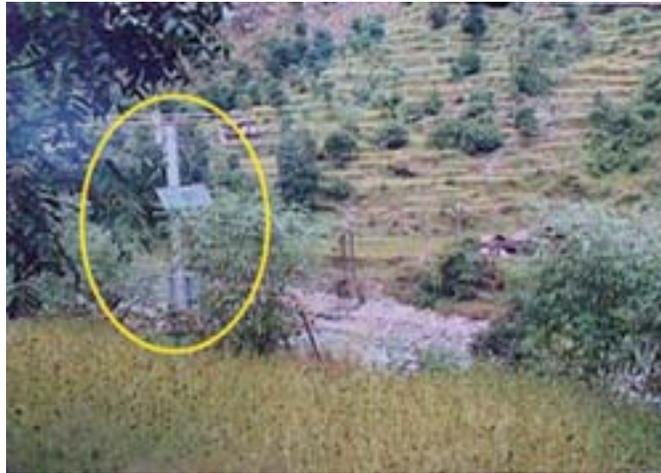
**Figure 6.4:** The early warning system installed at Jagat village

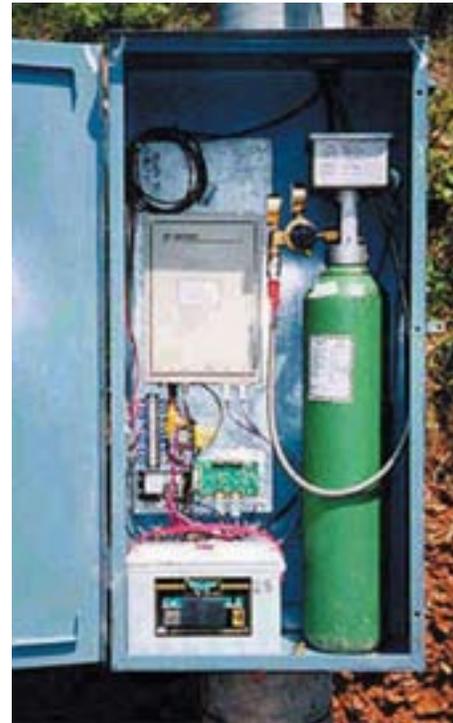
**Figure 6.5:** An MCC 545 unit with 12 V batteries, air cylinder, and MCC-545A RF modem for relay, mounted inside a lockable shelter

An antenna is mounted on an extension to the pole and approximately 5m above the ground. Also mounted on the pole are a lightning rod and a solar panel. The MCC 545 unit, battery, and relay for the horn are mounted inside a sheet metal box with a lockable shelter attached to the pole (Figure 6.5). All cables are protected by a plastic conduit, covered by galvanised

sheet metal and strapped to the pole. An air-powered horn is backed-up by an electric horn. The air horn is designed to operate off a charged air cylinder for a period of two minutes with a reserve for an additional one to two minutes in the event. The electric back-up horn will operate for four minutes. The air horn provides a sound of 80dB up to a minimum distance of 150m under the most adverse conditions (Bridges 99, 2001).

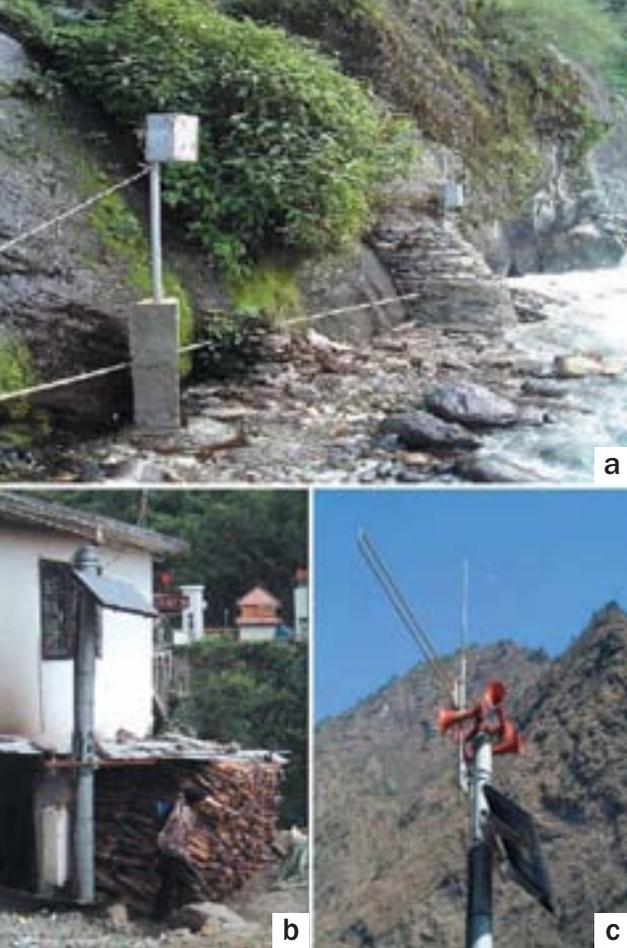
**Figure 6.6:** GLOF Sensor and early warning system in the Bhote Koshi, (a) Sensor at River Level, (b) Sensor at Friendship Bridge, (c) Early warning system siren

The early warning system installed in the Upper Bhote Koshi Hydroelectric Project (UBKHEP) is similar to the one that is part of the TRGRRP. There are two remote sensing stations with data loggers near the Friendship Bridge designated to receive, analyse, and transmit data from sensors. When the water level increases significantly, the system transmits evacuation warning signals to the warning stations installed at the intake and the powerhouse (Figure 6.6). The fully redundant warning systems consist of seven GLOF detection sensors at the Friendship Bridge, one ultrasonic water level measuring device, and six float type water level switches (Figure 6.7). It operates on short-burst VHF radio signals using meteor burst technology. As a result, warning sirens are set off from compressed air horns, which transmit the sound of 127 dB at a minimum distance of 100 feet. There are five such stations along the river.

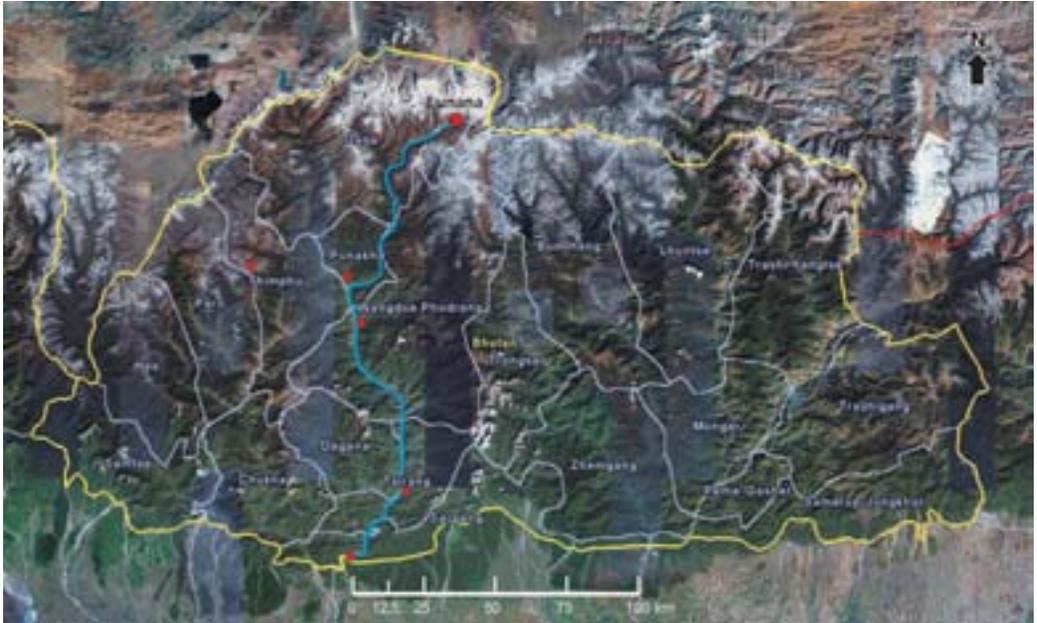
**Figure 6.10:** Manually operated early warning stations in the Pho Chu valley. Red dot: wireless station; Blue line: Pho Chu River

A manually operated early warning system was installed in the Lunana region by the Flood Warning Section (FWS) under the Department of Energy (DoE). In this system, two staff members from the FWS are stationed in the Lunana lake area and are equipped with both a wireless set and a satellite telephone. They use these to report lake water levels on a regular basis and to issue warnings to downstream inhabitants (in the event of any indications of GLOF). A number of gauges have been installed along the main river as well as at the lakes. These are monitored at various stations at different time intervals depending on the distance from the station and base camp. The station is in regular contact with other wireless stations in the downstream areas along the Puna Tsang Chu, including the villages and towns of Punakha, Wangduephodrang, Sunkosh, Khalikhola, and Thimphu (Figure 6.10).

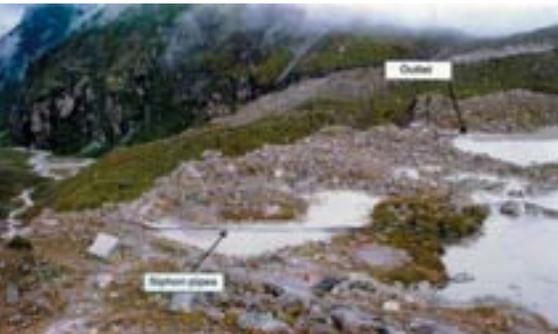
Figure 6.11: Siphon across the end moraine

In 1995 the Netherlands-Nepal Friendship Association successfully installed siphons, from the Wavin Overseas Company, the Netherlands (Figure 6.11), which were used to test the mechanisms and materials required to lower the level of Tsho Rolpa Lake. Three separate siphons, specially designed with fittings to increase the flow, were installed at the lake. The system of siphons consisted of about 100 HDPE plastic pipes and couplings, all of which were transported to the site by local people from the endangered villages. These plastic pipes were light enough that 5m sections could be carried by a single porter, flexible enough to accommodate the broken terrain, and rugged enough to withstand the extreme pressure, temperature, and unusually intense UV radiation. Assembly was possible without the need for skilled labour or special tools.

The three inlet pipes were submerged 15m below the surface of the lake in the deeper part. Water was carried up over the moraine dam, 1.5m above the surface of the lake, and released at a stable site 200m below. The siphon pipes were 16 ft long and 0.25 inches thick with openings of 5.5 inches, and joint couplings 0.8 inches thick. Tests of the trial installation showed that water was being evacuated at a rate of 170 l/sec, but this was not sufficient to have a noticeable impact on the level of the lake. Estimates indicated that an outflow of at least 30 times greater would be required to

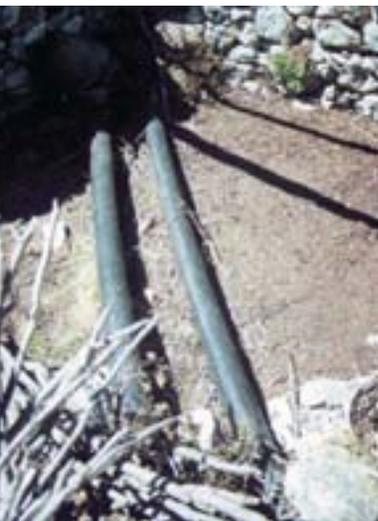
Figure 6.12: The test siphons lying in an open store in Naa village

lower the lake level by 3m. The siphon system worked for 14 months without any maintenance. However, by May 1996, the system was dislocated at three points, and by September 1996 it was out of order. Two months later, for unexplained reasons, the siphon again began to function; however by August 1997 another joint had been broken. The system continued to function under less than optimal conditions (Bridges 99, 2001), and owing to lack of regular maintenance, the joint couplings broke very often. When the water was drained by an open channel outlet, the siphons were removed and distributed to the local people who used them for sewerage management (Figure 6.12).

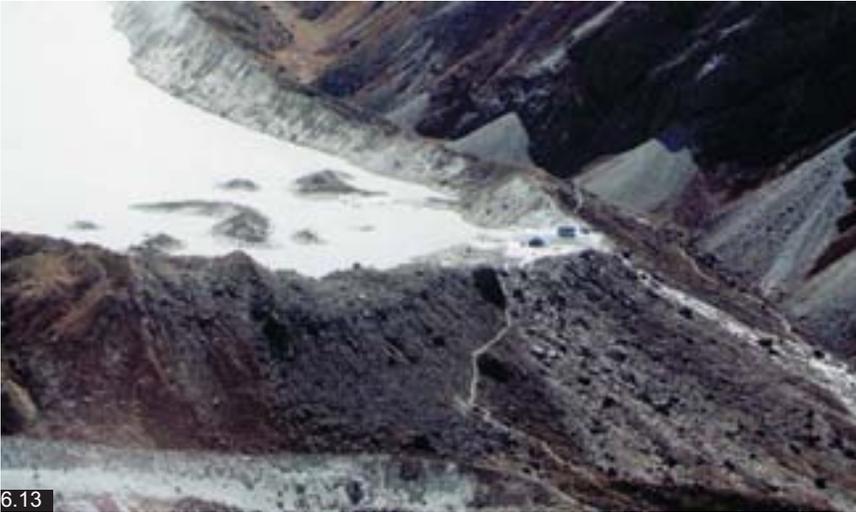
**Figure 6.13:** View of the moraine-dammed lake with a natural spillway (left) and an artificial outlet (right)

In the second approach, the water level in the Tsho Rolpa glacial lake was lowered by opening a channel through the end moraine. The natural spillway of the lake is located in the centre of the end moraine. An outlet channel (70m long, 4.2m wide, 3m deep) was constructed on the left side of the end moraine (Figures 6.13 to 17).

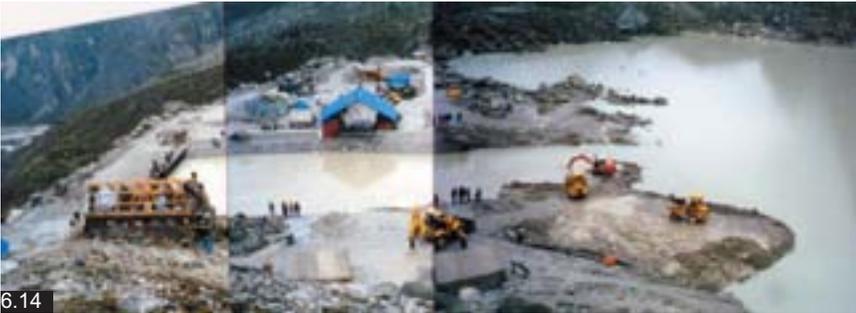
6.14

**Figure 6.14:** Synoptic view of mitigation measures being implemented at the end moraine

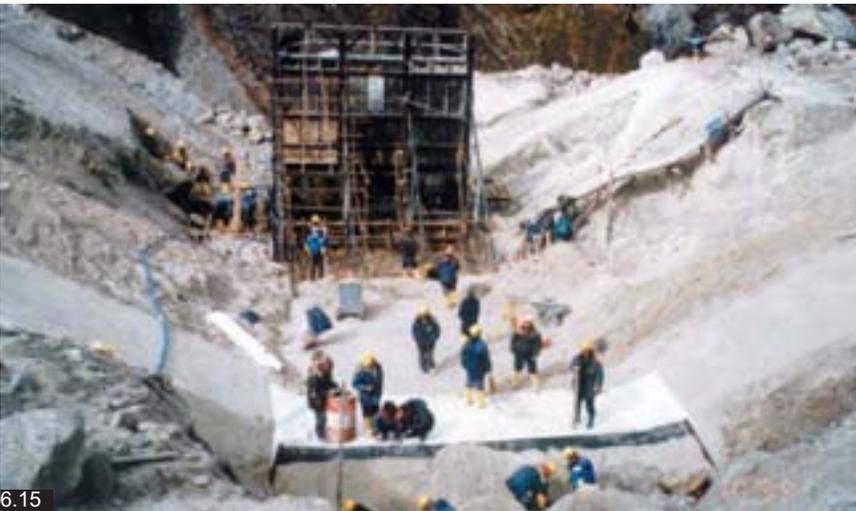
6.15

**Figure 6.15:** Construction of the outlet canal and gates; the canal bed is being covered by geotextile.

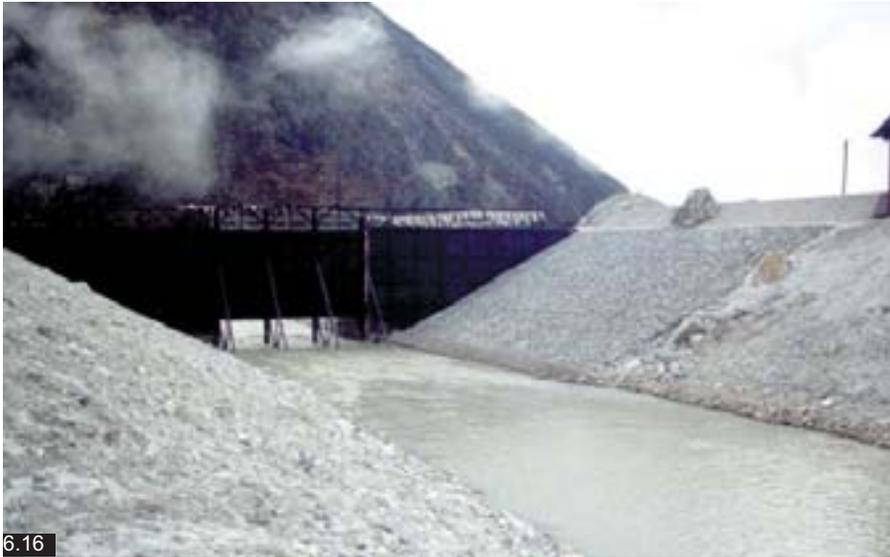
**Figure 6.16:** Completed outlet canal to drain water

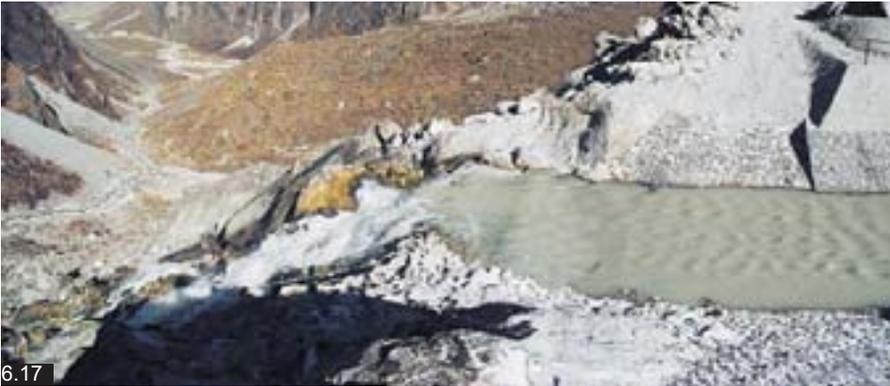
**Figure 6.17:** Spillway of the outlet canal on the moraine
