Plates

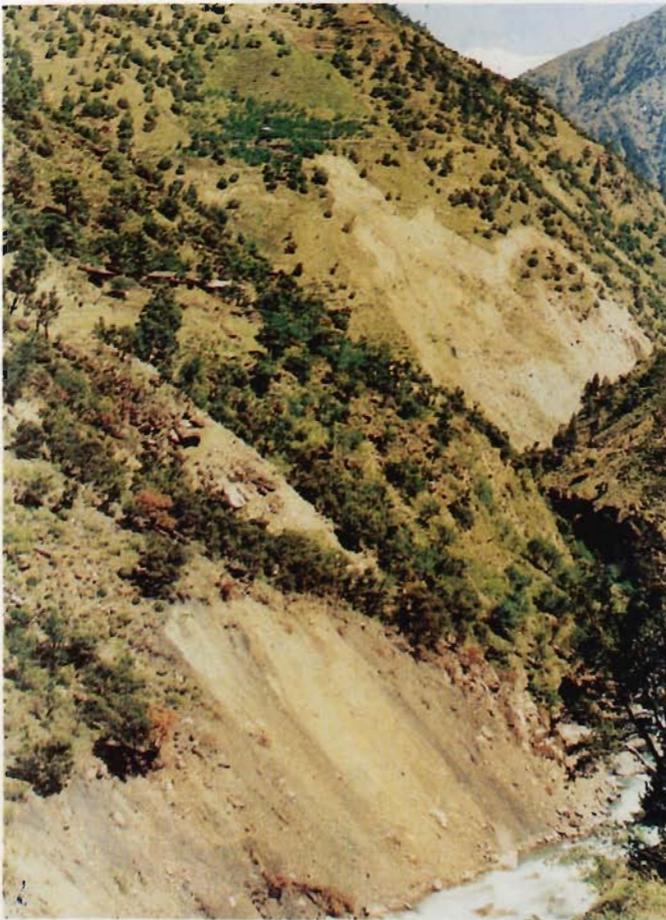
Plate 1: Sapni Slide:
Combination of rotational debris slump and translational slide in the Quaternary overburden with graphitic horizons in the lower and middle valley slope of the Baspa River near the Baspa-Sutlej confluence, NW Himalayas

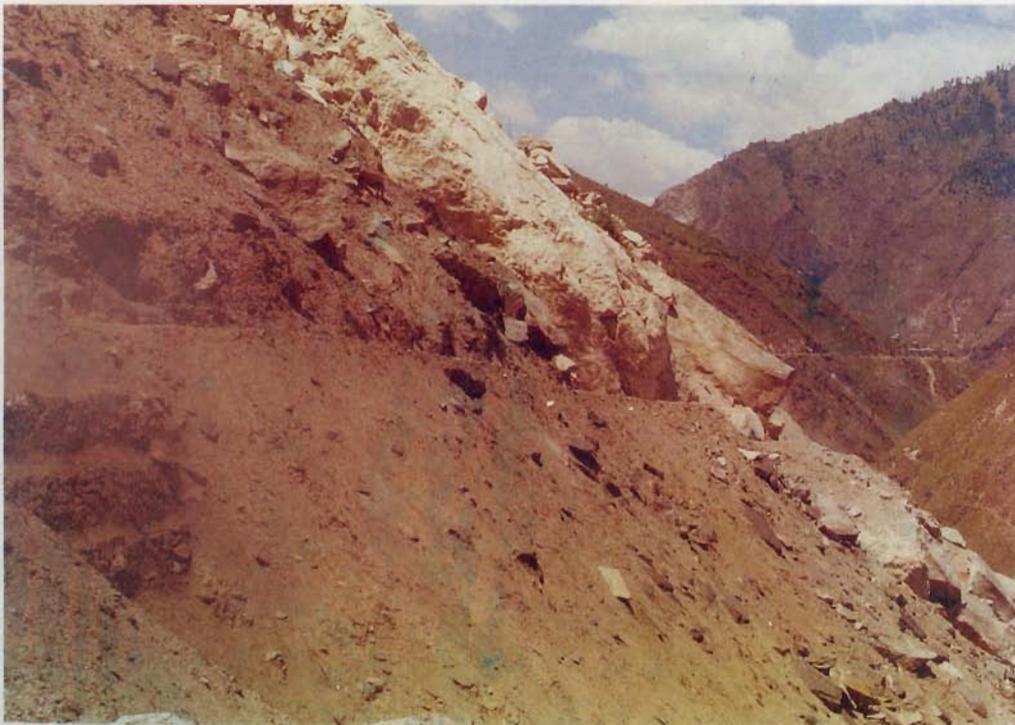
Plate 2: Rockfall : Wedge failure cum debris slide between Wangtu and Nathpa villages near Kandru Khad, NW Himalayas

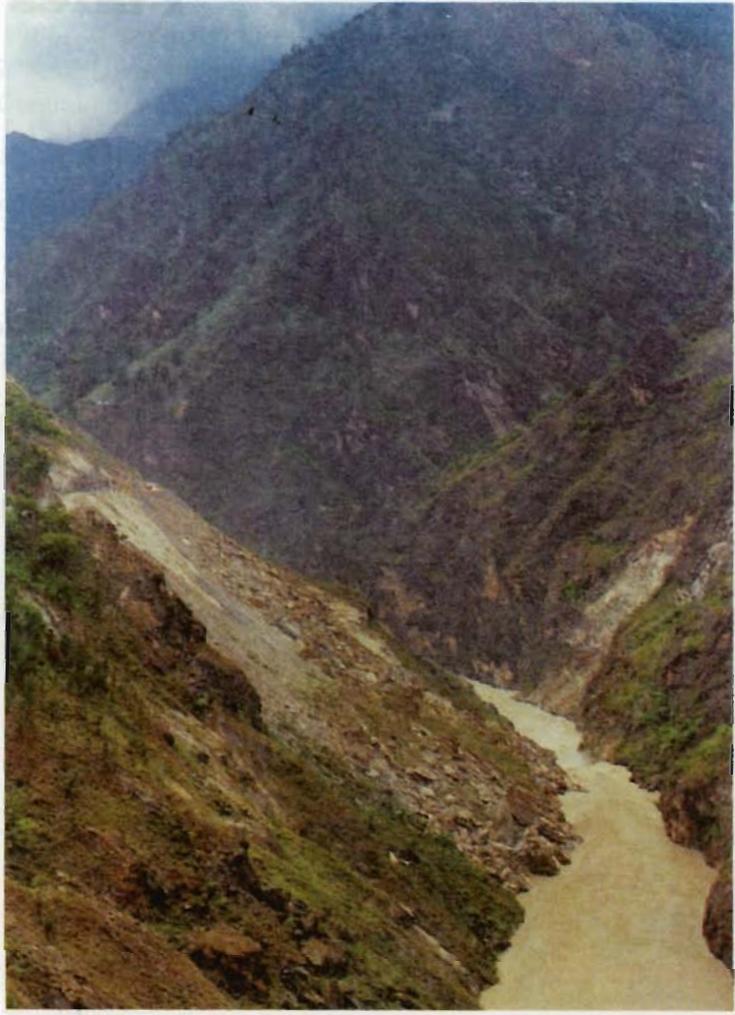
Plate 3: Debris Slide:
Looking from Wangtu
bridge downstream.
This slide is endanger-
ing the HPPWD
Wangtu Rest House,
NW Himalayas

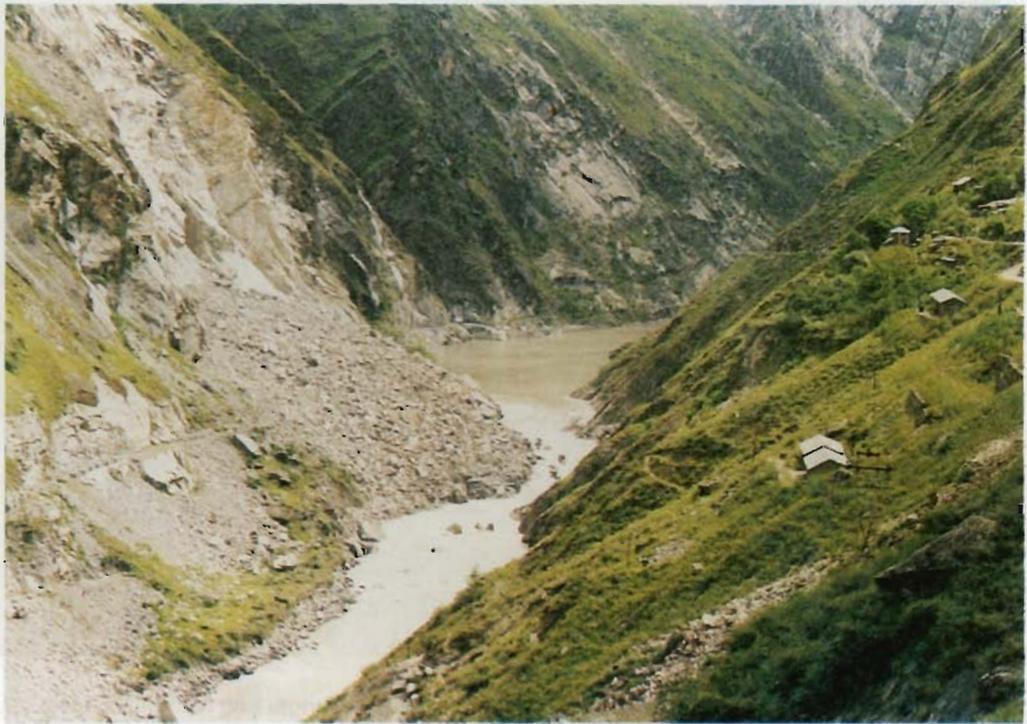
Plate 4: Rockfall cum debris slide: near Nathpa village. This slide has blocked the Sutlej River creating a lake more than one kilometre long, NW Himalayas

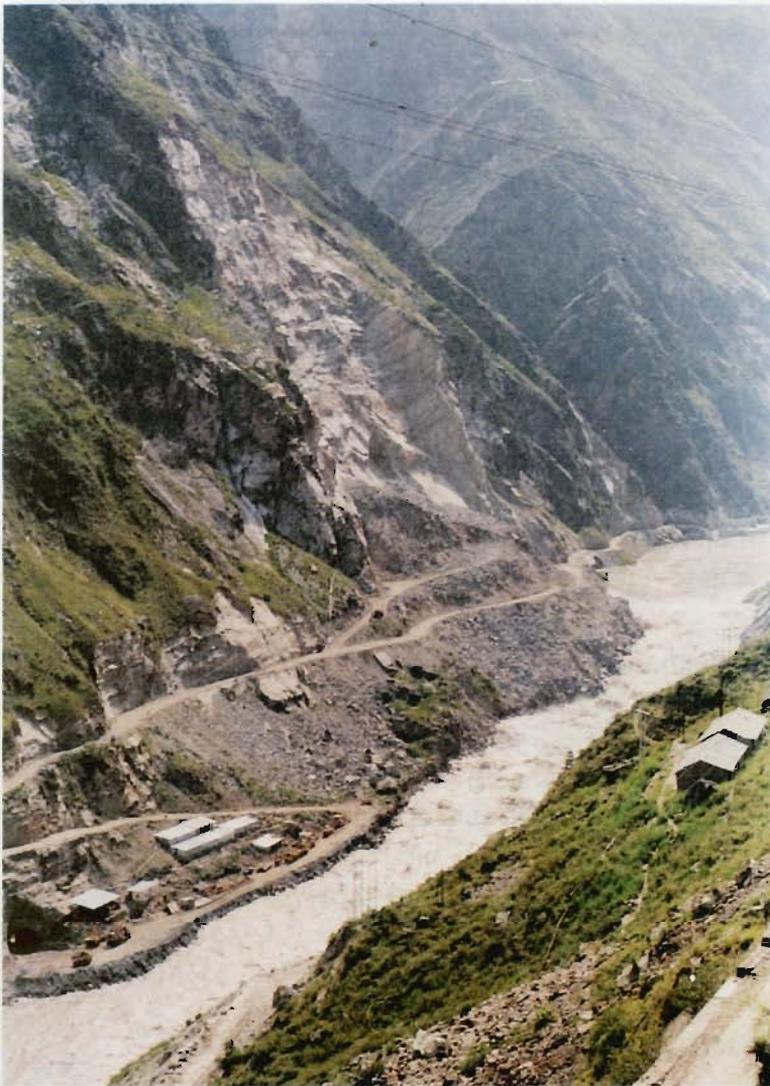
Plate 5:
Translational
debris slide:
near Nathpa
village, NW
Himalayas
